October 17, 2016 COGCC Environmental Field Inspection of CM Productions LLC Margaret Spaulding 2  
(Location ID: 324599, API 057-06273, 057-06062, 057-06080)

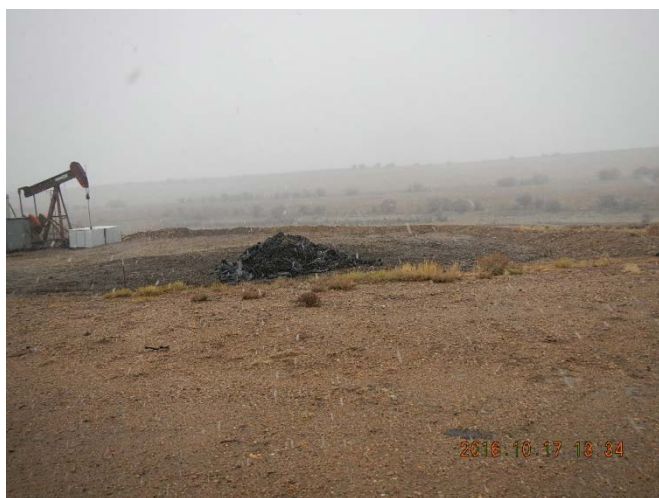
Former treater pit liner stockpiled.

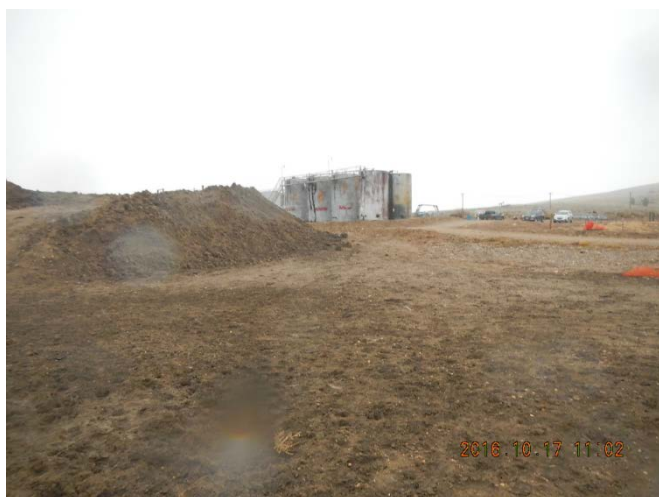
E&P waste stockpile.

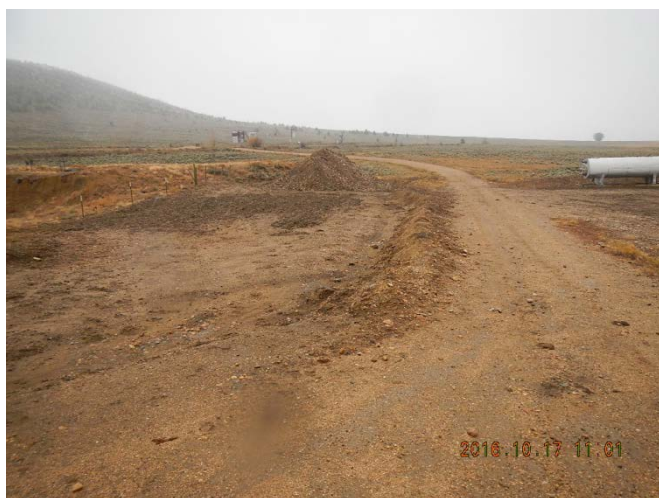
E&P waste stockpile.

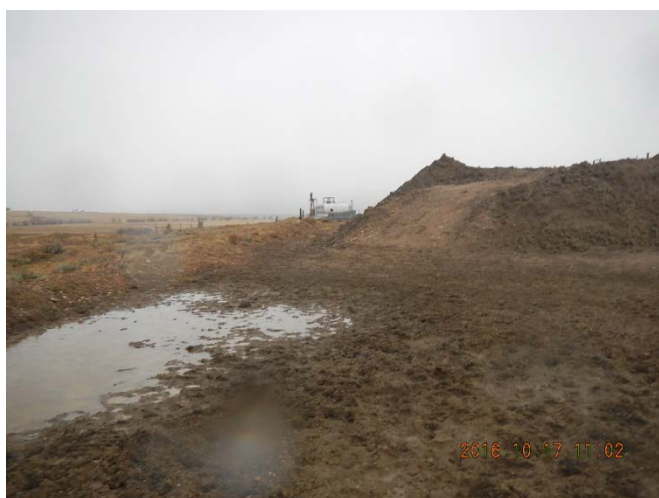
Looking North along west berm and E&P waste stockpile.

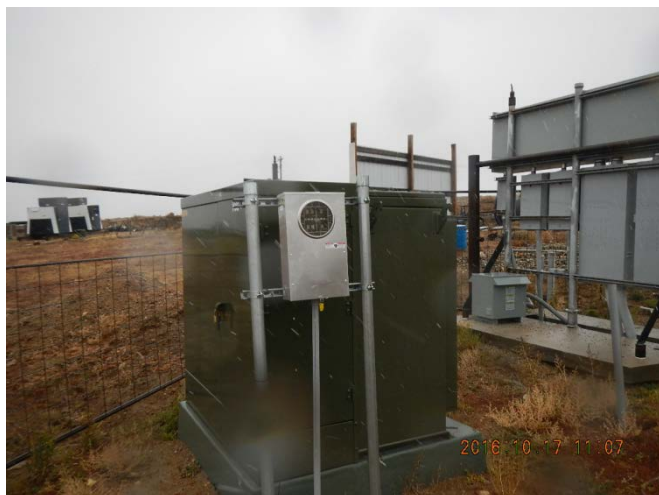
Electrical transformer. Note meter removed.

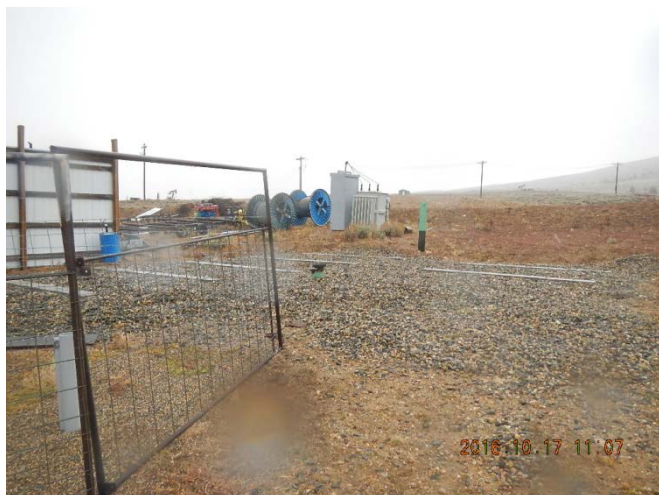
Platform for UIC pump. Note: pipe risers.

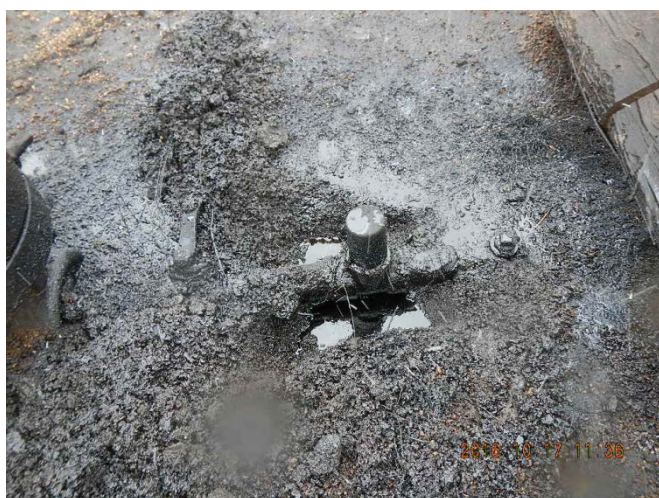
057-06062 possible bull plug leak.

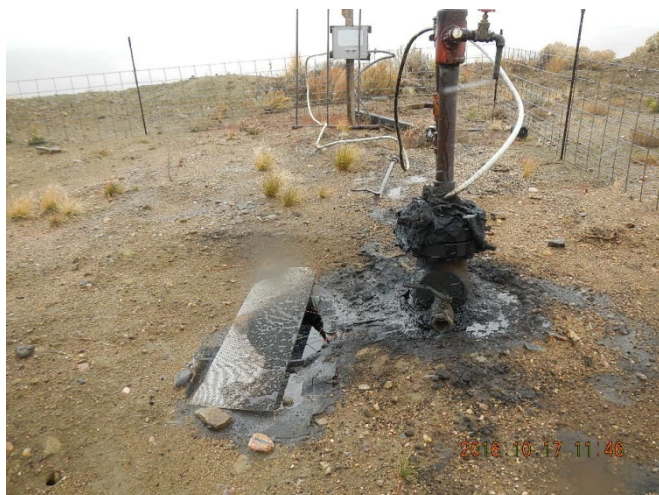
057-06080 Oil with sump and absorbent boom wrapped around well head.

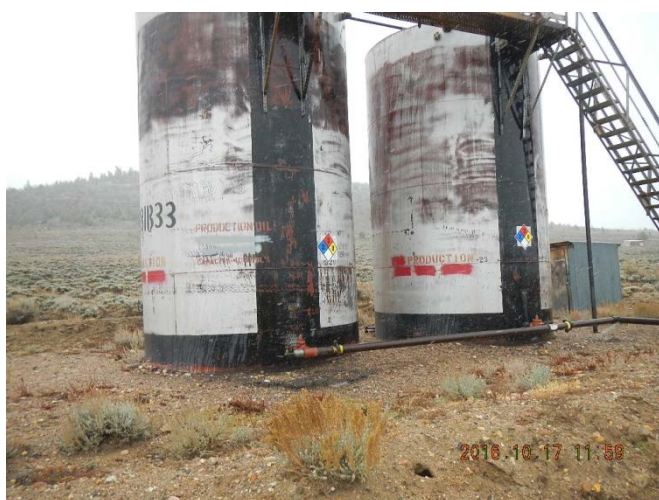
057-06021 Noffinger 1-C tank battery.

Tank # 4, #3, and #2. Tank #5 right side of photo.

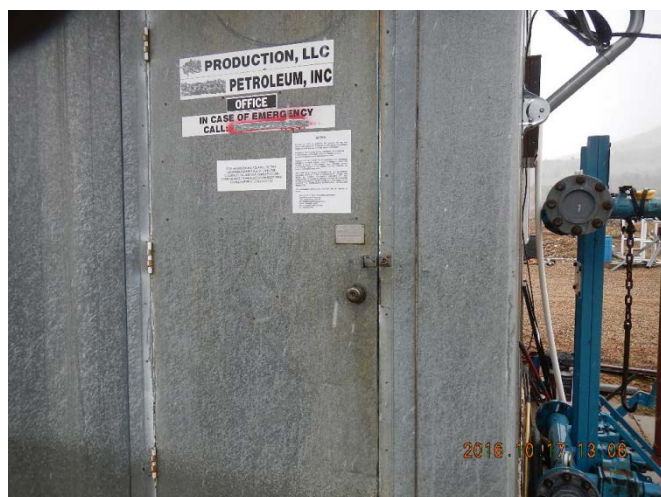
Office with "CM" and "Proven" and emergency contact number removed from signs on the office door. Note: Lock removed by others.

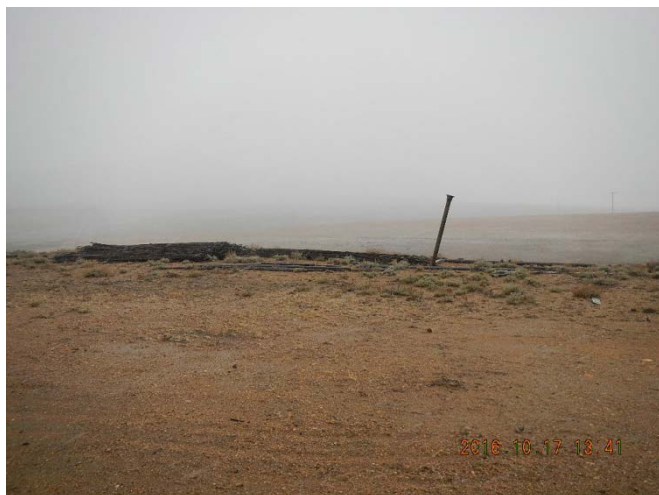
Equipment storage near barn/garage

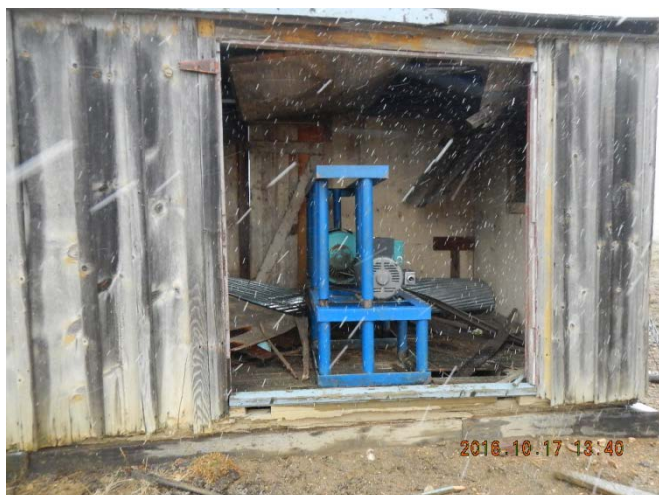
Equipment storage near barn/garage.

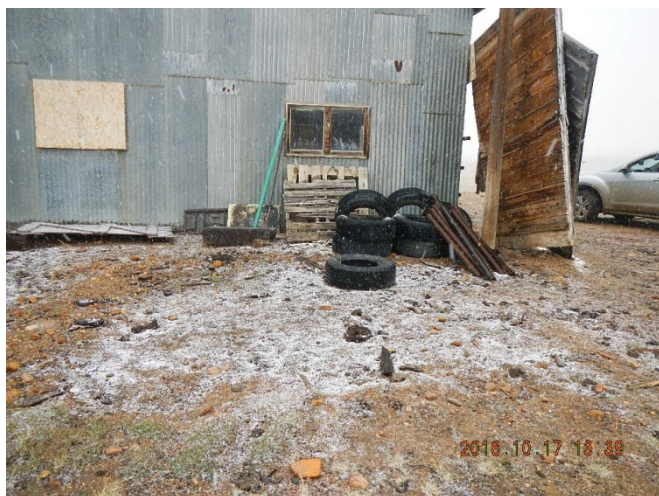
Equipment storage near barn/garage.
