Inspection Photos: TEP Crystal Creek API#045-06476

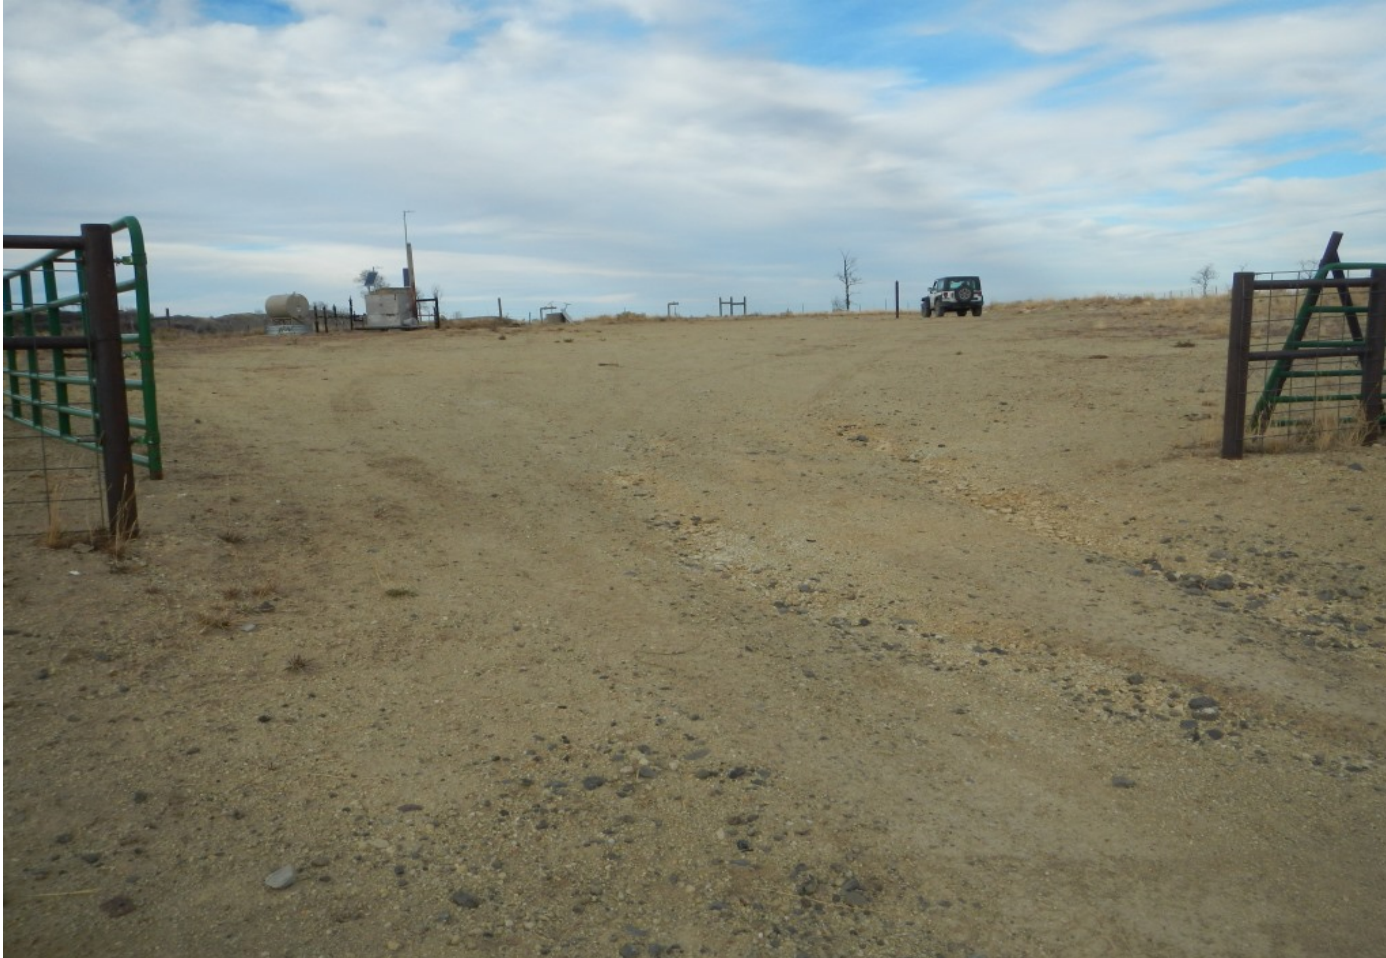
Photo#1: View of Location from Entry Road to NE

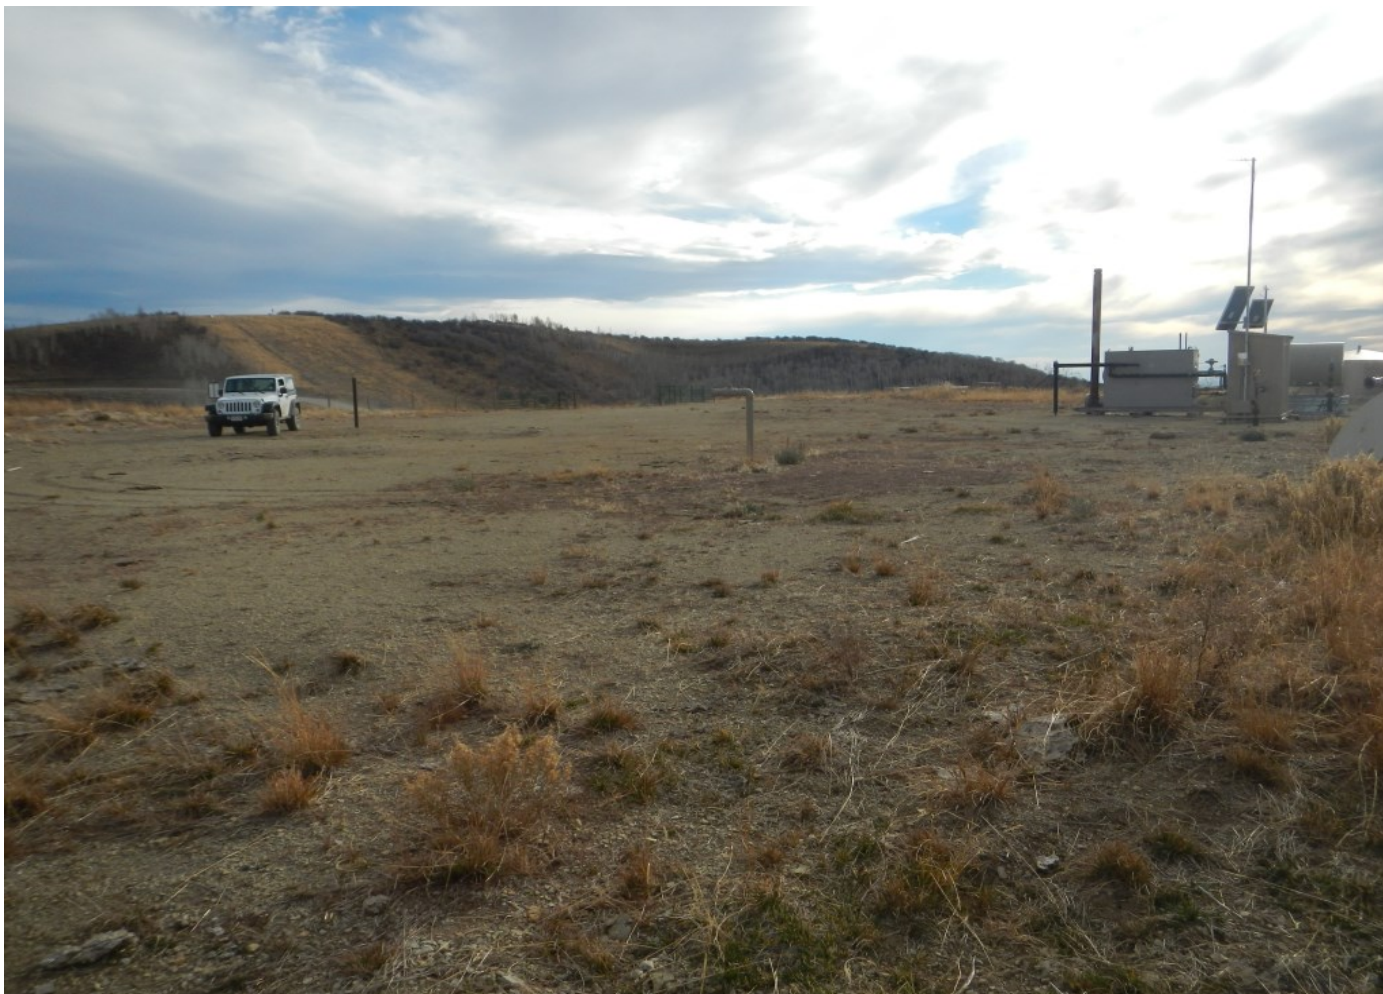
Photo#2: Overview of Location to SE

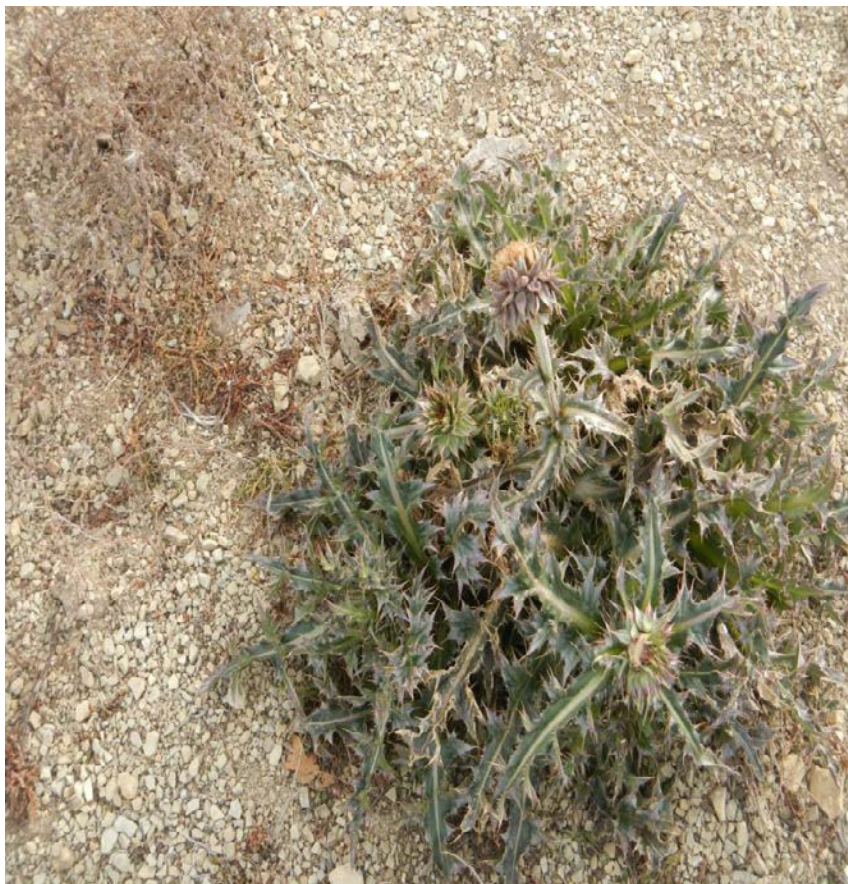
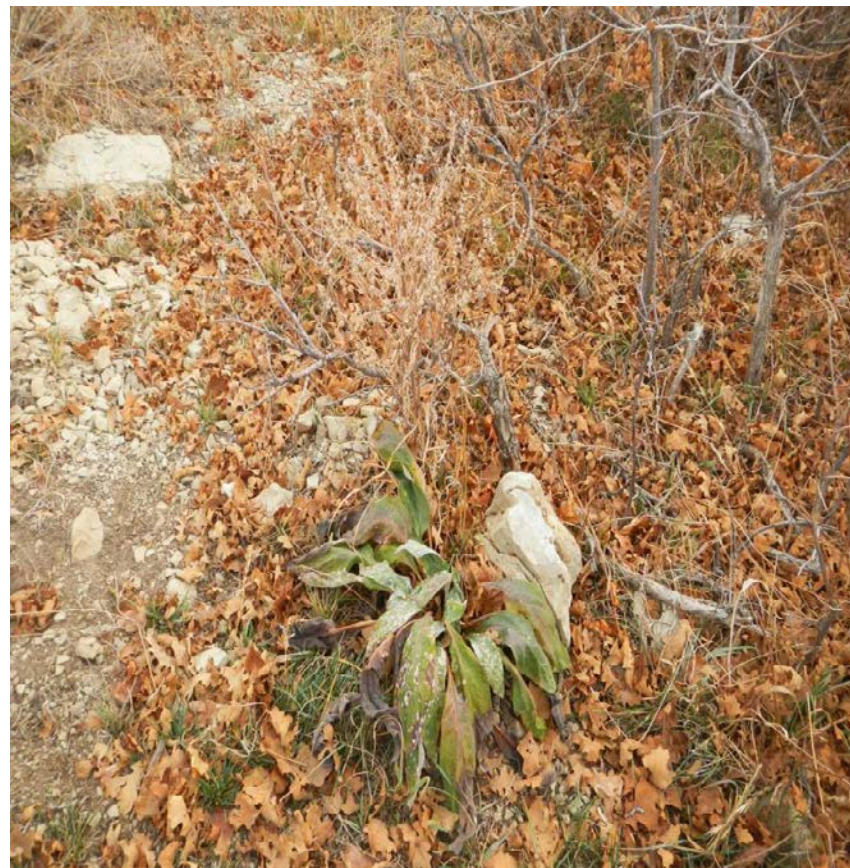
Photos# 3&4:

Noxious Weeds on Location; Houndstongue & Thistle.

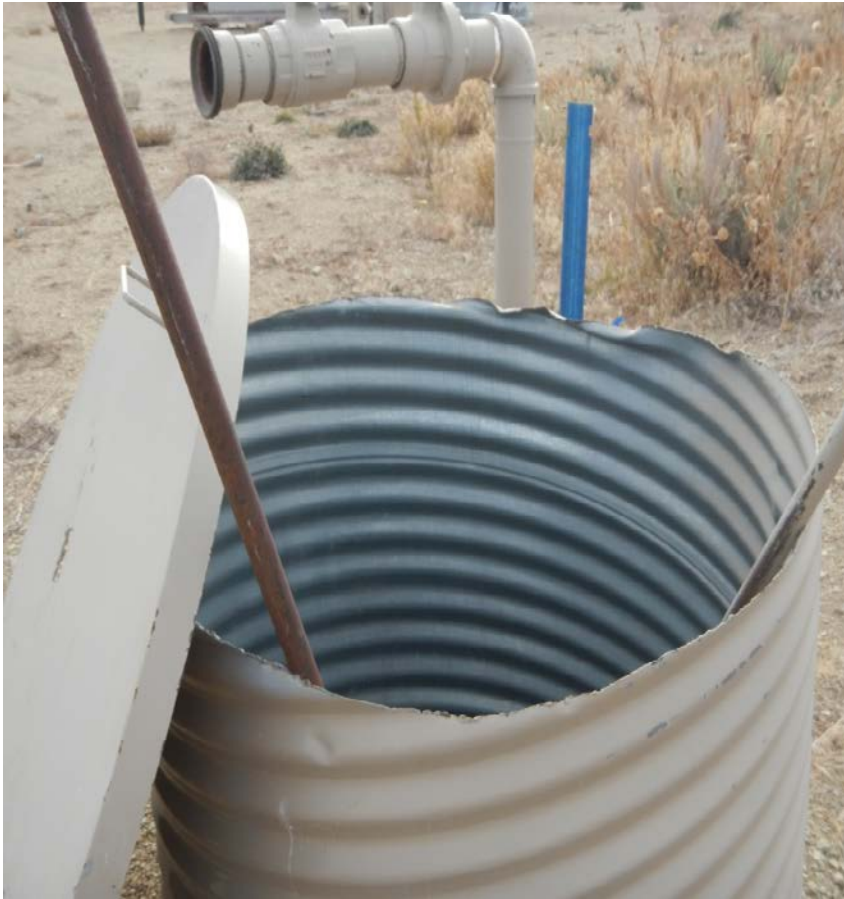
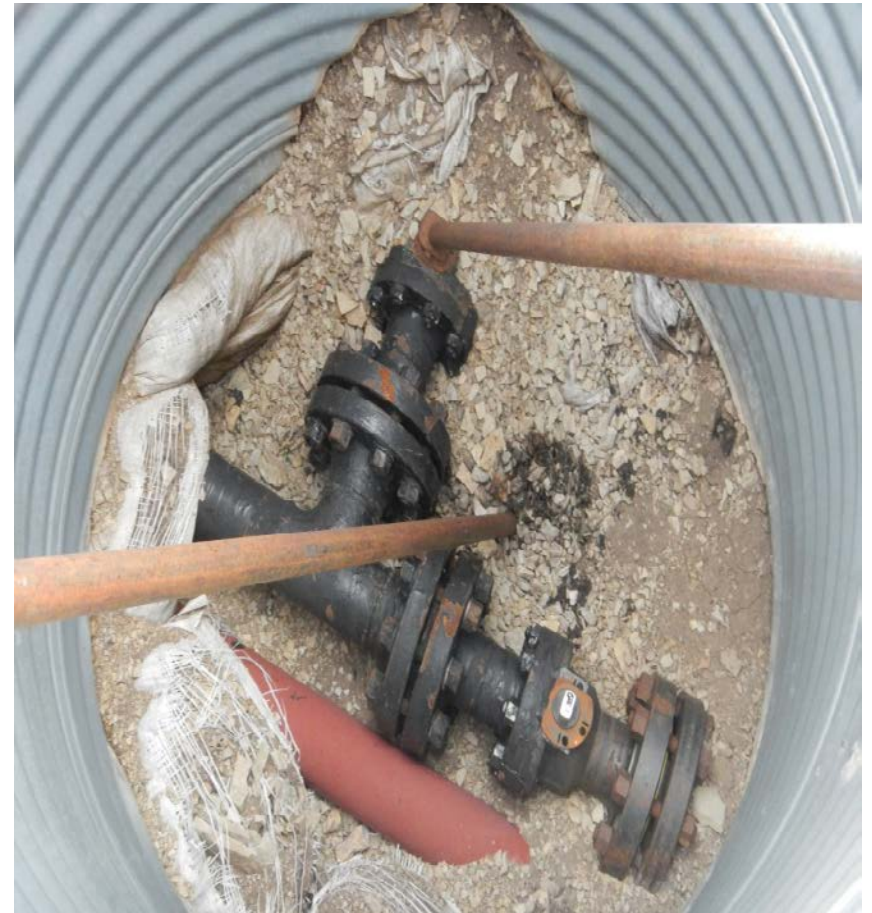
Photos#5&6:
Culverts Housing Lines/Valves are open

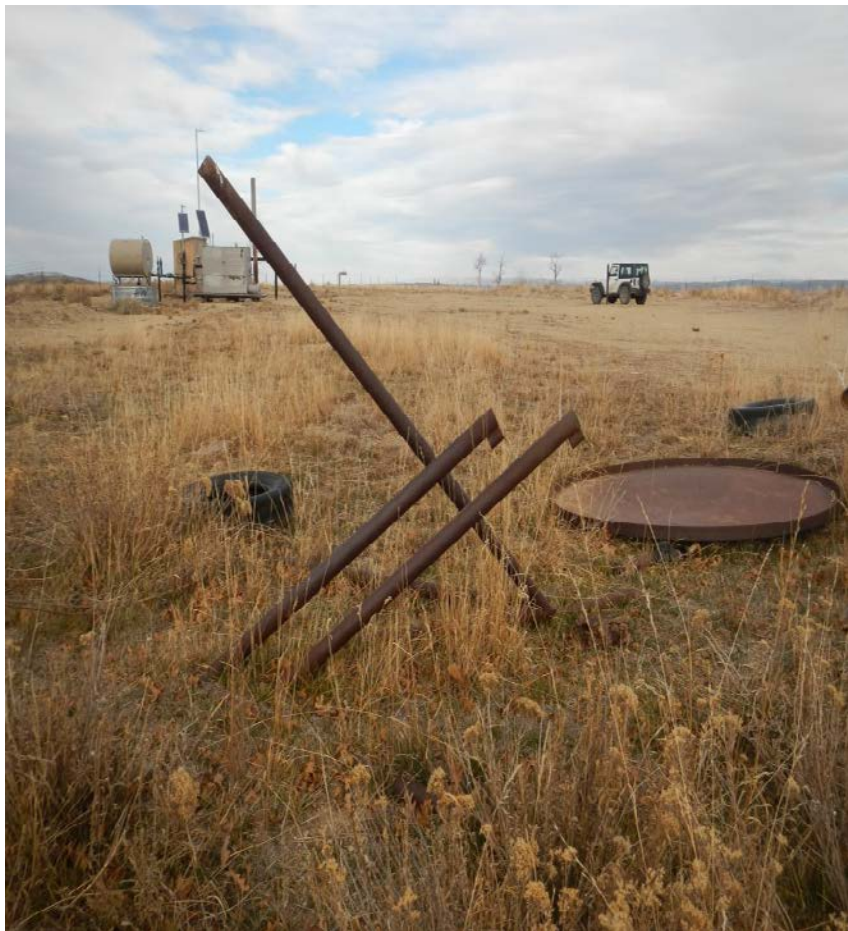
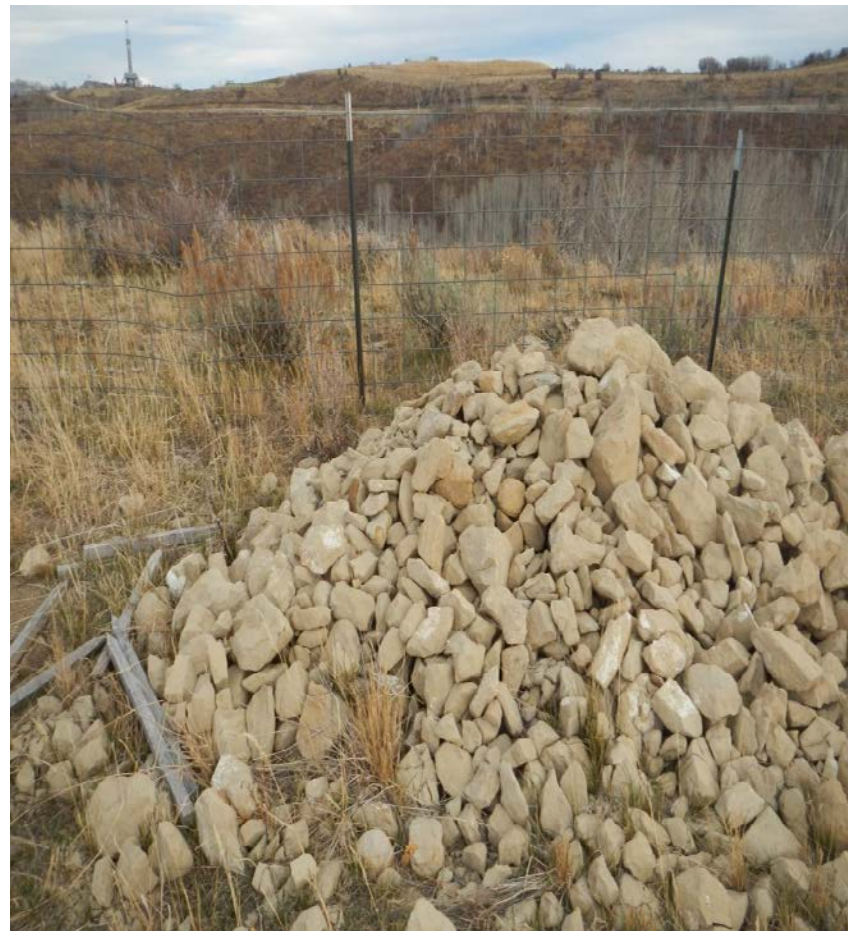
Photos#7&8:
Debris & Materials on Location

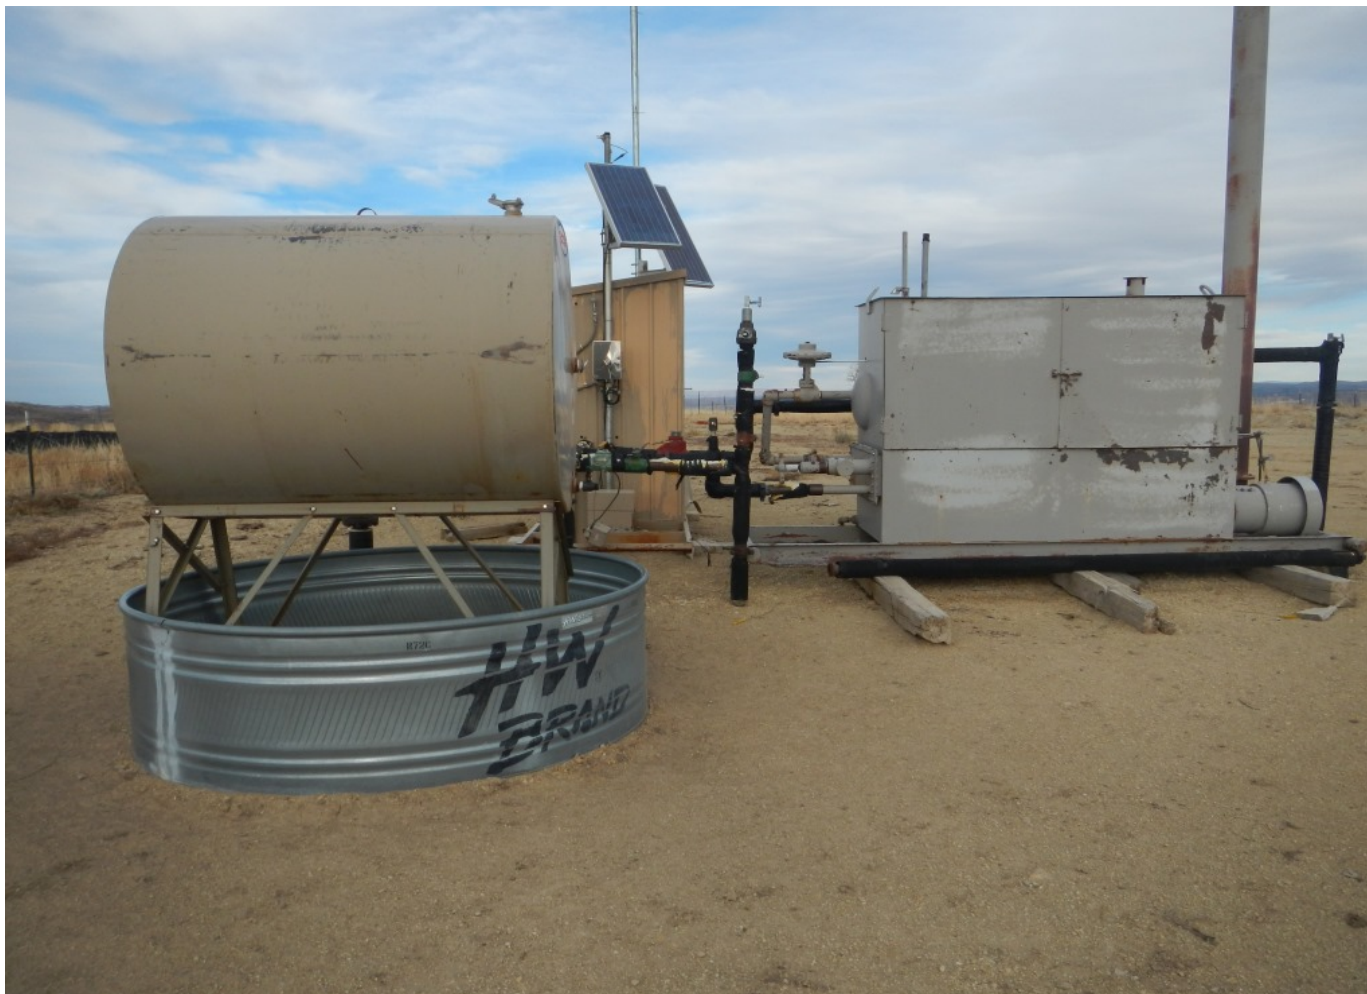
Photo#9: Facilities /Equipment on Location.

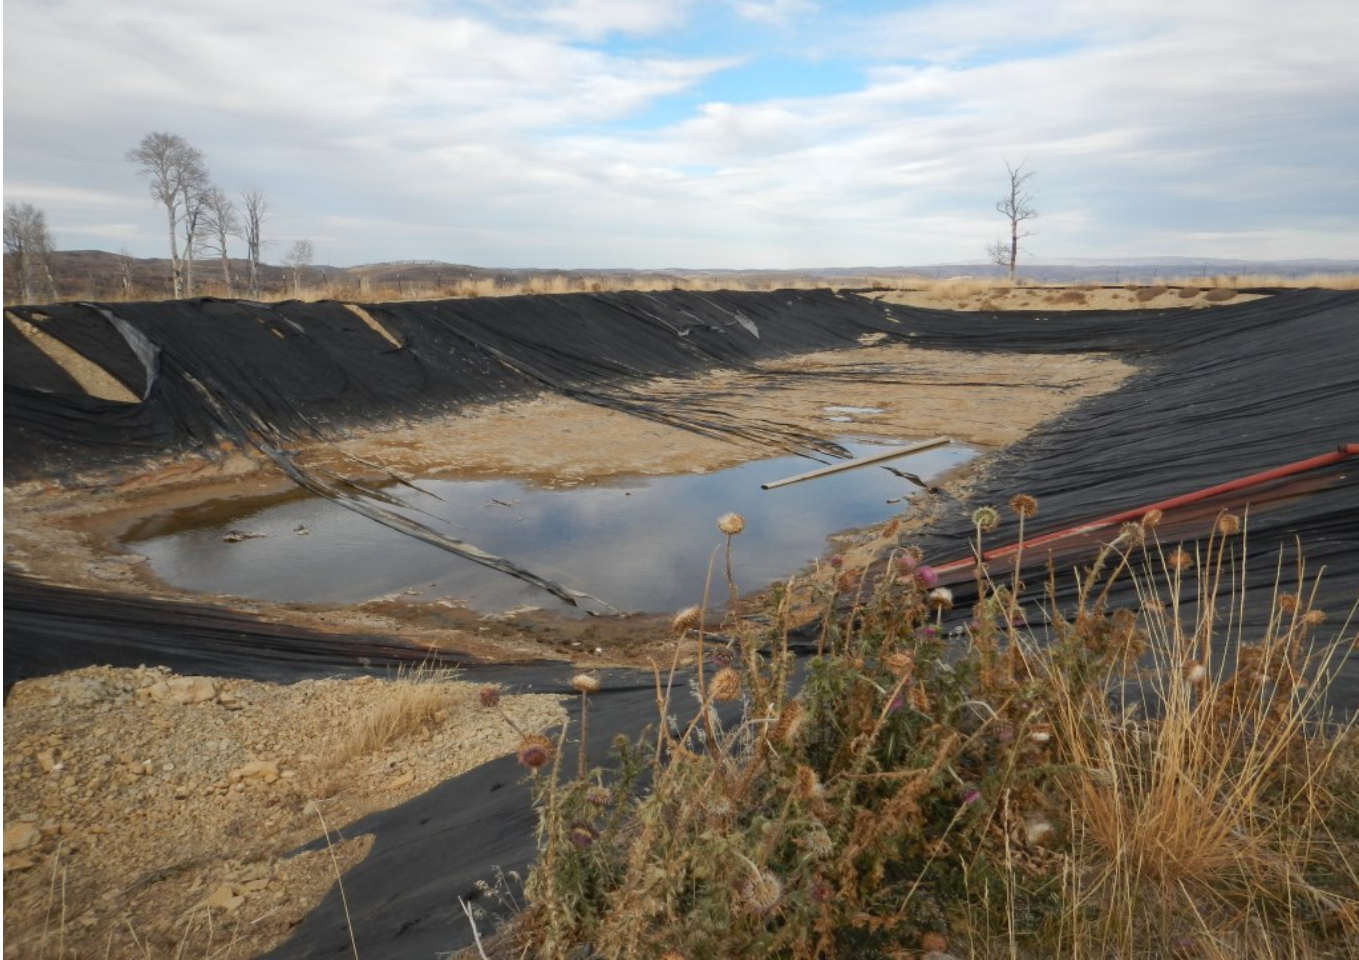
Photo#10: Large Pit Located to North of Well.
