Reclamation Inspection- Overview

Google Earth aerial photo taken 9/7/16 illustrating total disturbance of the Railay #28-3-1 well location. Total area of 10.2 acres (Position dilution of precision (PDOP) = 2.6) was mapped using a Trimble Juno 3B handheld device indicates the location was overbuilt by approximately 3.5 acres.

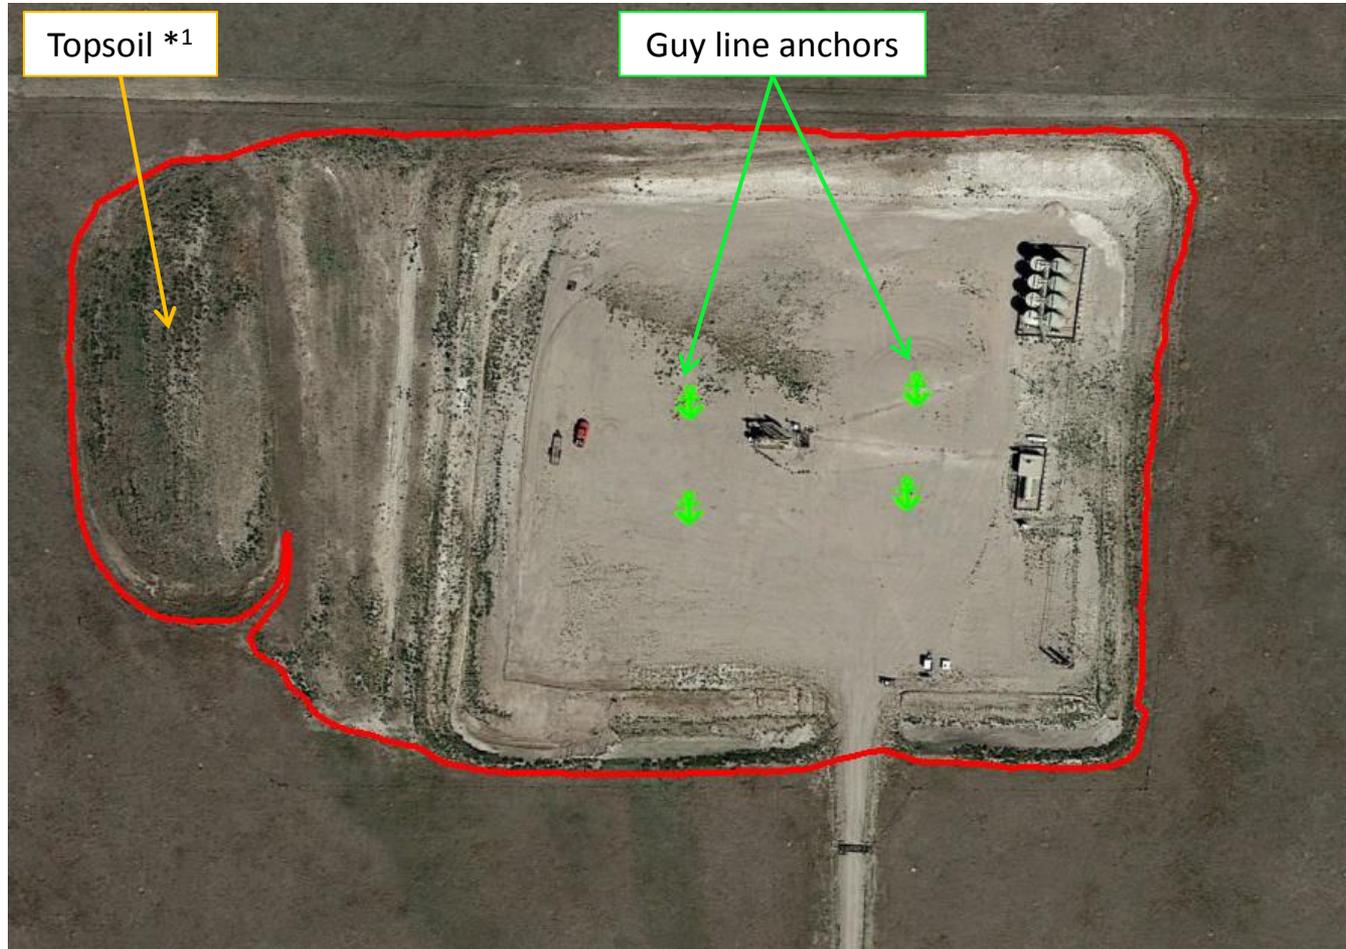
*1 = Possible topsoil stockpile. Stockpile not marked or documented.

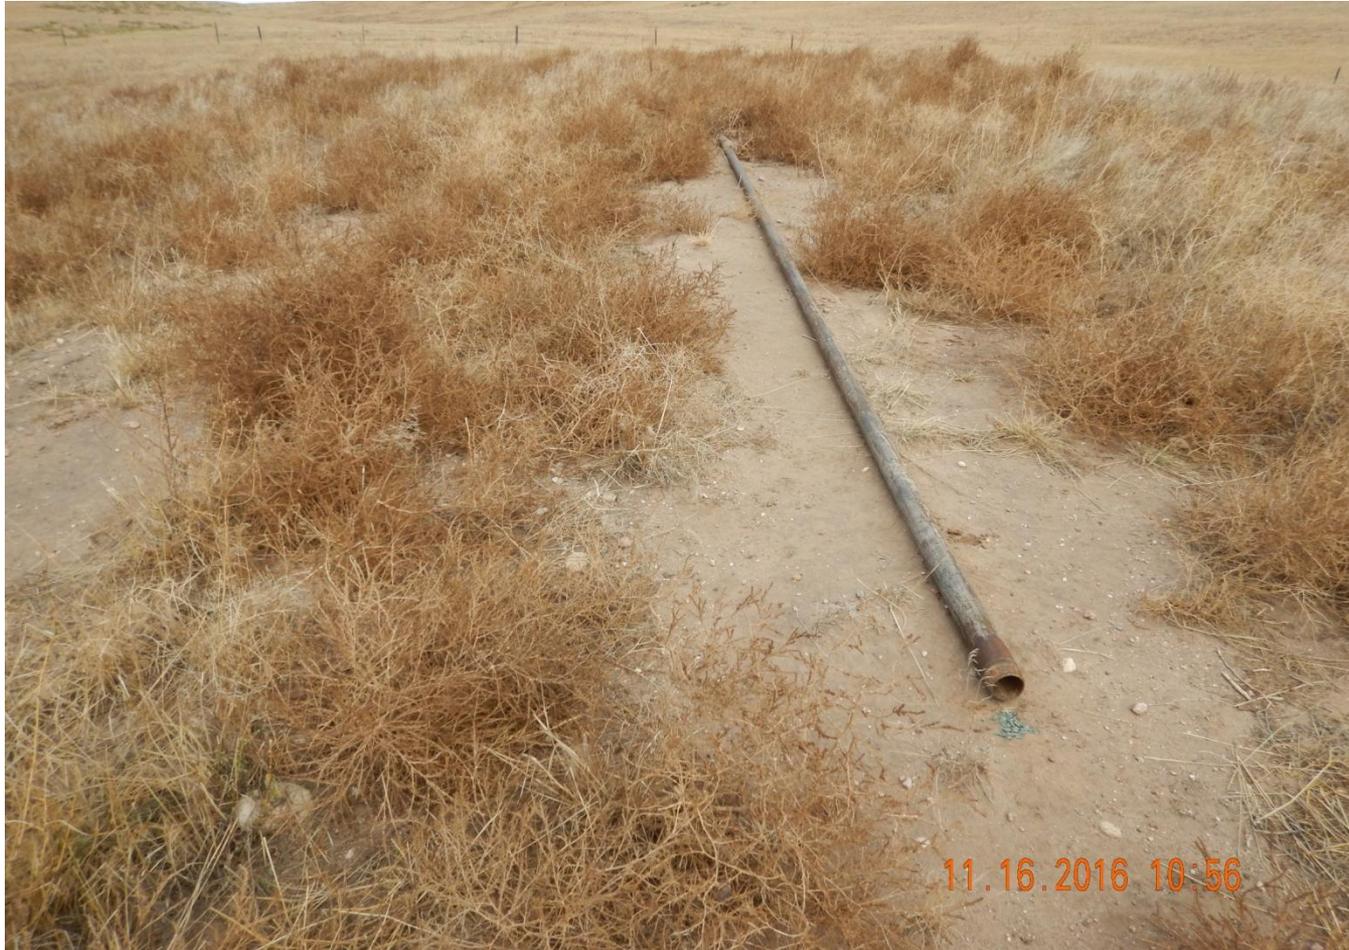
Photo 1. Photo taken of debris on topsoil stockpile. Need to remove debris per Rule 603.f.

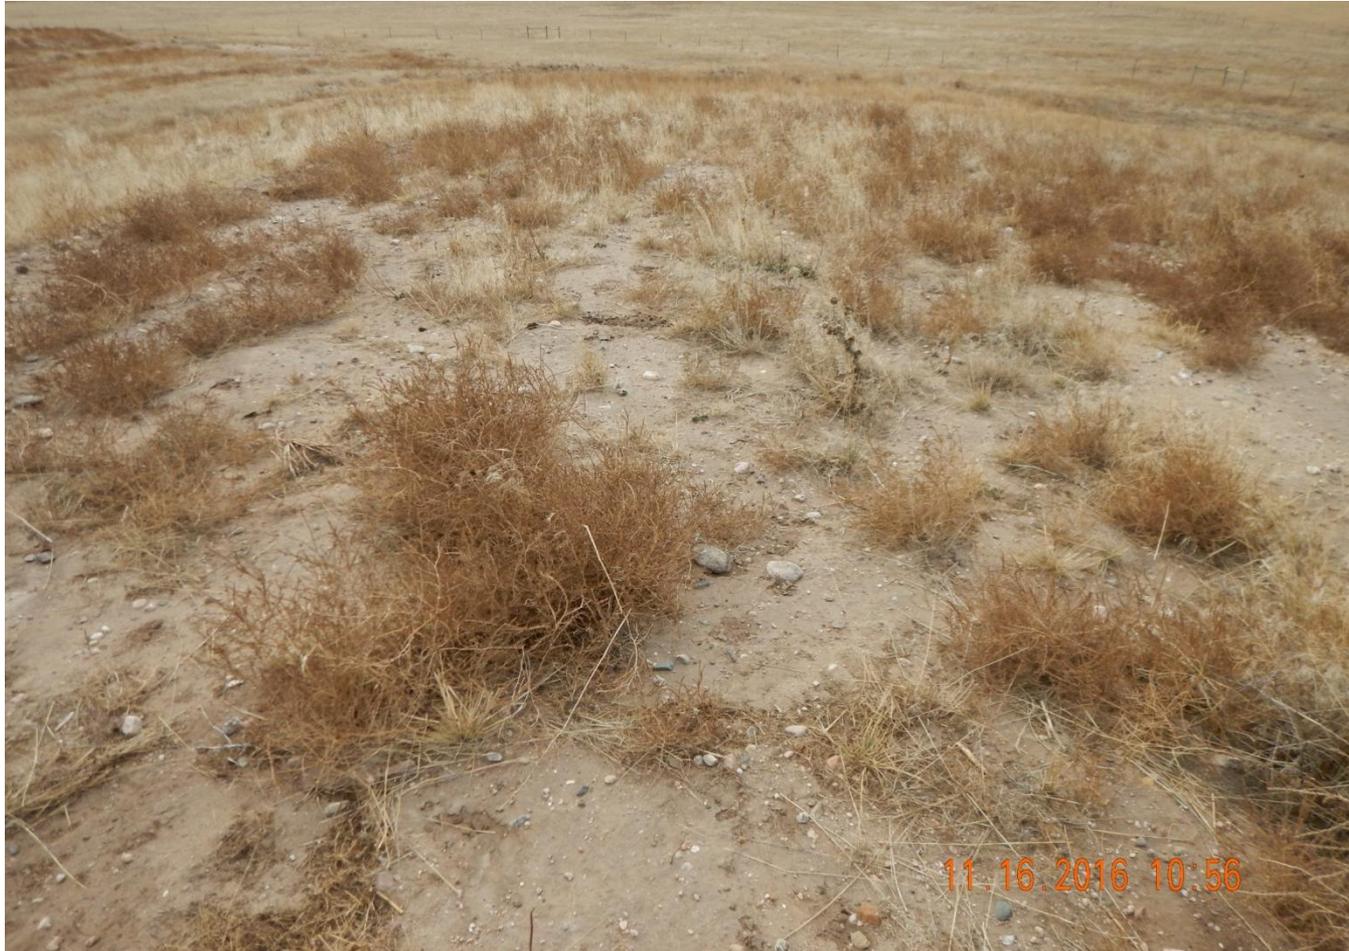
Photo 2. Photo taken from the approximate center (i.e., top) of the topsoil stockpile, facing South. Topsoil stockpile has undesirable plant species established throughout the stockpile (i.e., cheatgrass and Russian thistle) which is not protective of soils to prevent weed establishment under Rule 1002.c.

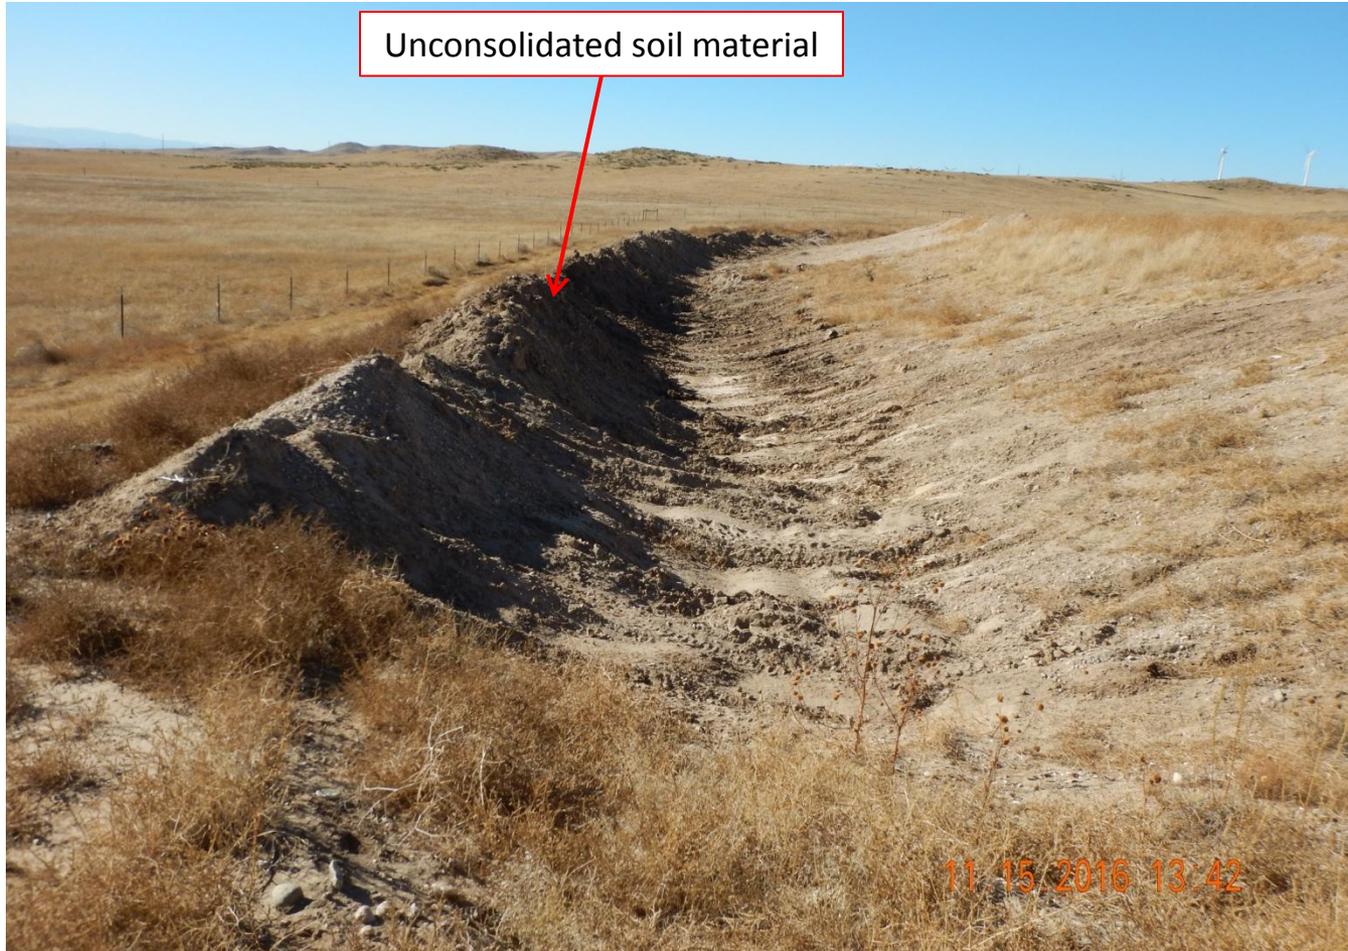
Photo 3. Photo taken from entrance of location, facing West. Need to stabilize unconsolidated soil material and implement BMPs in accordance with good engineering practices along the southern location in a manner that minimizes erosion, transport of sediment offsite, and site degradation per Rule 1002.f.

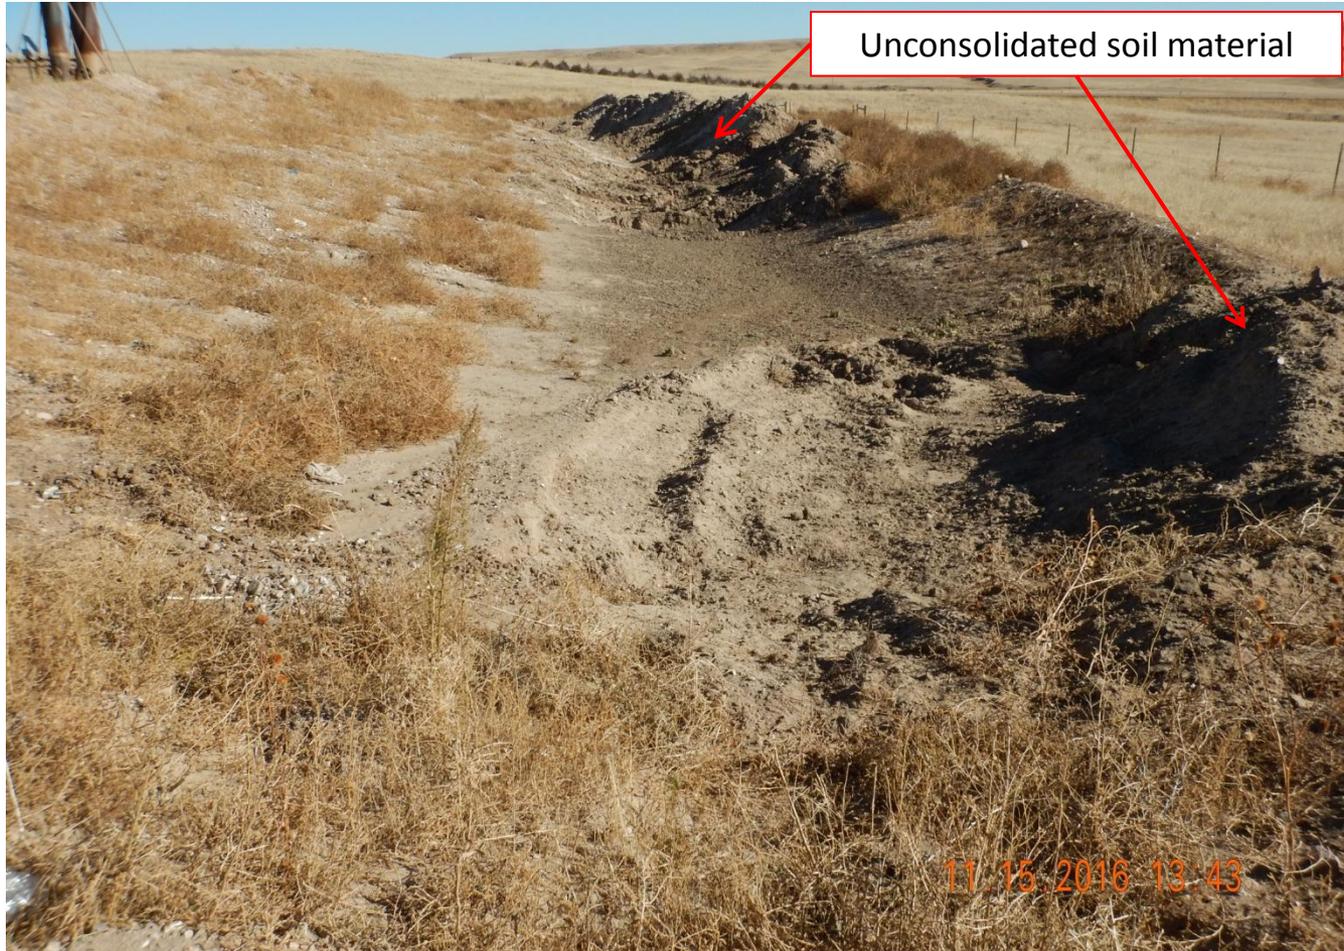
Photo 4. Photo taken from entrance of location, facing East. Need to stabilize unconsolidated soil material and implement BMPs in accordance with good engineering practices along the southern location in a manner that minimizes erosion, transport of sediment offsite, and site degradation per Rule 1002.f.

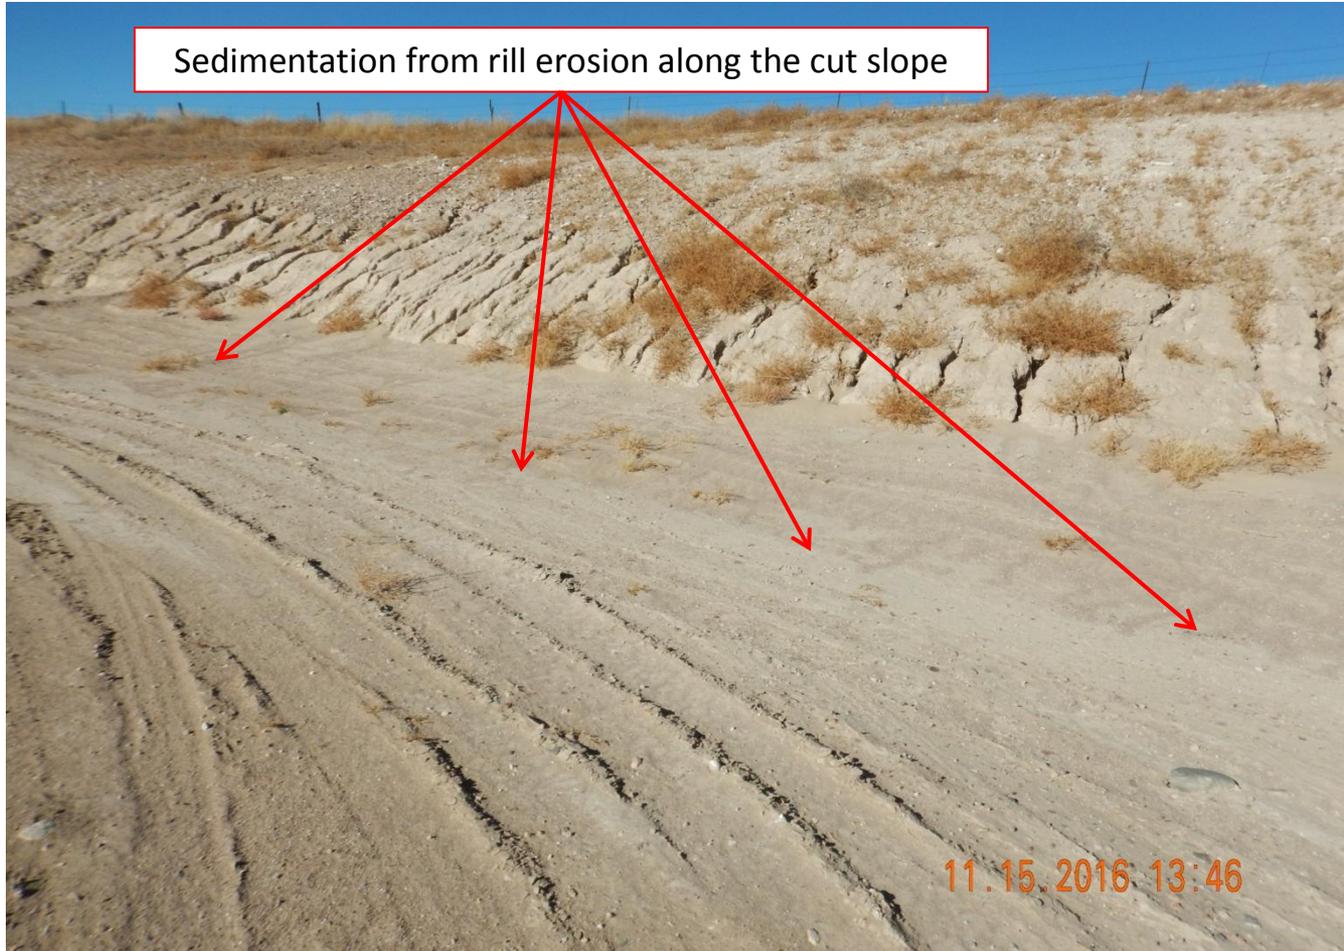
Photo 5. Photo taken from the northeast location, facing North. Rill erosion occurring throughout entire north cut slope. Need to stabilize and implement erosion controls designed to minimize erosion along the entire north cut slope per Rule 1002.f.

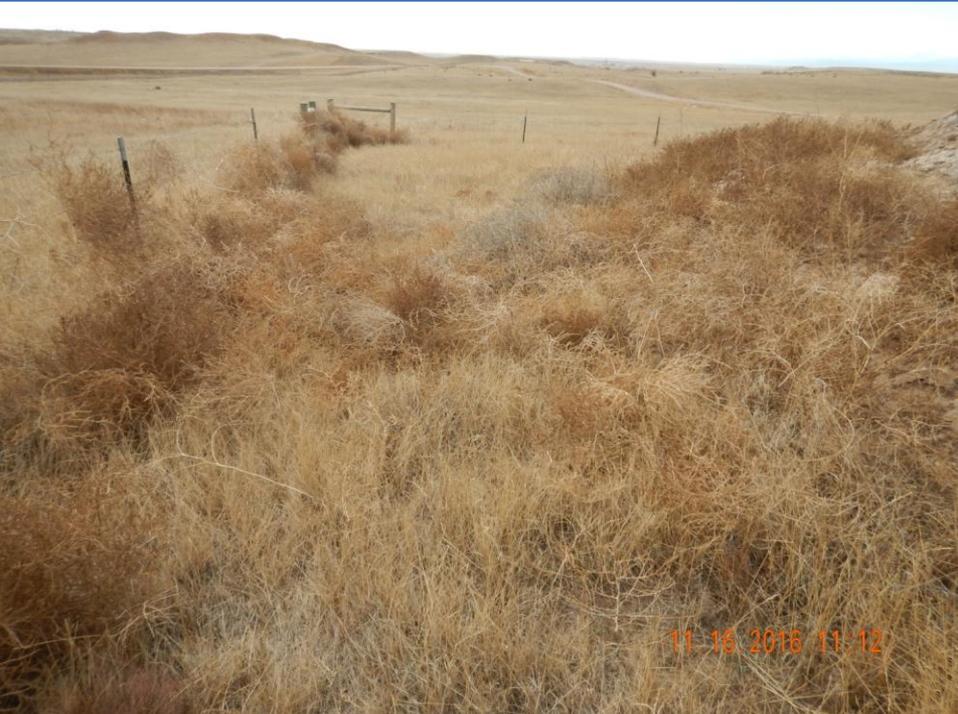
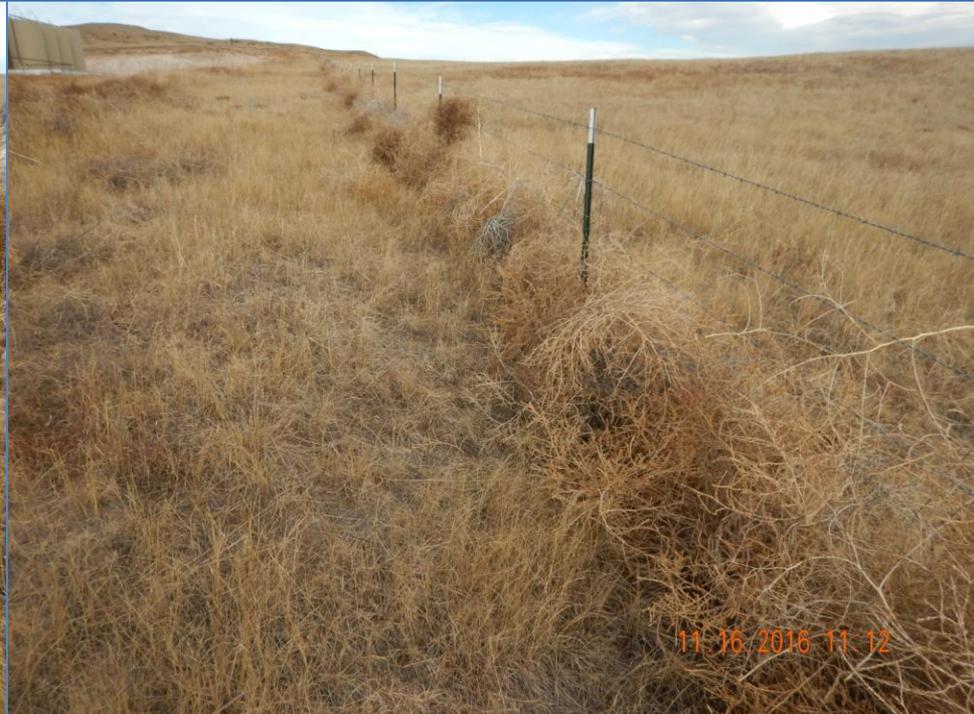
Photo taken from the southeast location, facing South

Photo taken from the southeast location, facing North

Photo 6. Accumulations of Russian thistle were observed along the east fence line. This constitutes as waste material and needs to be removed per Rule 603.f., using the Rule 603.f. guidance document for further details..
