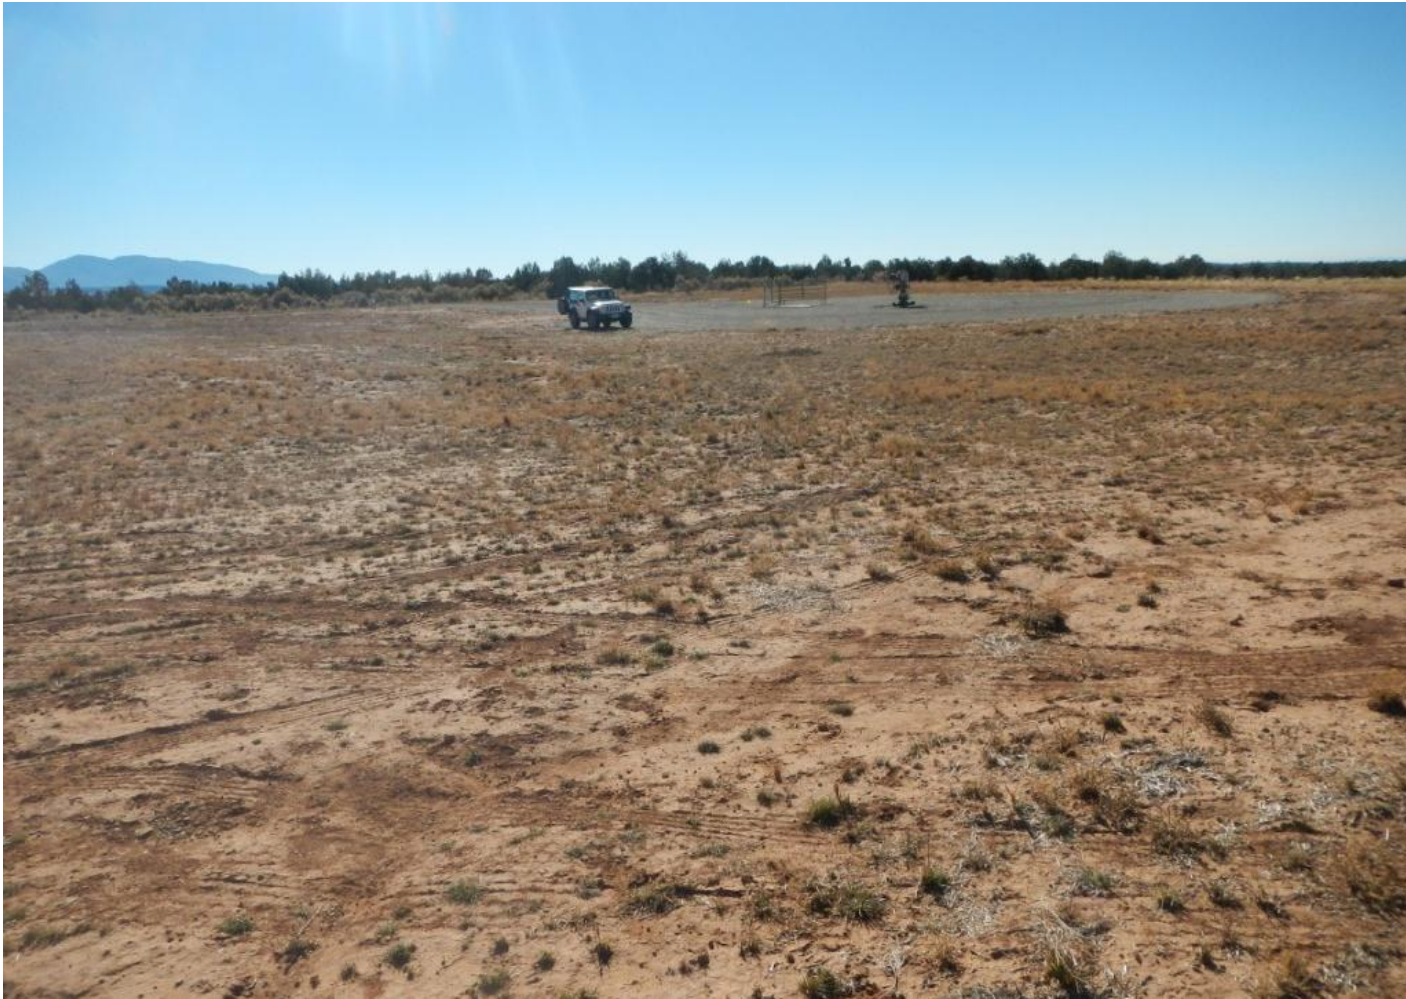
Photo 1. View of the project area from the northeastern corner facing center.

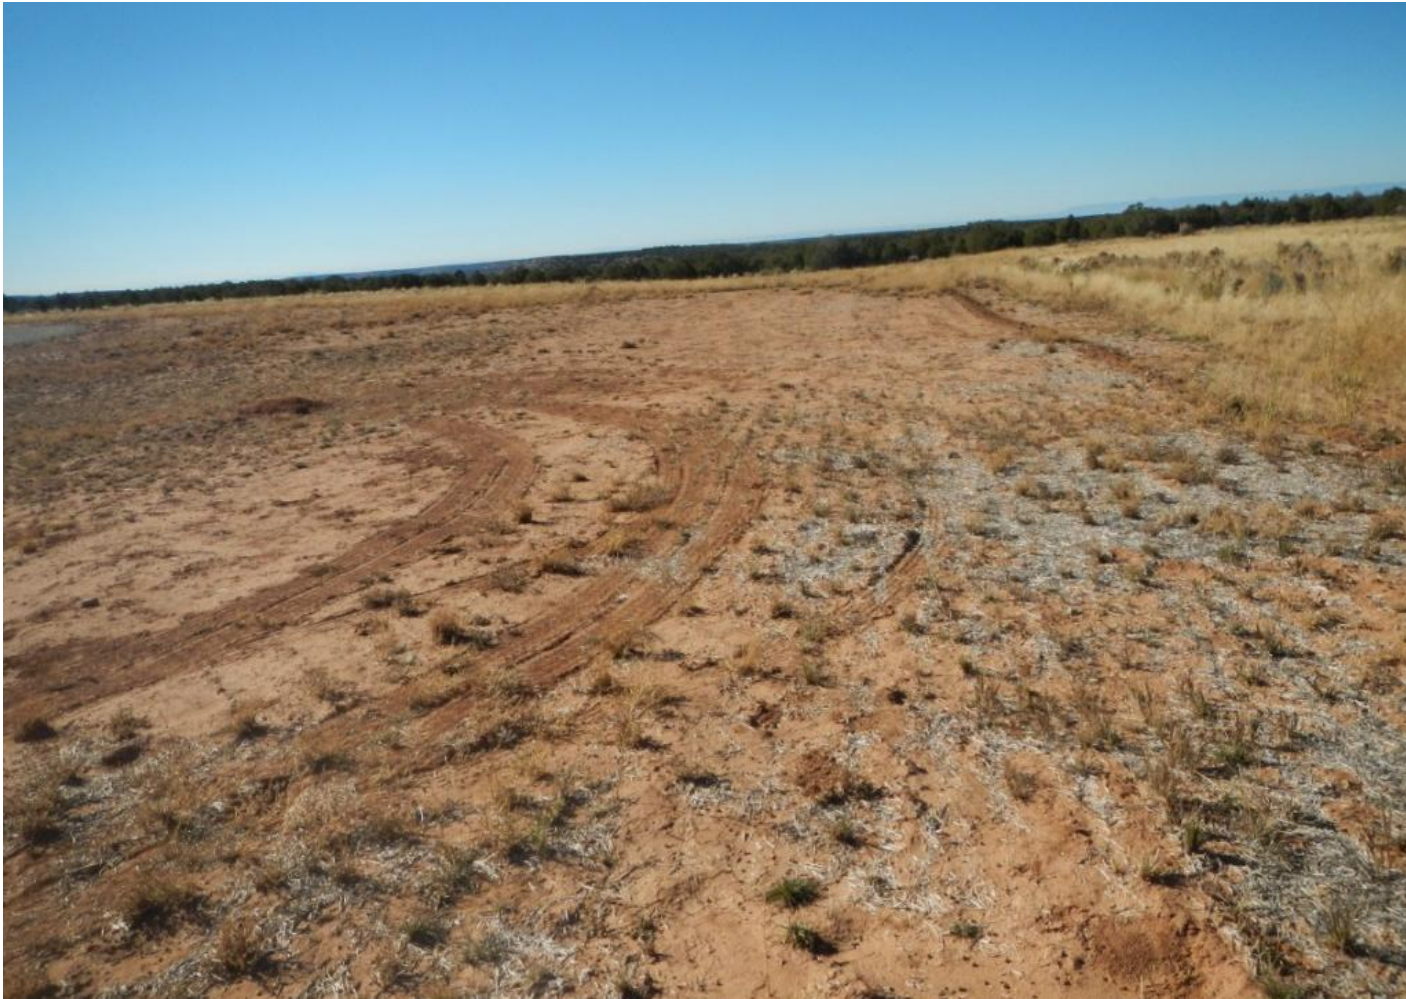
Photo 2. View of the northern portion of the project area from the northeastern corner facing westward. Vegetation within the interim reclamation area is sparse and patchy.

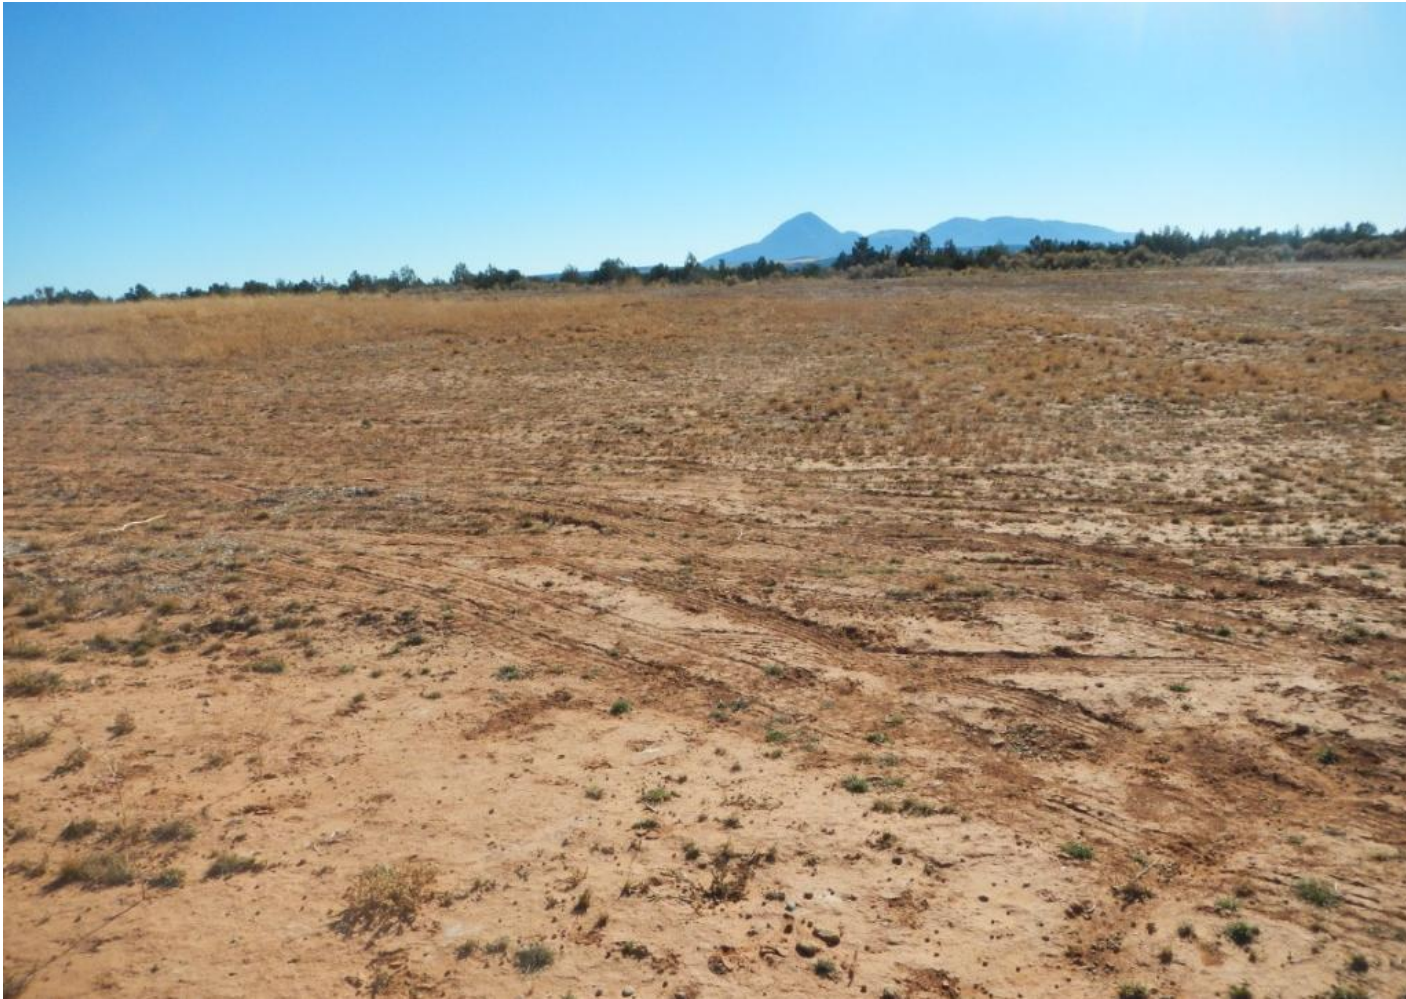
Photo 3. View of the eastern portion of the project area from the northeastern corner facing southward.

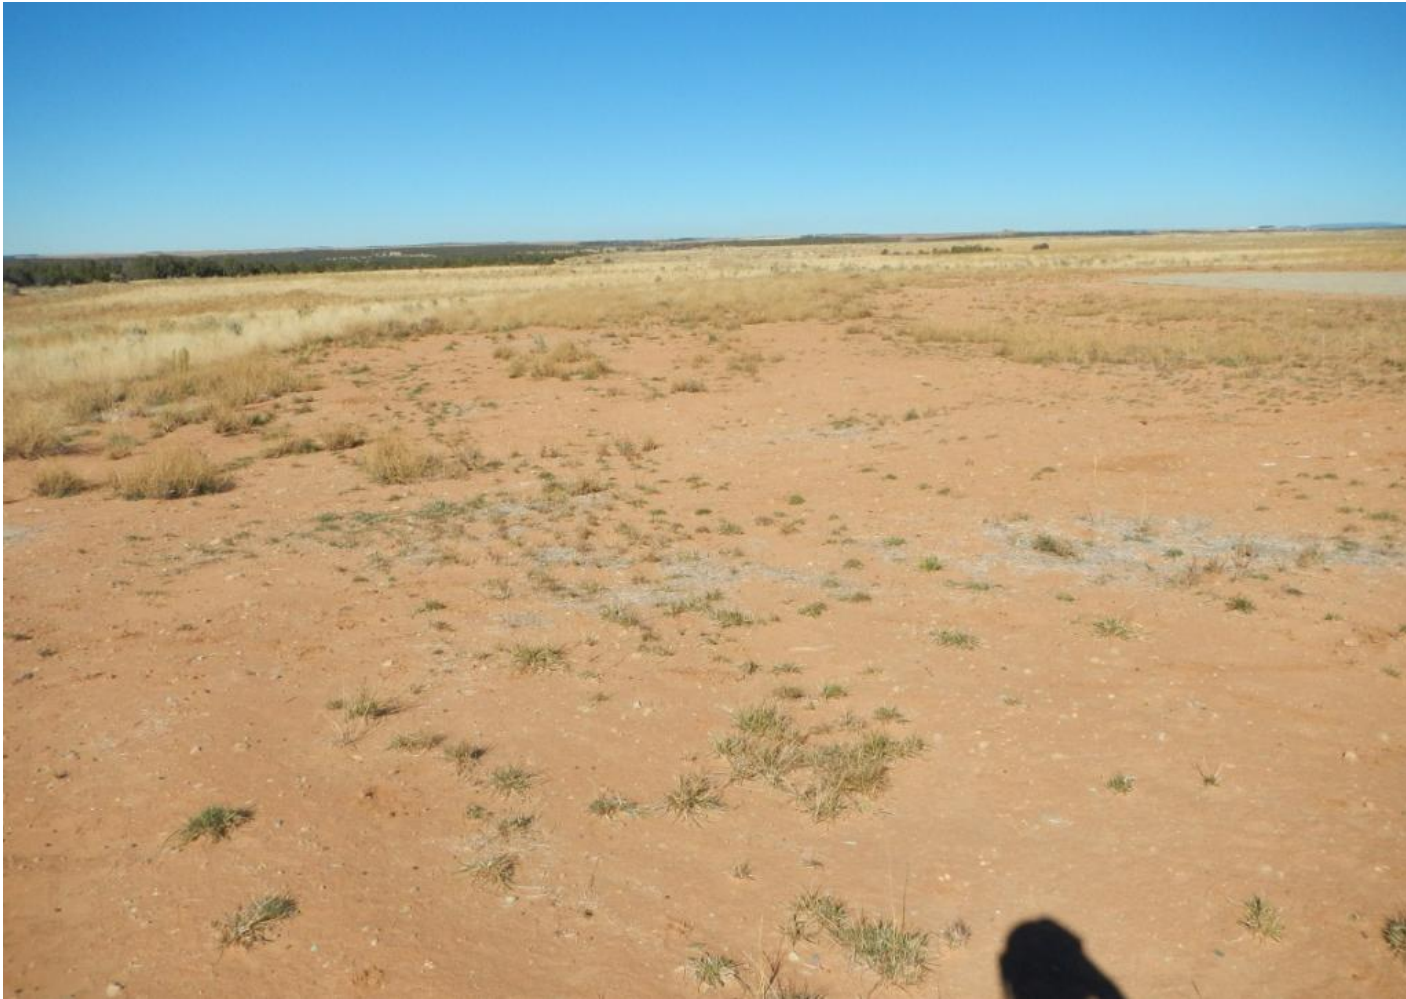
Photo 4. View of the western portion of the project area from the southwestern corner facing northward.

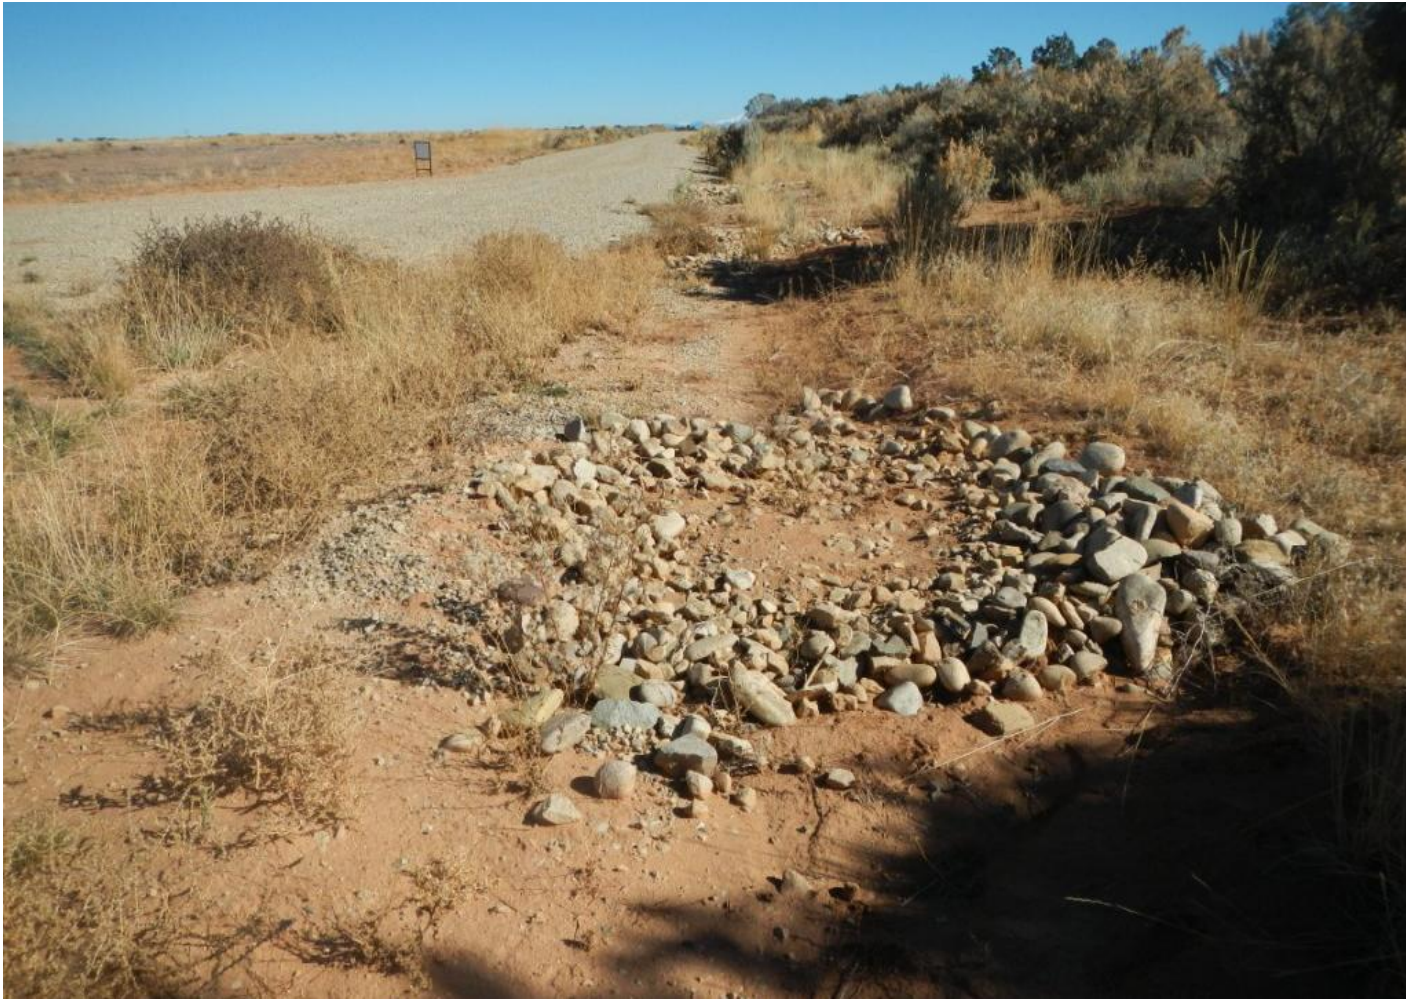
Photo 5. View of stormwater controls along the southern edge of the well pad and access road that appear to be functioning.

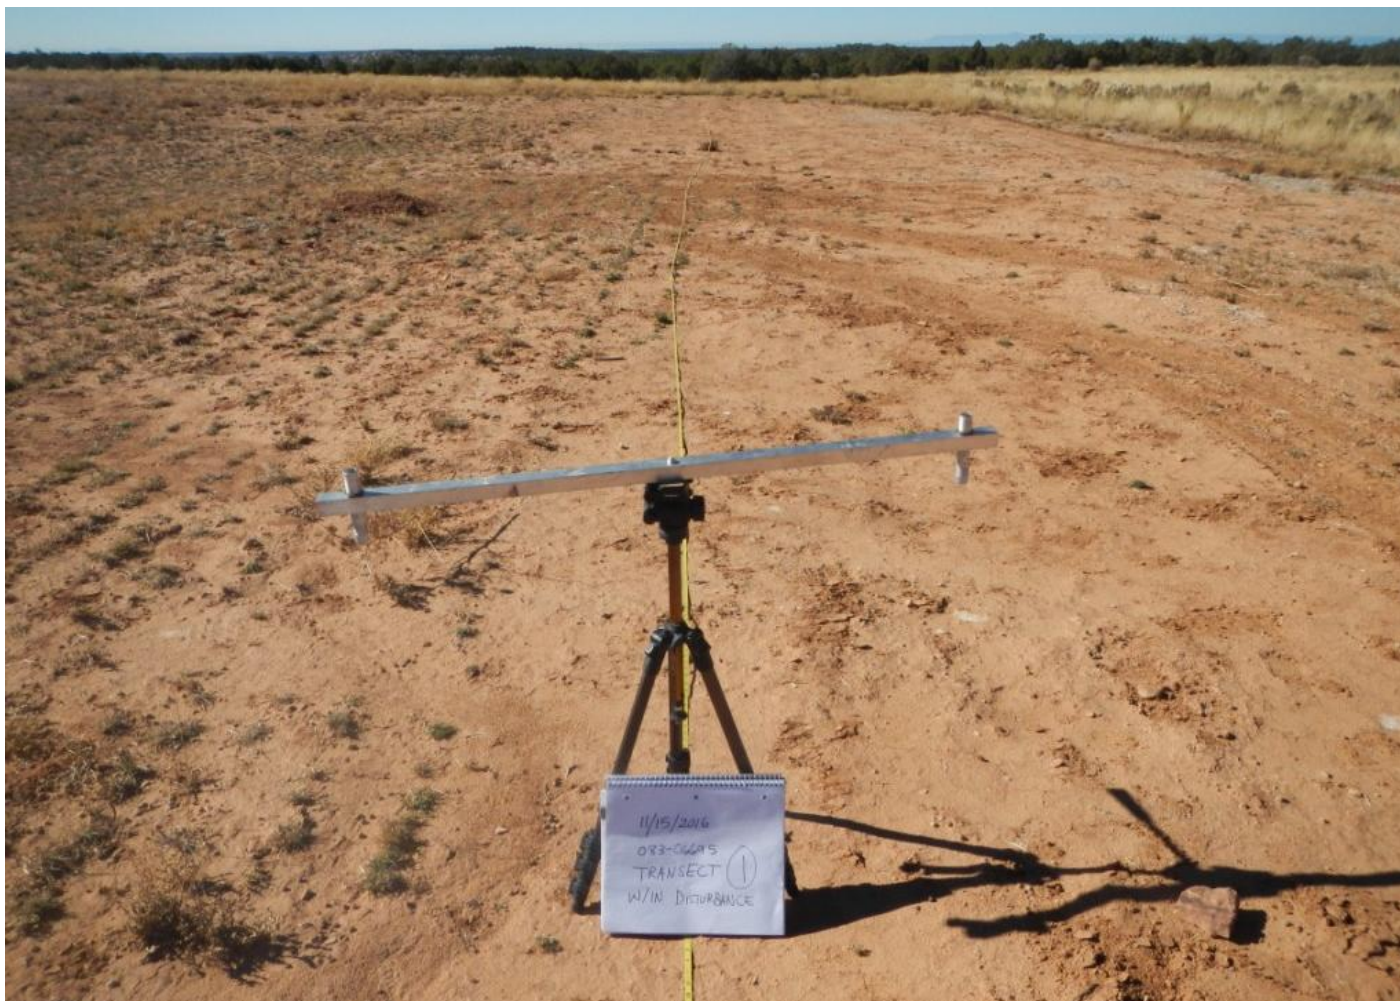
Photo 6. View of the beginning of Transect 1-within the interim reclamation area facing southward.

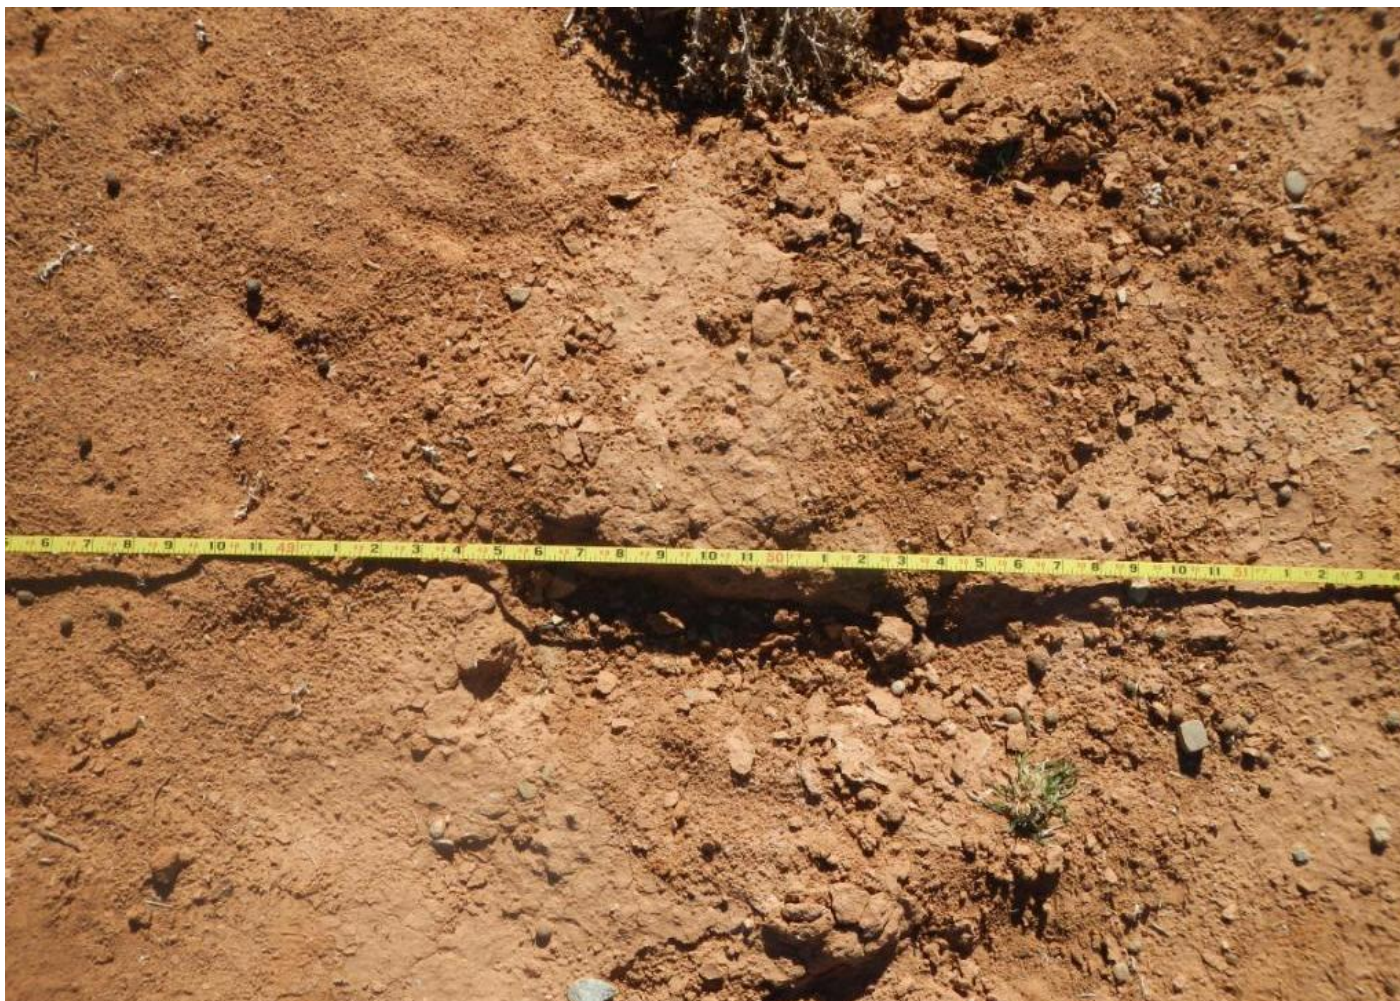
Photo 7. Birdseye view of vegetation at the midpoint along Transect 1.

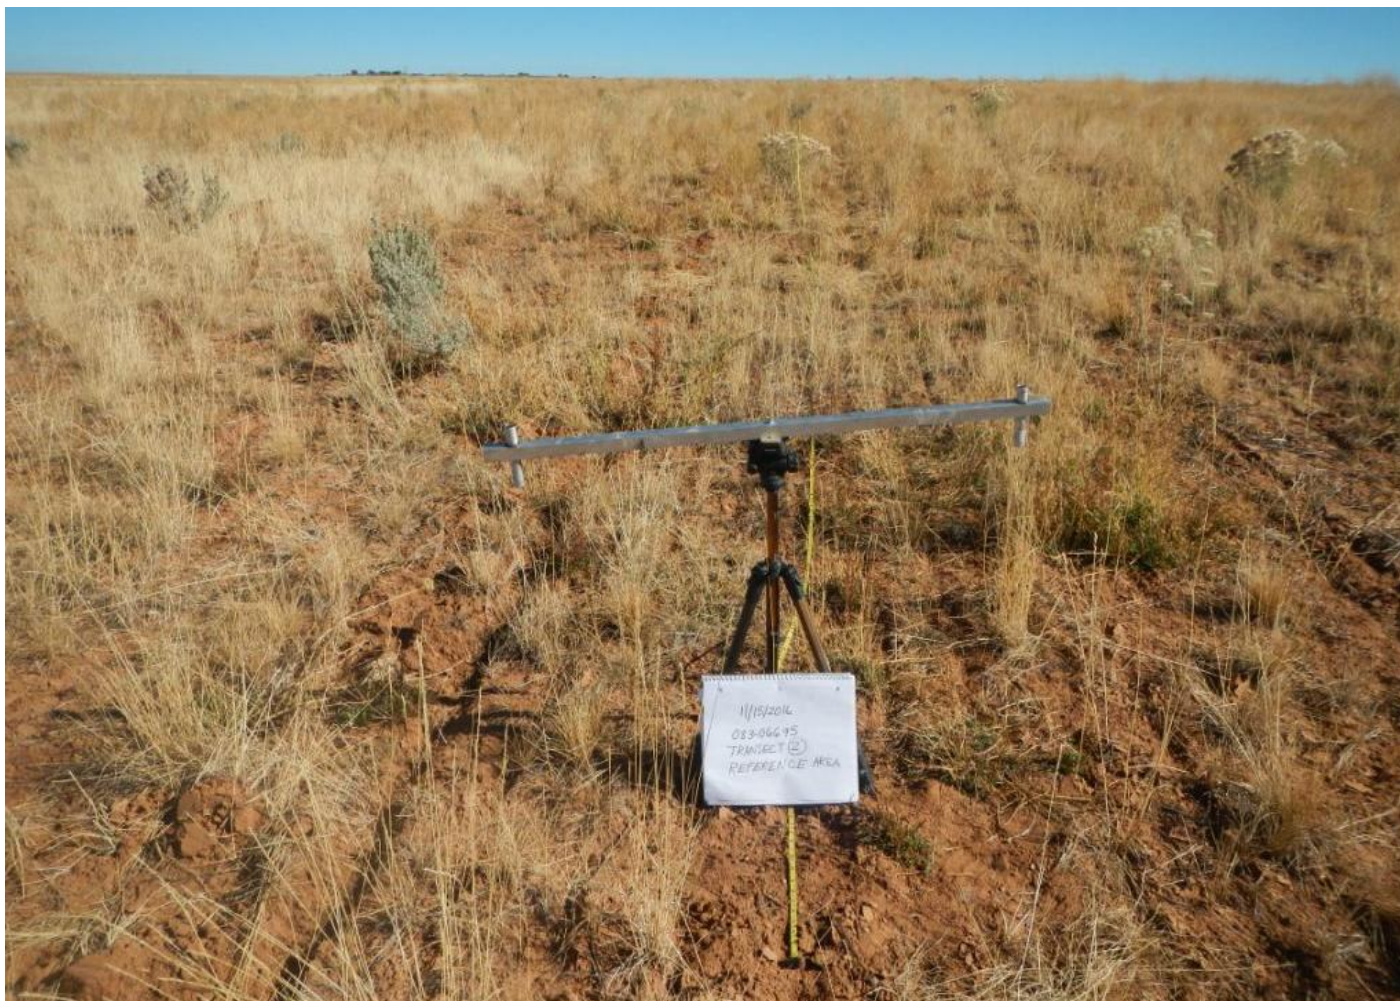
Photo 8. View of Transect 2- within the reference area, outside of the project area facing northward.

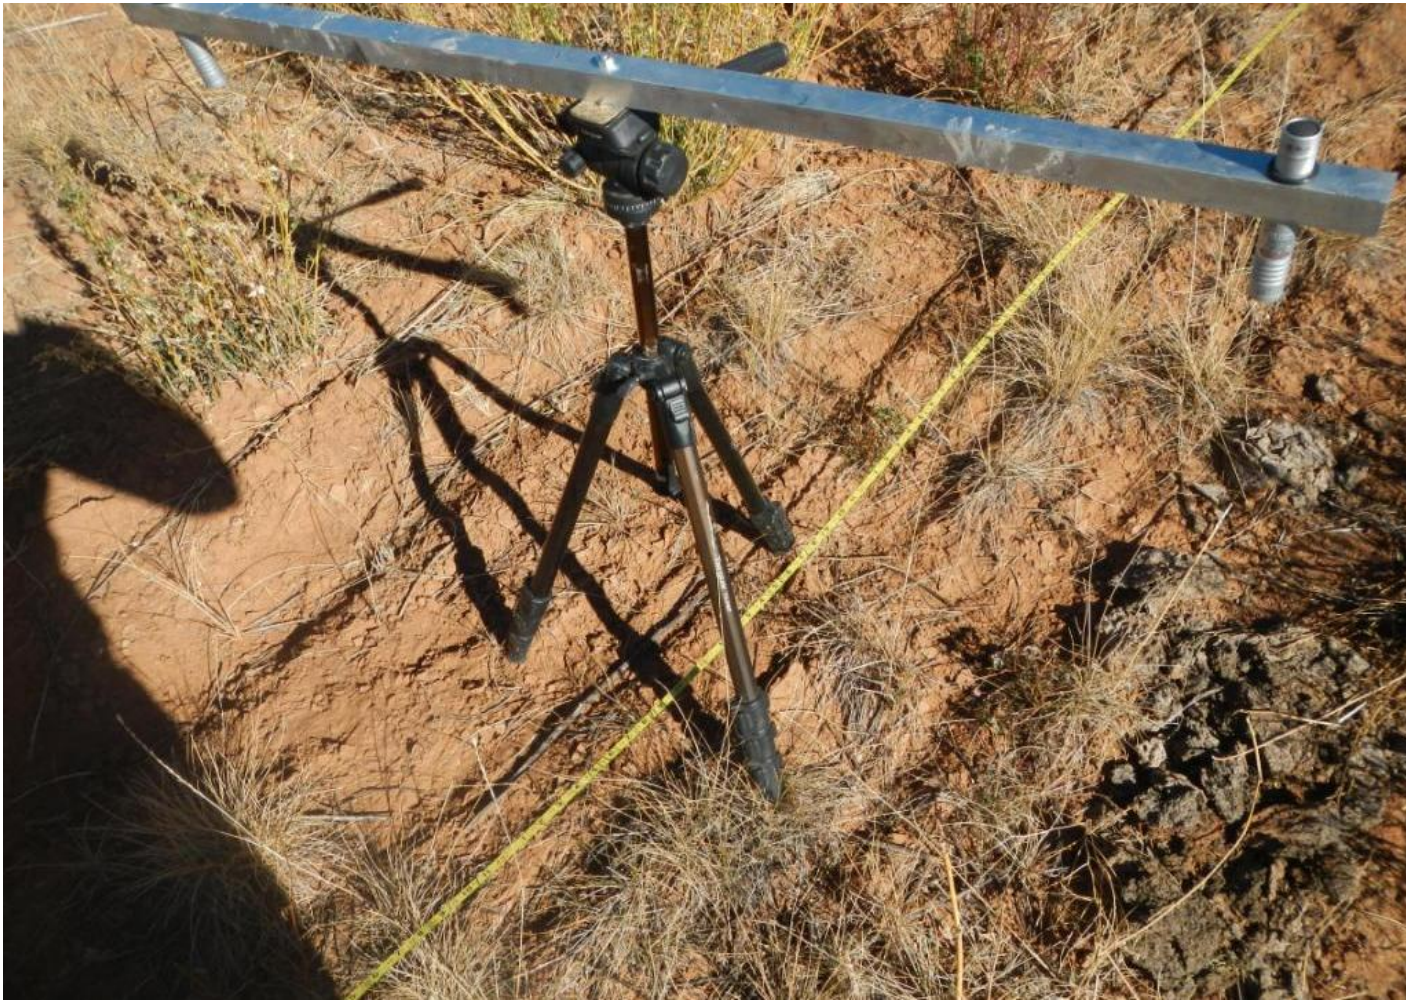
Photo 9. Birdseye view of vegetation at the midpoint of Transect 2.
