Location Multi Well Plan

Construction and Stormwater Inspection

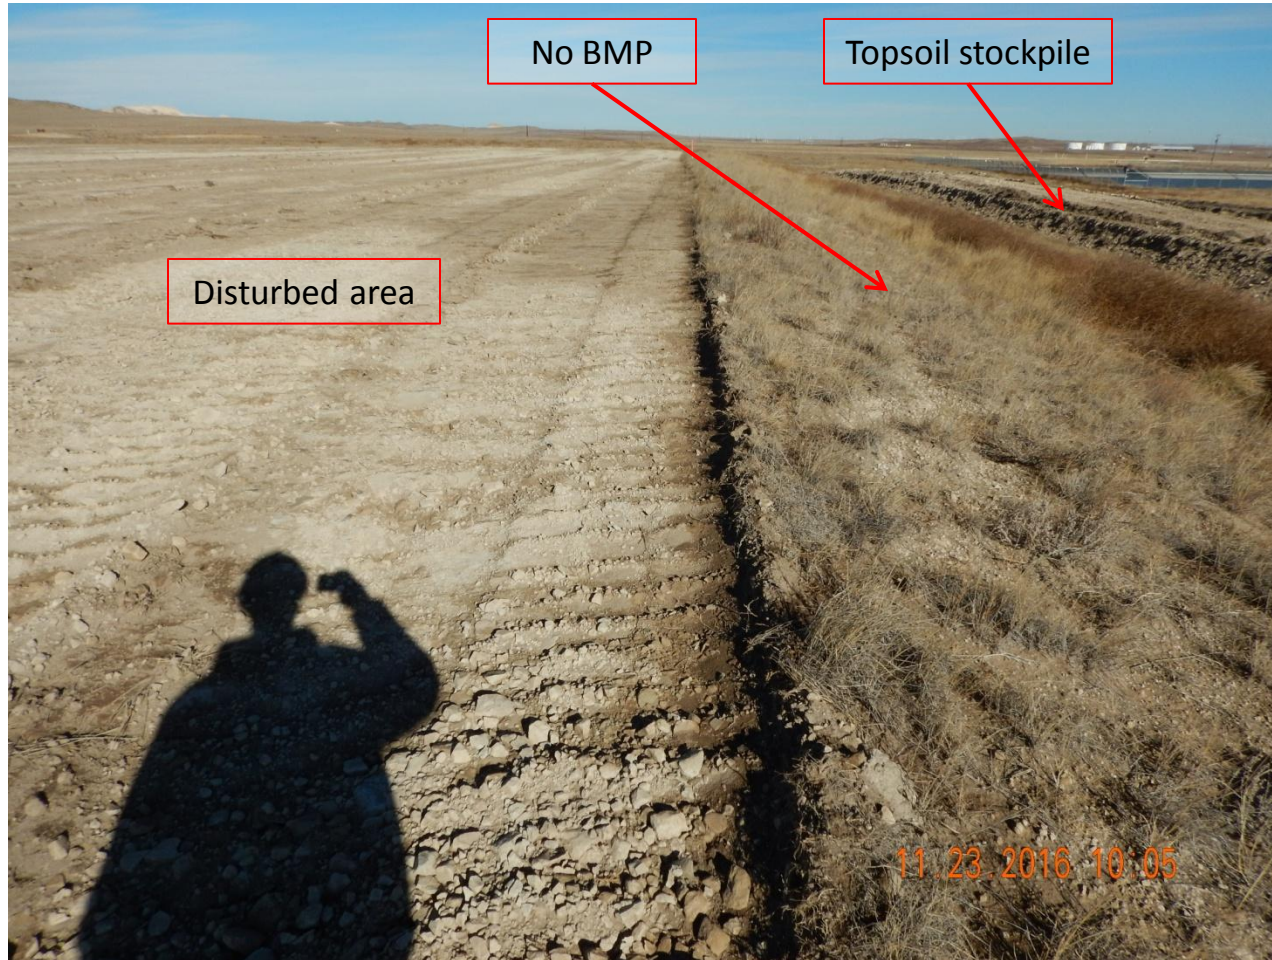
Photo 1. Photo taken from the eastern Holliday pad, facing North. No BMPs. Stormwater and erosion control BMPs need to be installed prior to the start of construction.

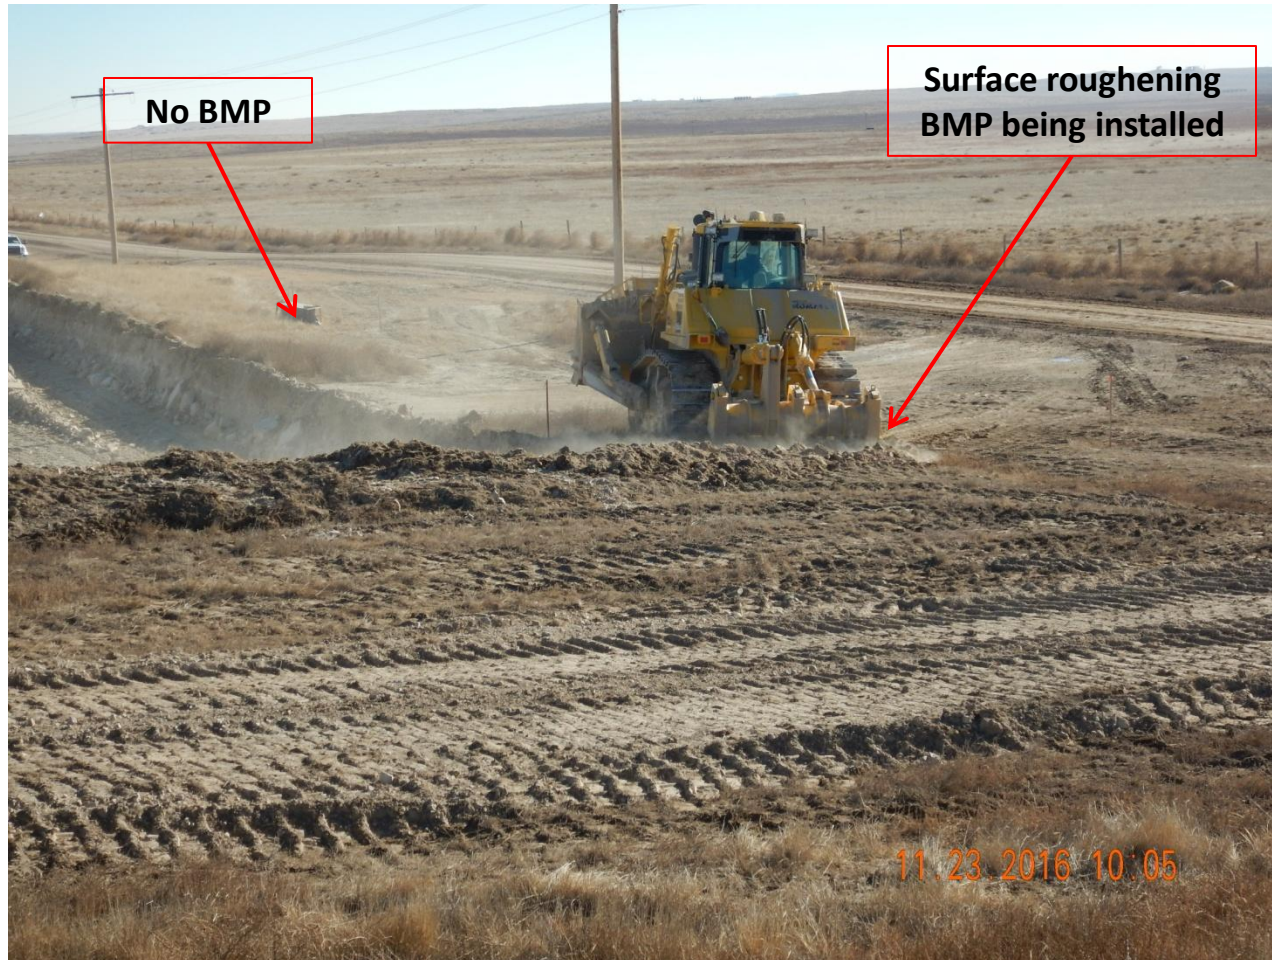
Photo 2. Photo taken from the previous location, facing East, towards the southern Tombstone pad. After making a previous call to the operator regarding a location ~ ¼ mile to the west that did not have stormwater and erosion control BMPs, a BMP was installed during this inspection.

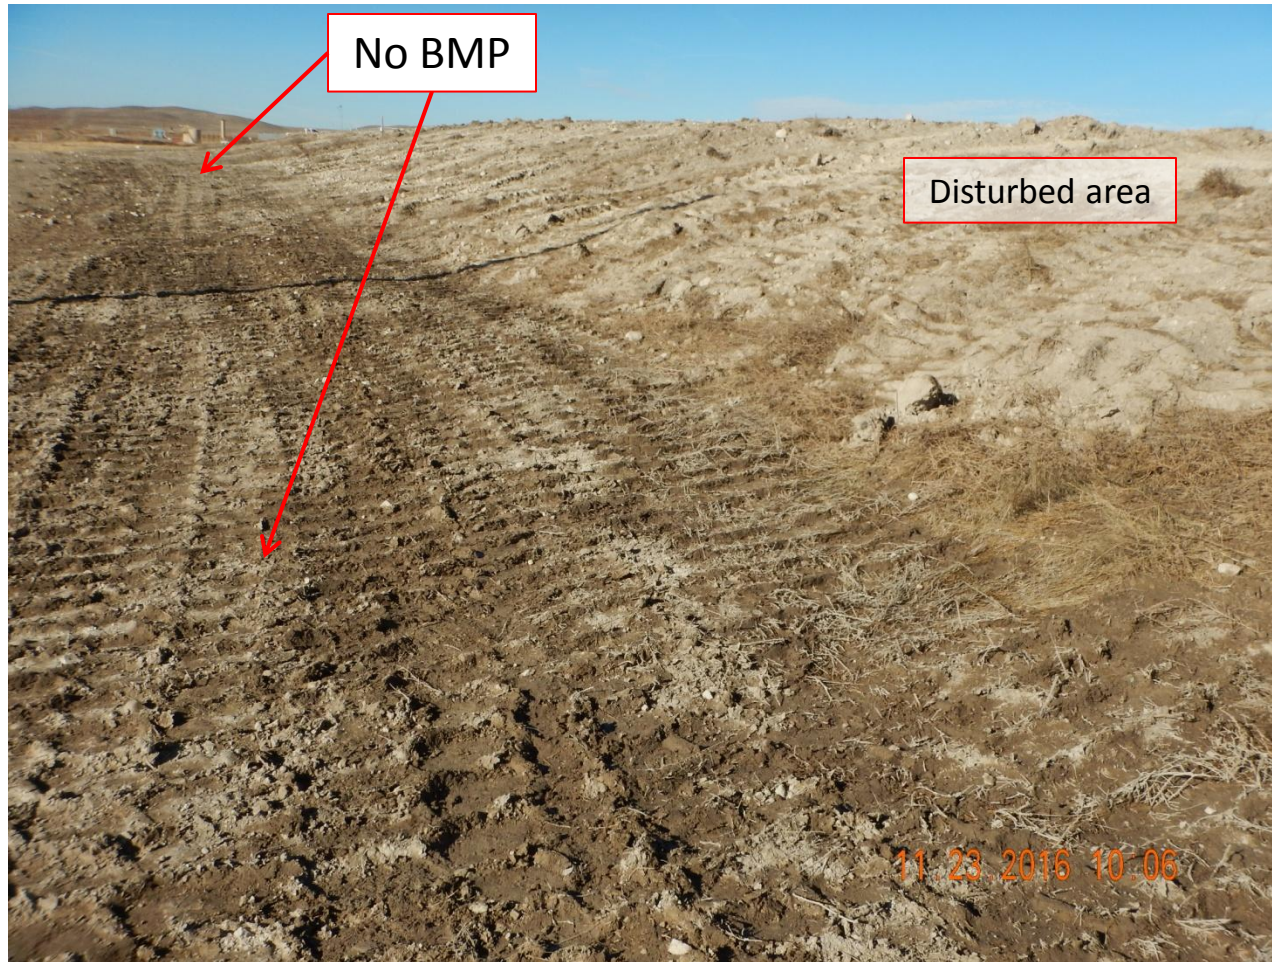
Photo 3. Photo taken from the southern Holliday pad, facing West. No BMPs. Stormwater and erosion control BMPs need to be installed prior to the start of construction.

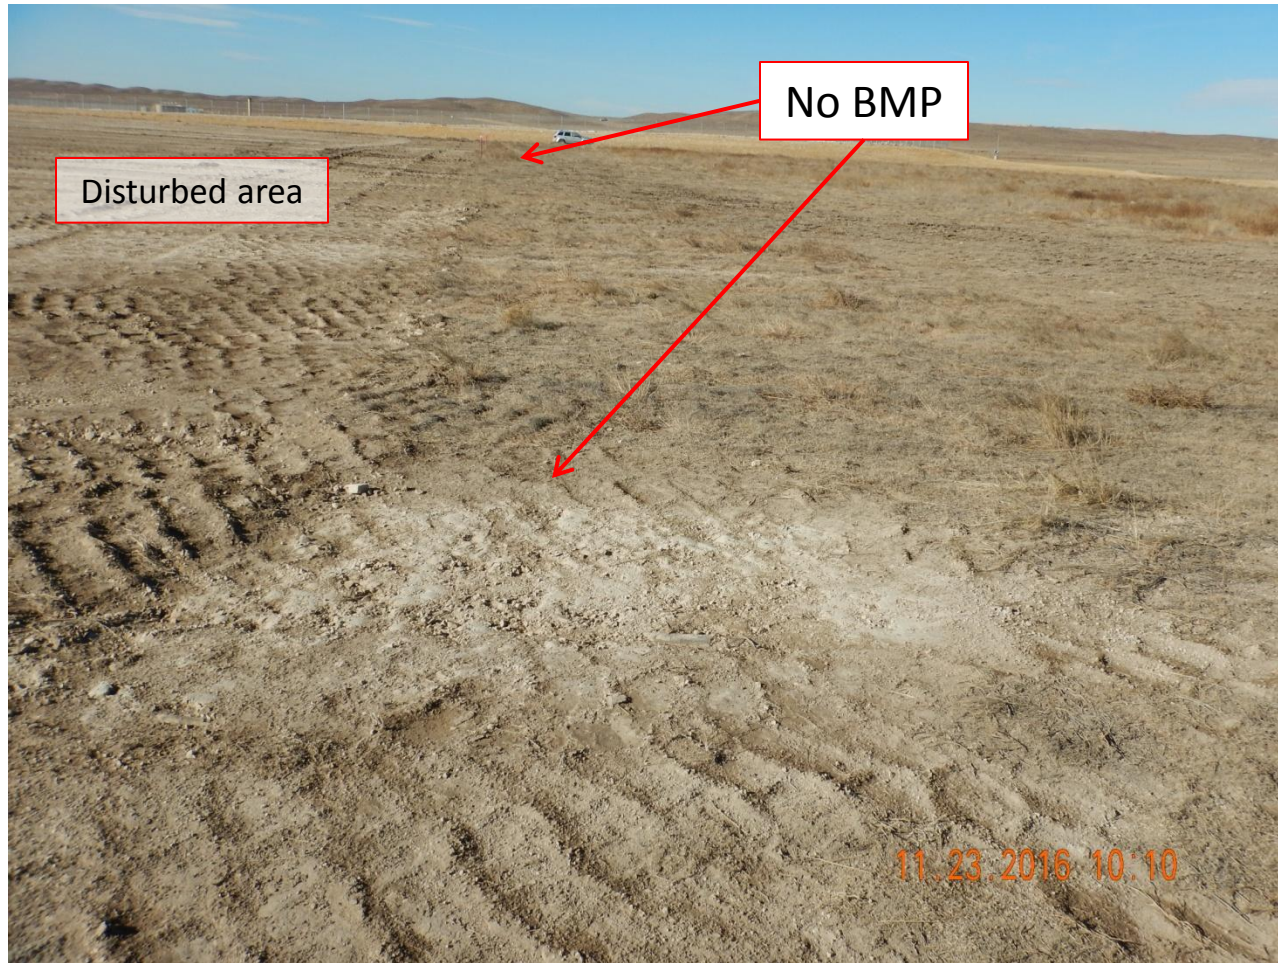
Photo 4. Photo taken from the northern Holliday pad, facing West. No BMPs. Stormwater and erosion control BMPs need to be installed prior to the start of construction.

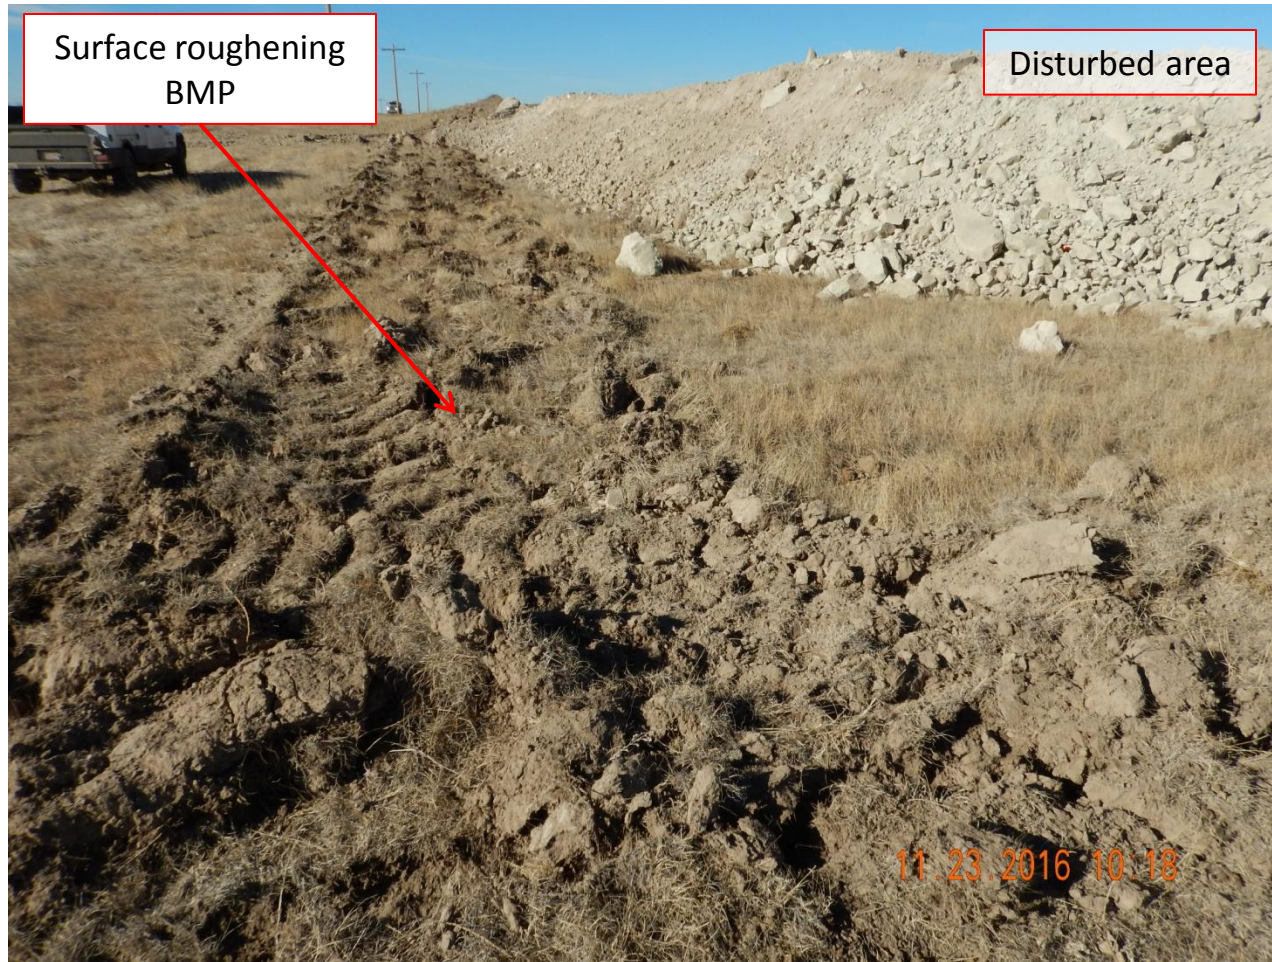
Photo 5. Photo taken from the southeast Tombstone pad, facing West. Surface roughening BMP, which is a temporary BMP, was installed during this inspection.

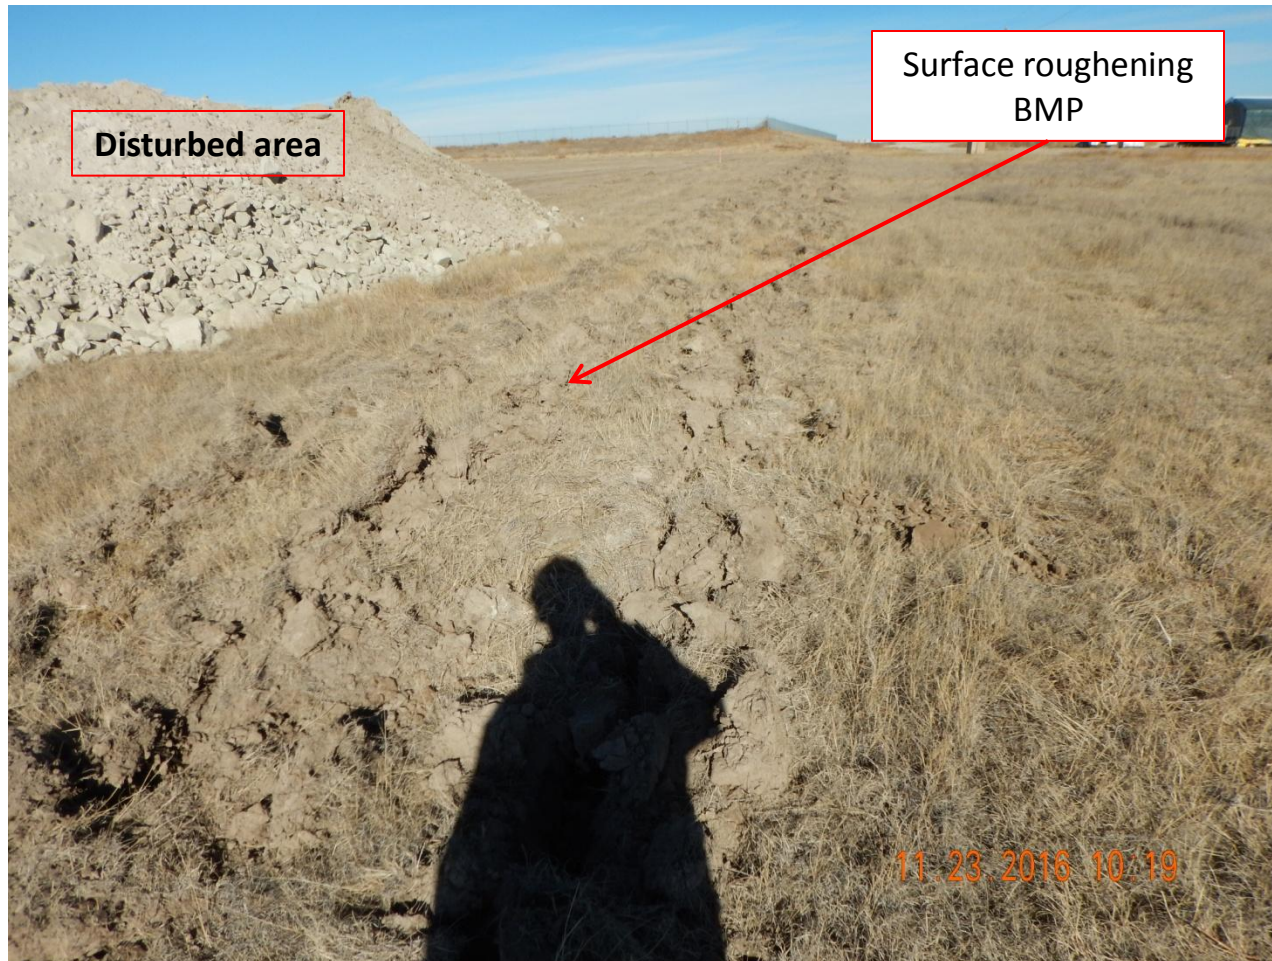
Photo 6. Photo taken from the southeast Tombstone pad, facing North. Surface roughening BMP, which is a temporary BMP, was installed during this inspection.
