November 16, 2016

Inspection Photos: OXY USA WPT Cascade Creek PA 045-06870

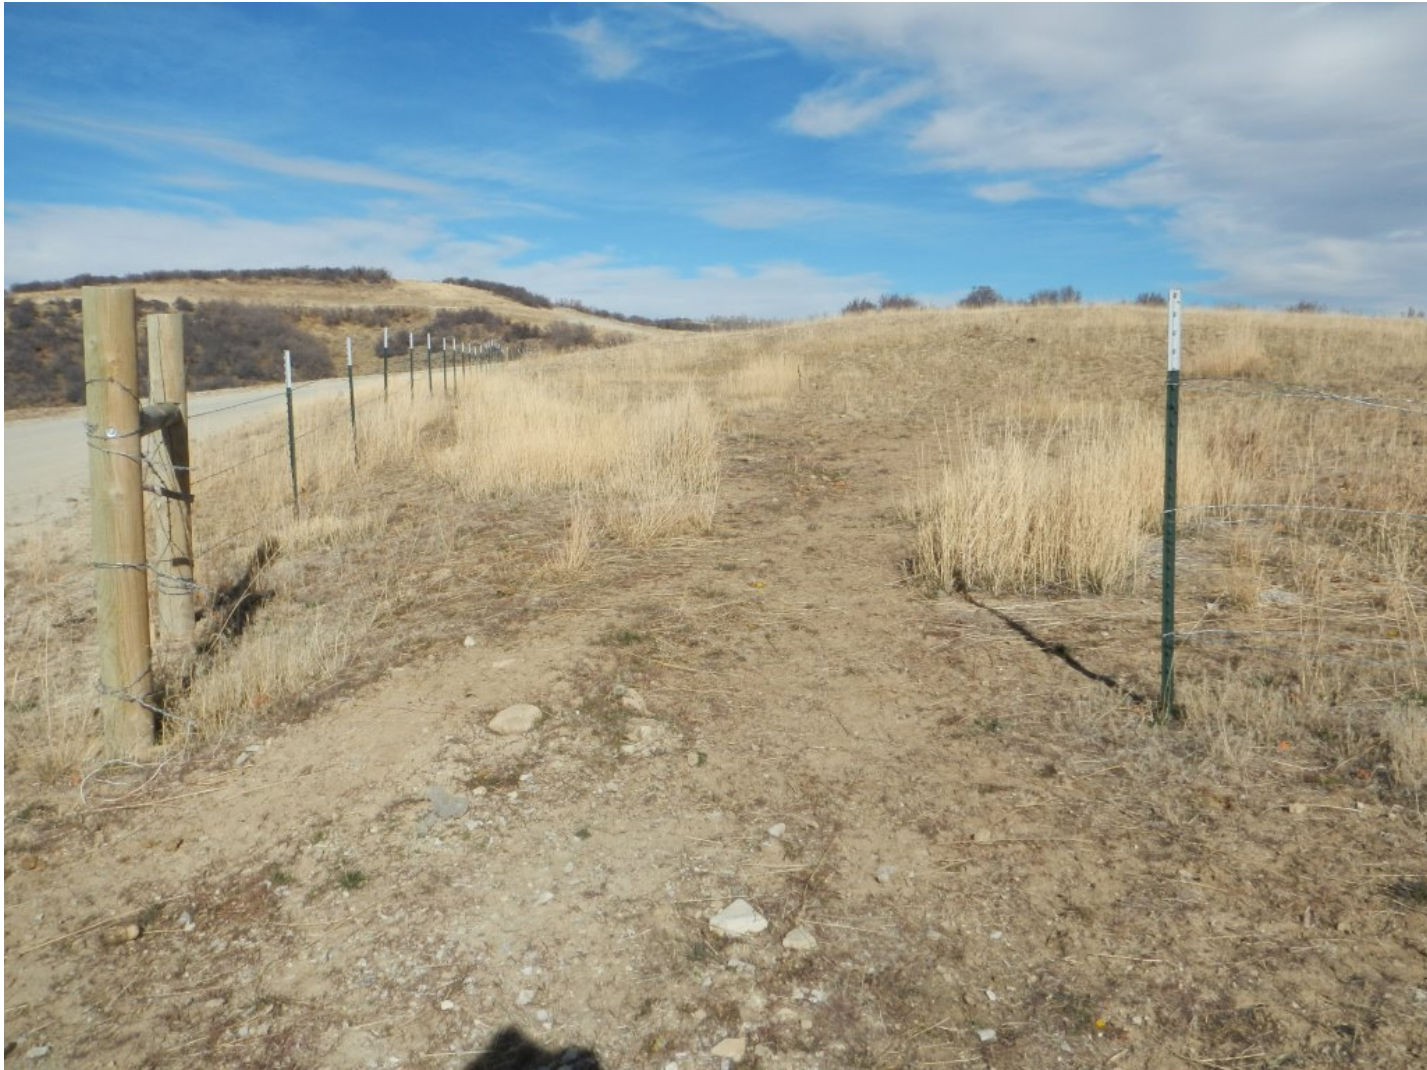
Photo#1: View to North over Location at Fence Corner where Fence was Cut.

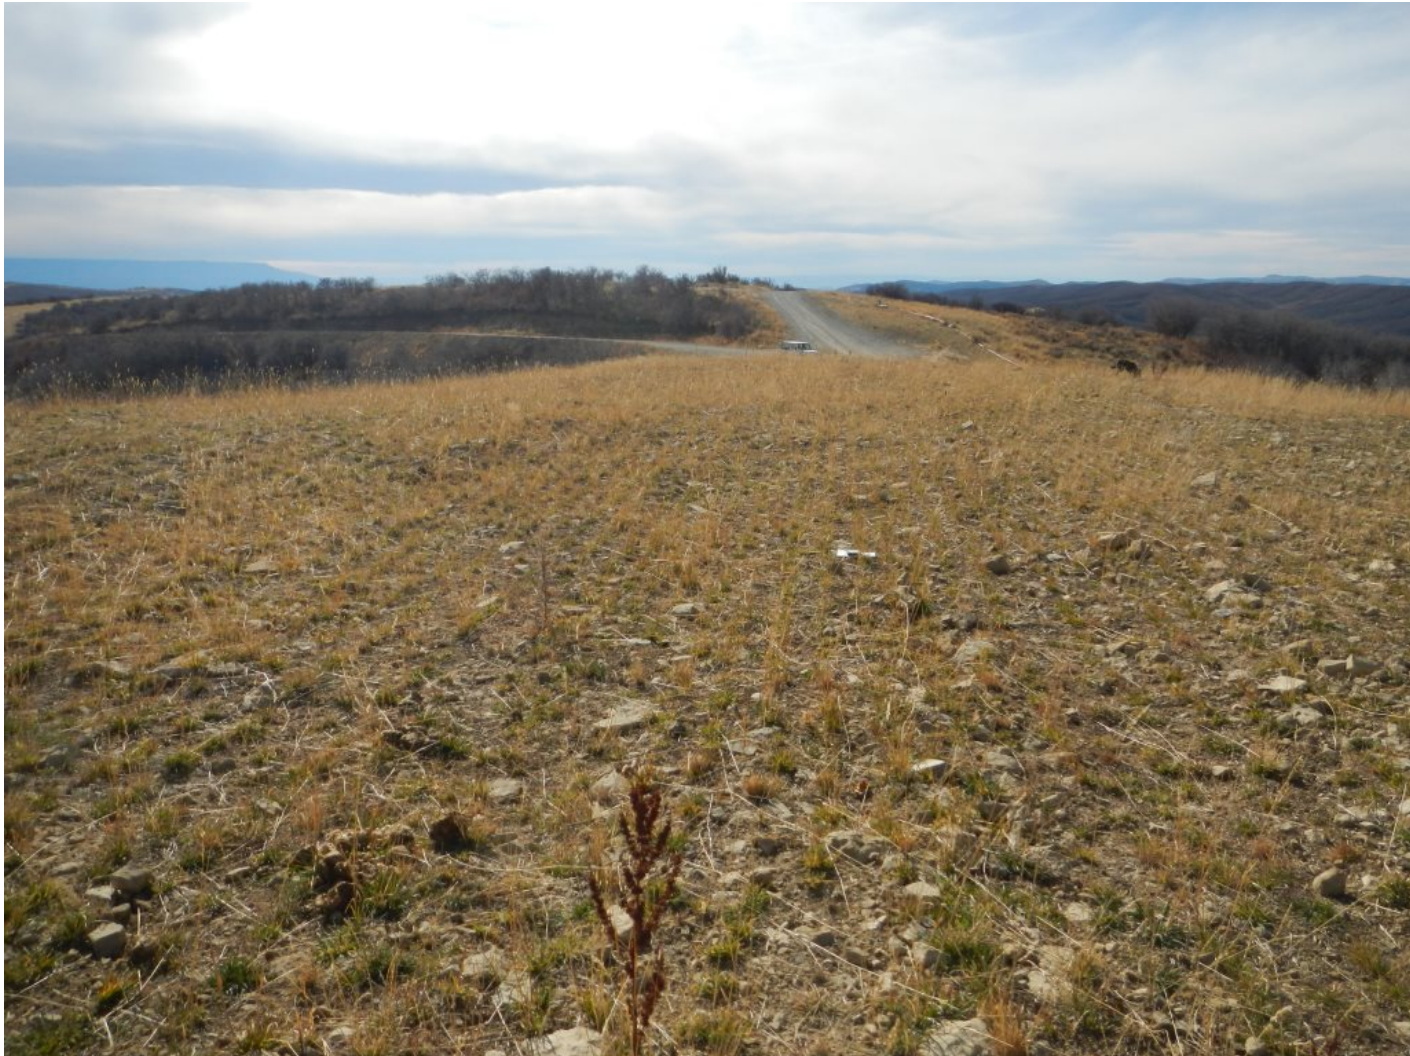
Photo#2: View South over Location

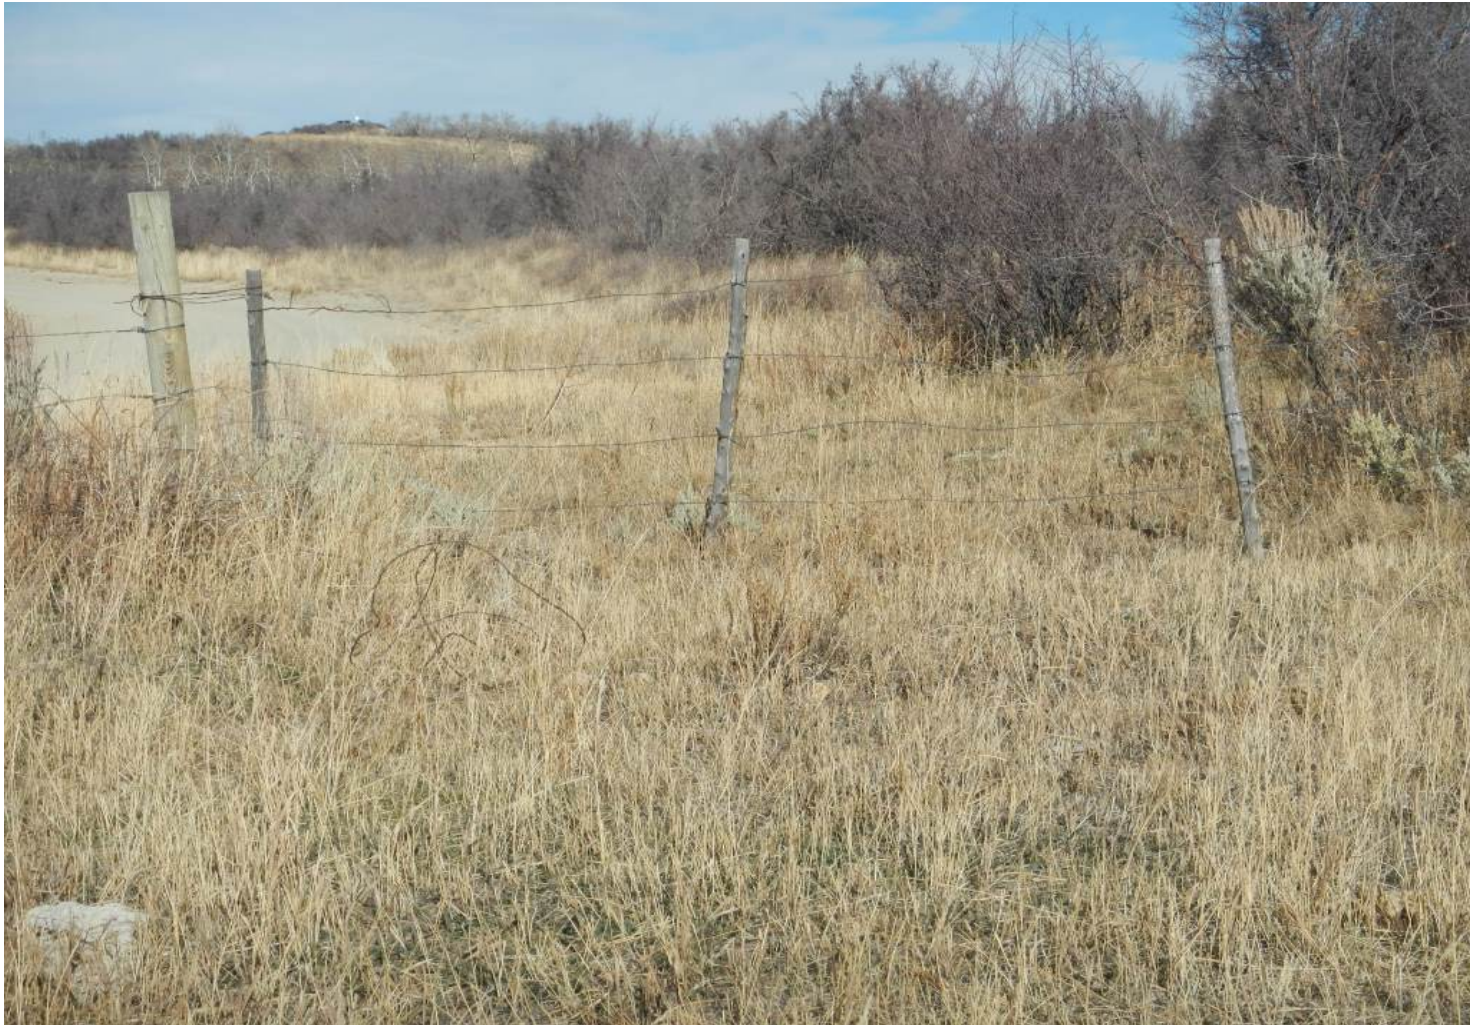
Photo#3: Gate at North end is Intact.

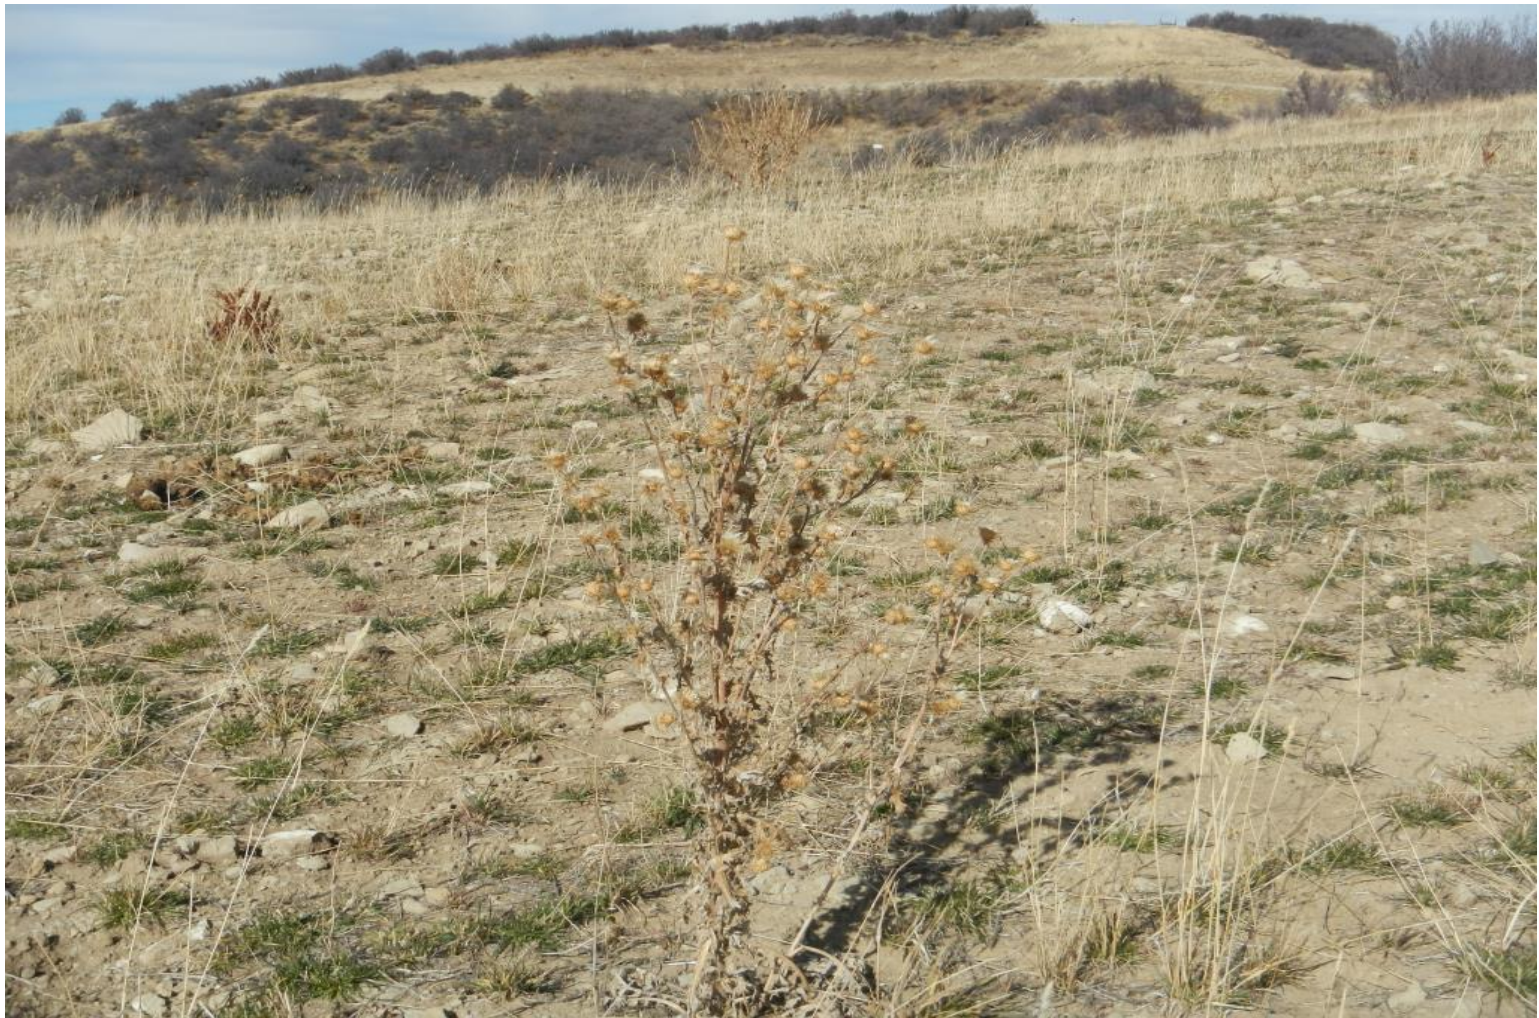
Photo#4: Noxious weeds on Location.

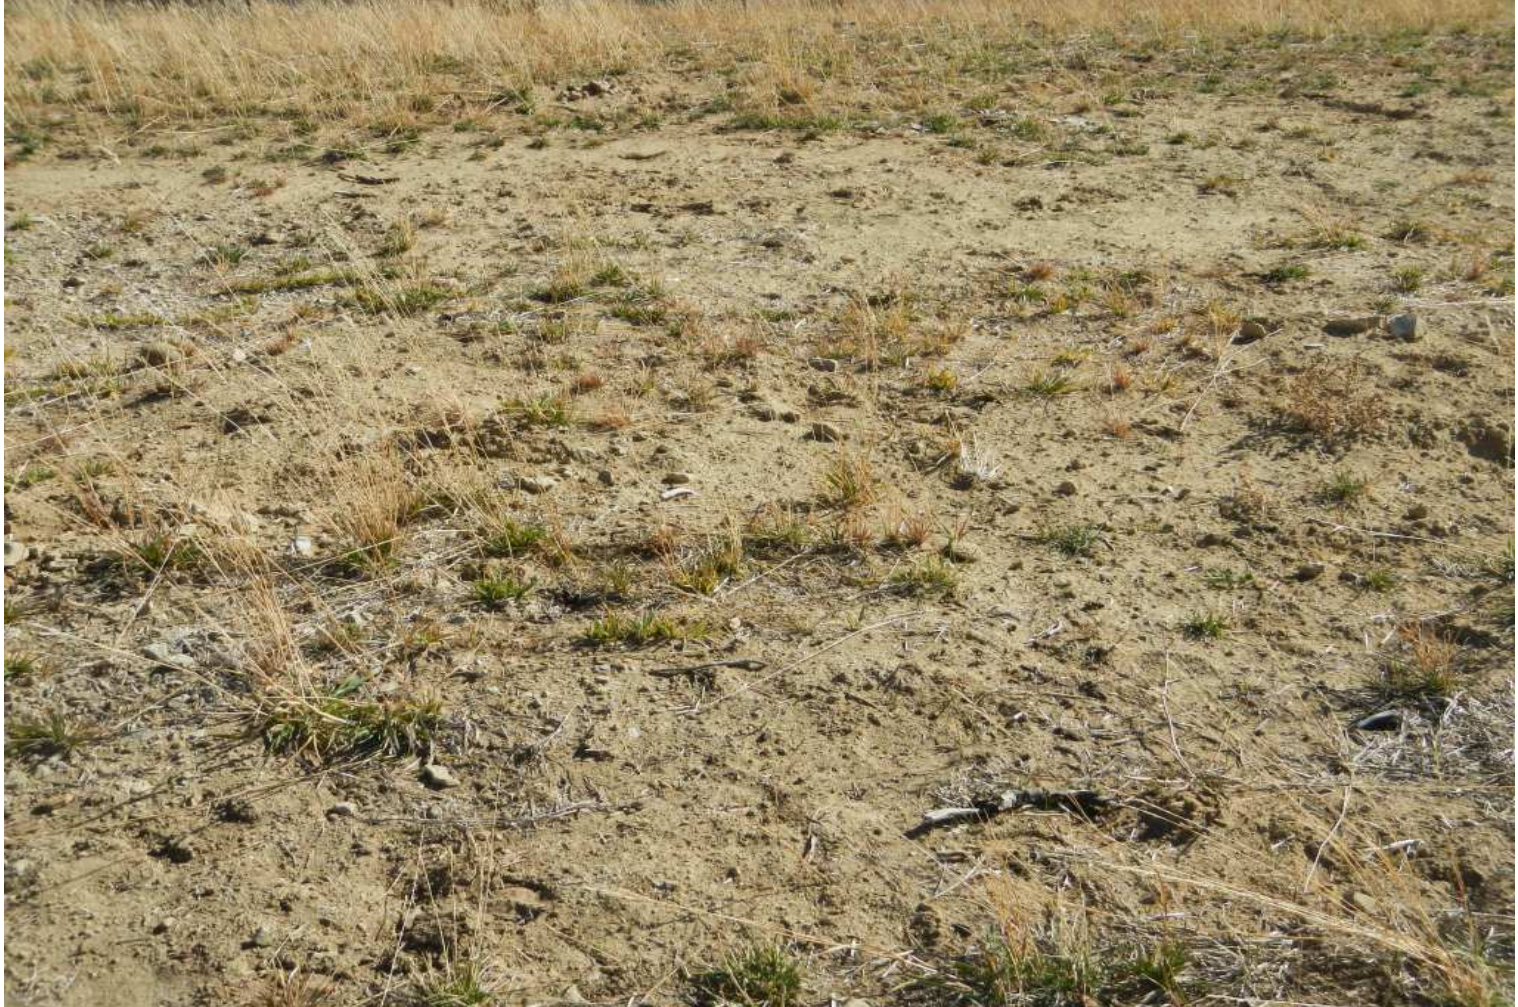
Photo#5: Vegetation has been severely Grazed.
