# Stormwater Inspection

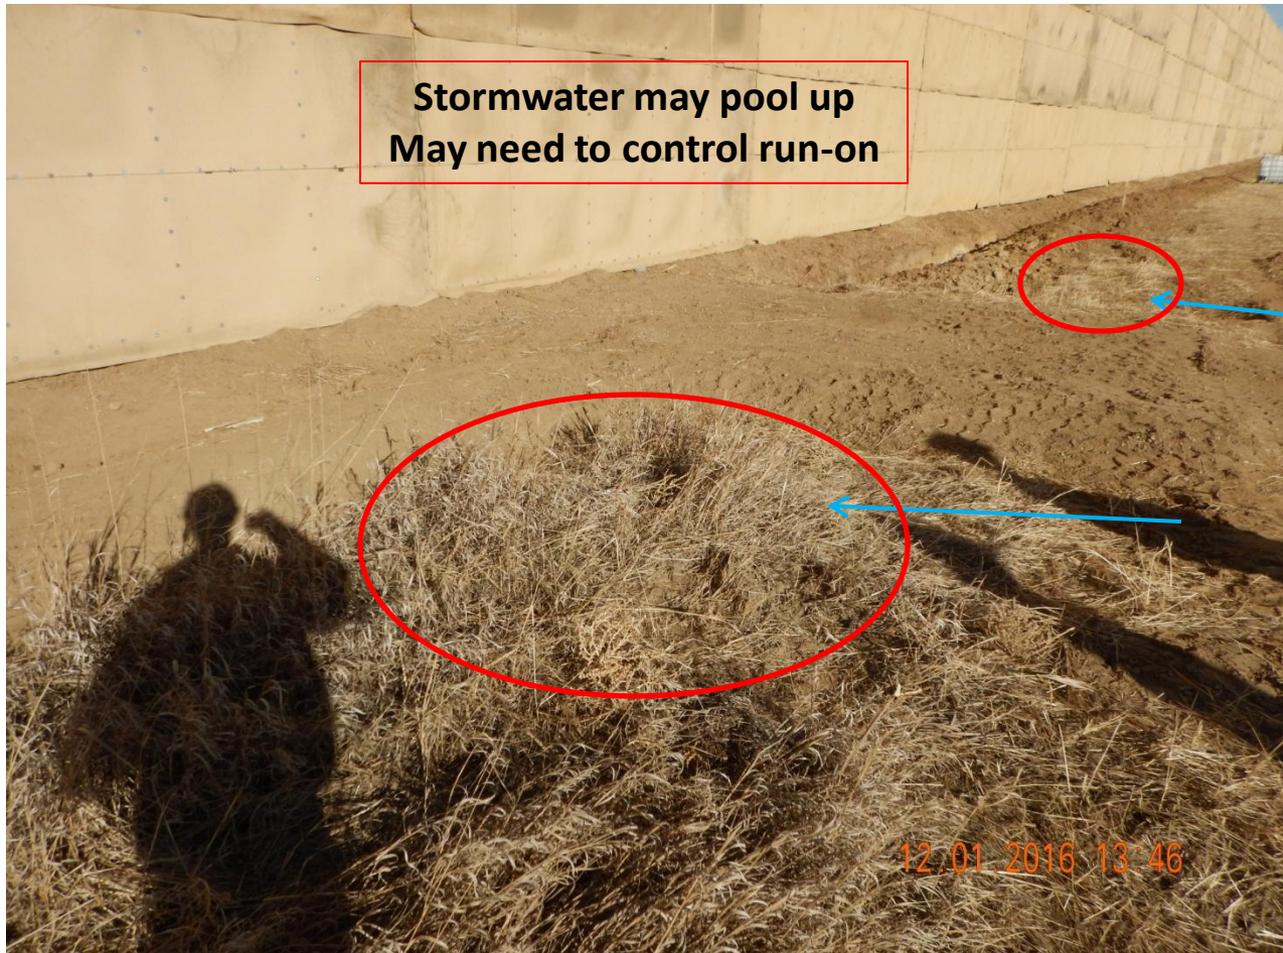
**Photo 1.** Photo taken from the southern location, along the existing access road, facing East. Stormwater from the existing access road will likely travel north towards location and pool up in red-circled areas. May need to control stormwater run-on.

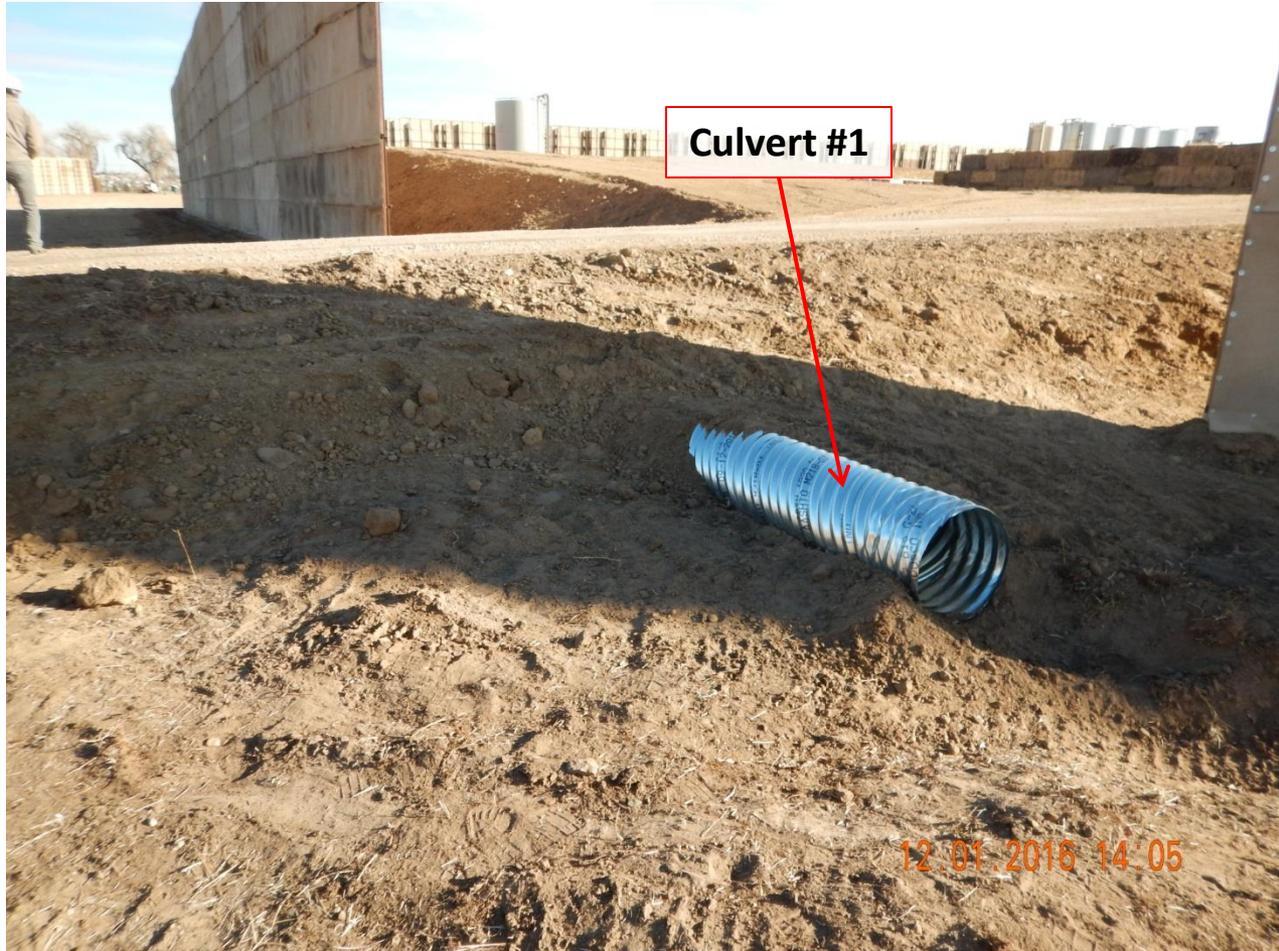
**Photo 2.** Photo taken from the entrance of the well location, facing East. Observations were made that additional BMPs were required to stabilize this area. Refer to the following photo of performed work.

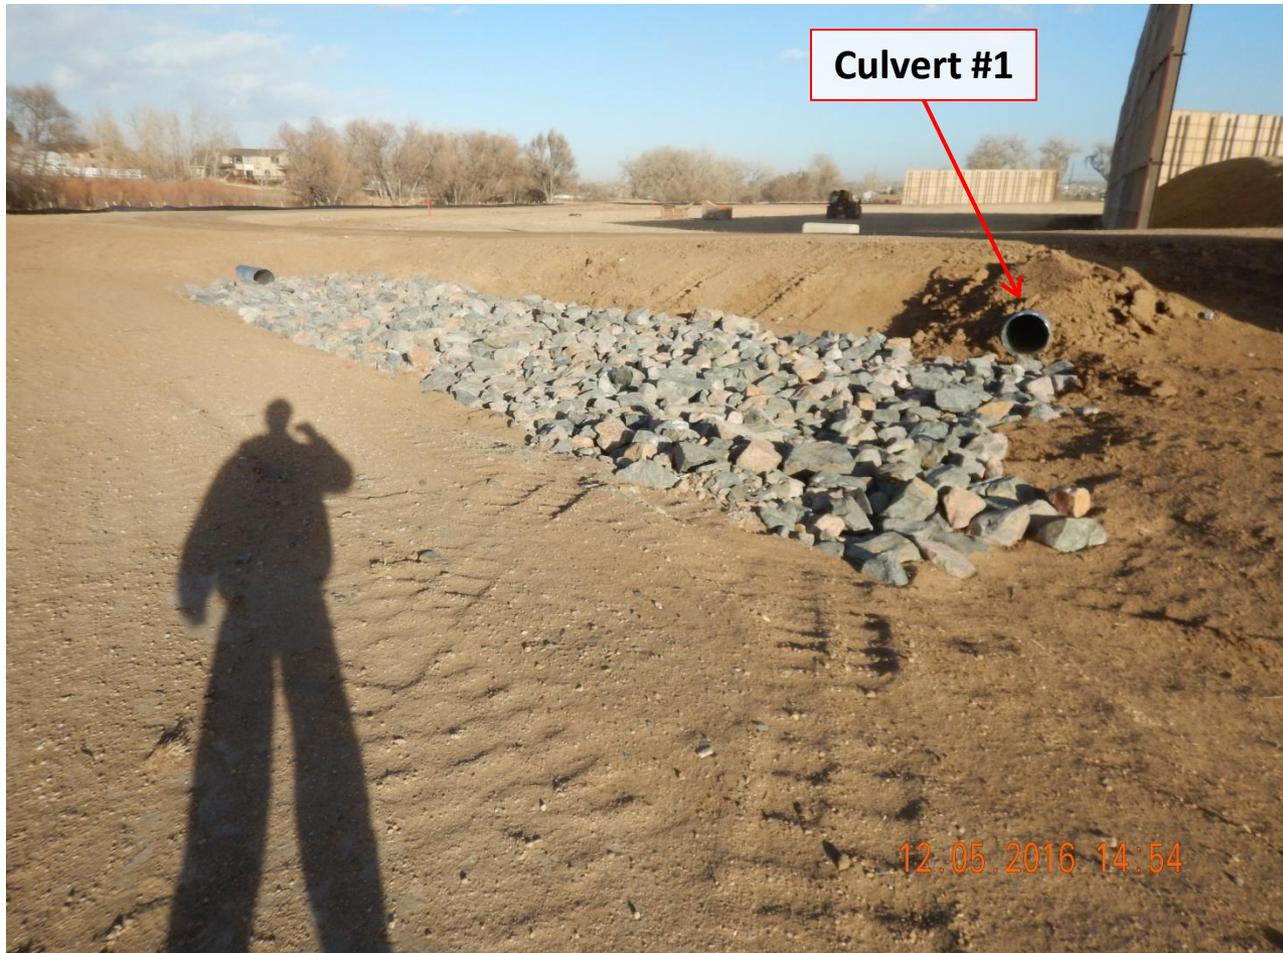
**Photo 3.** Photo taken from the entrance of the well location, facing East. Area has been stabilized to control sediment laden storm runoff from leaving location.

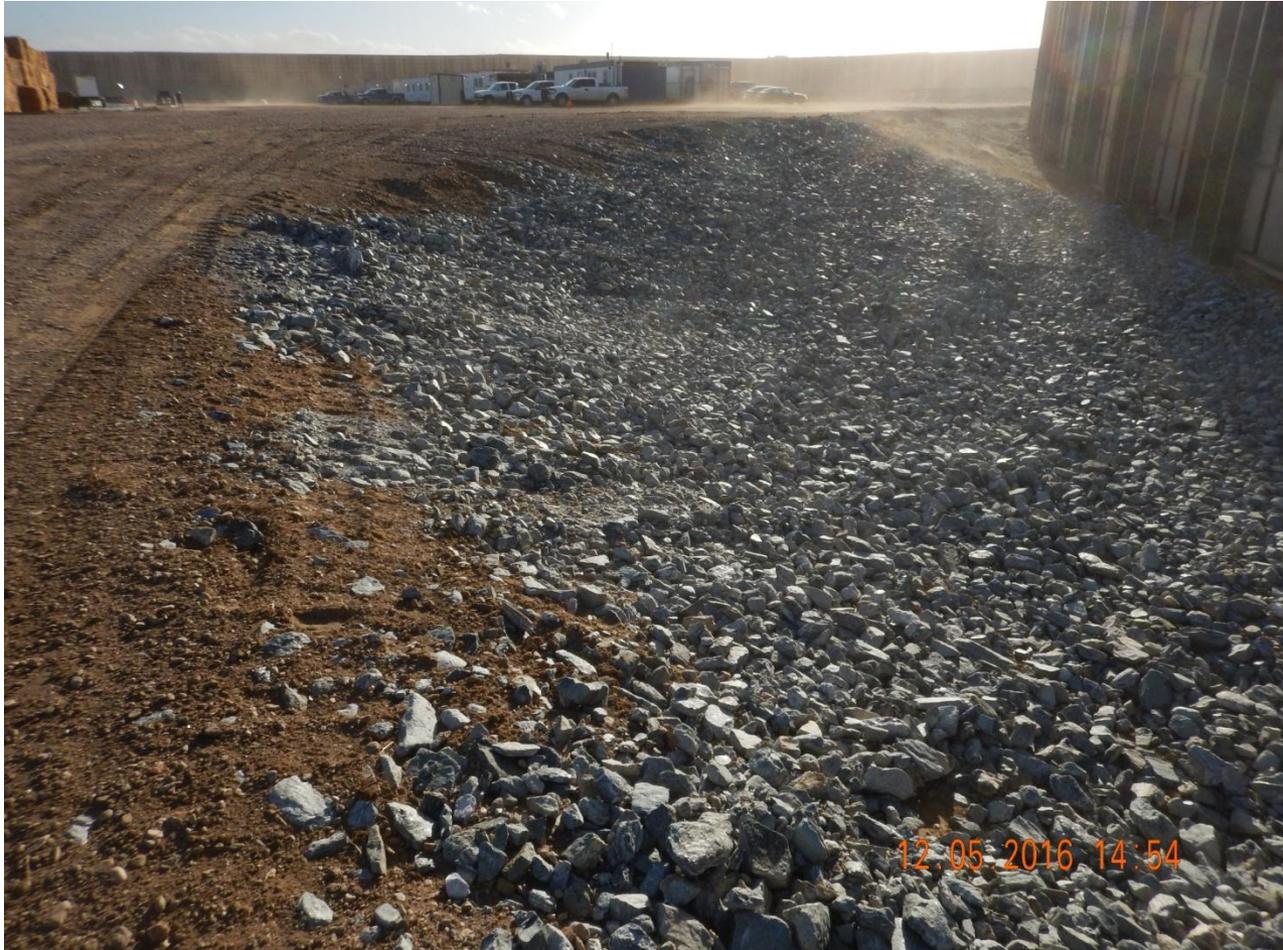
**Photo 4.** Photo taken from the west-side of the entrance of the well location, facing South. Fill slope has been stabilized to prevent erosion.

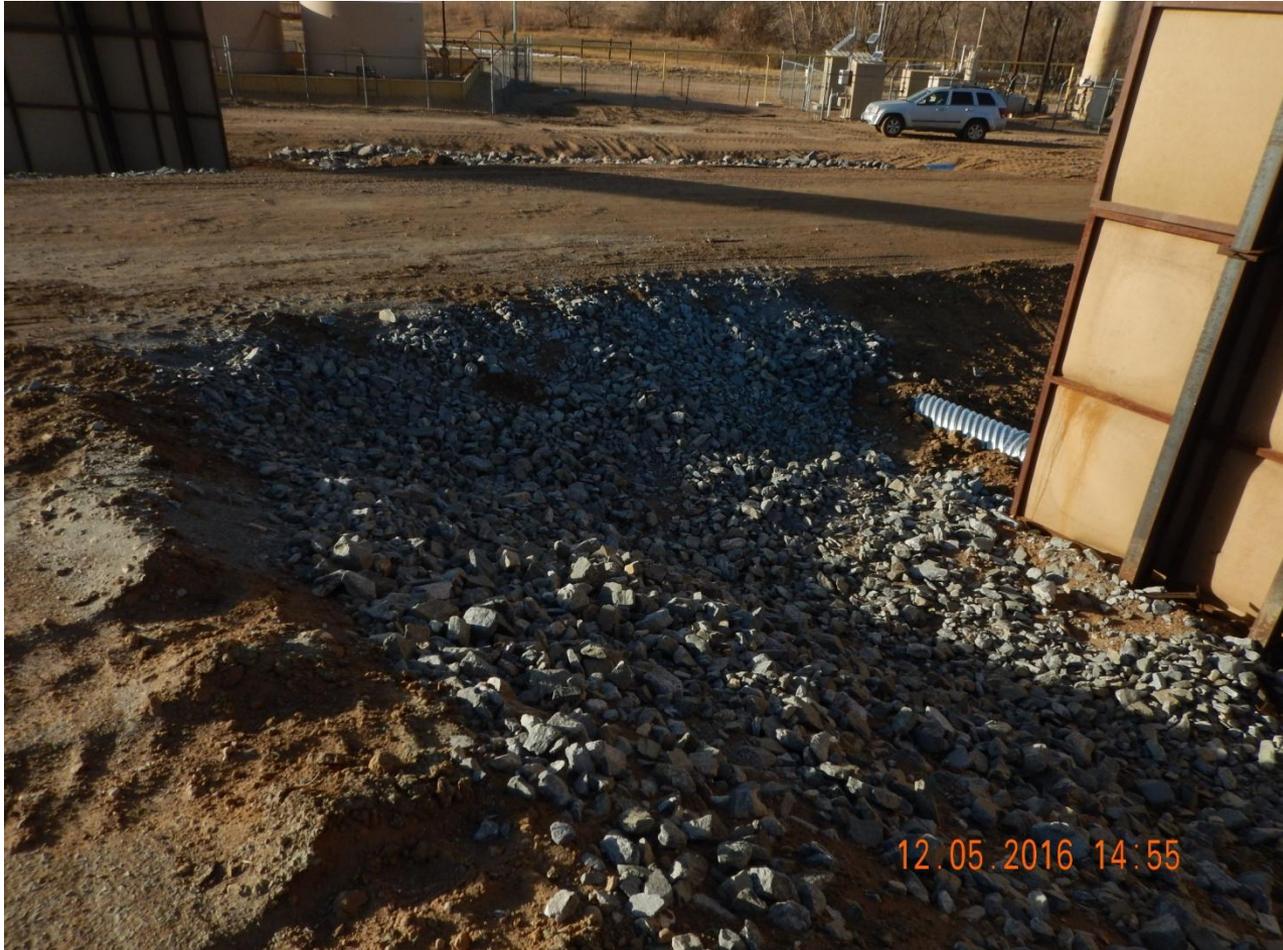
**Photo 5.** Photo taken from the east-side of the entrance of the well location, facing West. Fill slope has been stabilized to prevent erosion.

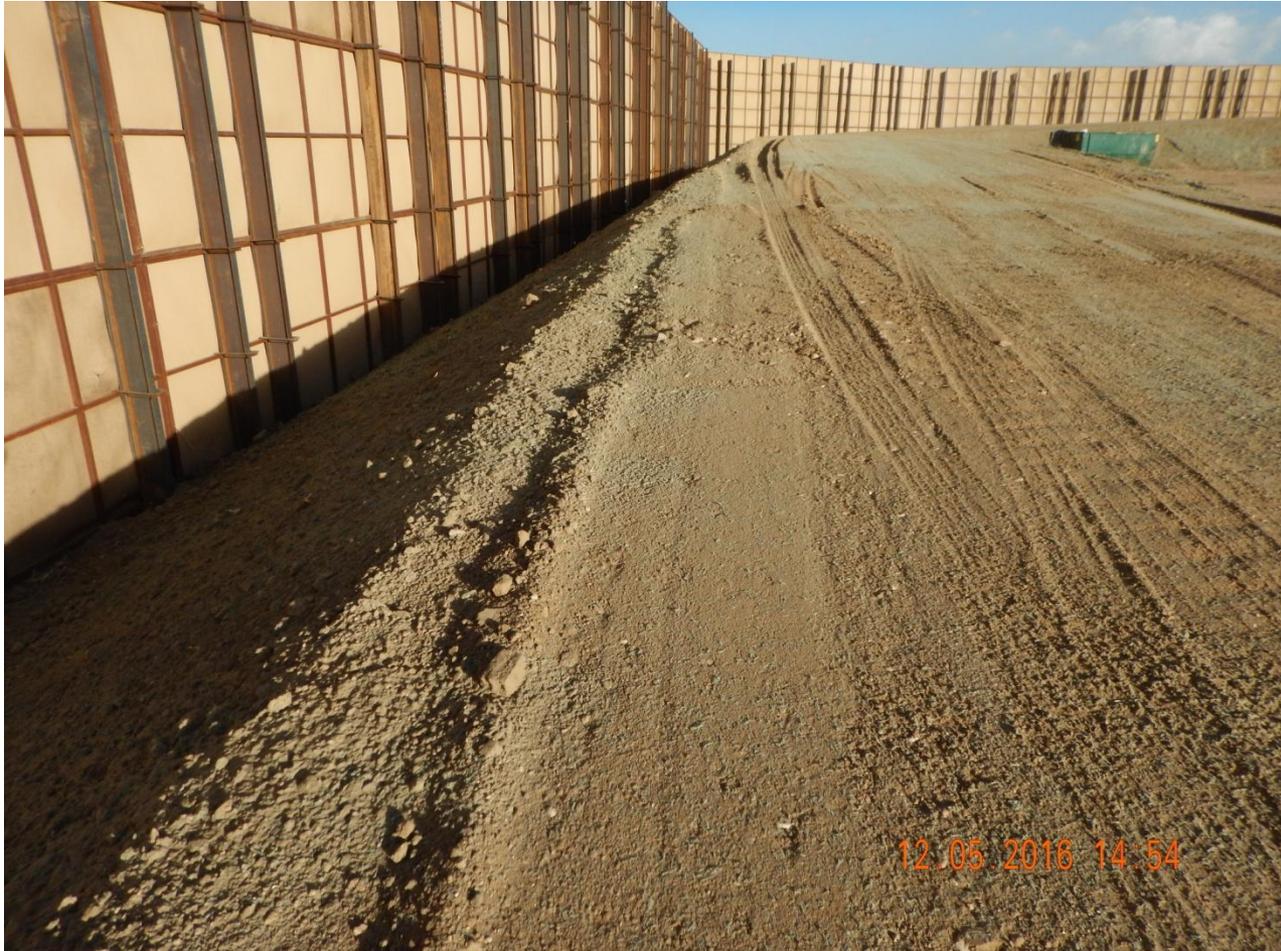
**Photo 6.** Photo taken from the entrance of the location, facing East, along the inside perimeter soil barrier. Soil barrier and MLVT area has been sprayed with a tacifier to stabilize from erosion.

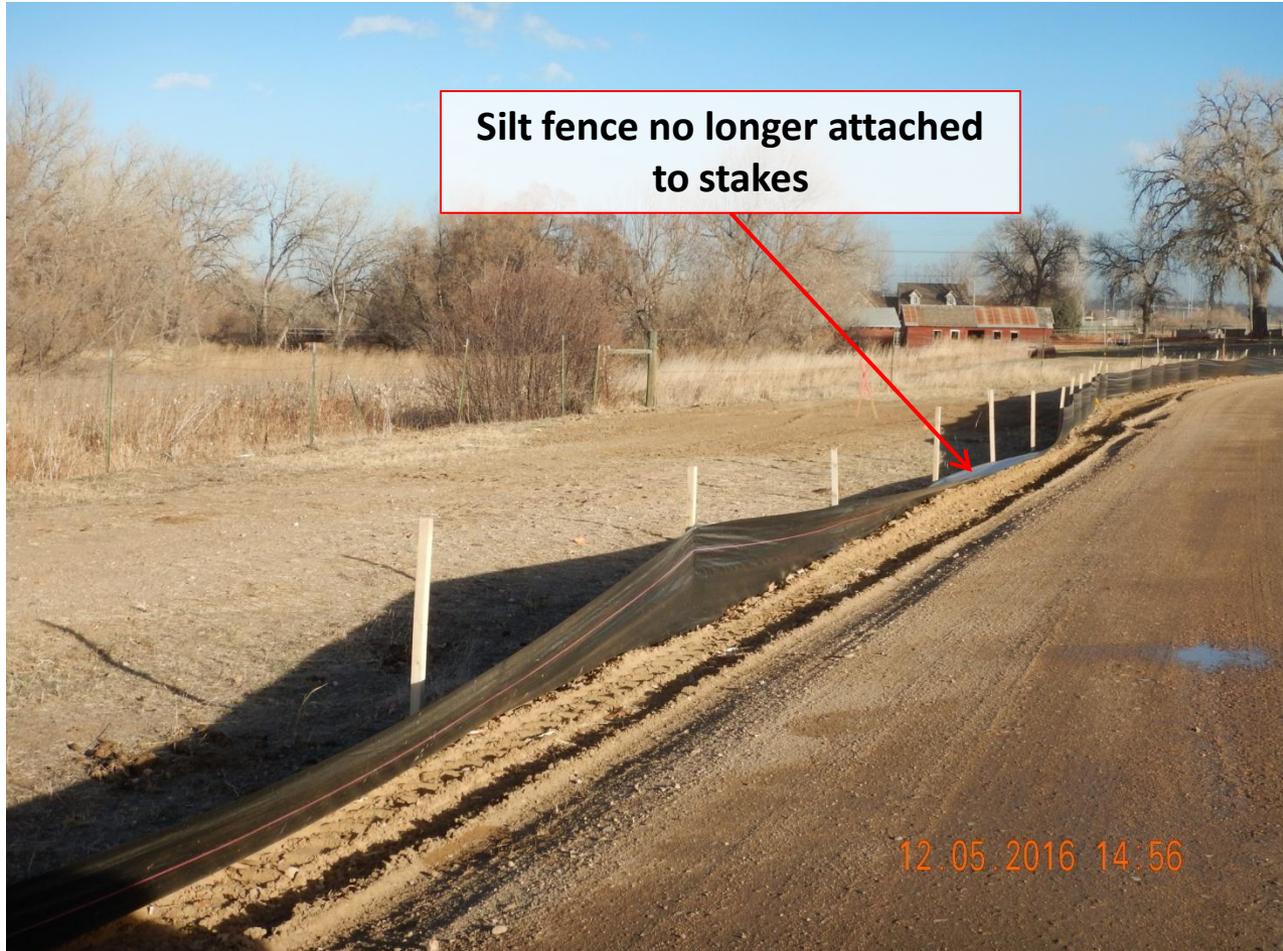
**Photo 7.** Photo taken from the access road near the entrance of the location, facing East. Silt fence has been installed along the northern portion of the access road and needs to be maintained.
