Final Reclamation Inspection- Overview

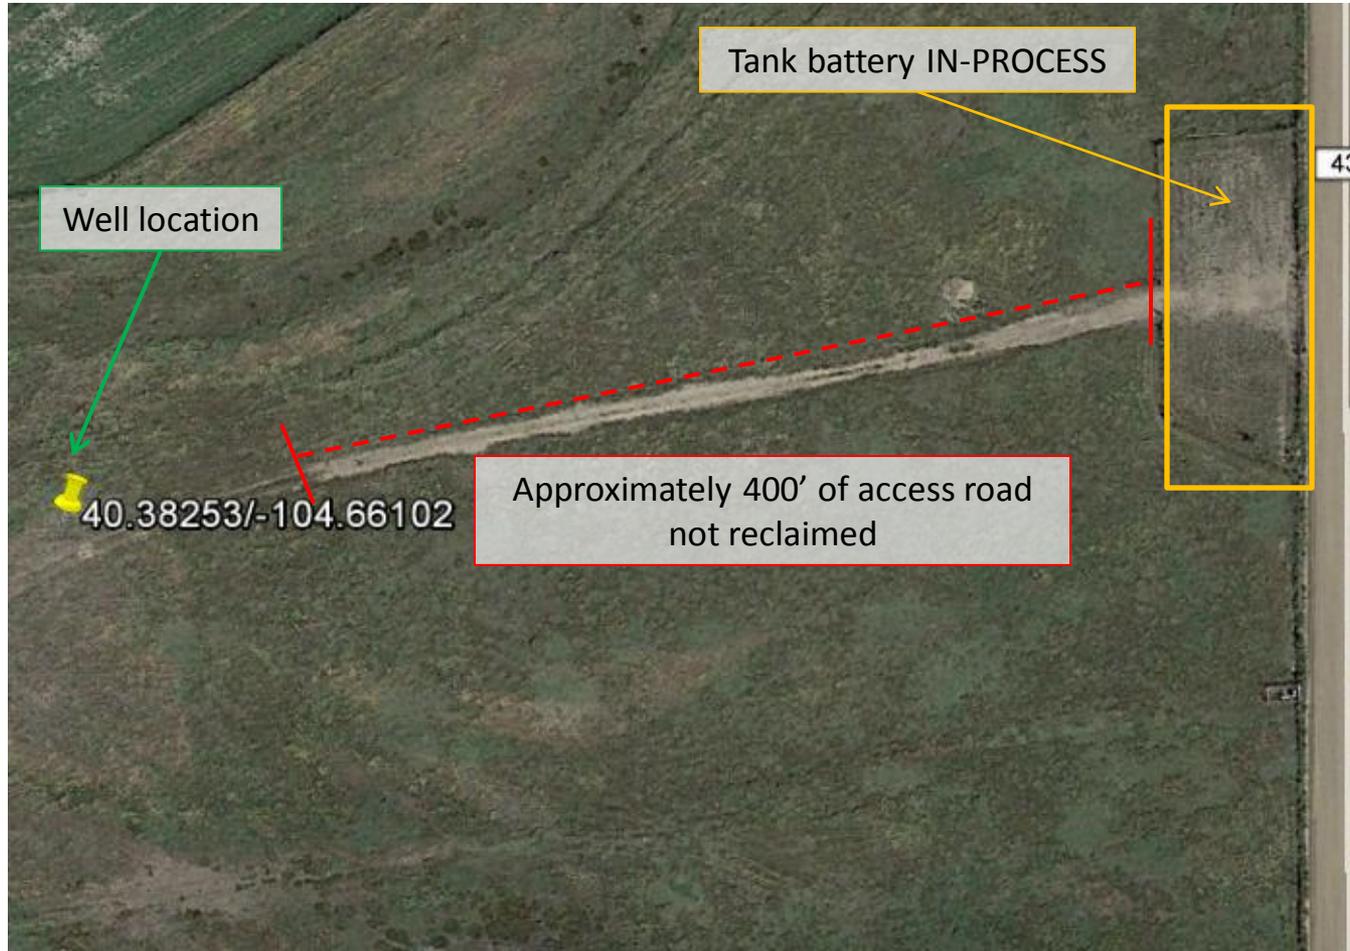
Google Earth aerial photo taken 9/7/2016 illustrating total extent of disturbance. Well location passes Rule 1004 standards. Tank battery location IN-PROCESS. Appears that approximately 400' of the access road has not been reclaimed.

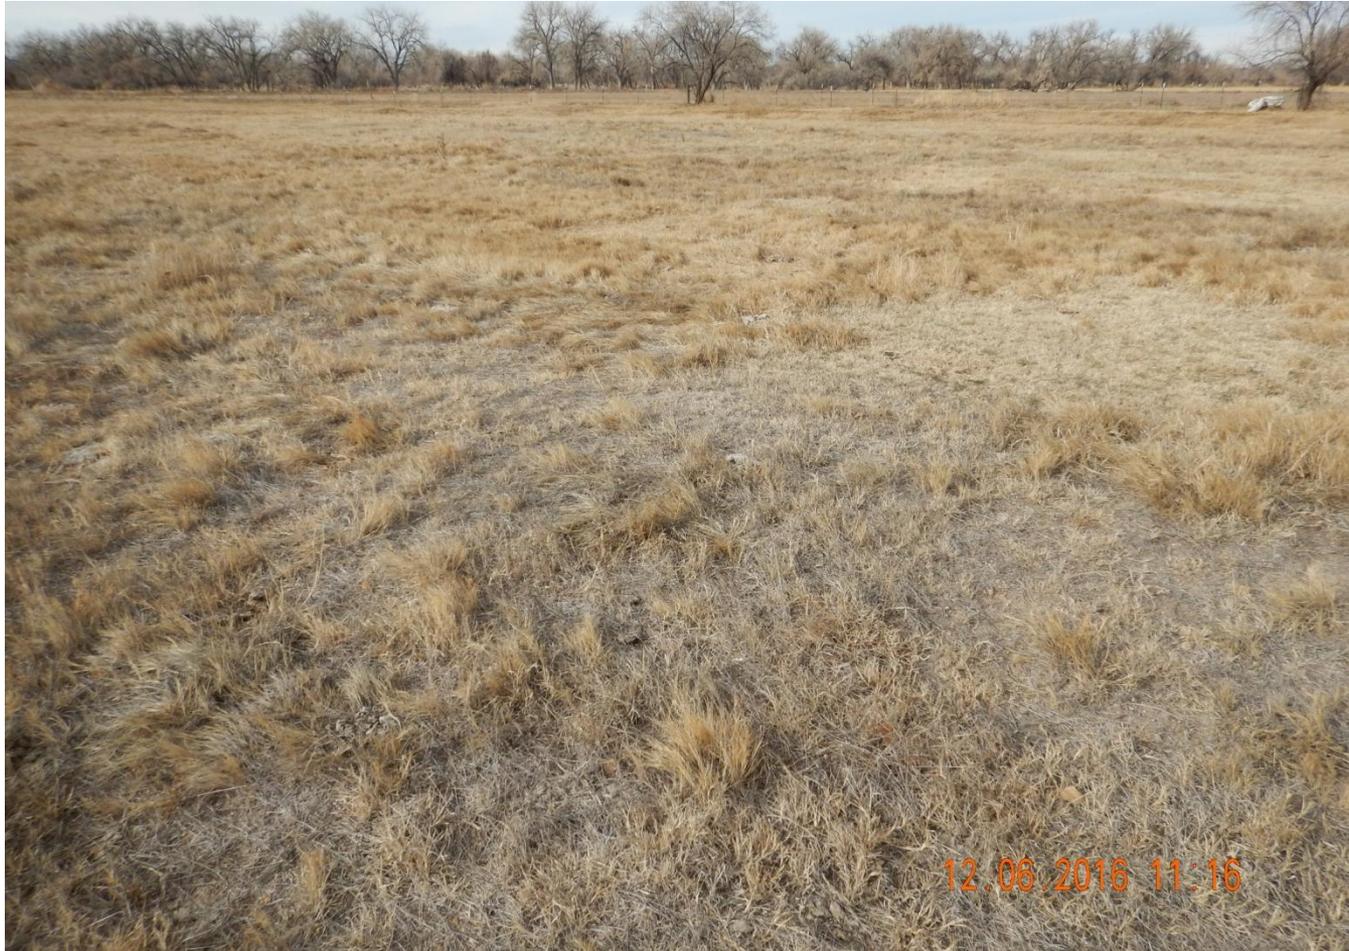
Photo 1. Photo taken from center of location, facing West. No evidence of disturbance. Uniform vegetative growth throughout location.

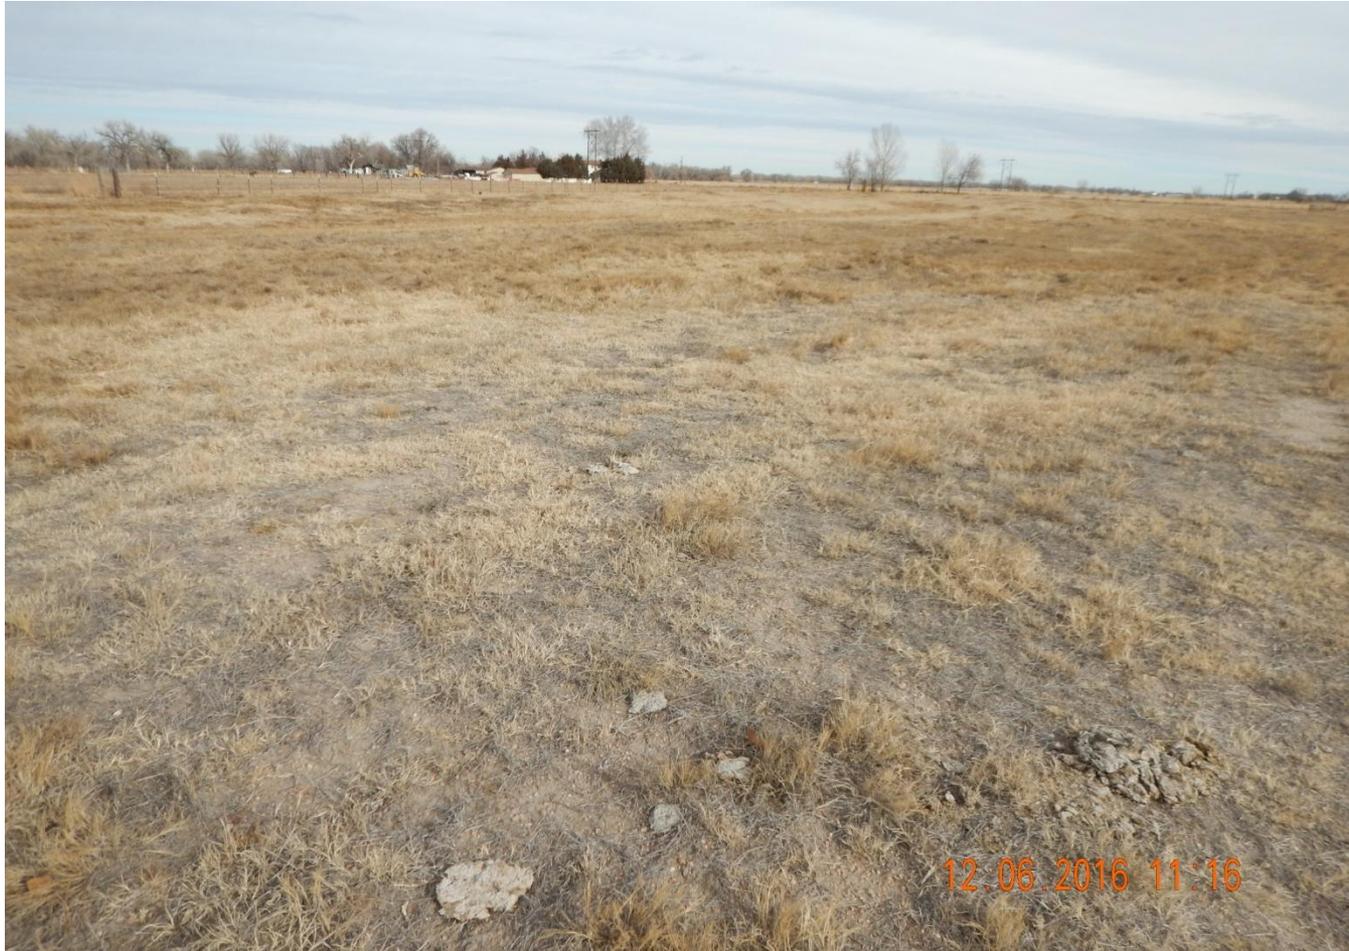
Photo 2. Photo taken from center of location, facing North. No evidence of disturbance. Uniform vegetative growth throughout location.

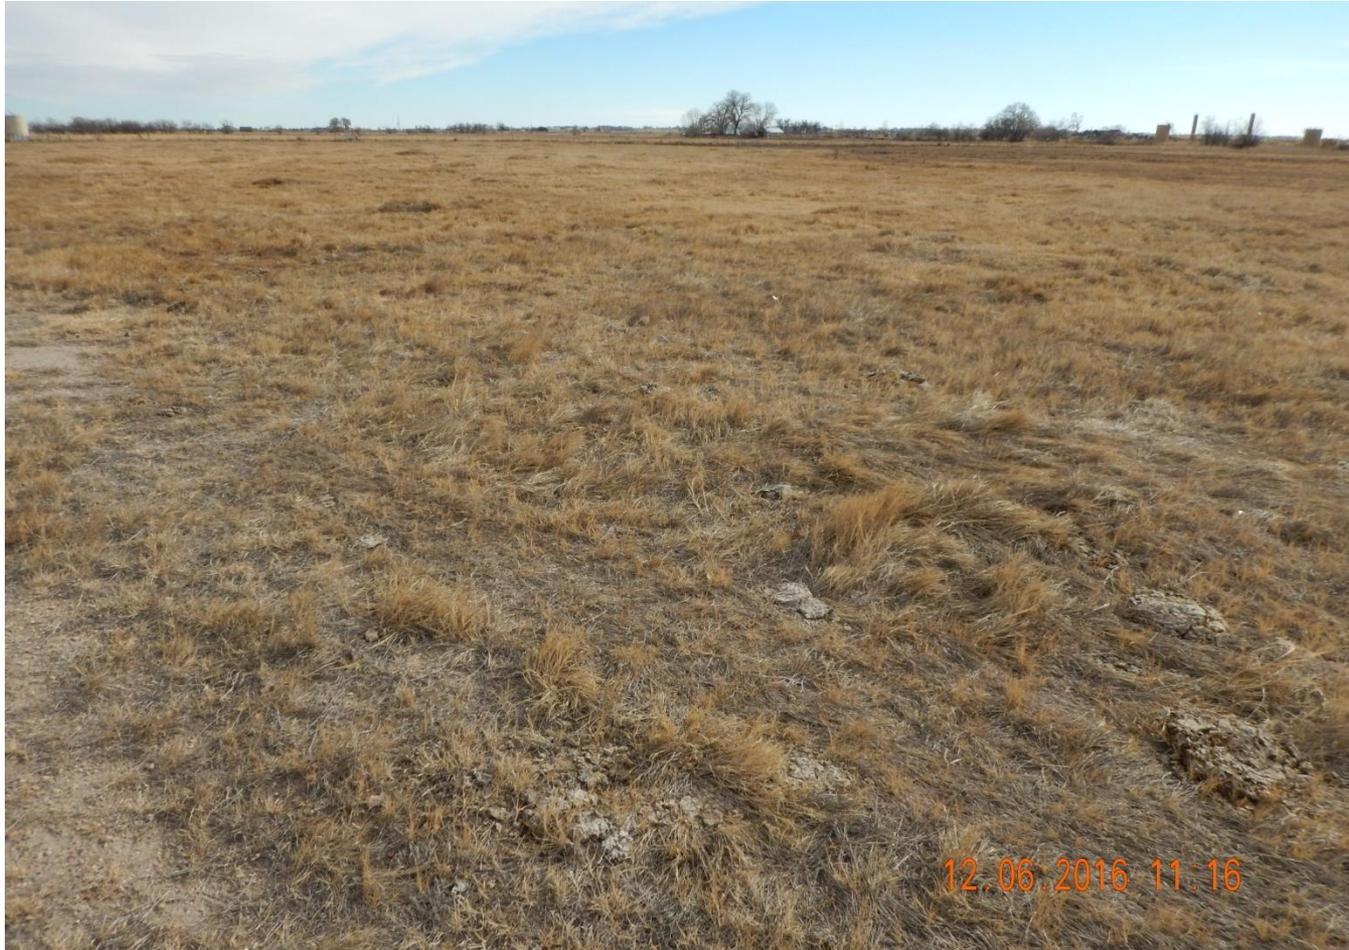
Photo 3. Photo taken from center of location, facing East. No evidence of disturbance. Uniform vegetative growth throughout location.

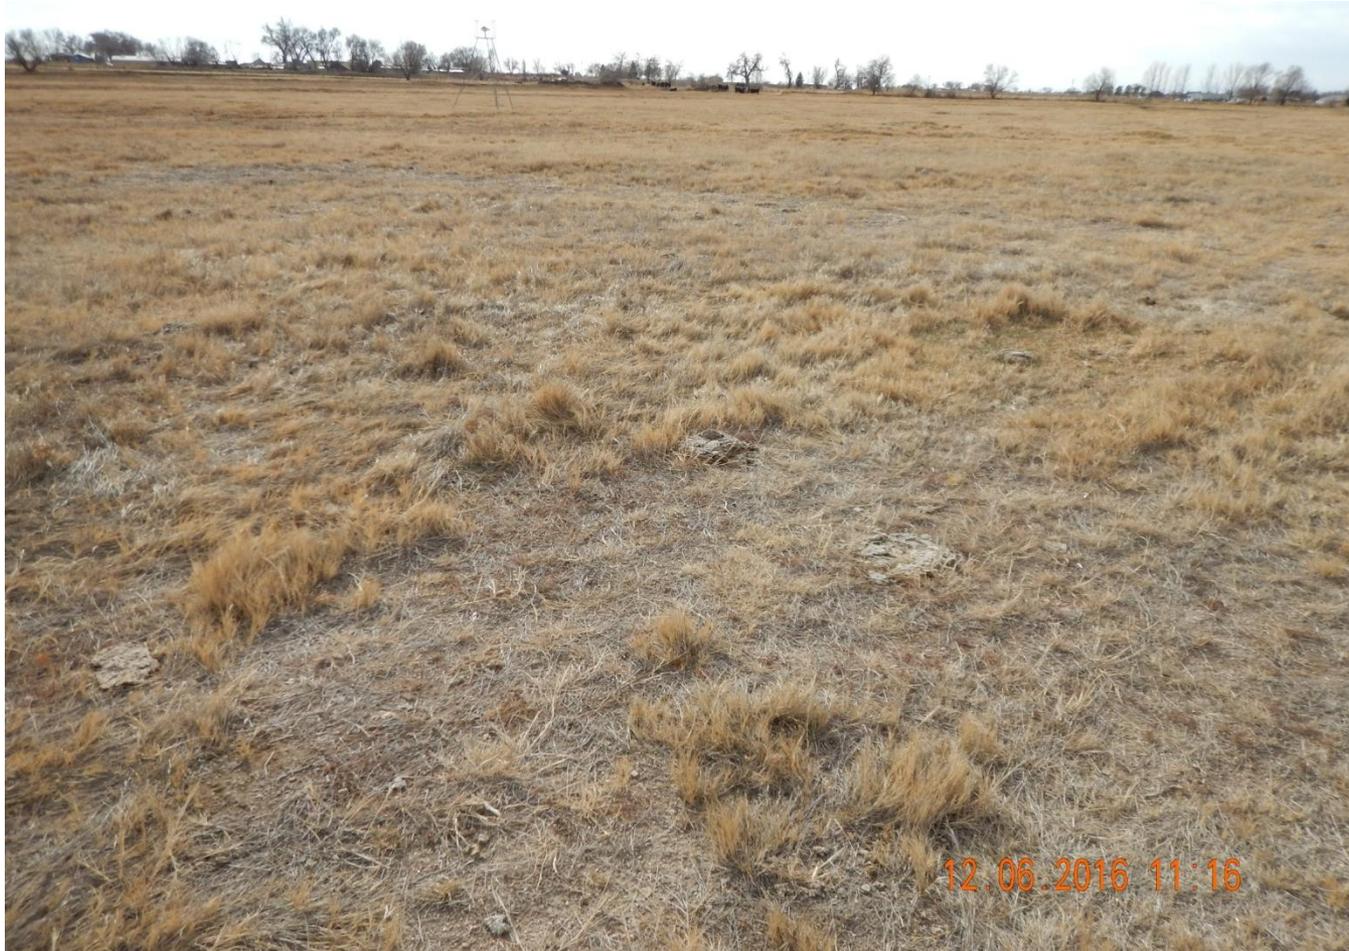
Photo 4. Photo taken from center of location, facing South. No evidence of disturbance. Uniform vegetative growth throughout location.

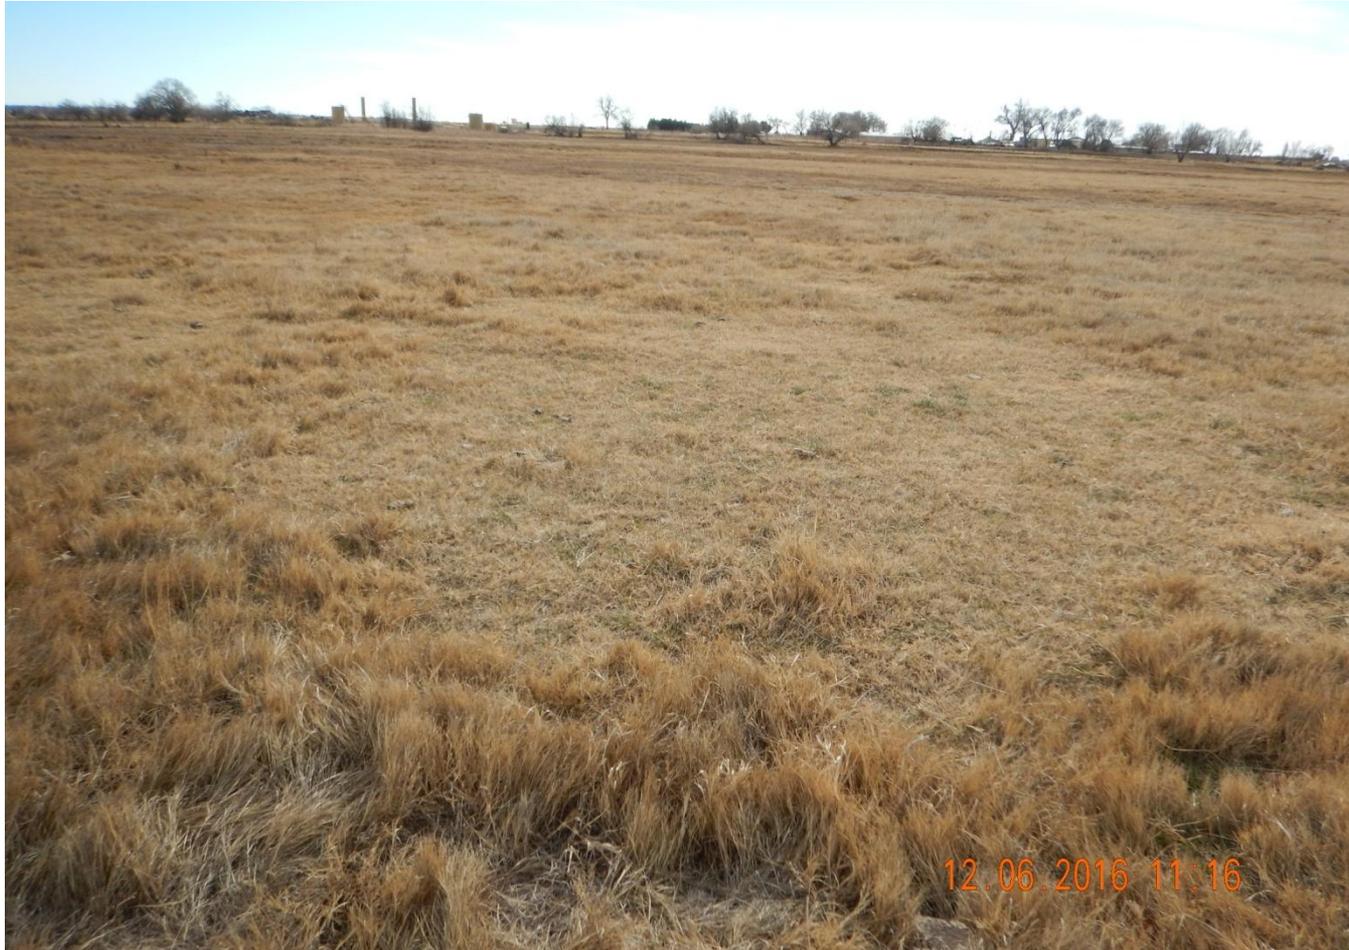
Photo 5. Reference photo taken east of location, facing East. Location appears to be reflective of the reference areas.

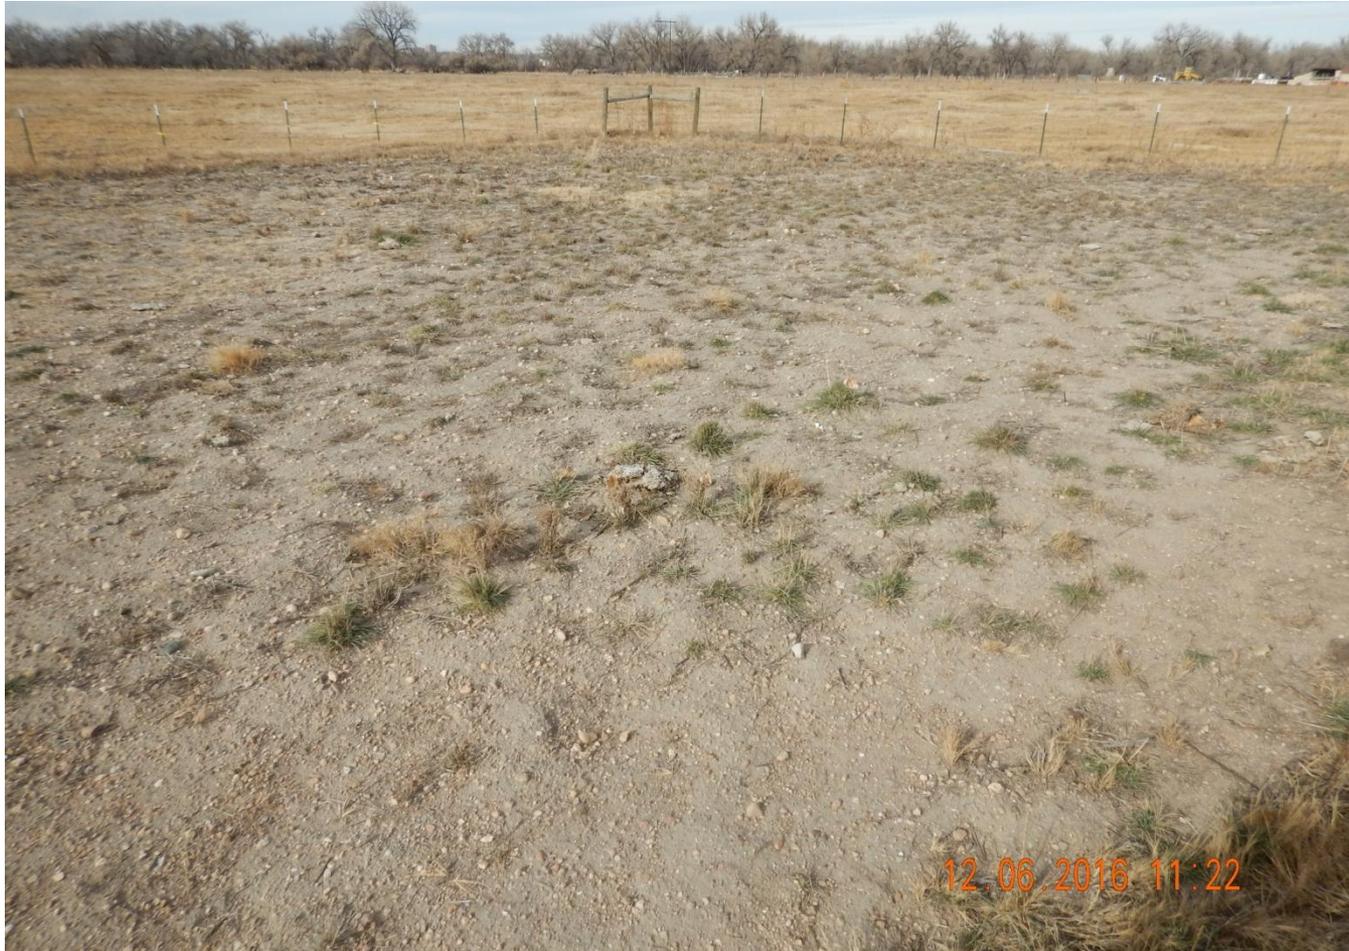
Photo 6. Photo taken from the tank battery location (i.e., fenced in location), facing Northwest. Location IN-PROCESS. A seeding attempt is evident but location lacks uniform vegetative growth that is not reflective of reference areas.
