Iles Dome Unit 37

Inspection# 673403915

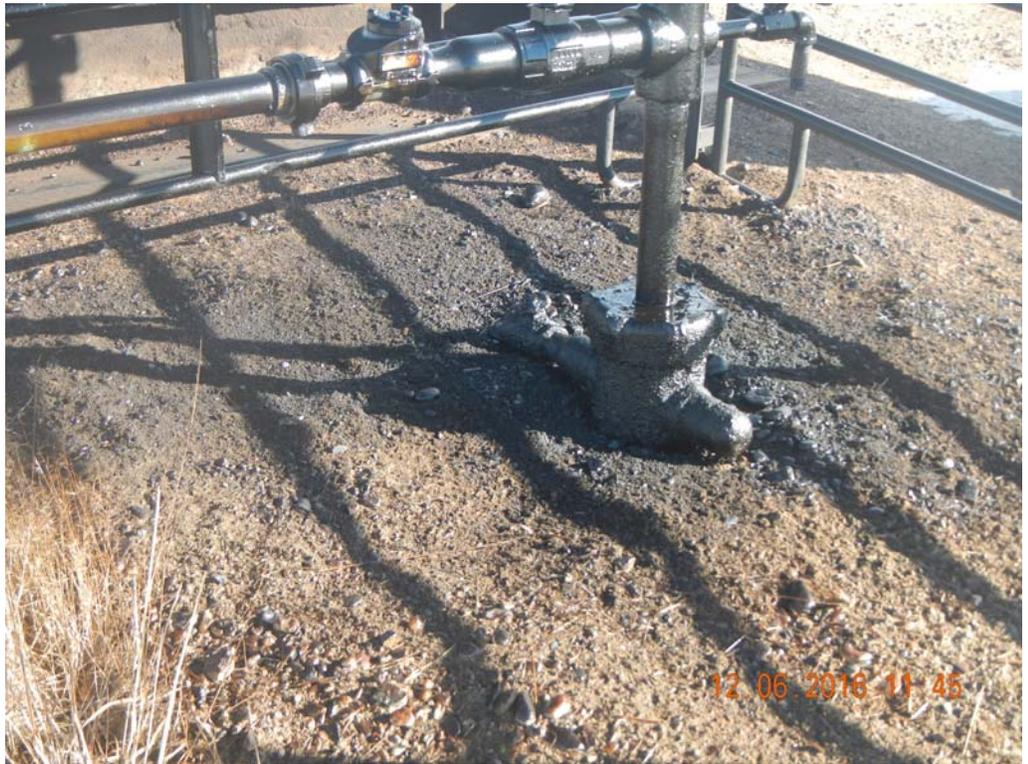
12/6/2016

Active leak at wellhead.

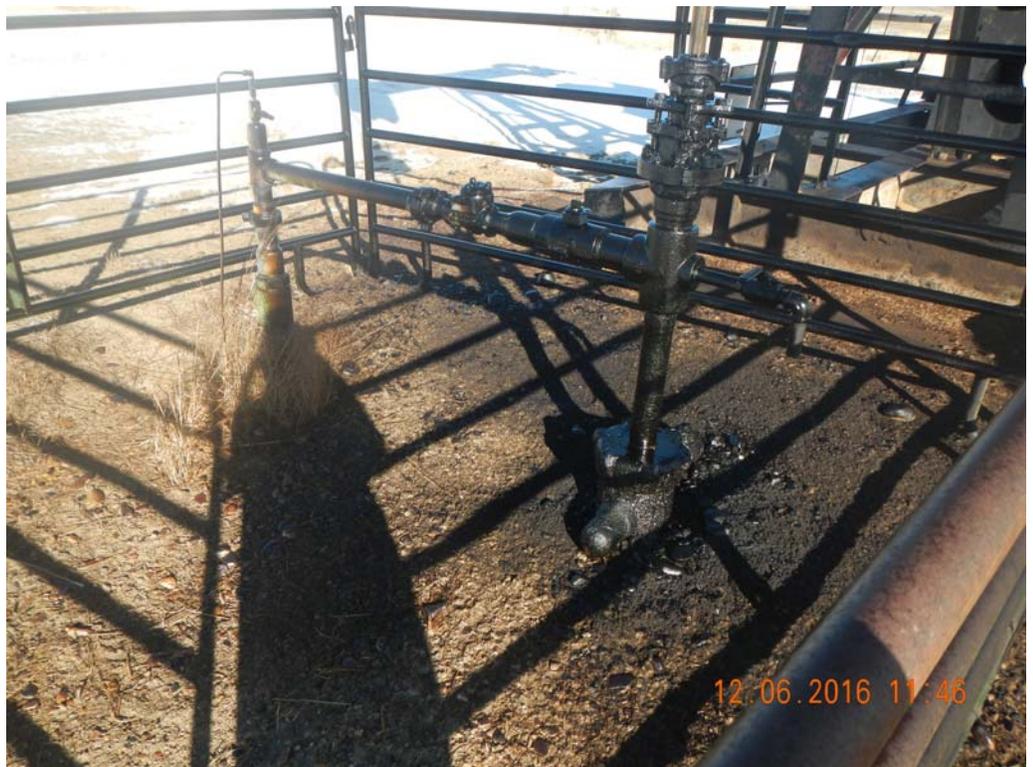
12/6/2016

Active leak at wellhead.

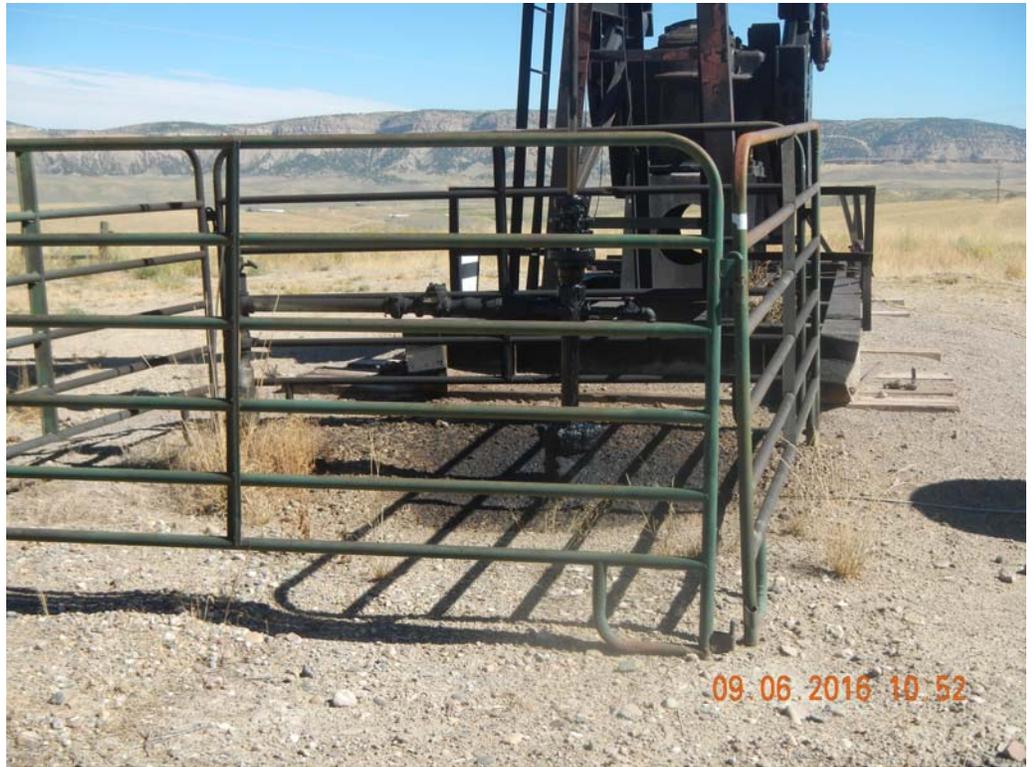
9/6/2016

Leak and stained soil at wellhead.

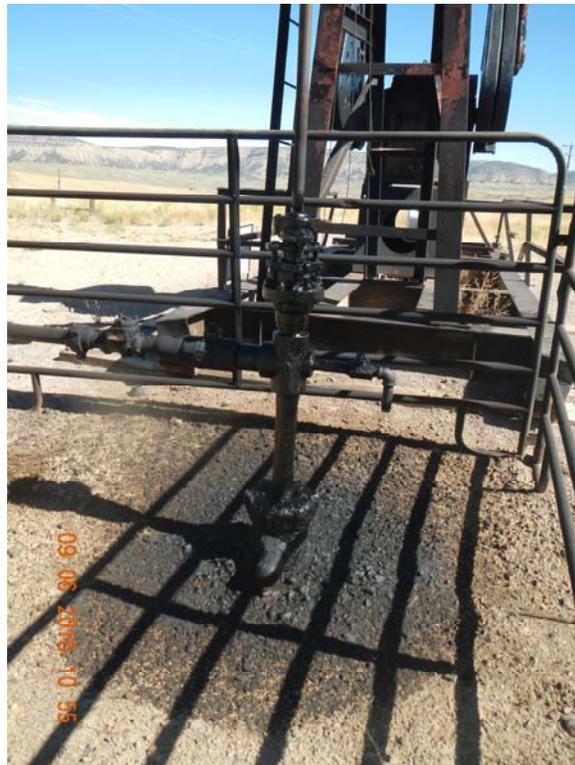
9/6/2016

Leak and stained soil at wellhead.
