Construction and Stormwater Inspection

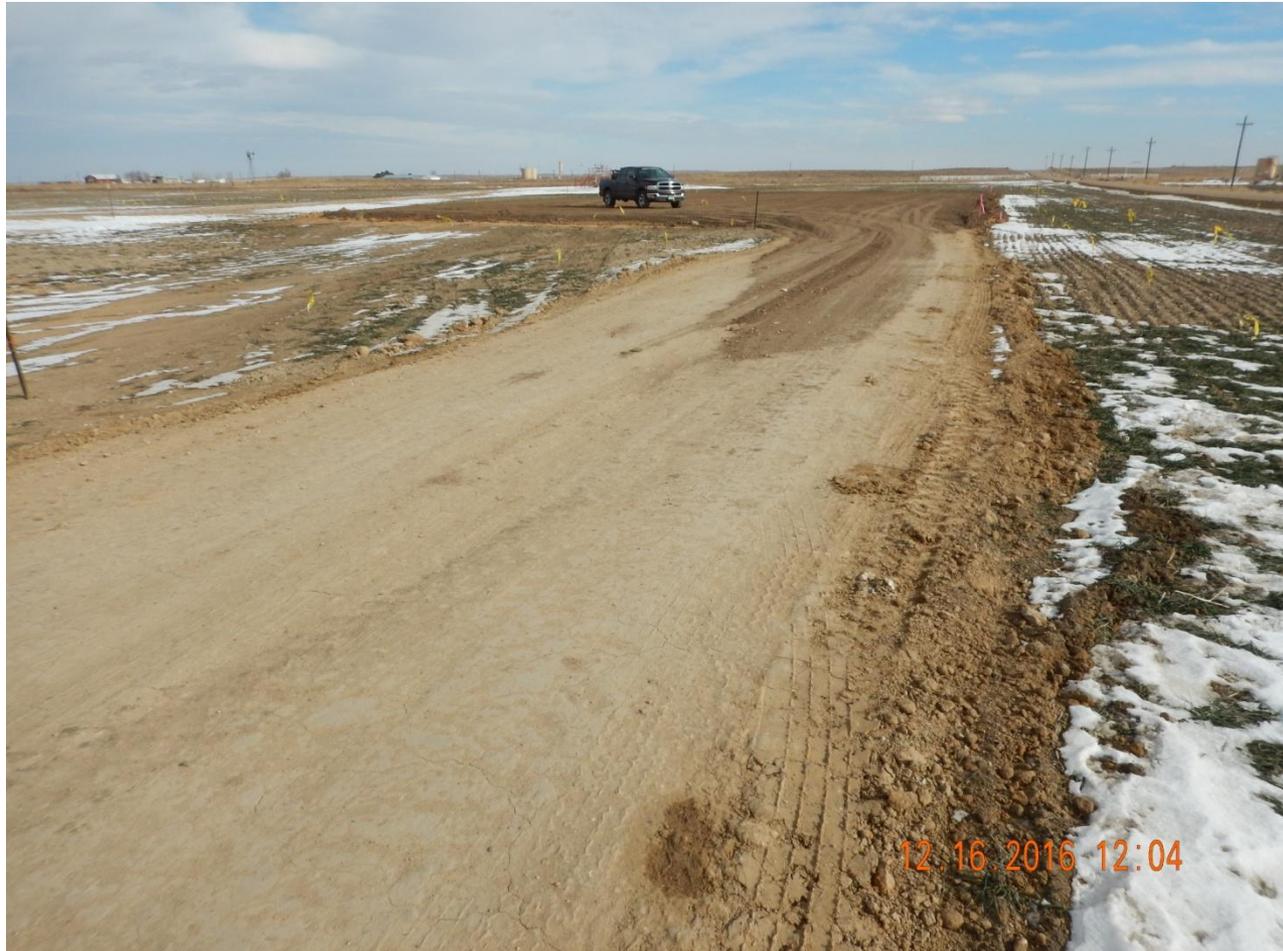
Photo 1. Photo taken from the entrance of location, facing East. Location IN-PROCESS of being built. Topsoil was not salvaged before construction of location. Also, no stormwater or erosion control BMPs in place prior to or during construction.

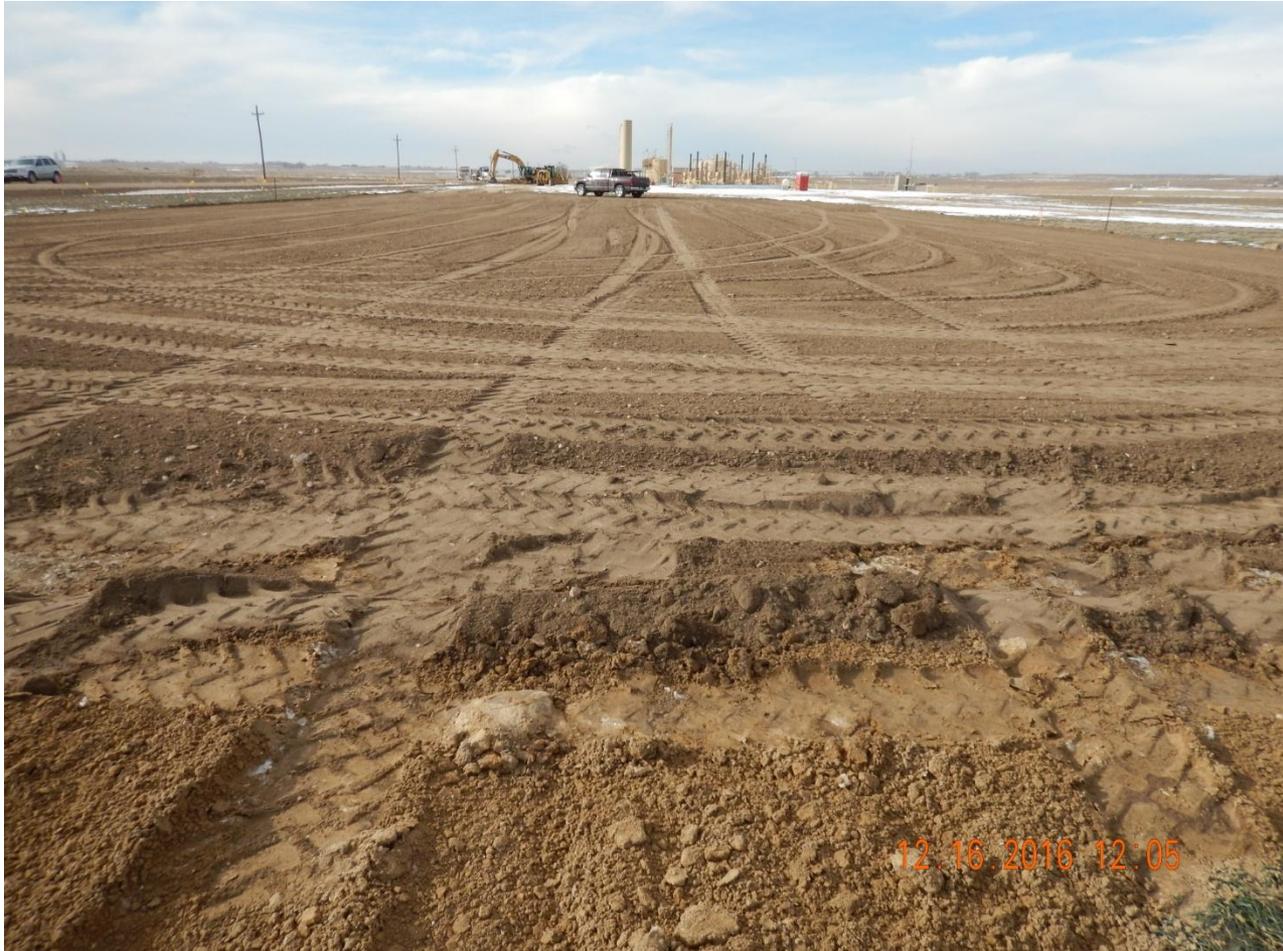
Photo 2. Photo taken from the eastern location, facing West. Location IN-PROCESS of being built. Topsoil was not salvaged before construction of location. Also, no stormwater or erosion control BMPs in place prior to or during construction.
