December 27, 2016

Inspection Photos: Encana AL & DA Shaeffer API#045-10455 & 045-10452

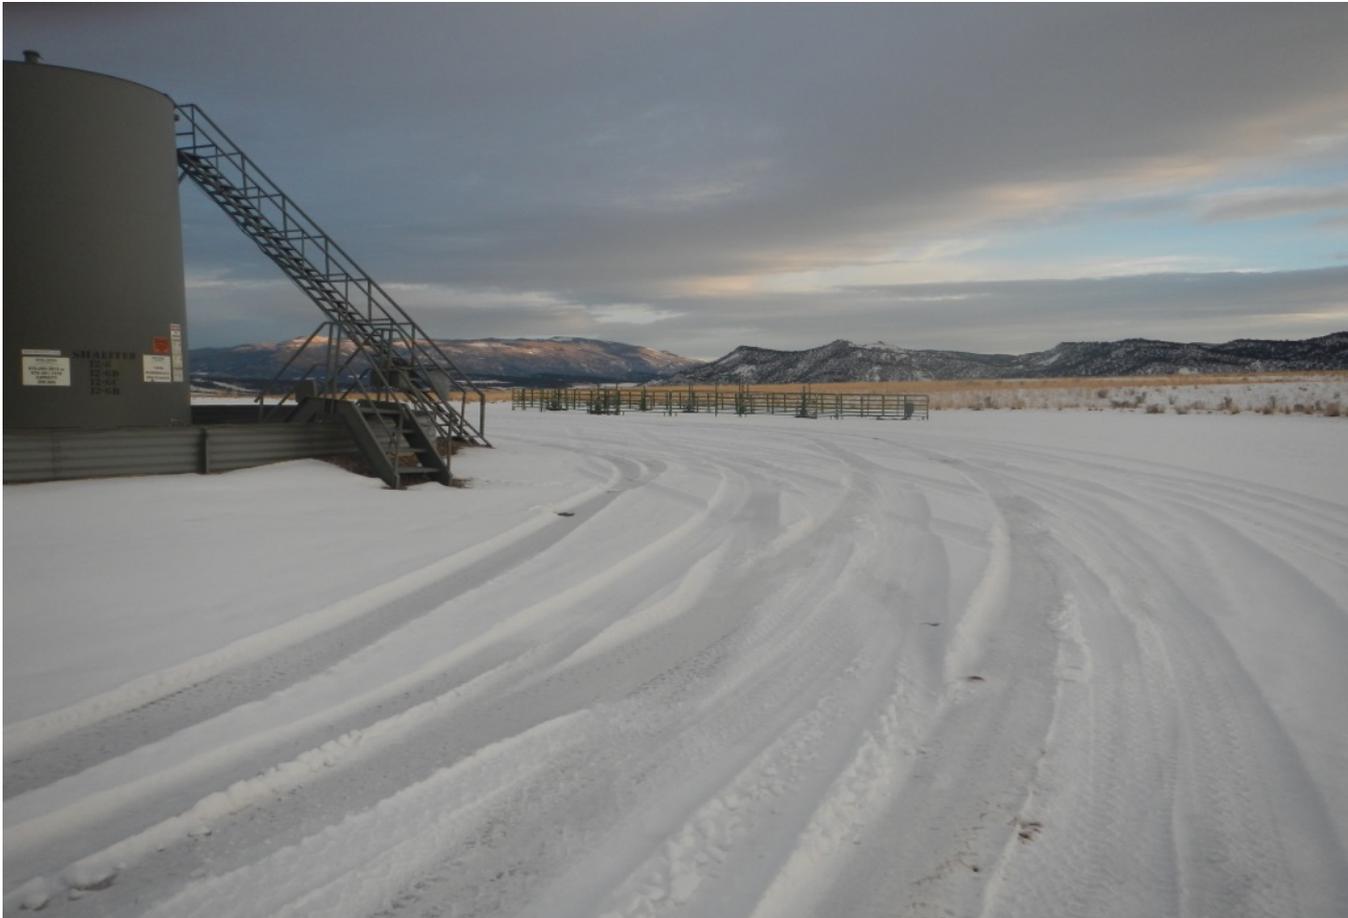
Photo#1: There is no evidence of the AL or DA Well on this Active Location.

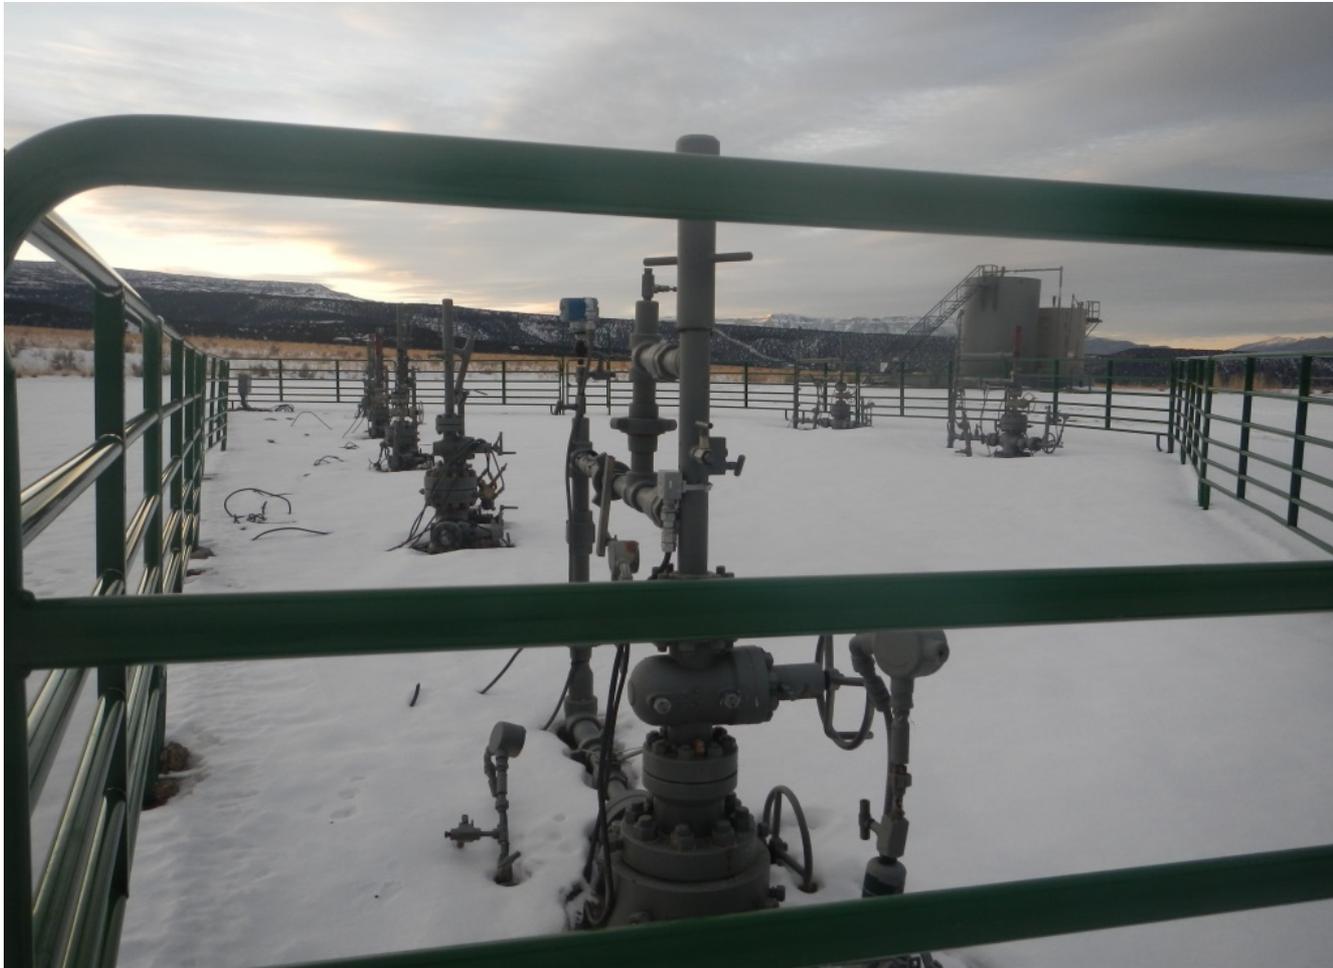
Photo#2: There is no evidence of the AL or DA Well on this Active Layered Location.
