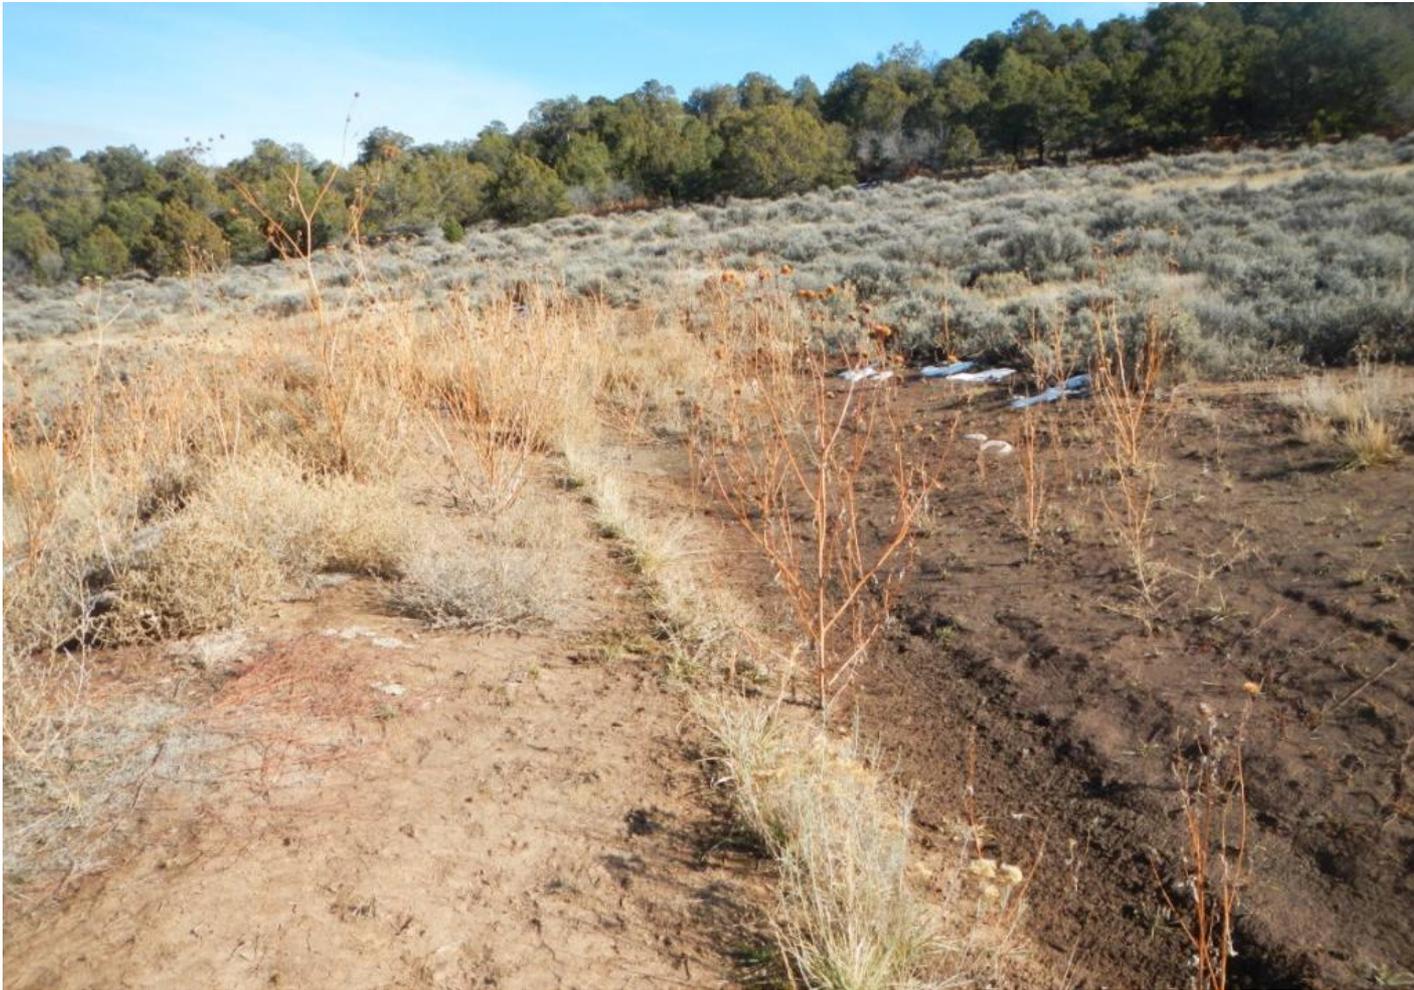
Photo 4. View of area in the southeastern portion of the project area where erosional channels and tunneling have been repaired.

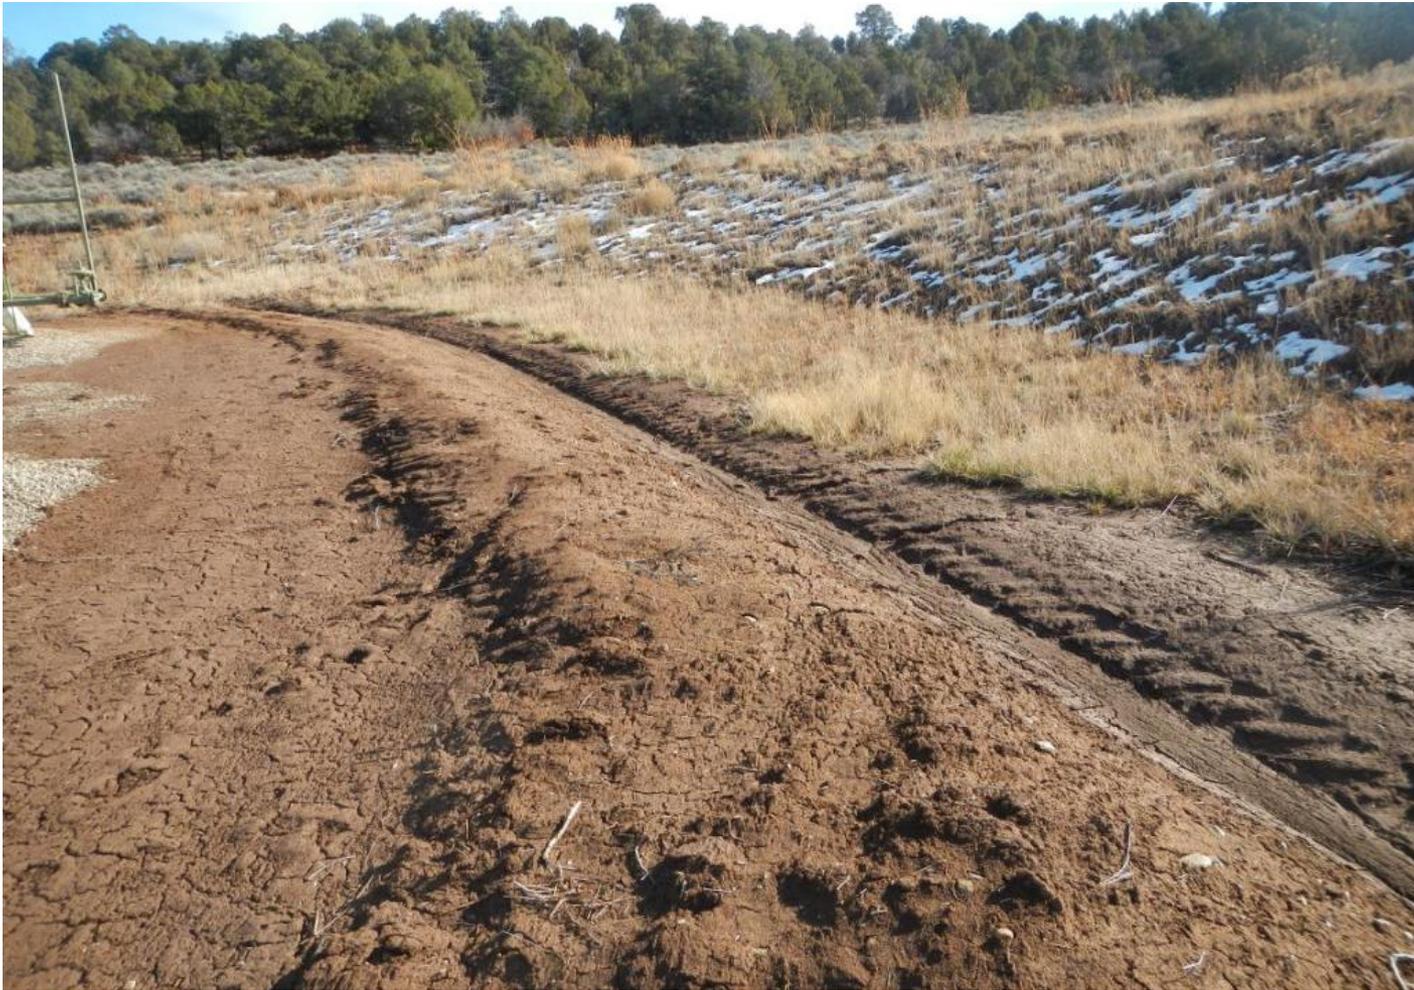
Photo 5. View diversion ditches recently maintained in the southern portion of the project area.

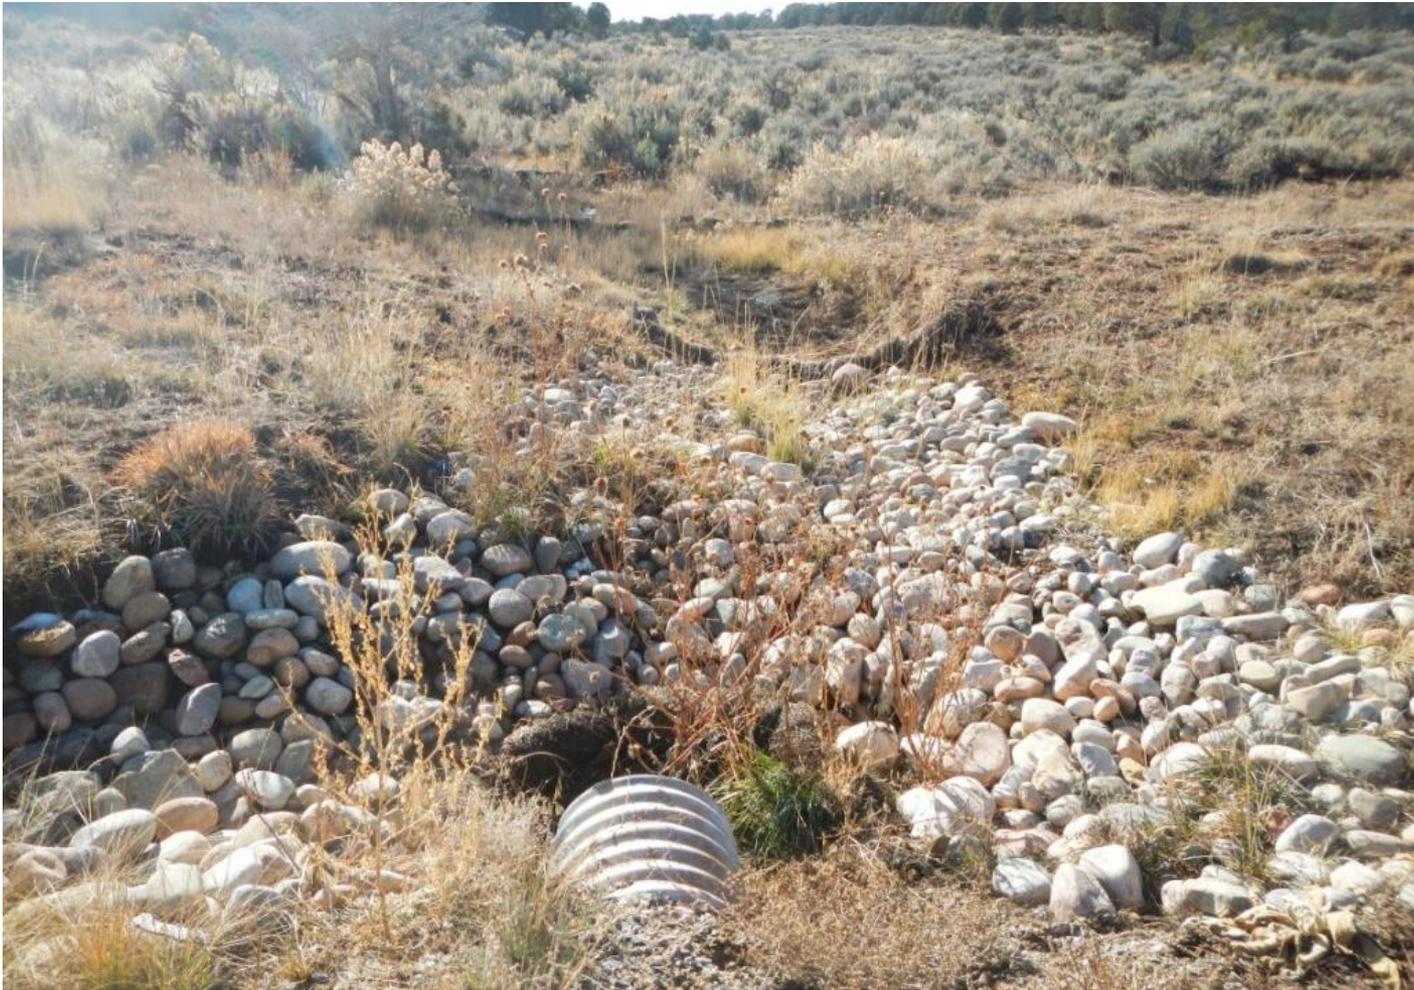
Photo 6. View of cobble armouring installed around the culvert near the entrance of the project area.

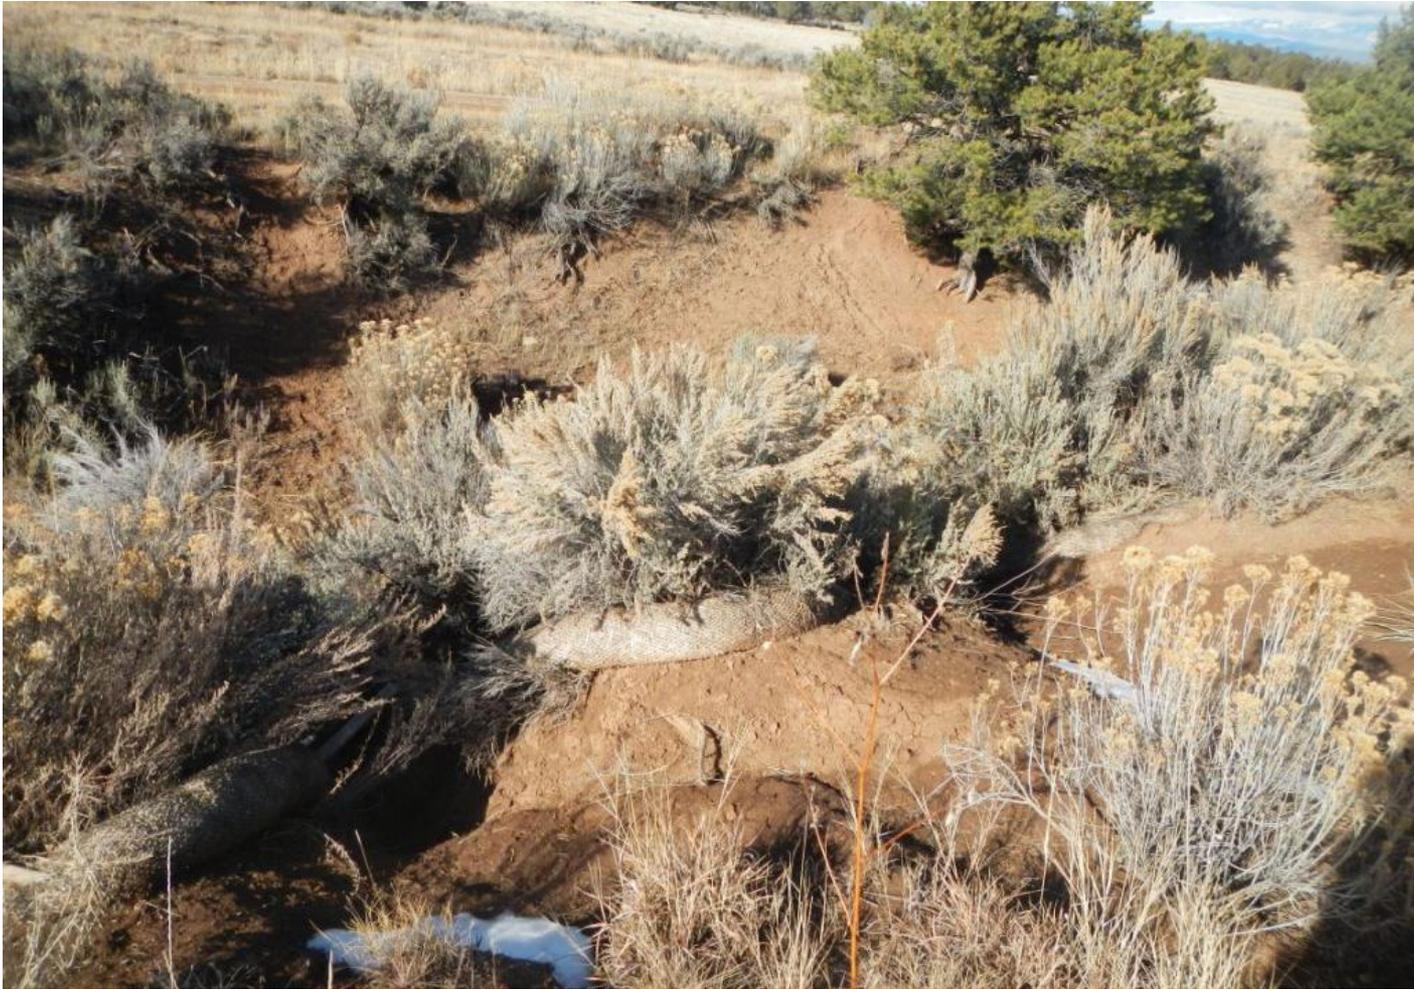
Photo 7. View of area along the western edge of the project area where wattles have failed and additional stormwater controls are needed.

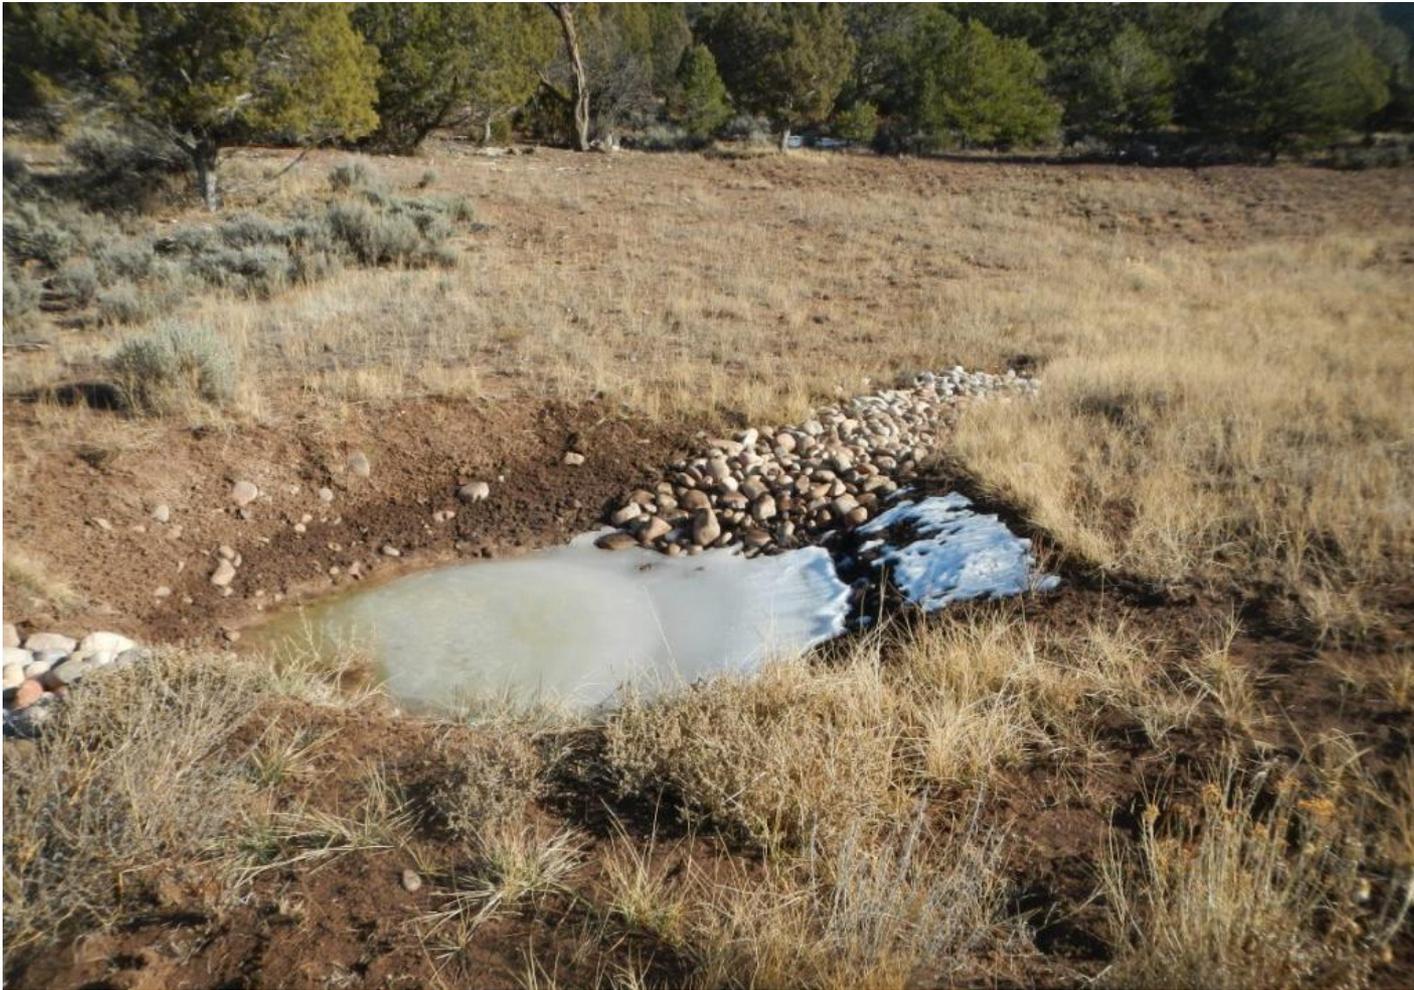
Photo 8. View of newly installed silt trap in the northern portion of the project area. Overflow and a portion of diversion channel are lined with cobble.
