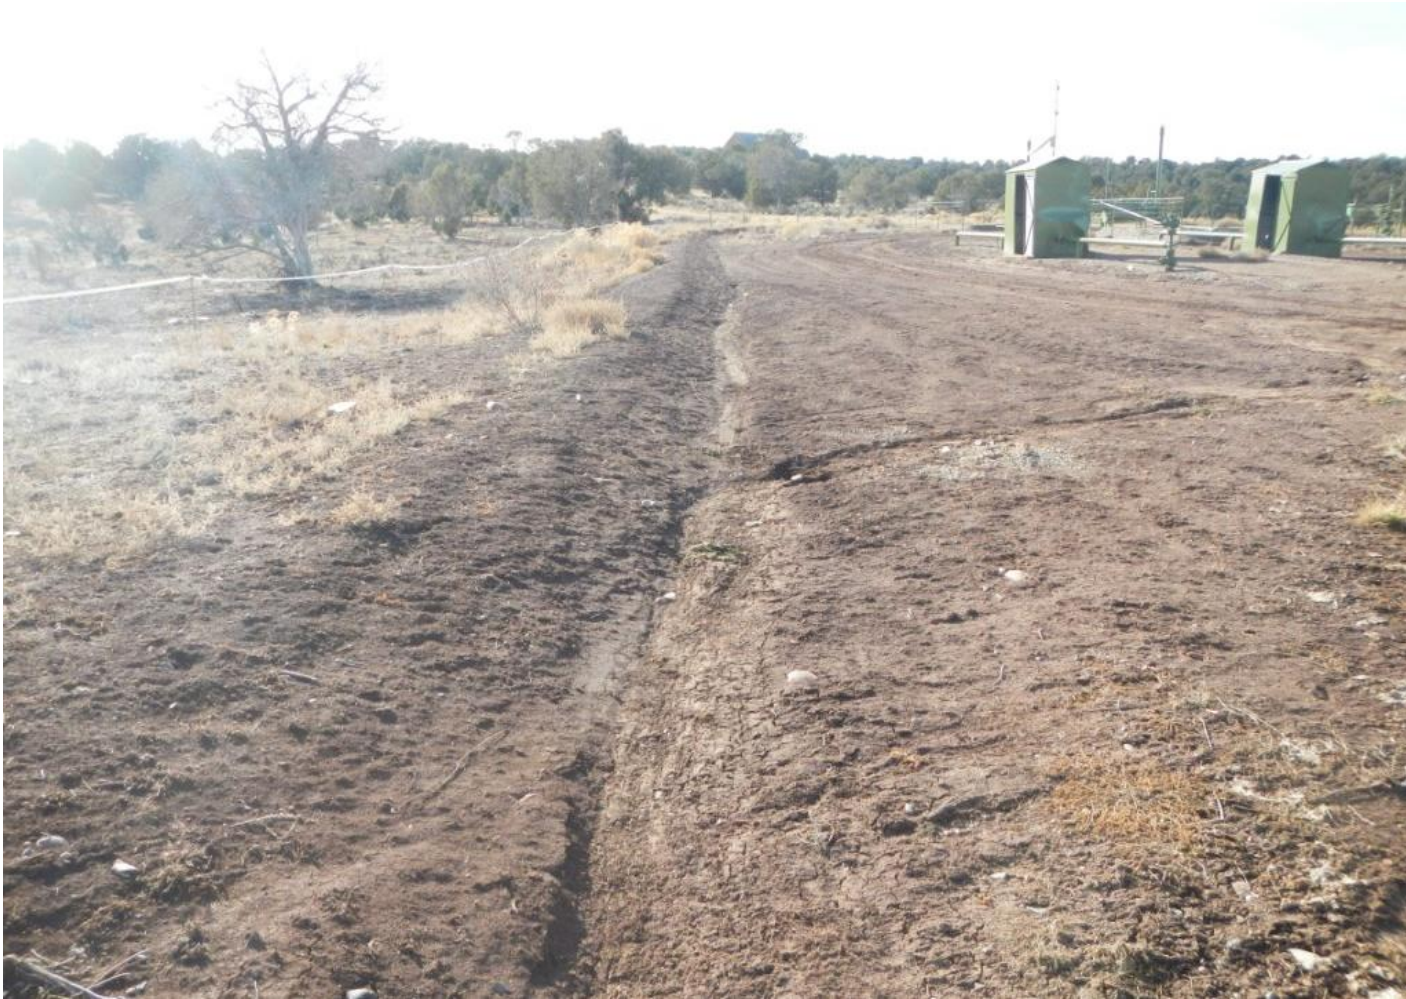
Photo 1. View of the southern edge of the project area from the southeastern corner facing westward. A new diversion berm has been installed and appears to be functioning.

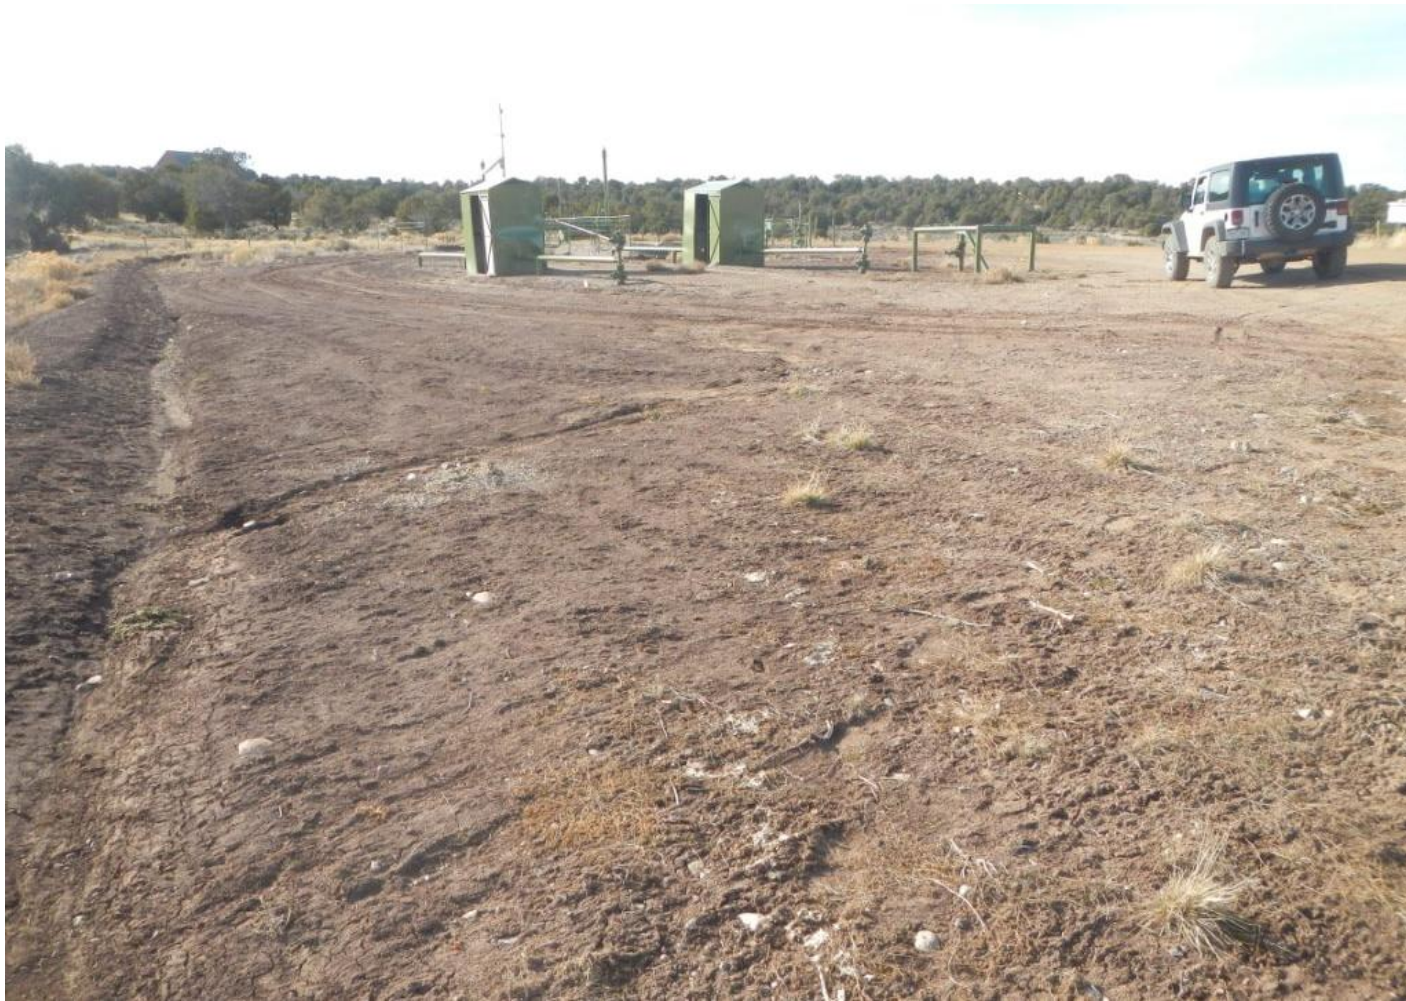
Photo 2. View of the project area from the southeastern corner of the project area facing center.

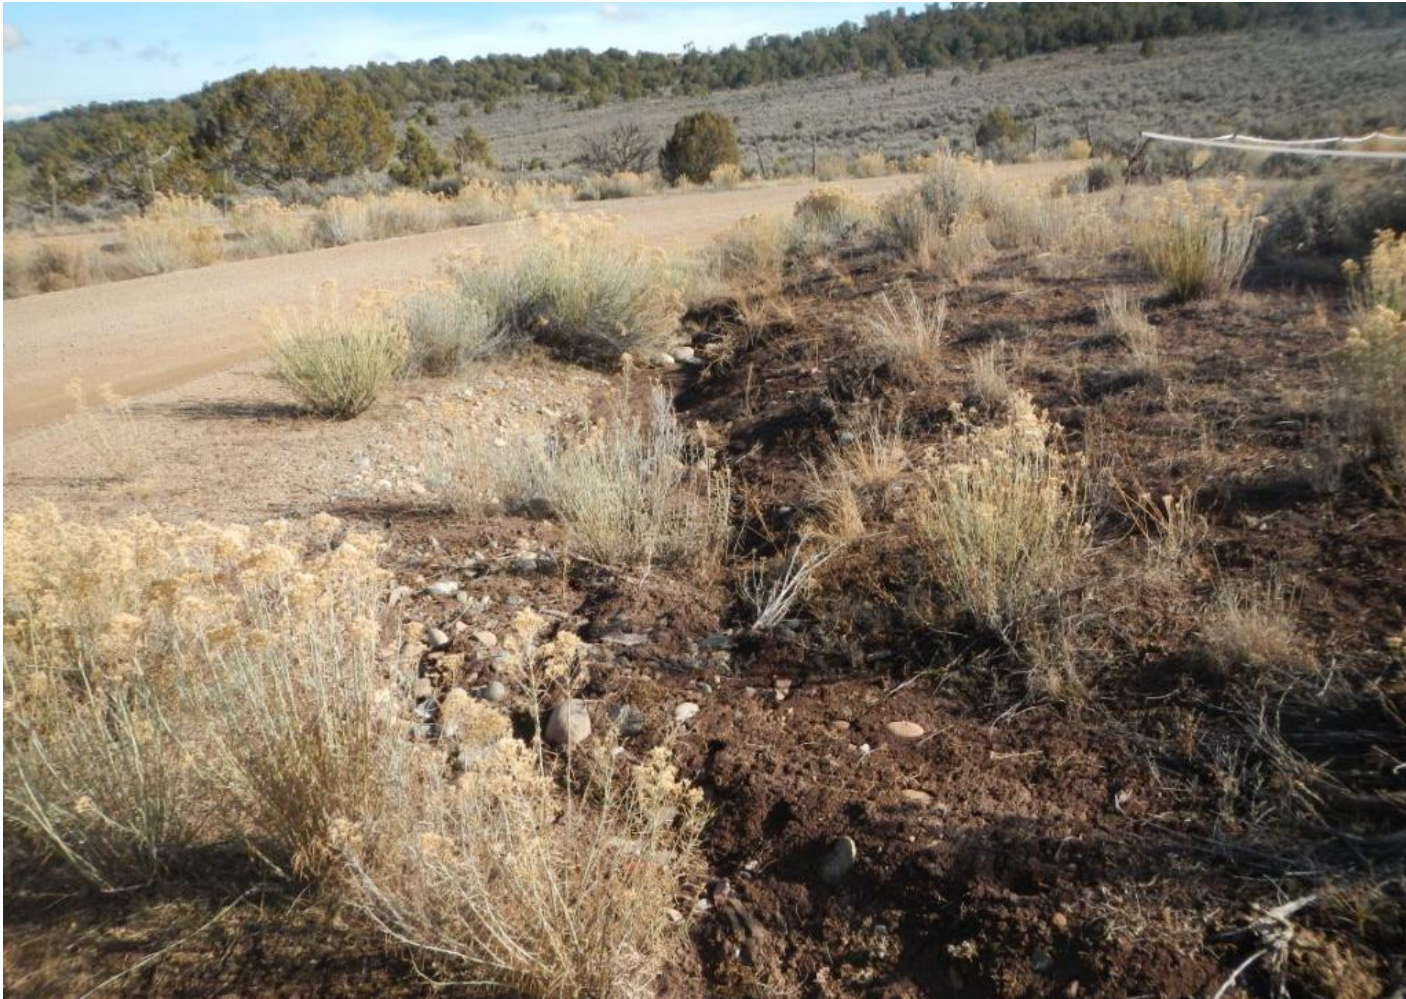
Photo 3. View of area where stormwater drains off of the southeastern corner of the project area that does not appear to be eroding significantly. This should continue to be monitored and BMPs applied if erosion worsens.
