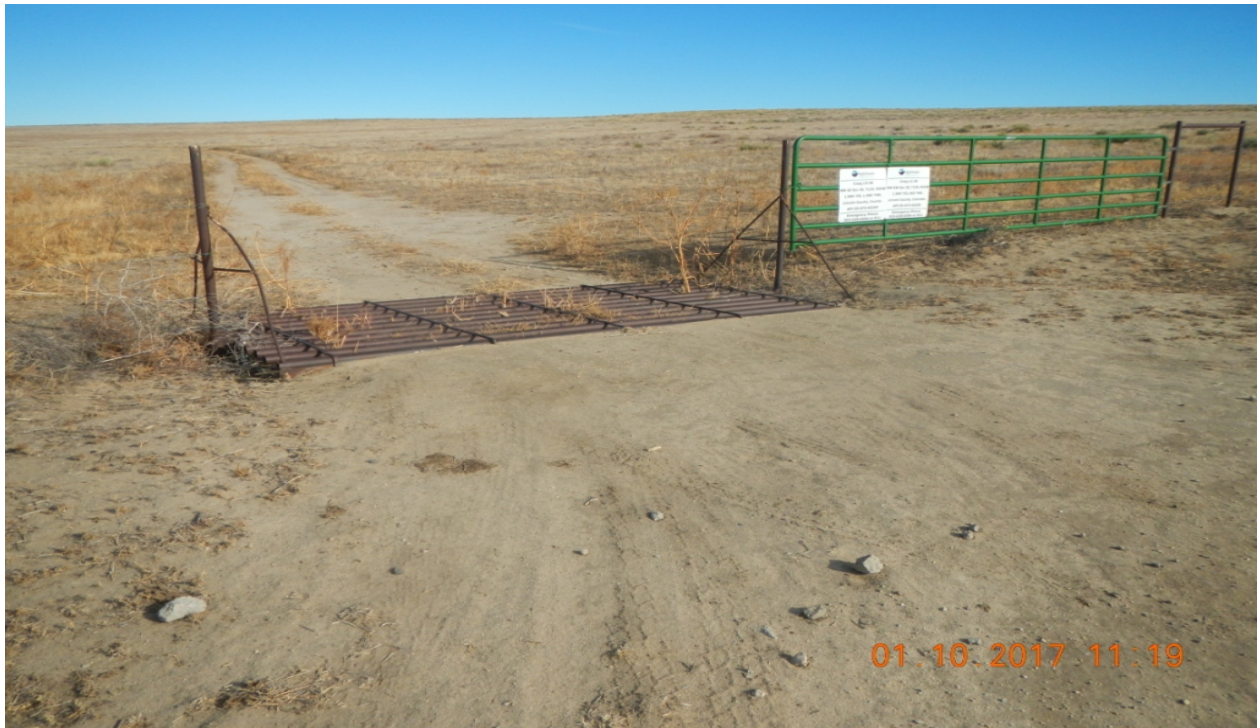
**photo 1:** Facing northeast toward the beginning of the access road.

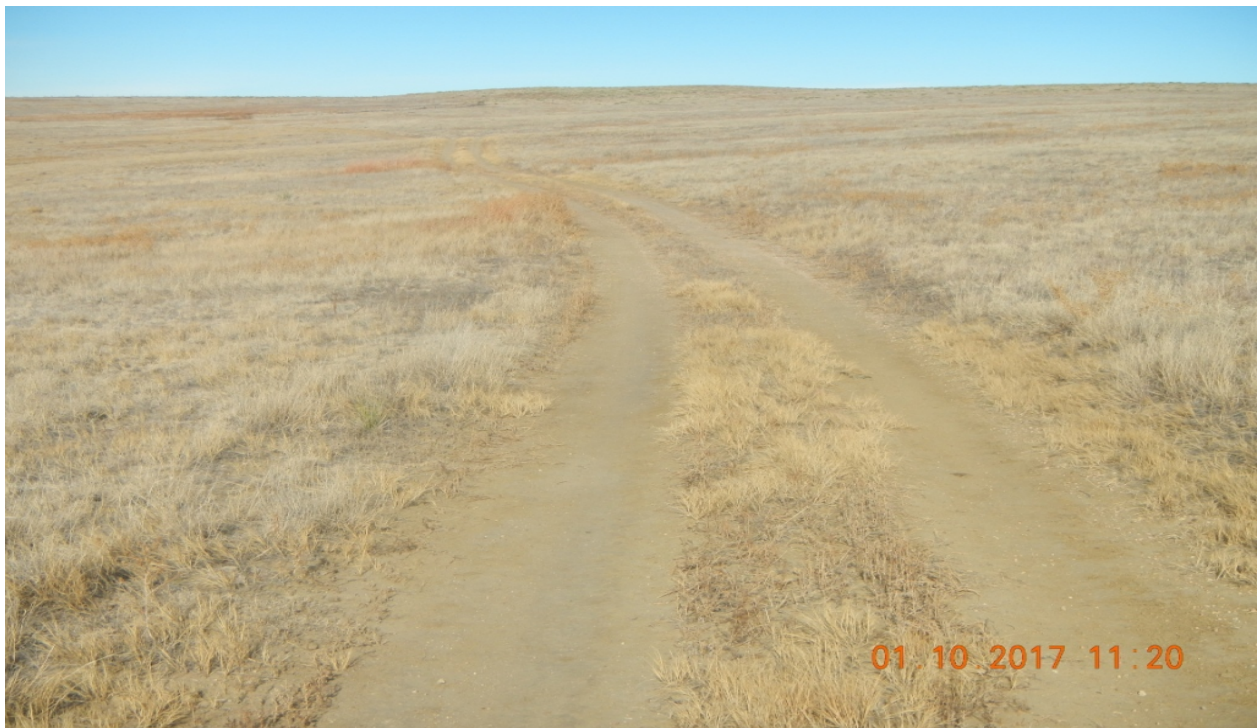
**photo 2:** Facing northwest along the access road.

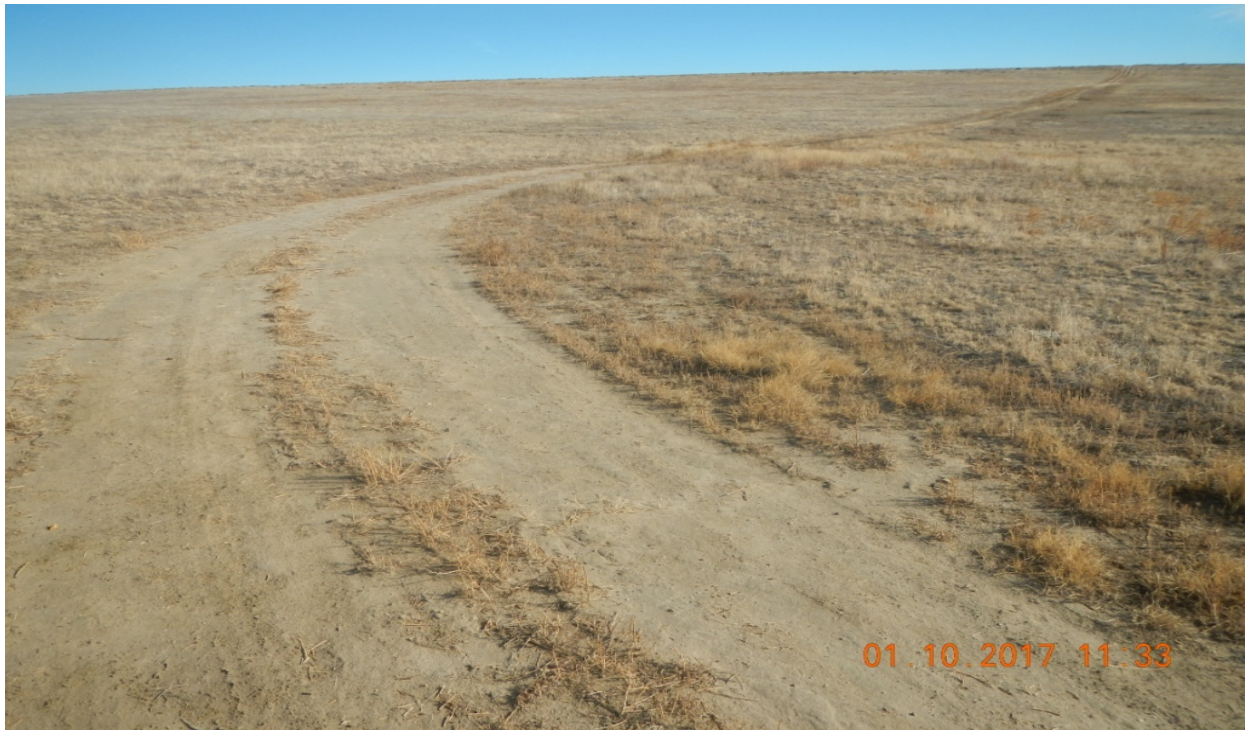
**photo 3:** Facing northeast along the access road.

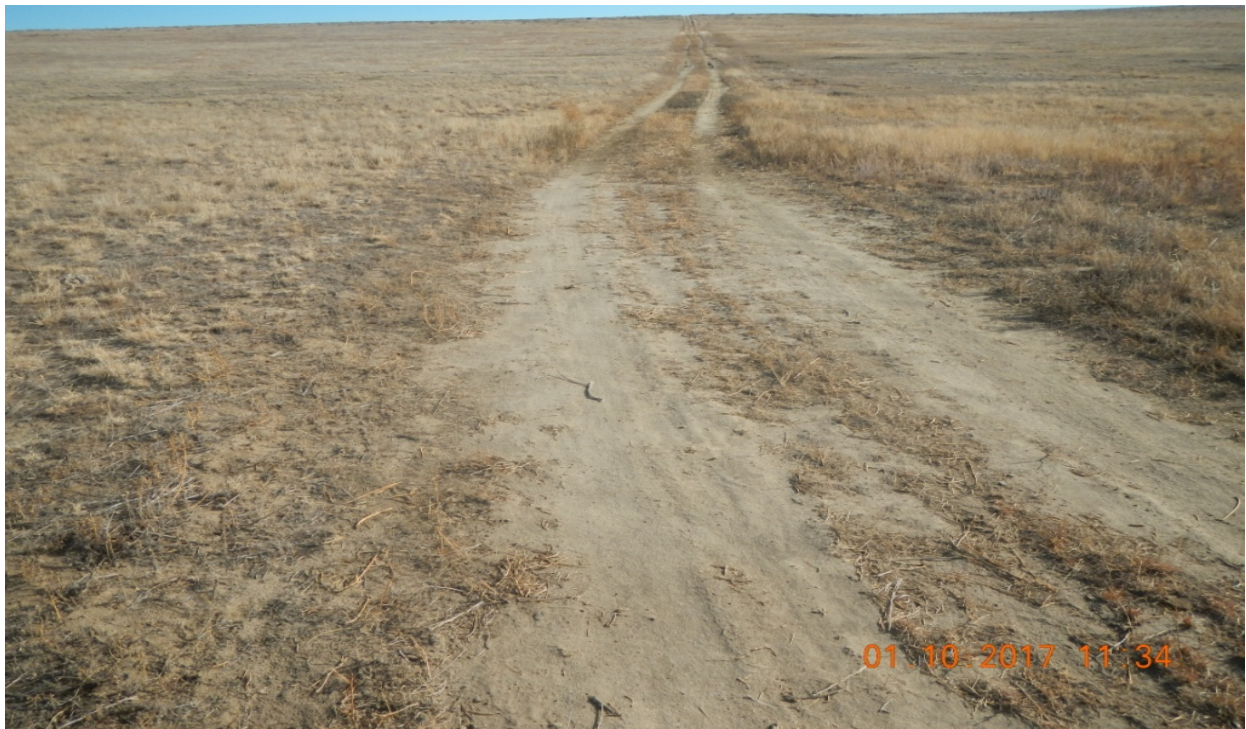
**photo 4:** Facing east along the access road.

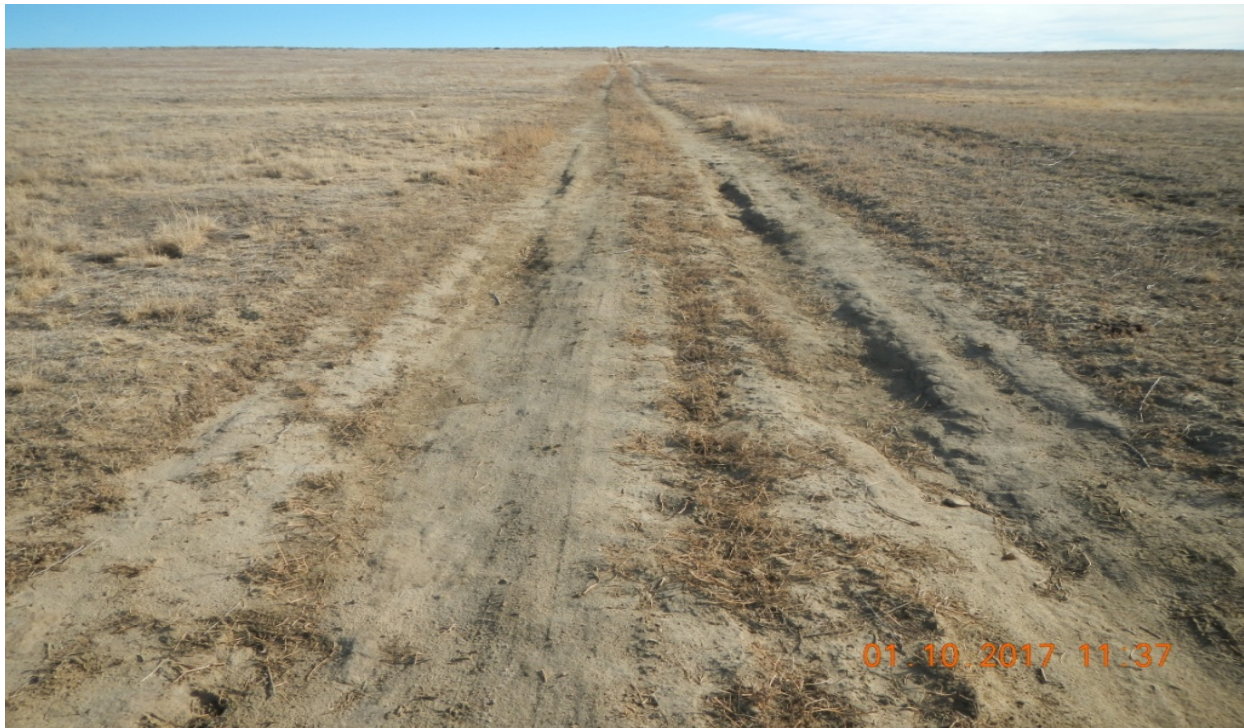
**photo 5:** Facing east along the access road. This are signs of vehicle rutting in this area.

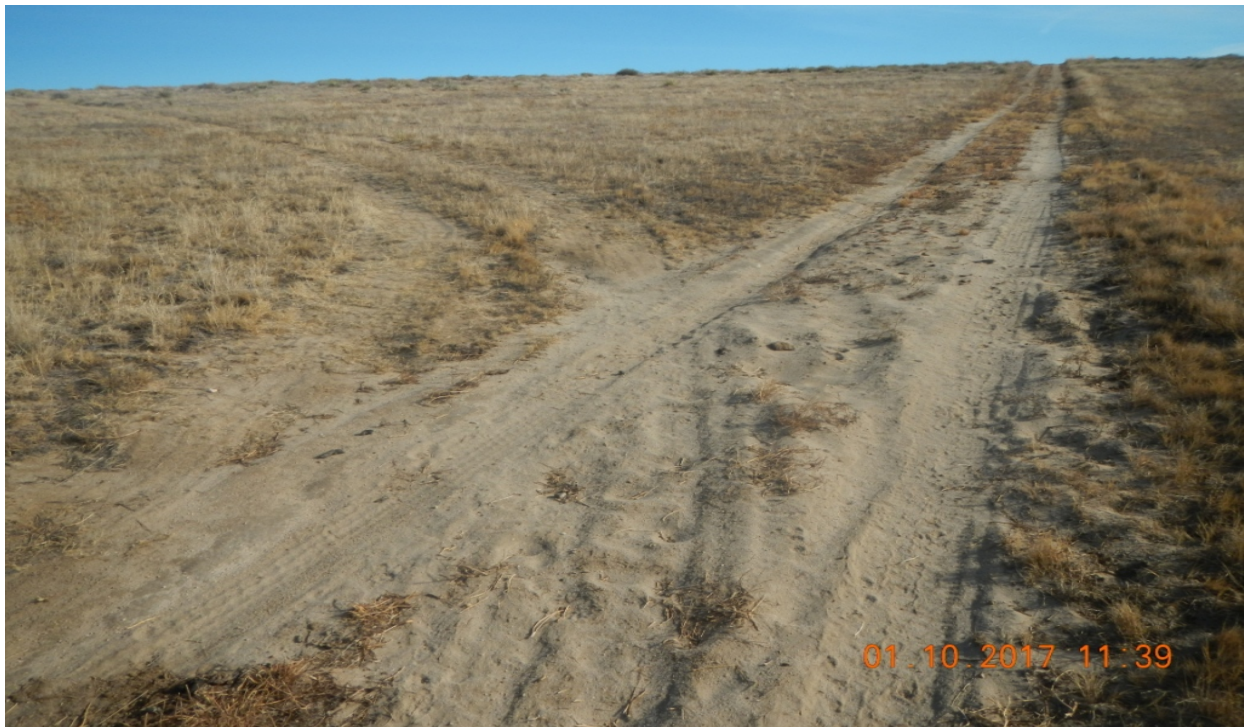
**photo 6:** End of the access road where the ranch road turns to the northeast,
