Reclamation Inspection

01/12/2017

Operator: Whiting

Location ID: 431782

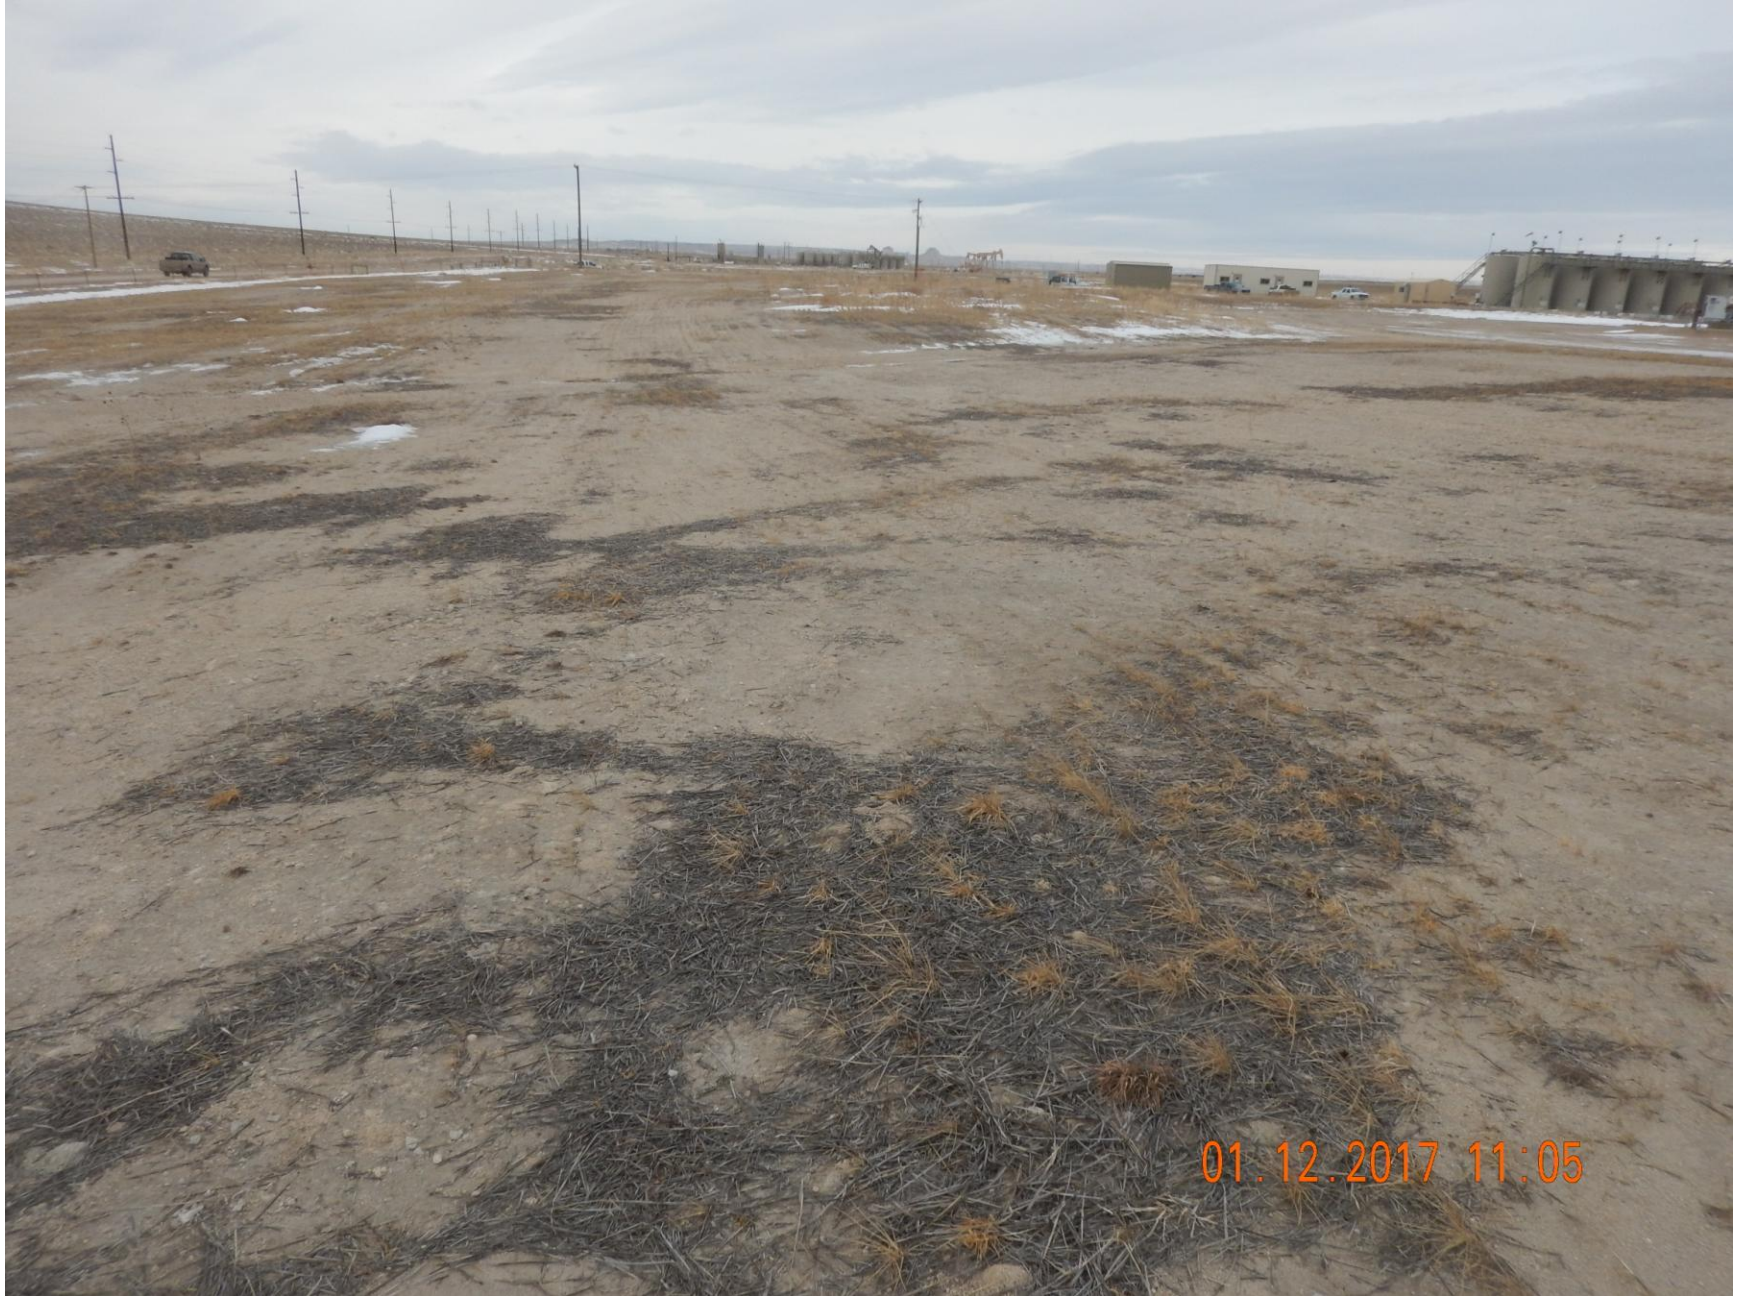
Figure 1: Photo taken from the south end of the location, facing west. Photo shows interim and production areas.

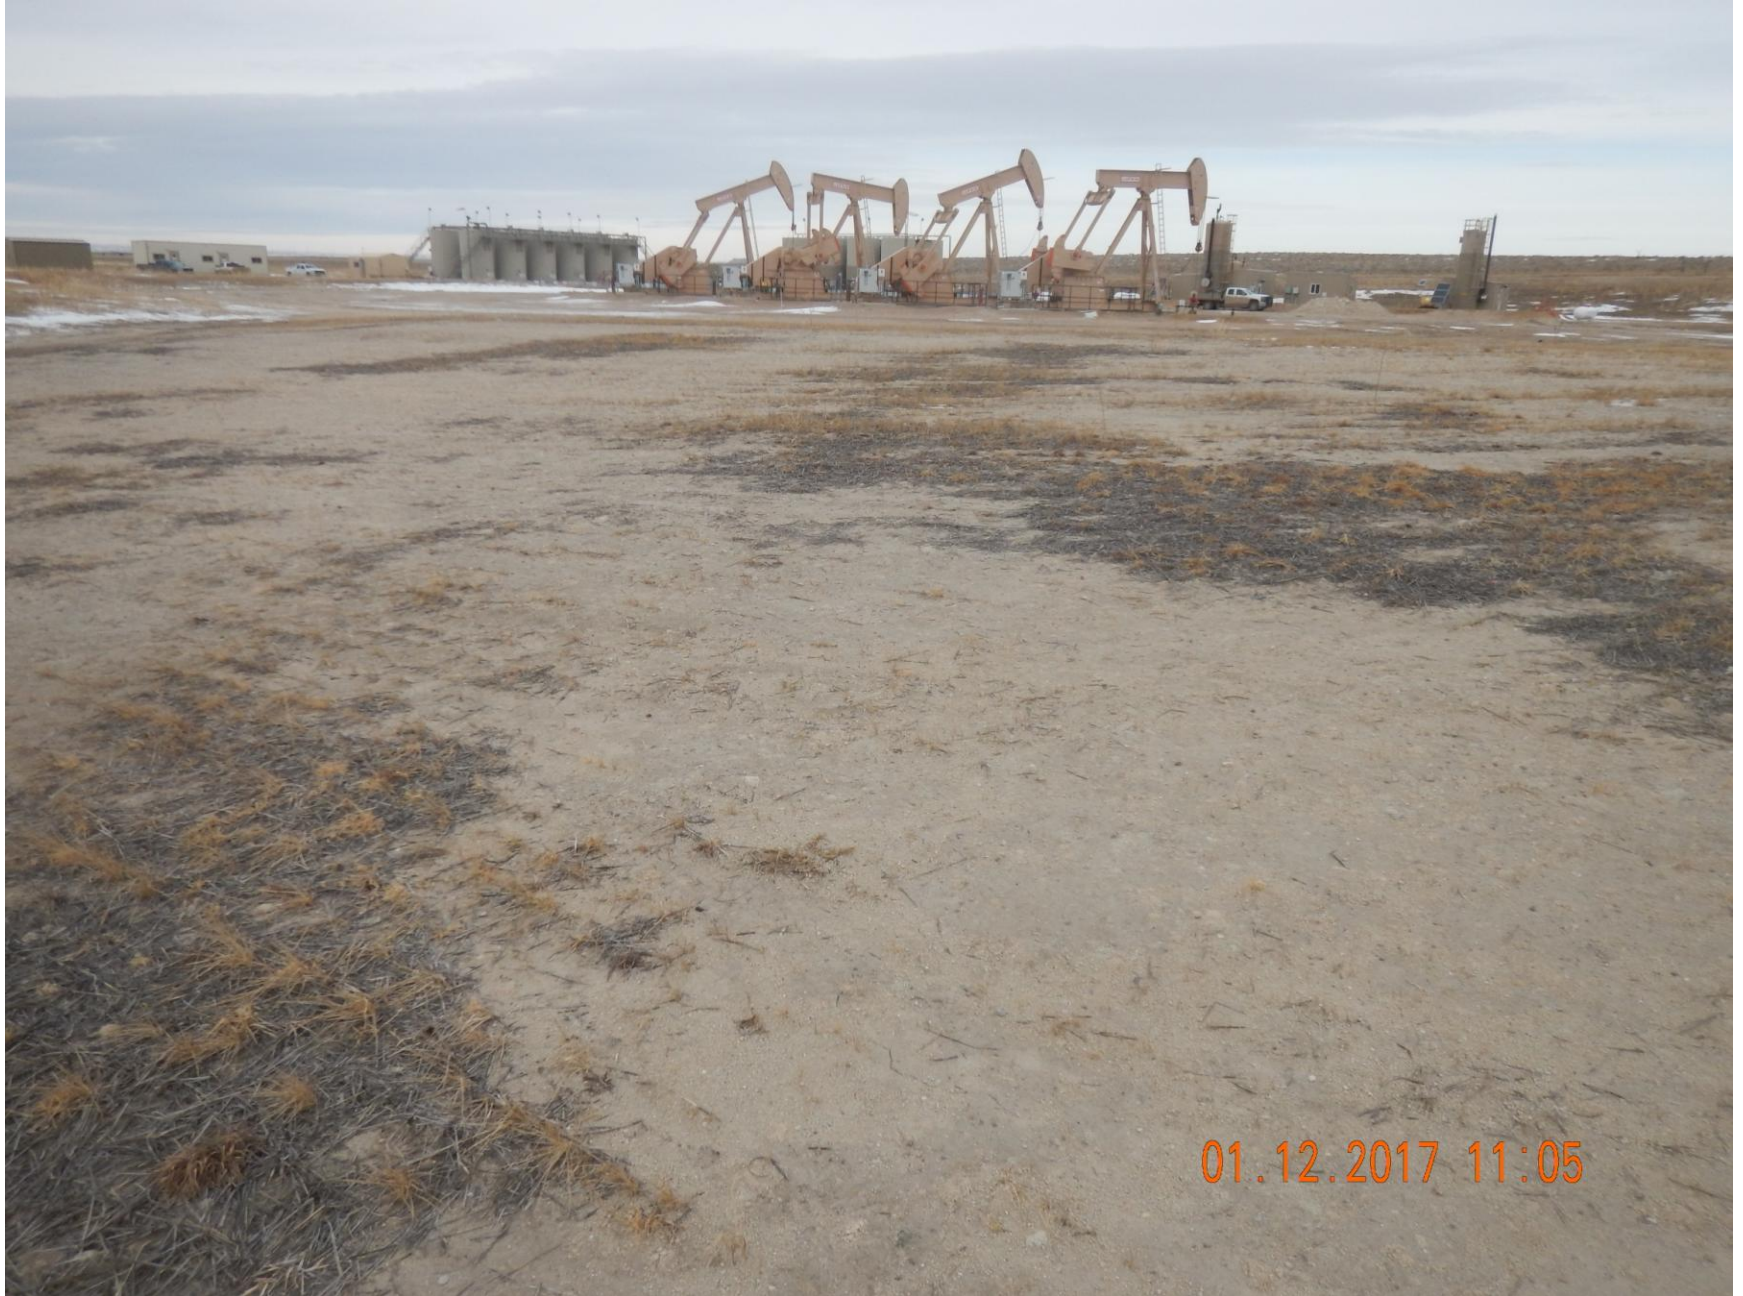
Figure 2: Photo taken from the south end of the location, facing northwest. Photo shows interim and production areas. Photo shows the 4 pump jacks/wells on location.

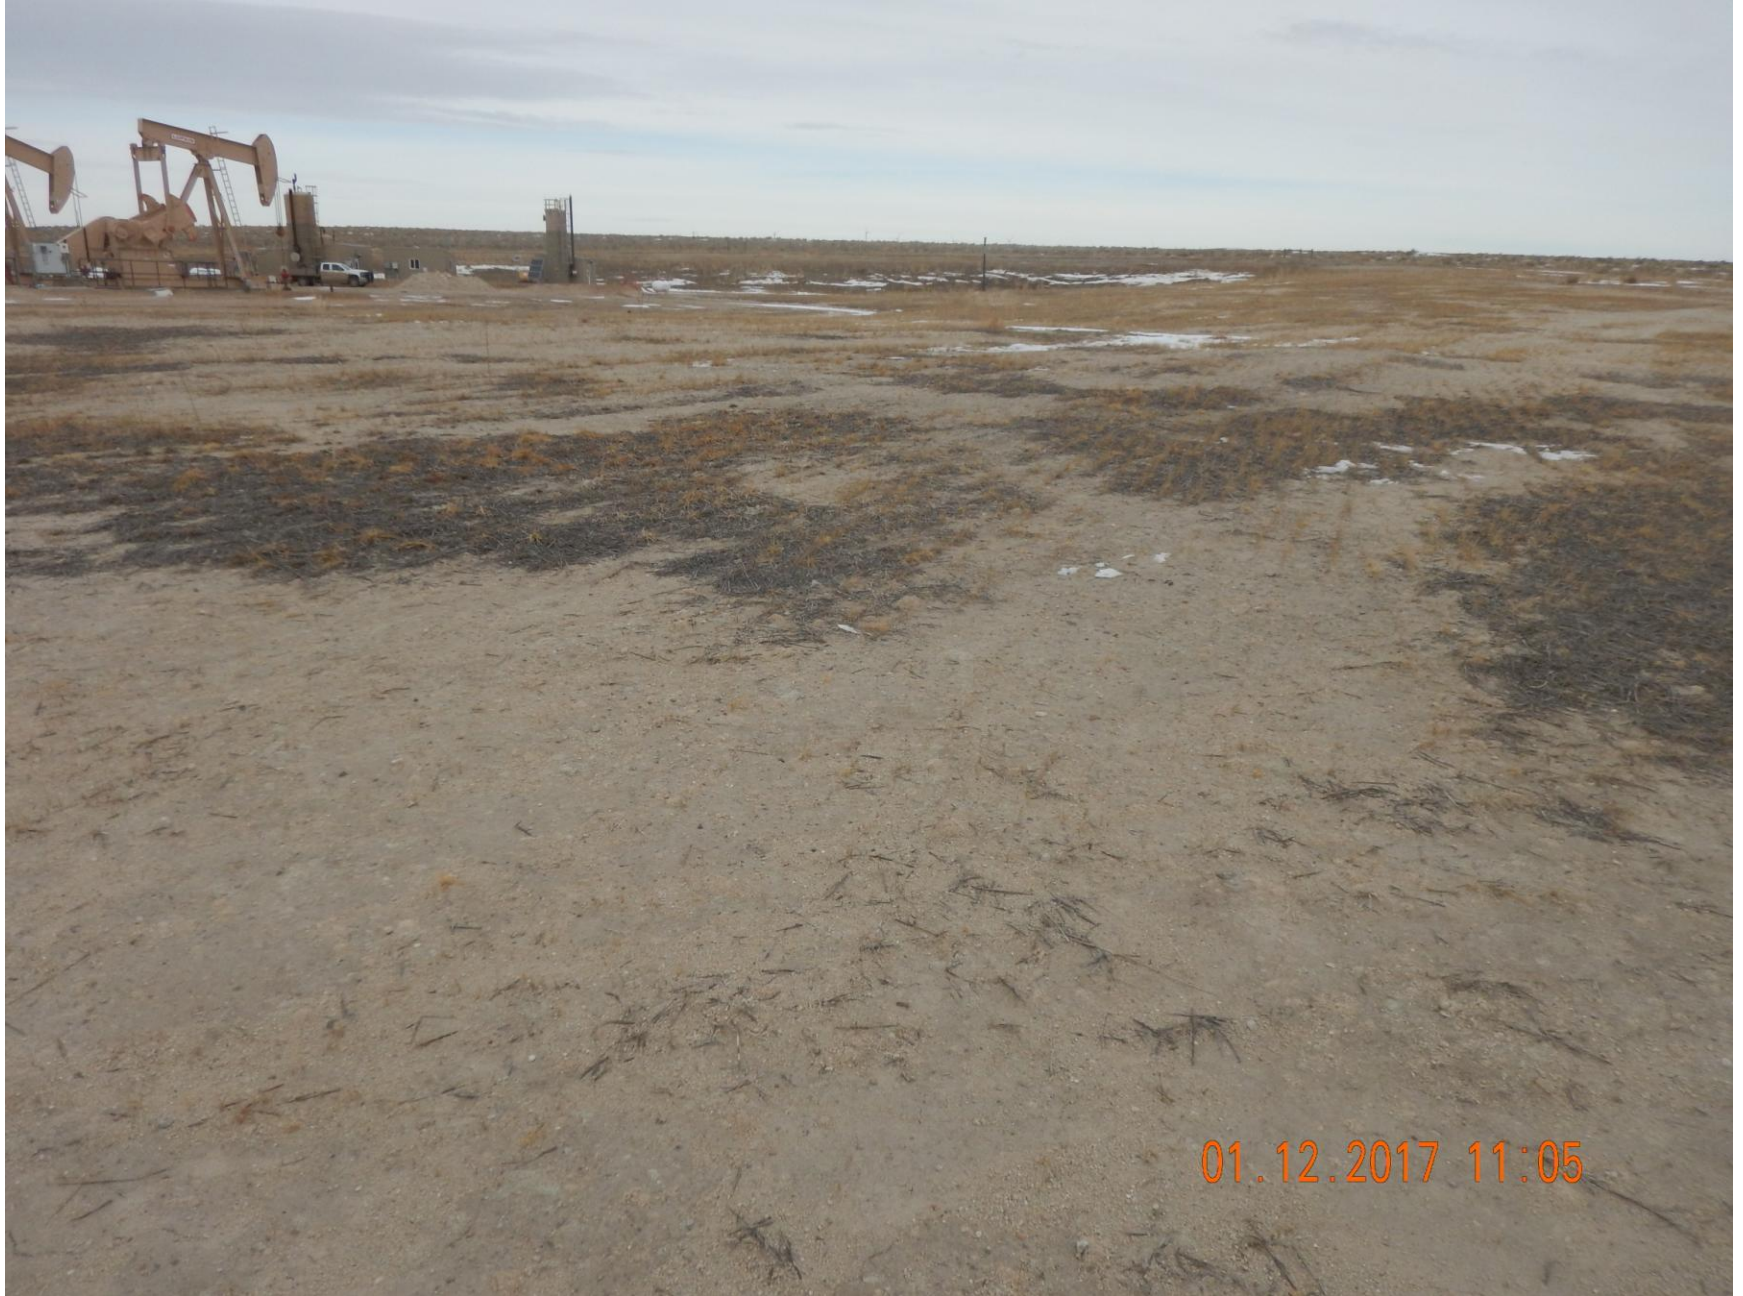
Figure 3: Photo taken from the south end of the location, facing north. Photo shows interim and production areas.

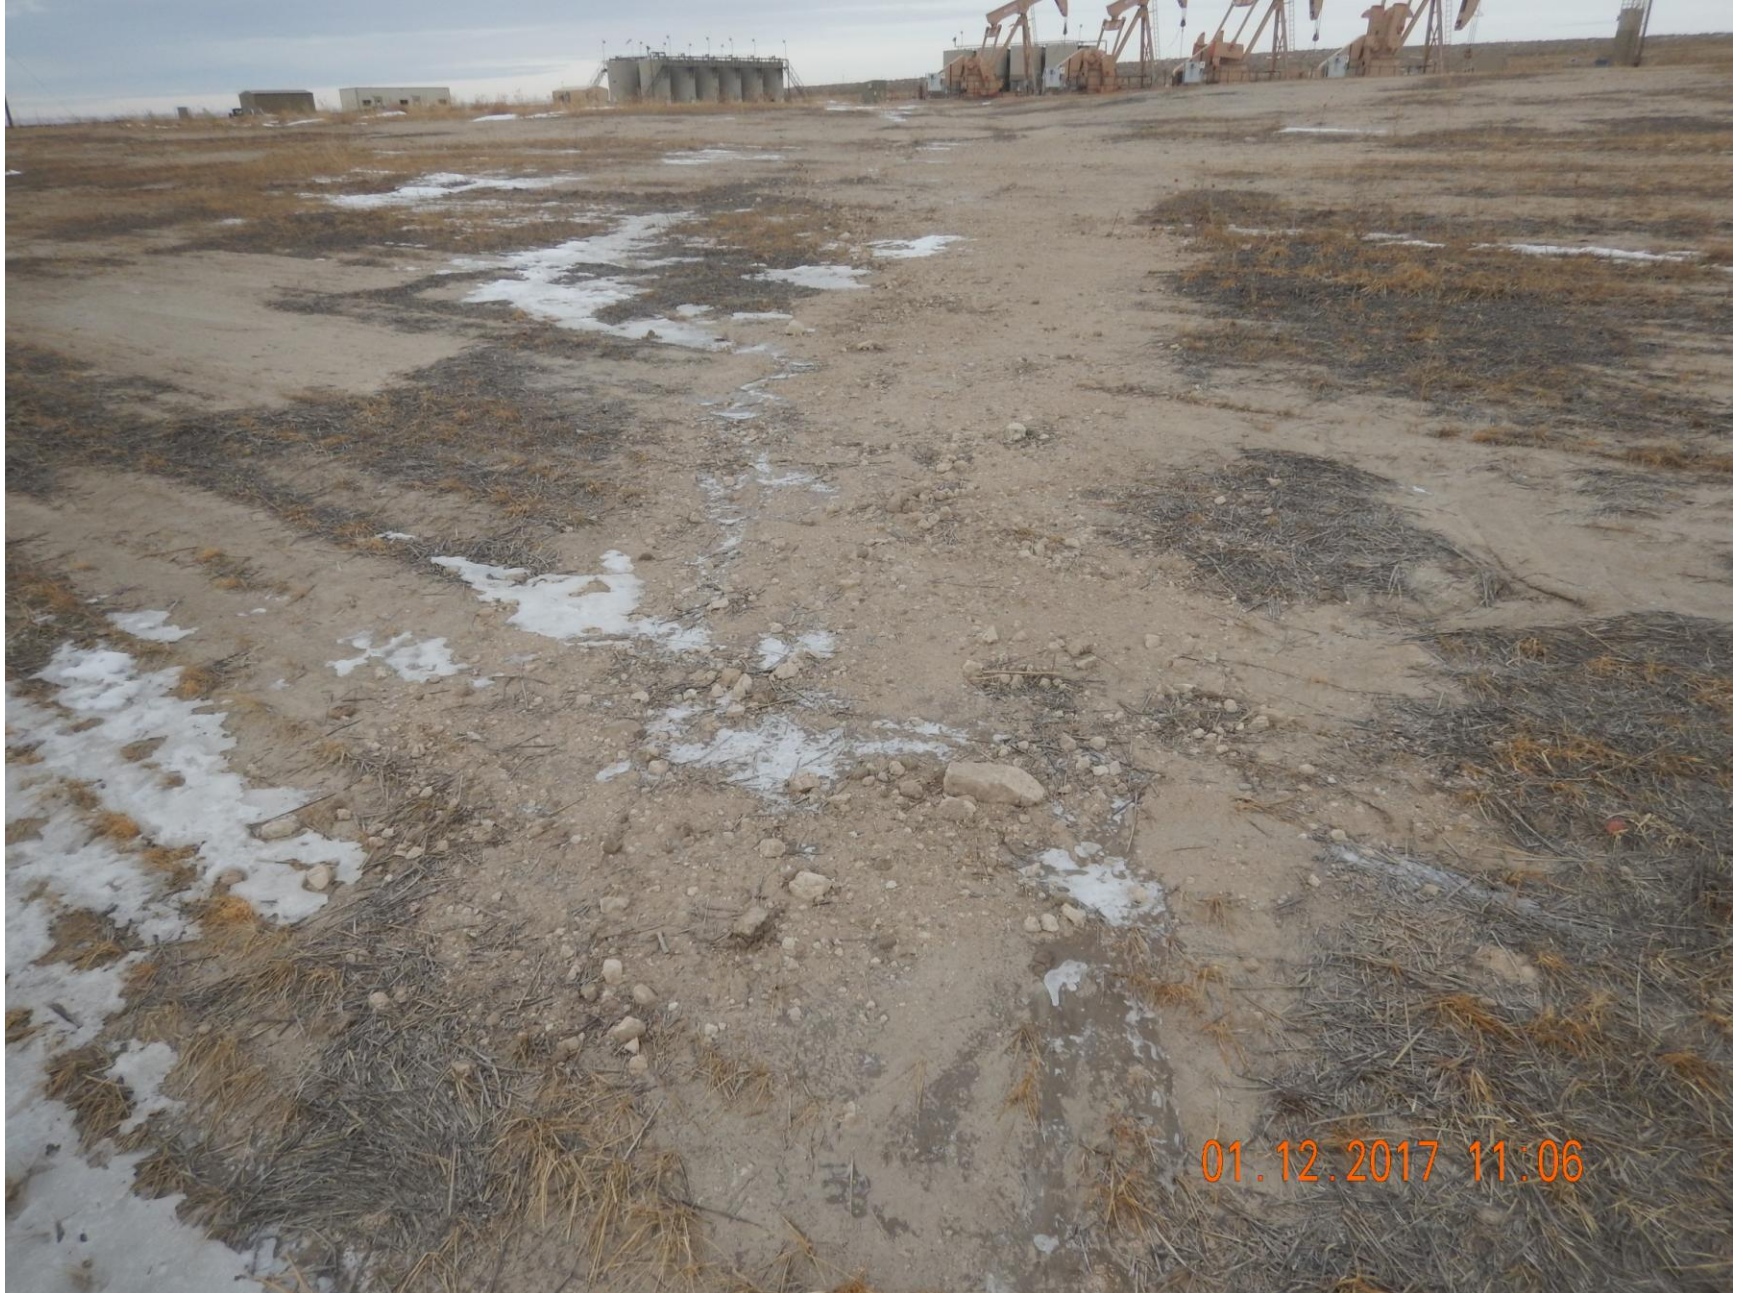
Figure 4: Photo taken from the south end of the location, facing north. Photo shows low point on the south end designed to allow stormwater to travel off location to ditch. Note sediment deposits from stormwater erosion.

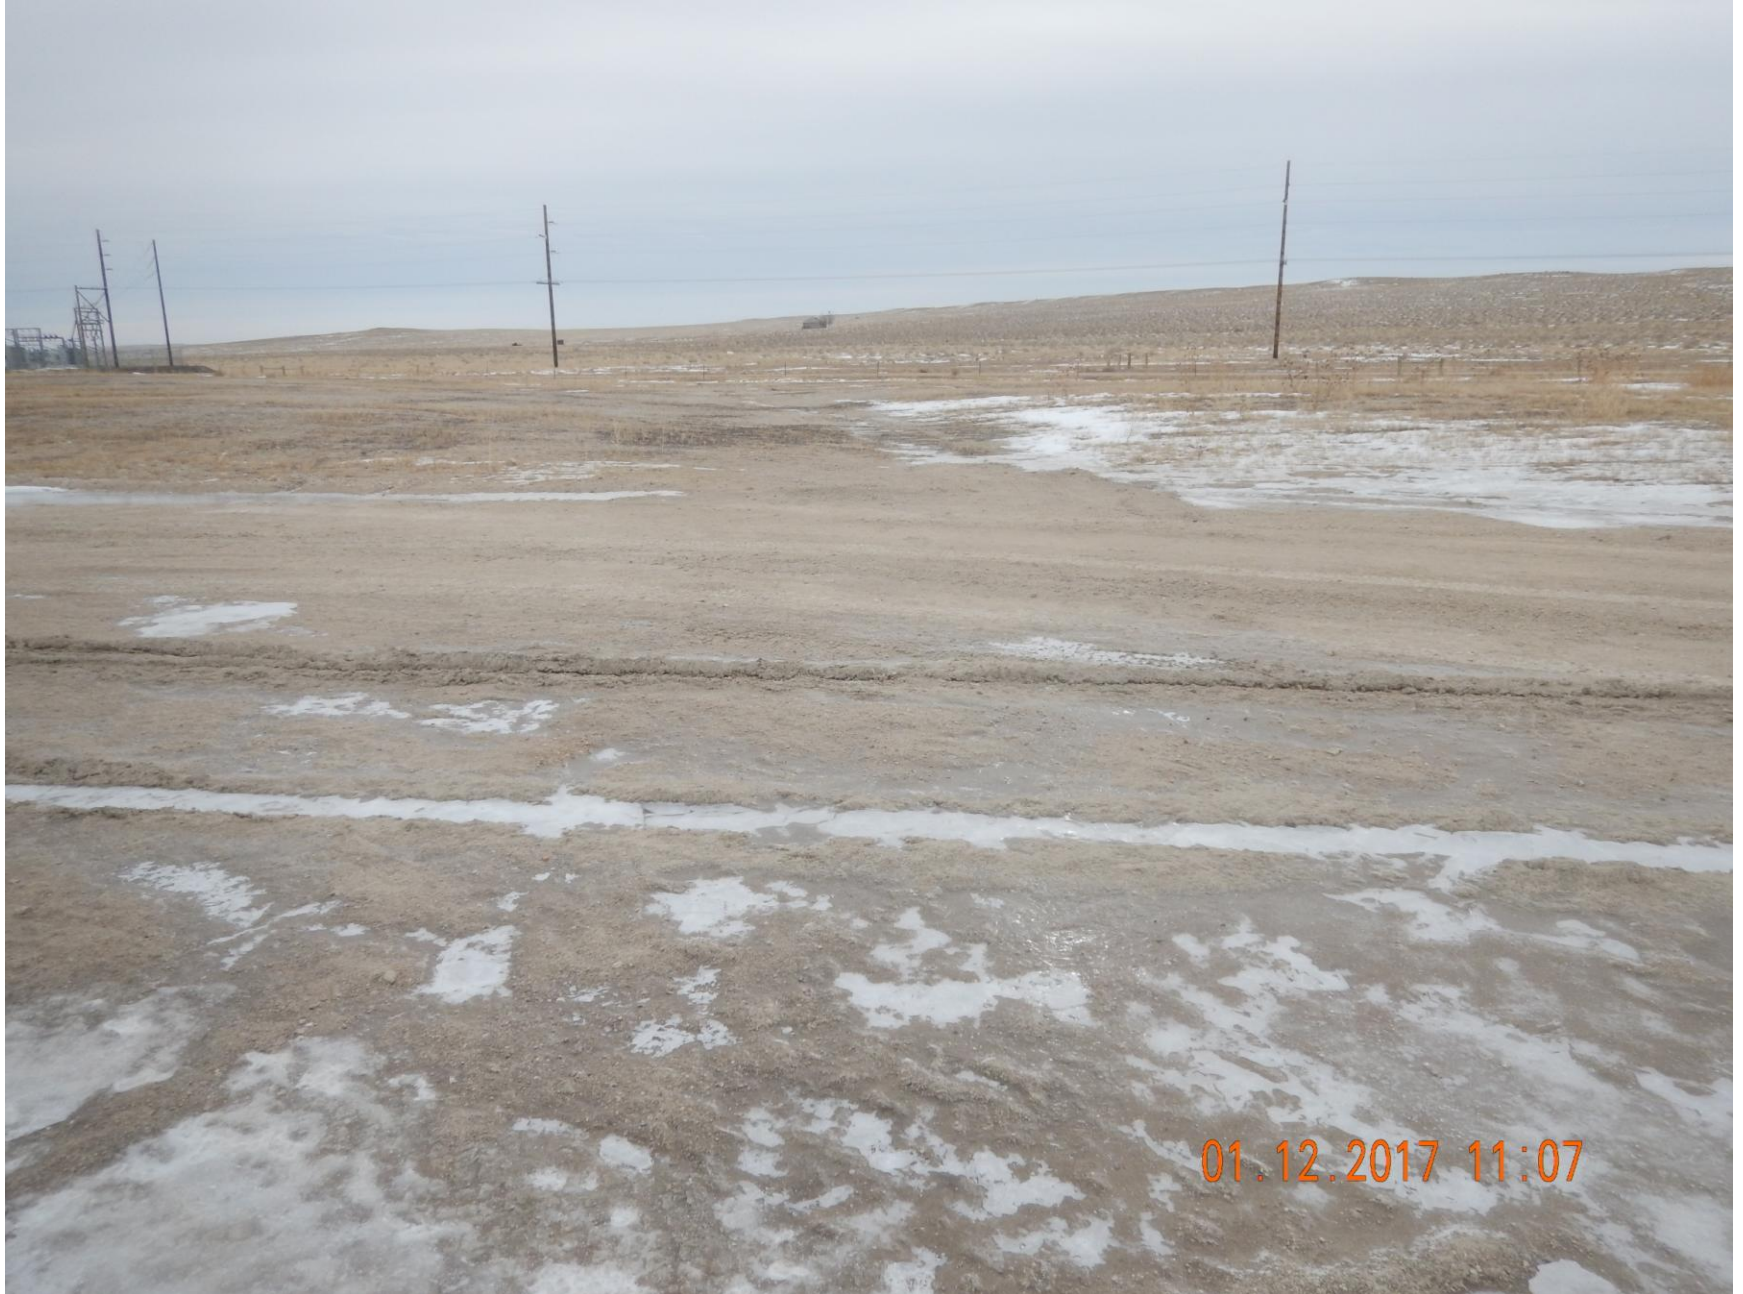
Figure 5: Photo taken from the south end of the location, facing south. Photo shows low point in interim left as a stormwater outlet from the production area.

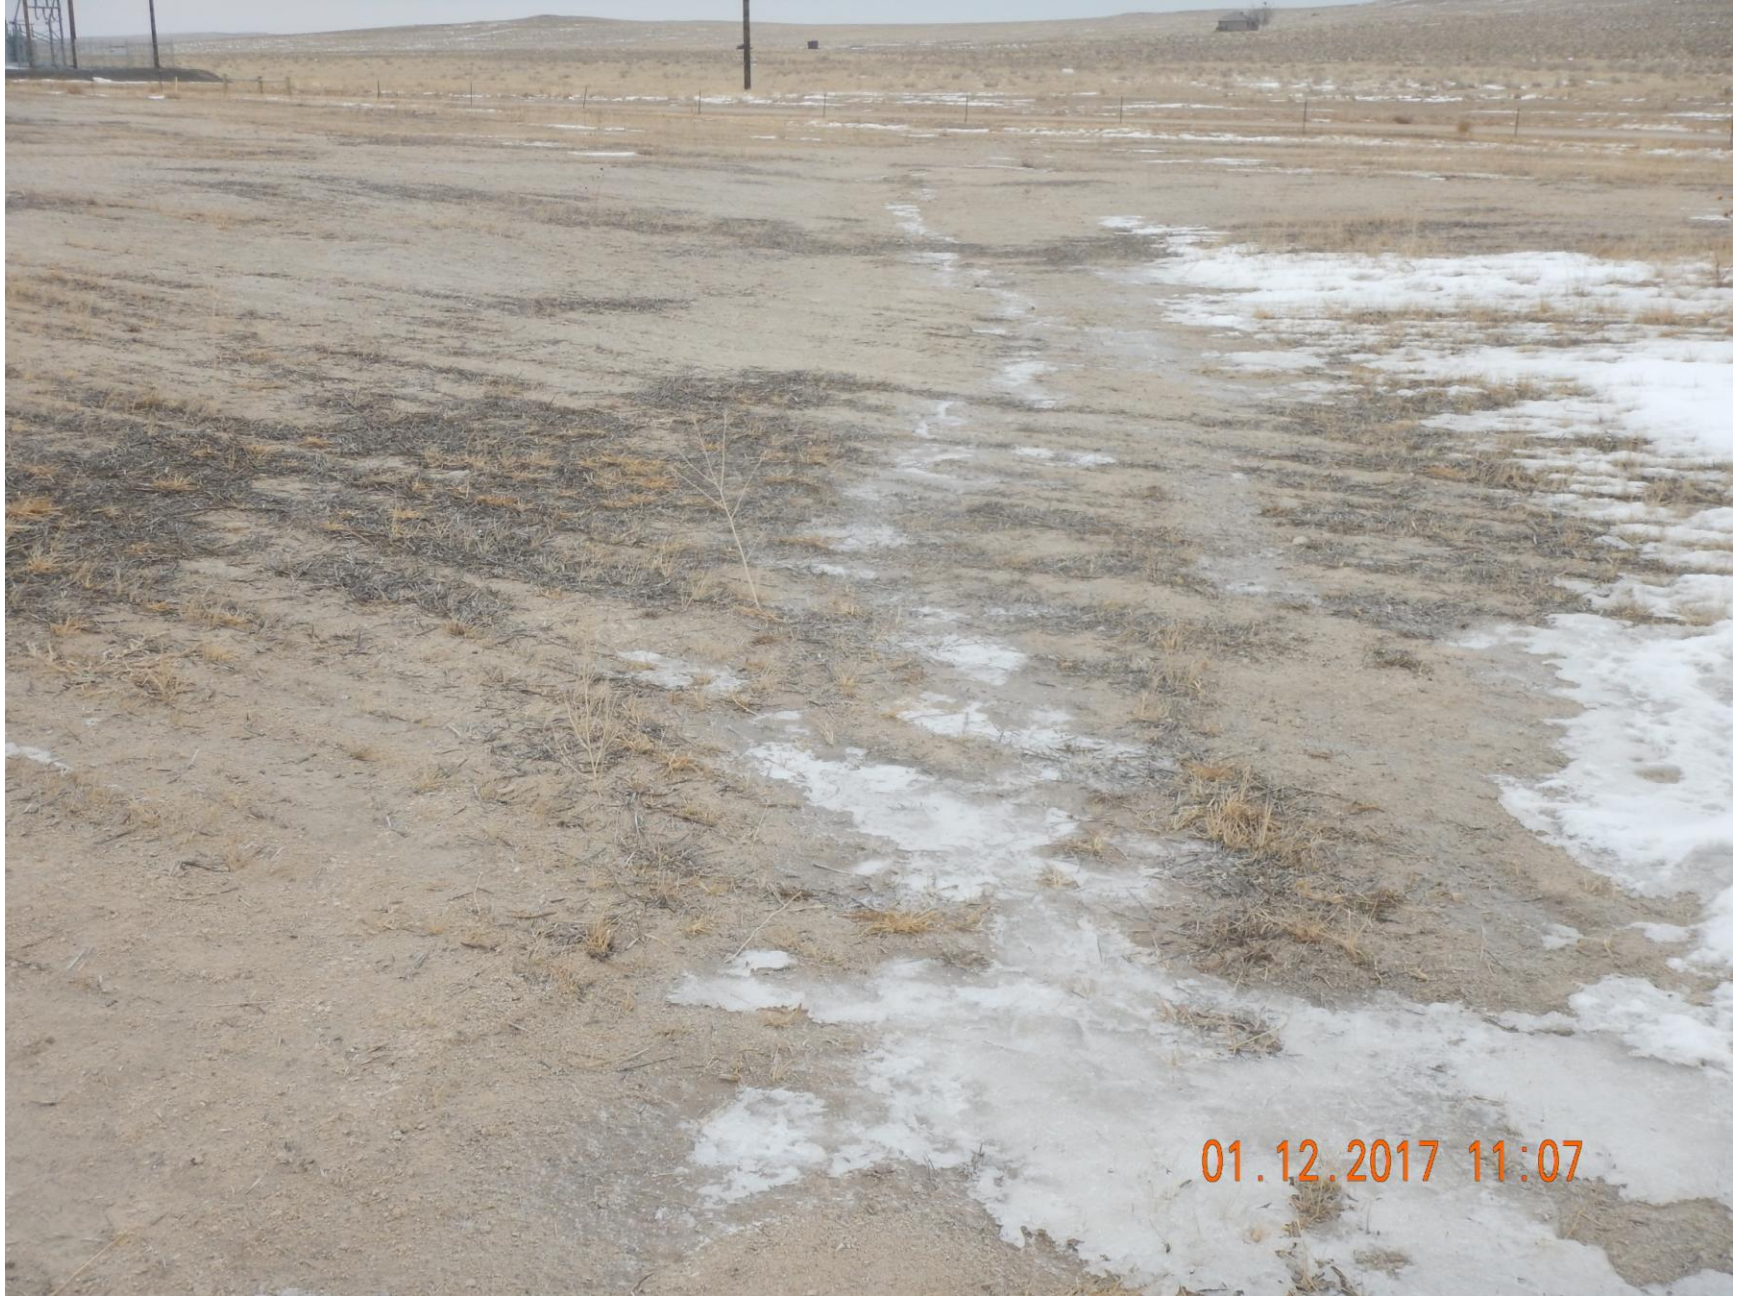
Figure 6: Photo taken from the south end of the interim area. Facing south. Photo shows stormwater erosion concerns forming on the interim area.

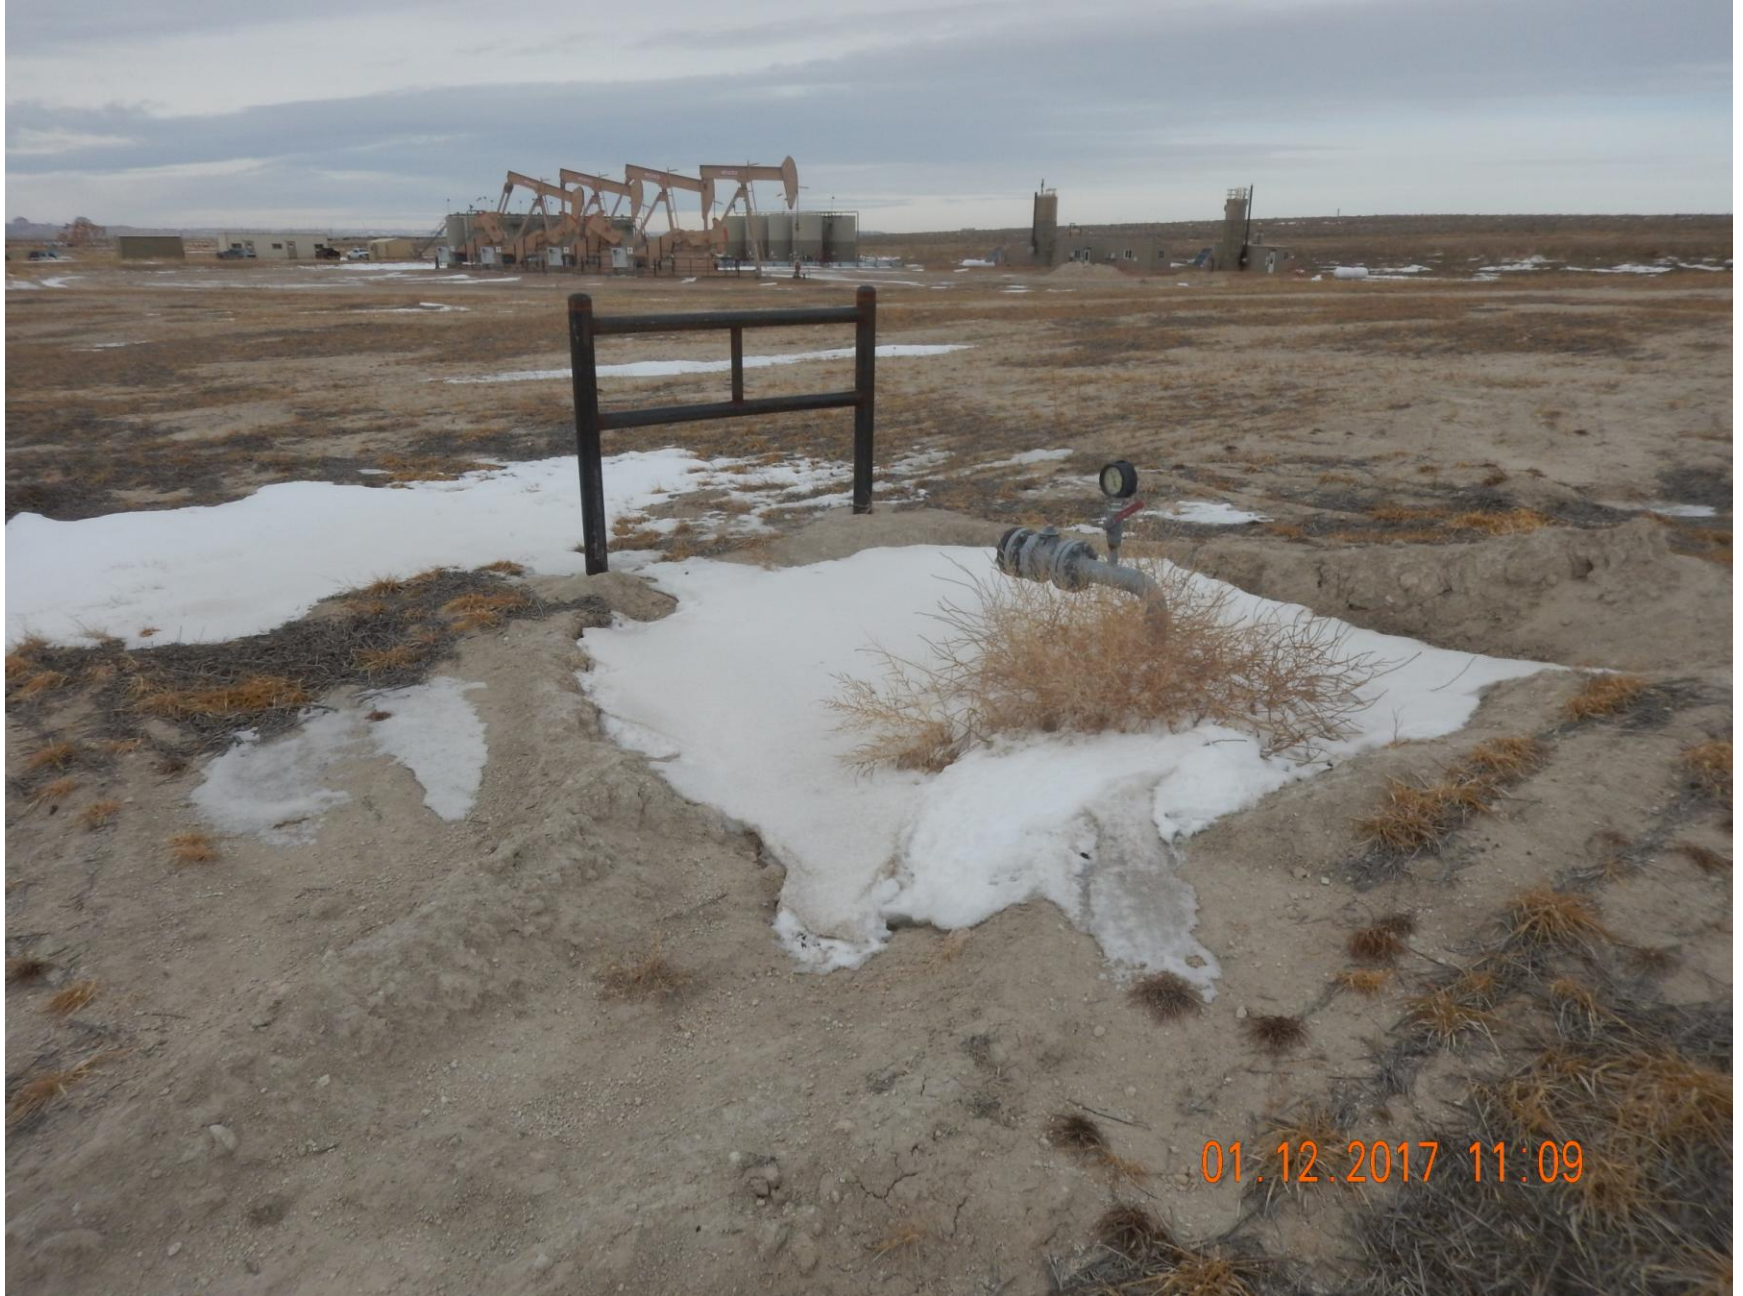
Figure 7: Photo taken from the southeast end of the interim area. Photo shows pipe riser remaining on the interim area. Equipment needs to be removed.

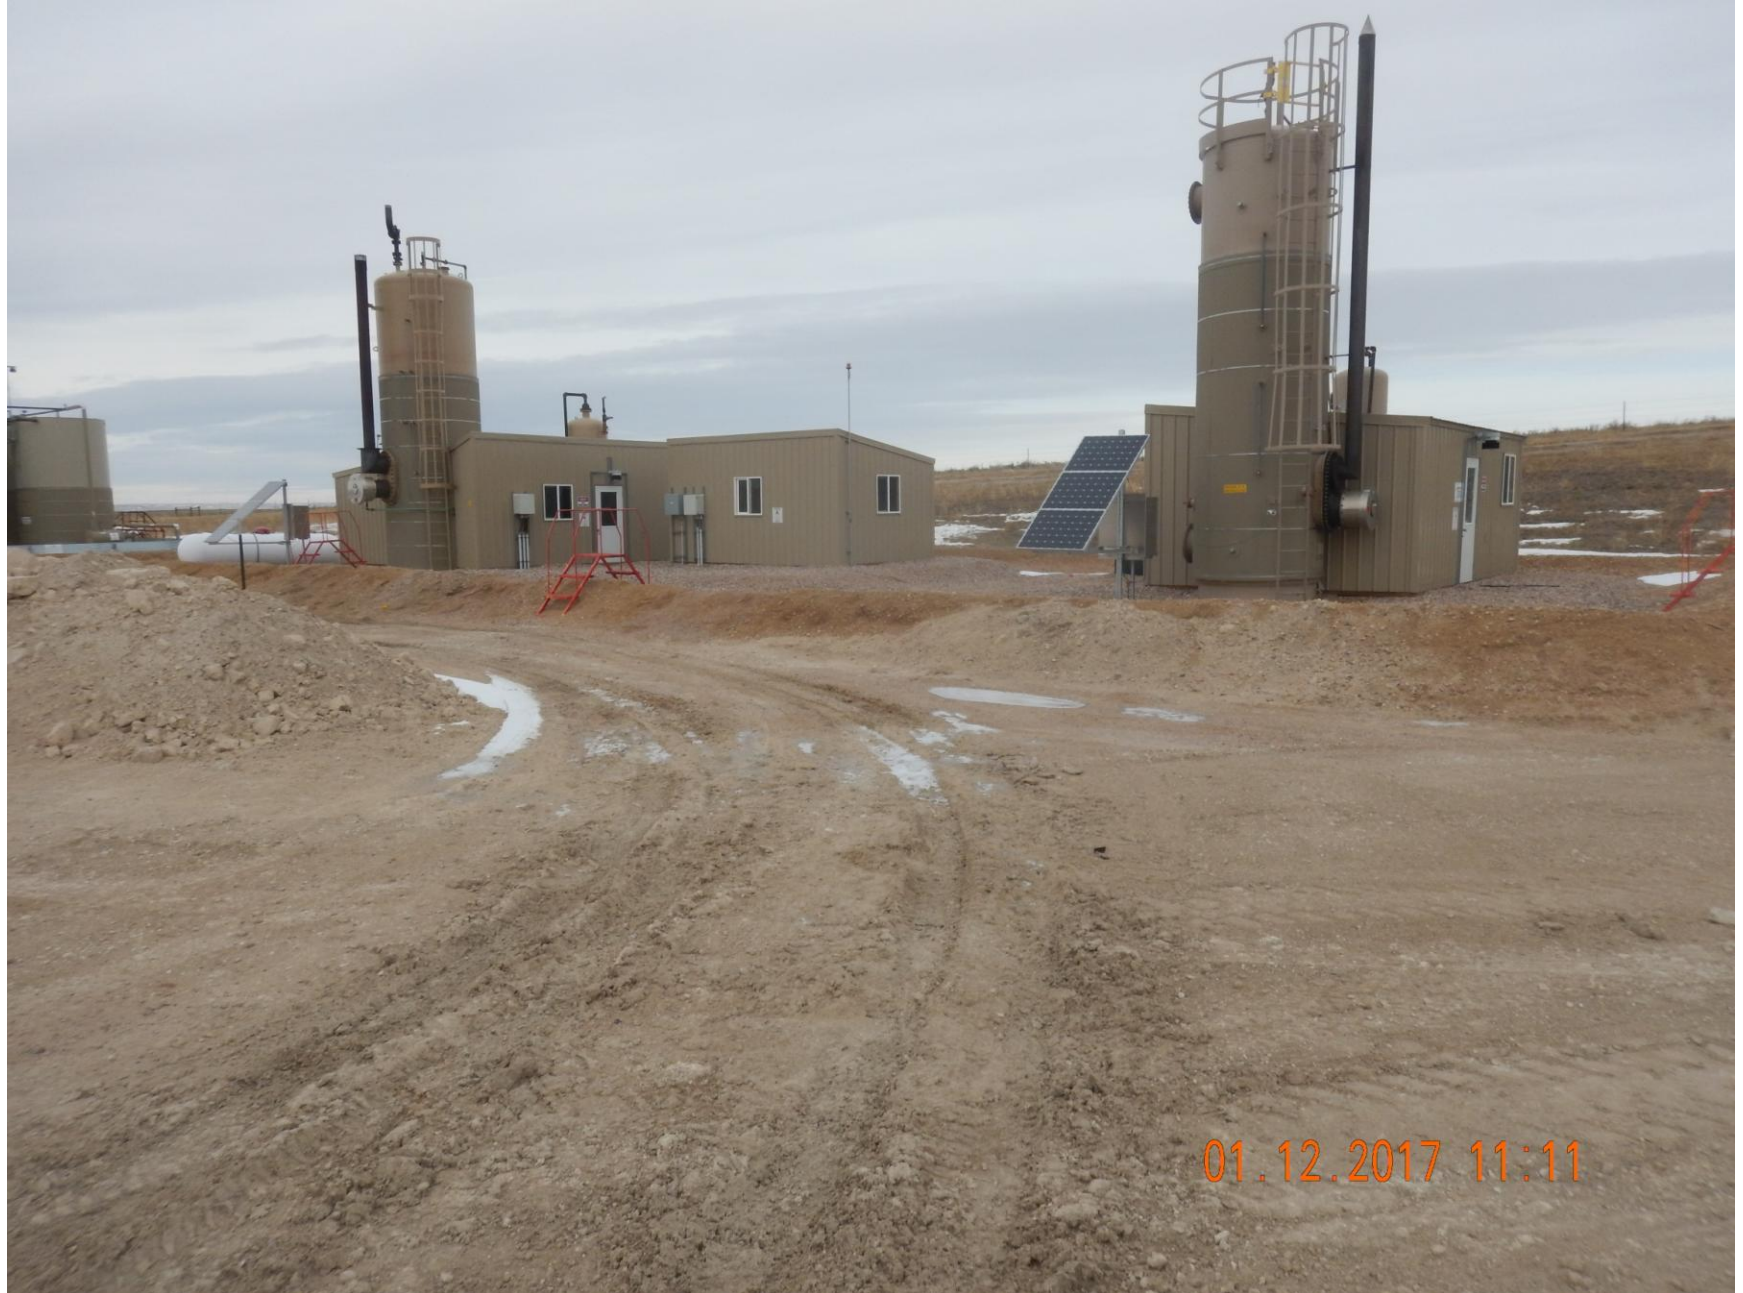
Figure 8: Photo taken from the north end of the location, facing north. Photo shows two vertical heater treaters and vertical gas separators.

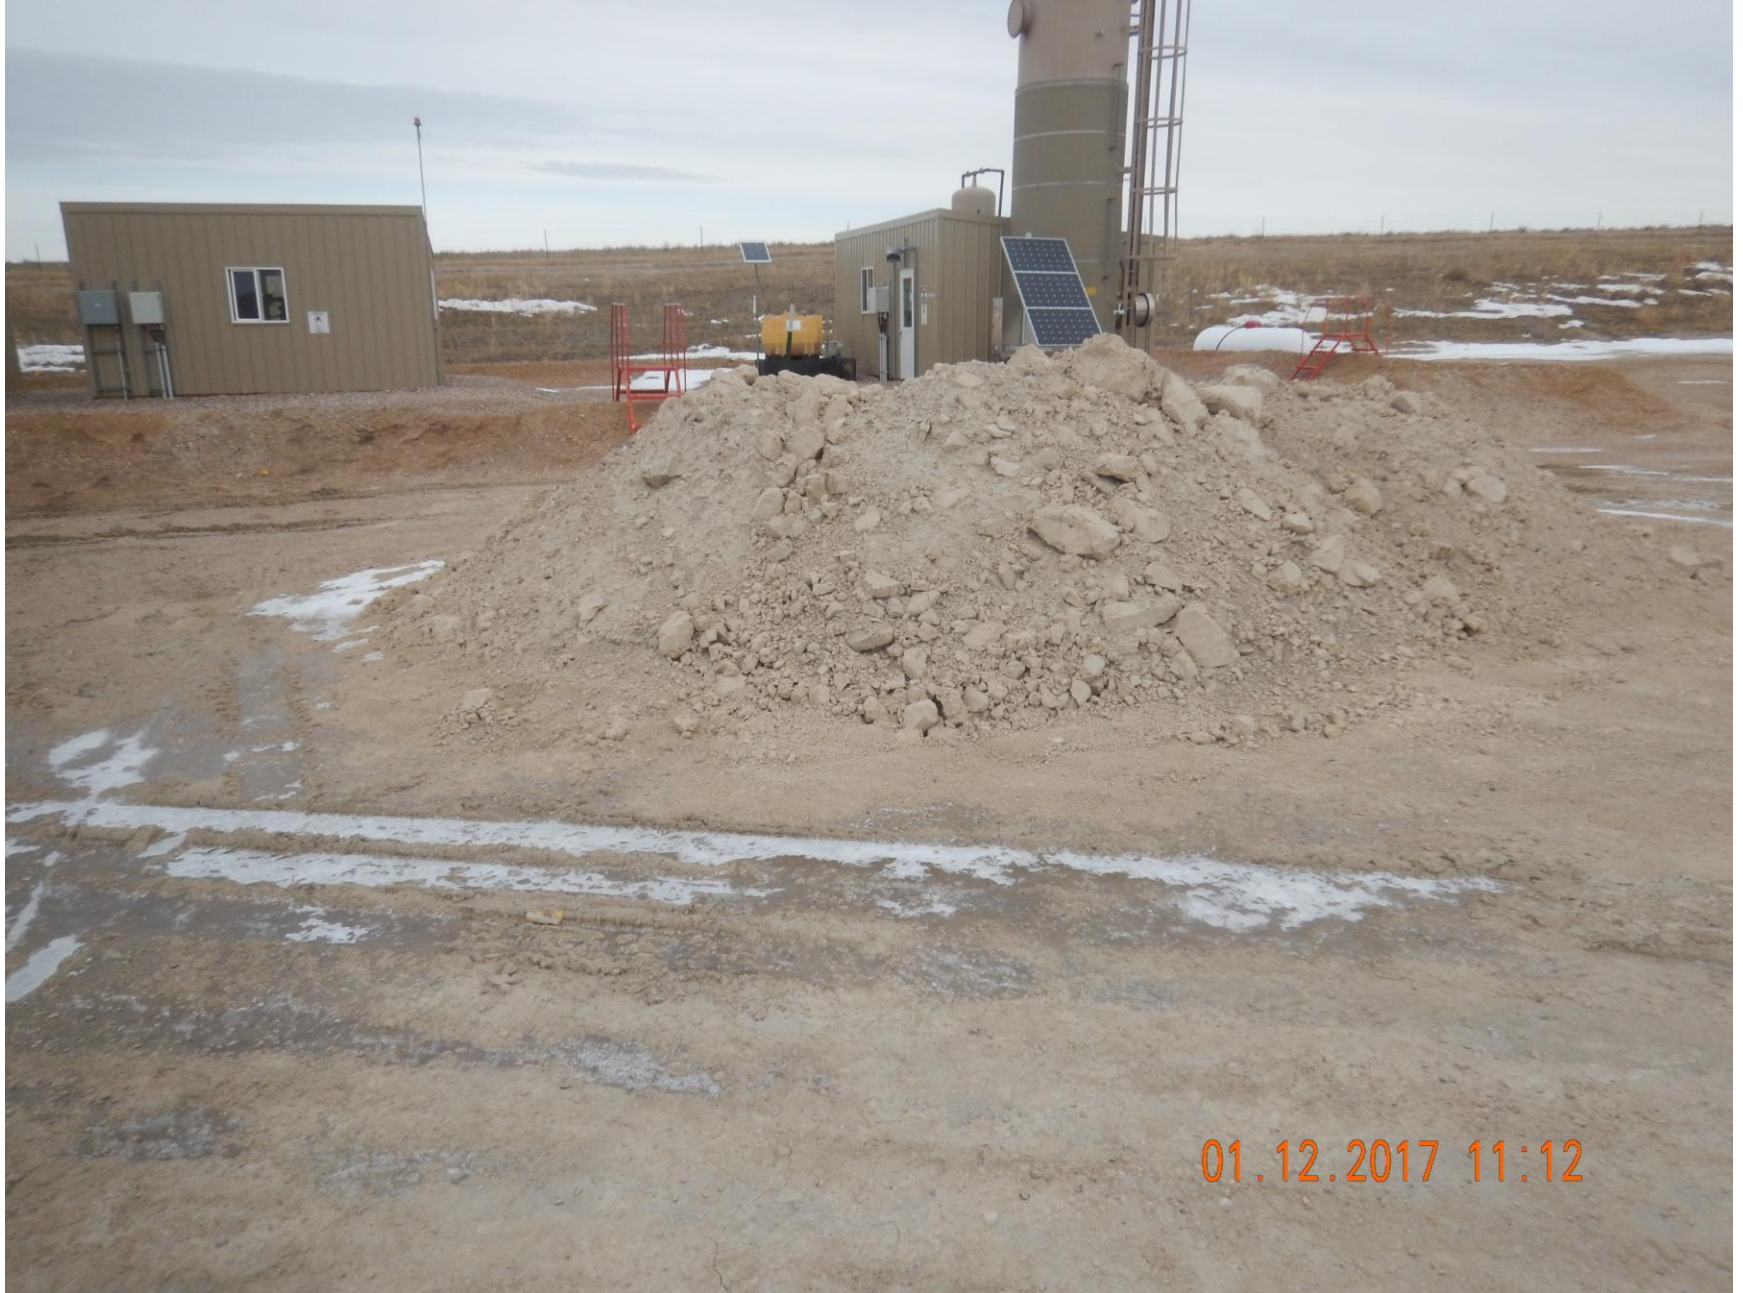
Figure 9: Photo taken from the northend of the location, facing north. Photo shows unlabeled soil stockpile on location. No stormwater BMPs in place.

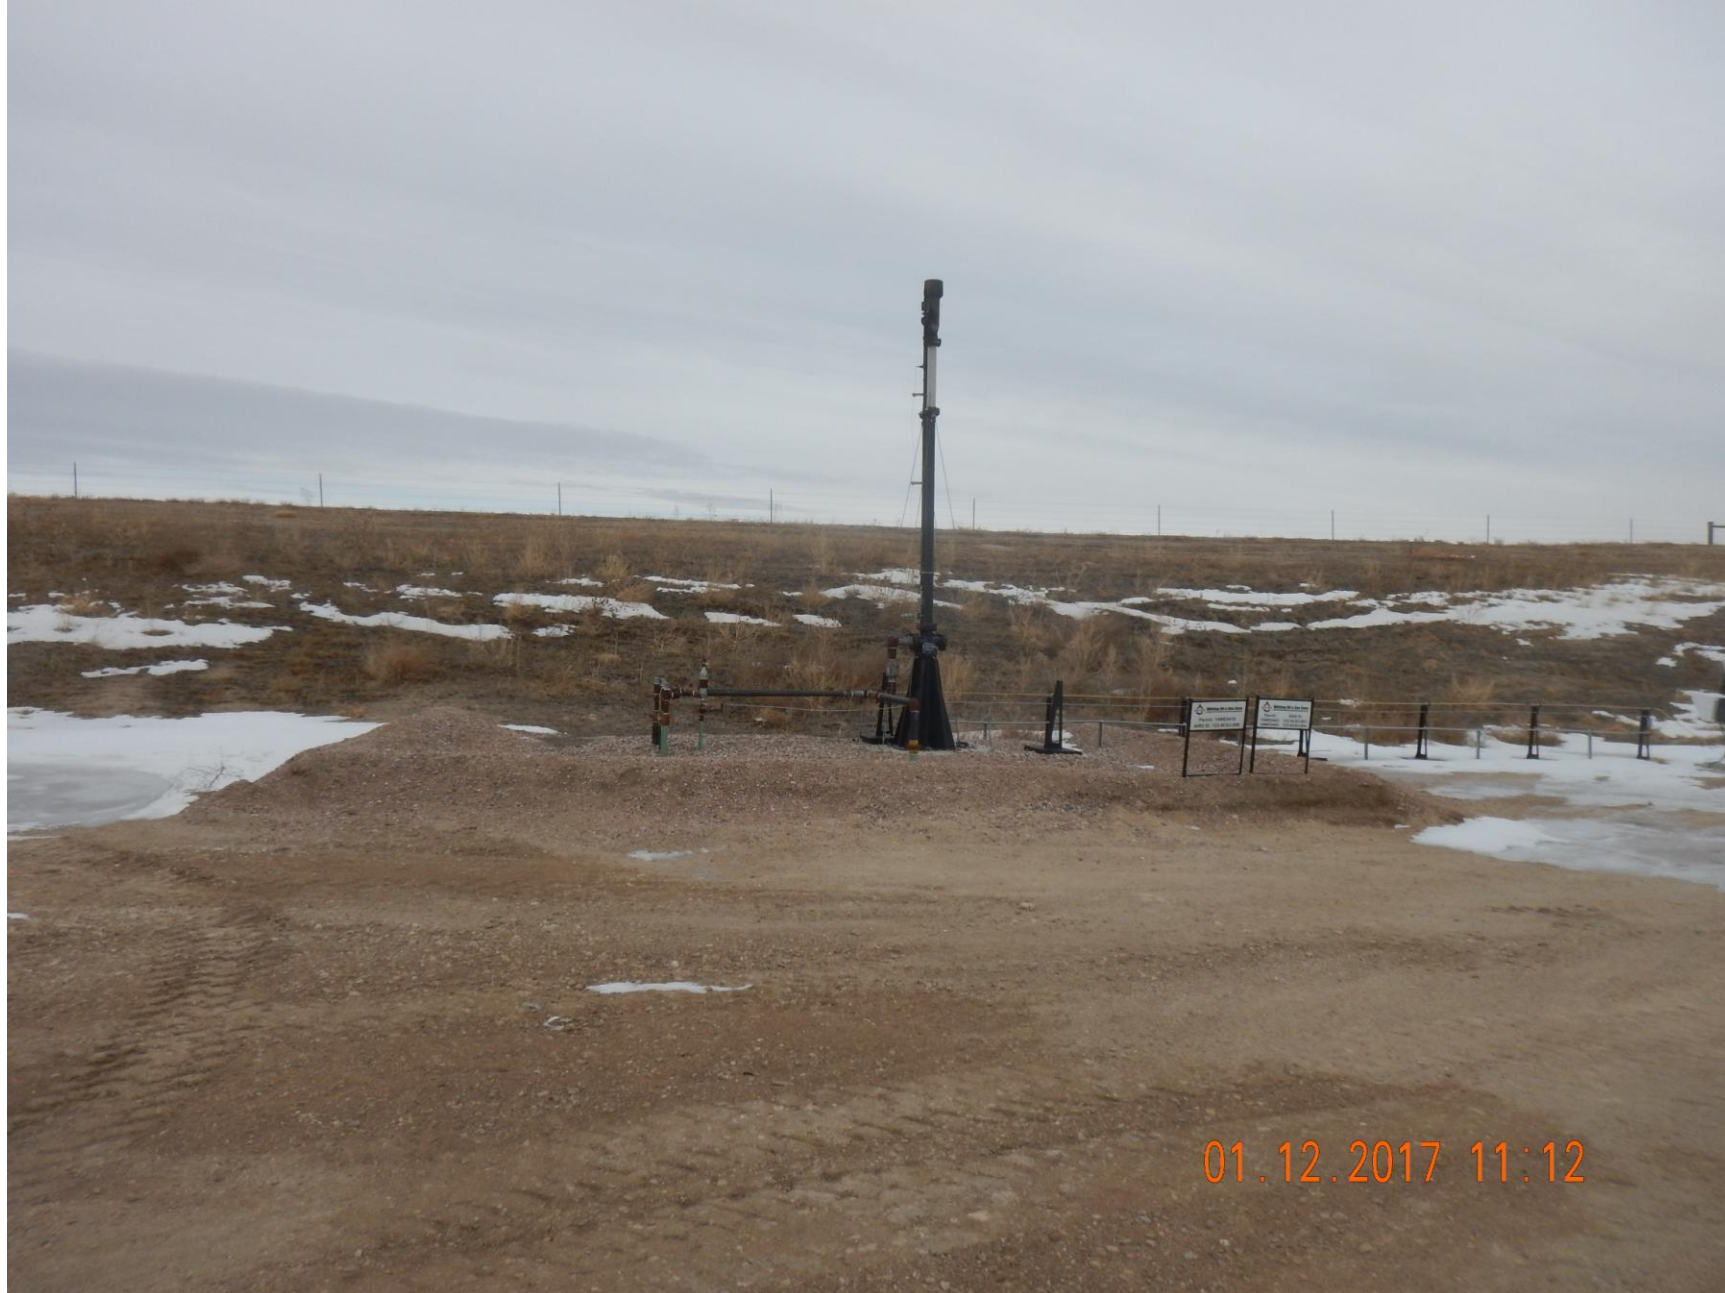
Figure 10: Photo taken from the northeast end of the production area, facing north. Photo shows field flare.
