Reclamation Inspection

01/12/2017

Operator: Whiting

Location ID: 431782

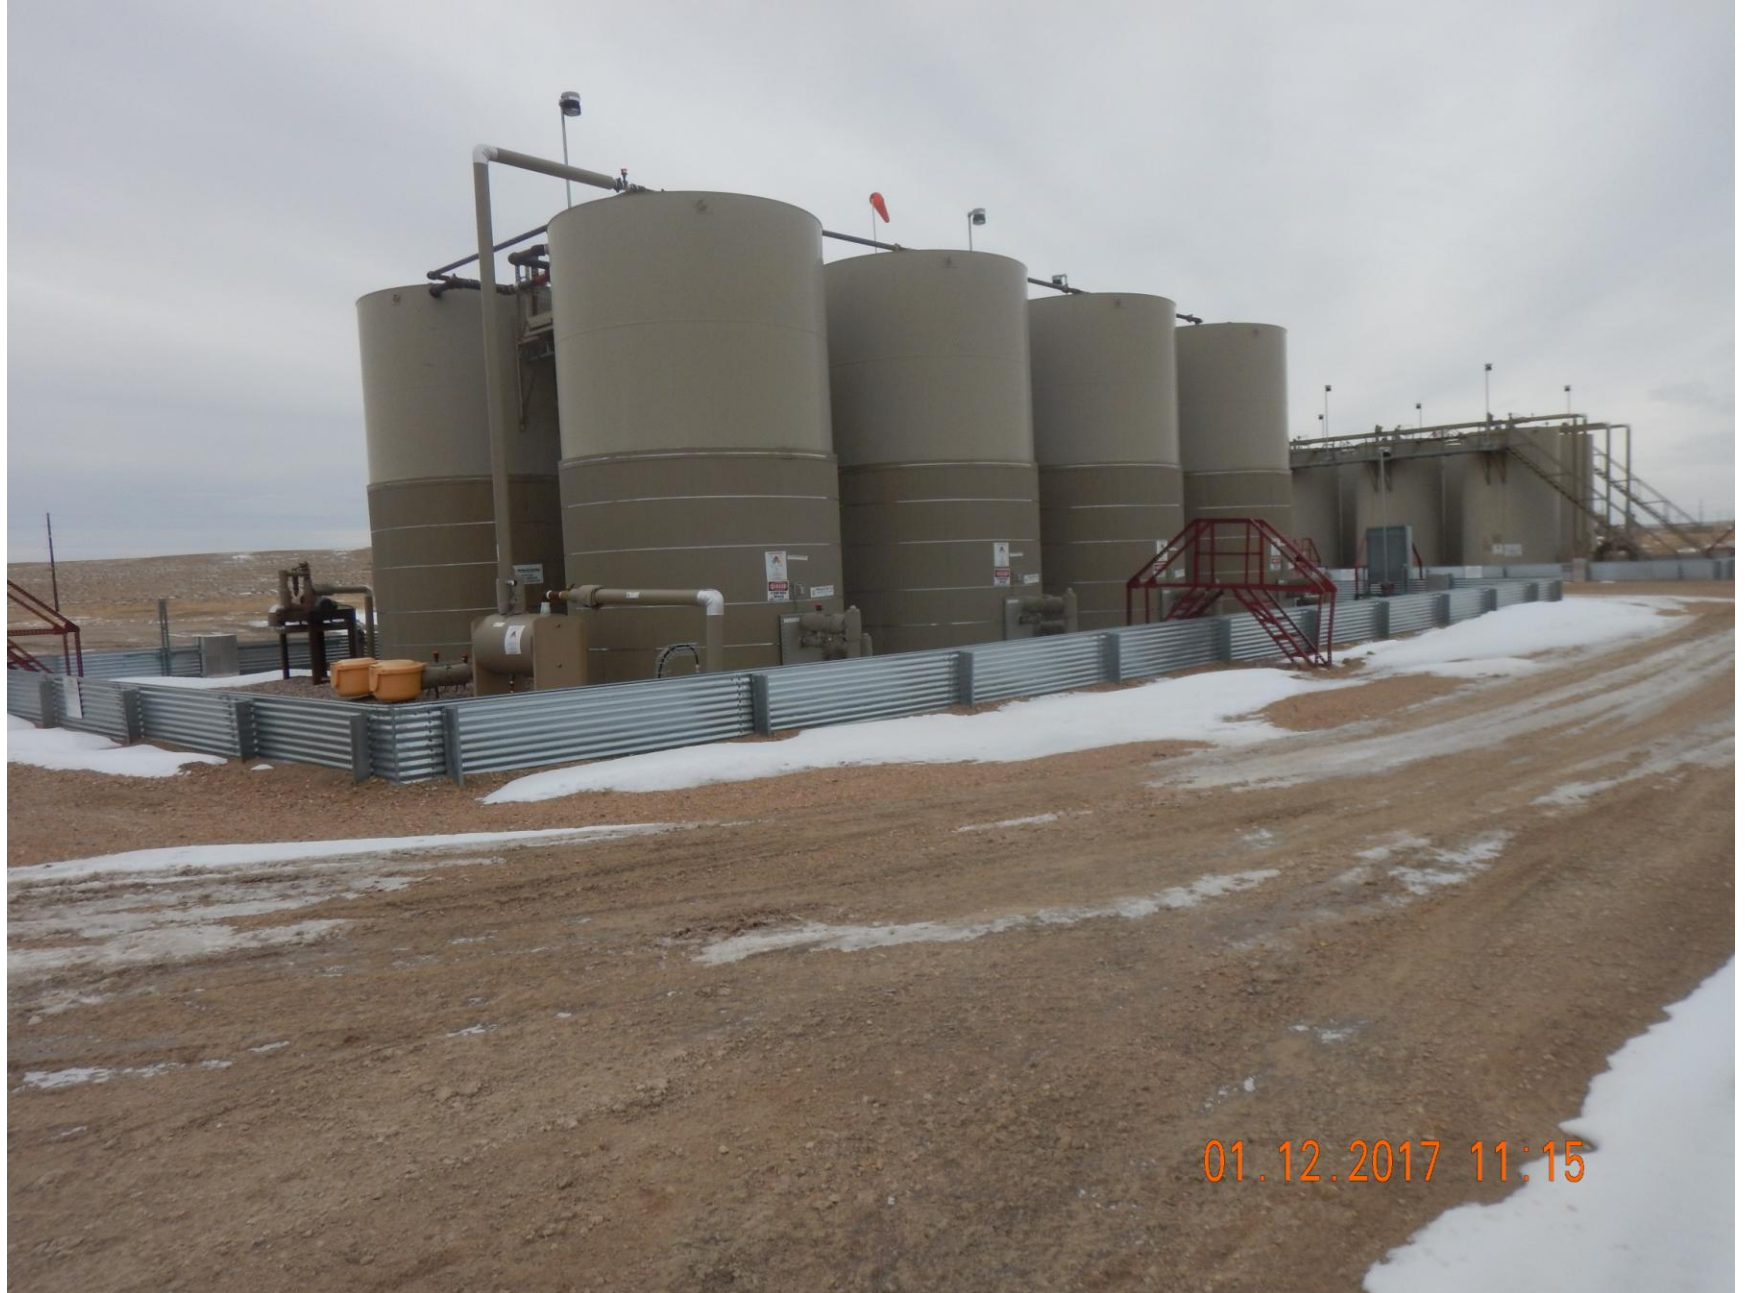
Figure 11: Photo taken from the north end of the location, facing southwest. Photo shows 8, 400 bbl produced water tanks.

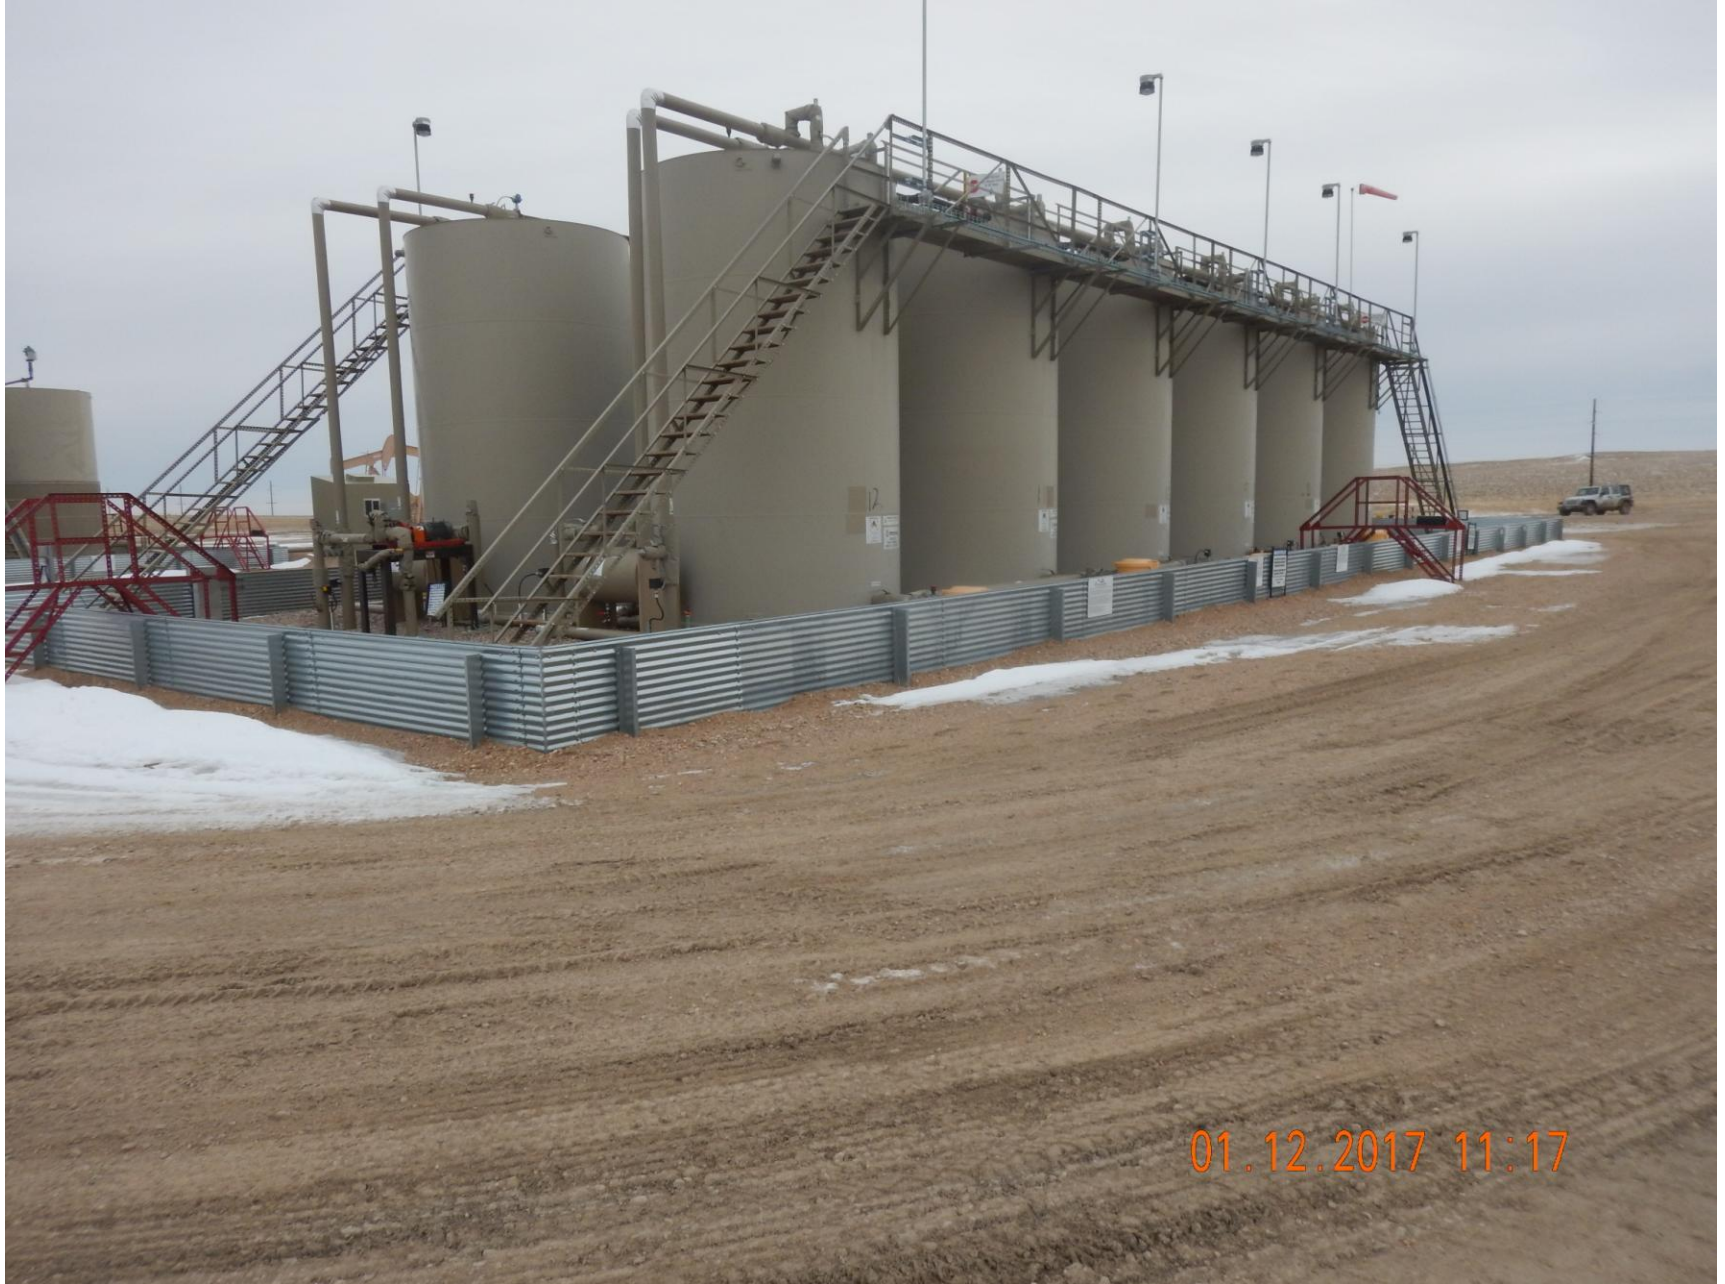
Figure 12: Photo taken from the north end of the location, facing south. Photo shows 12, 400 bbl crude oil tanks.

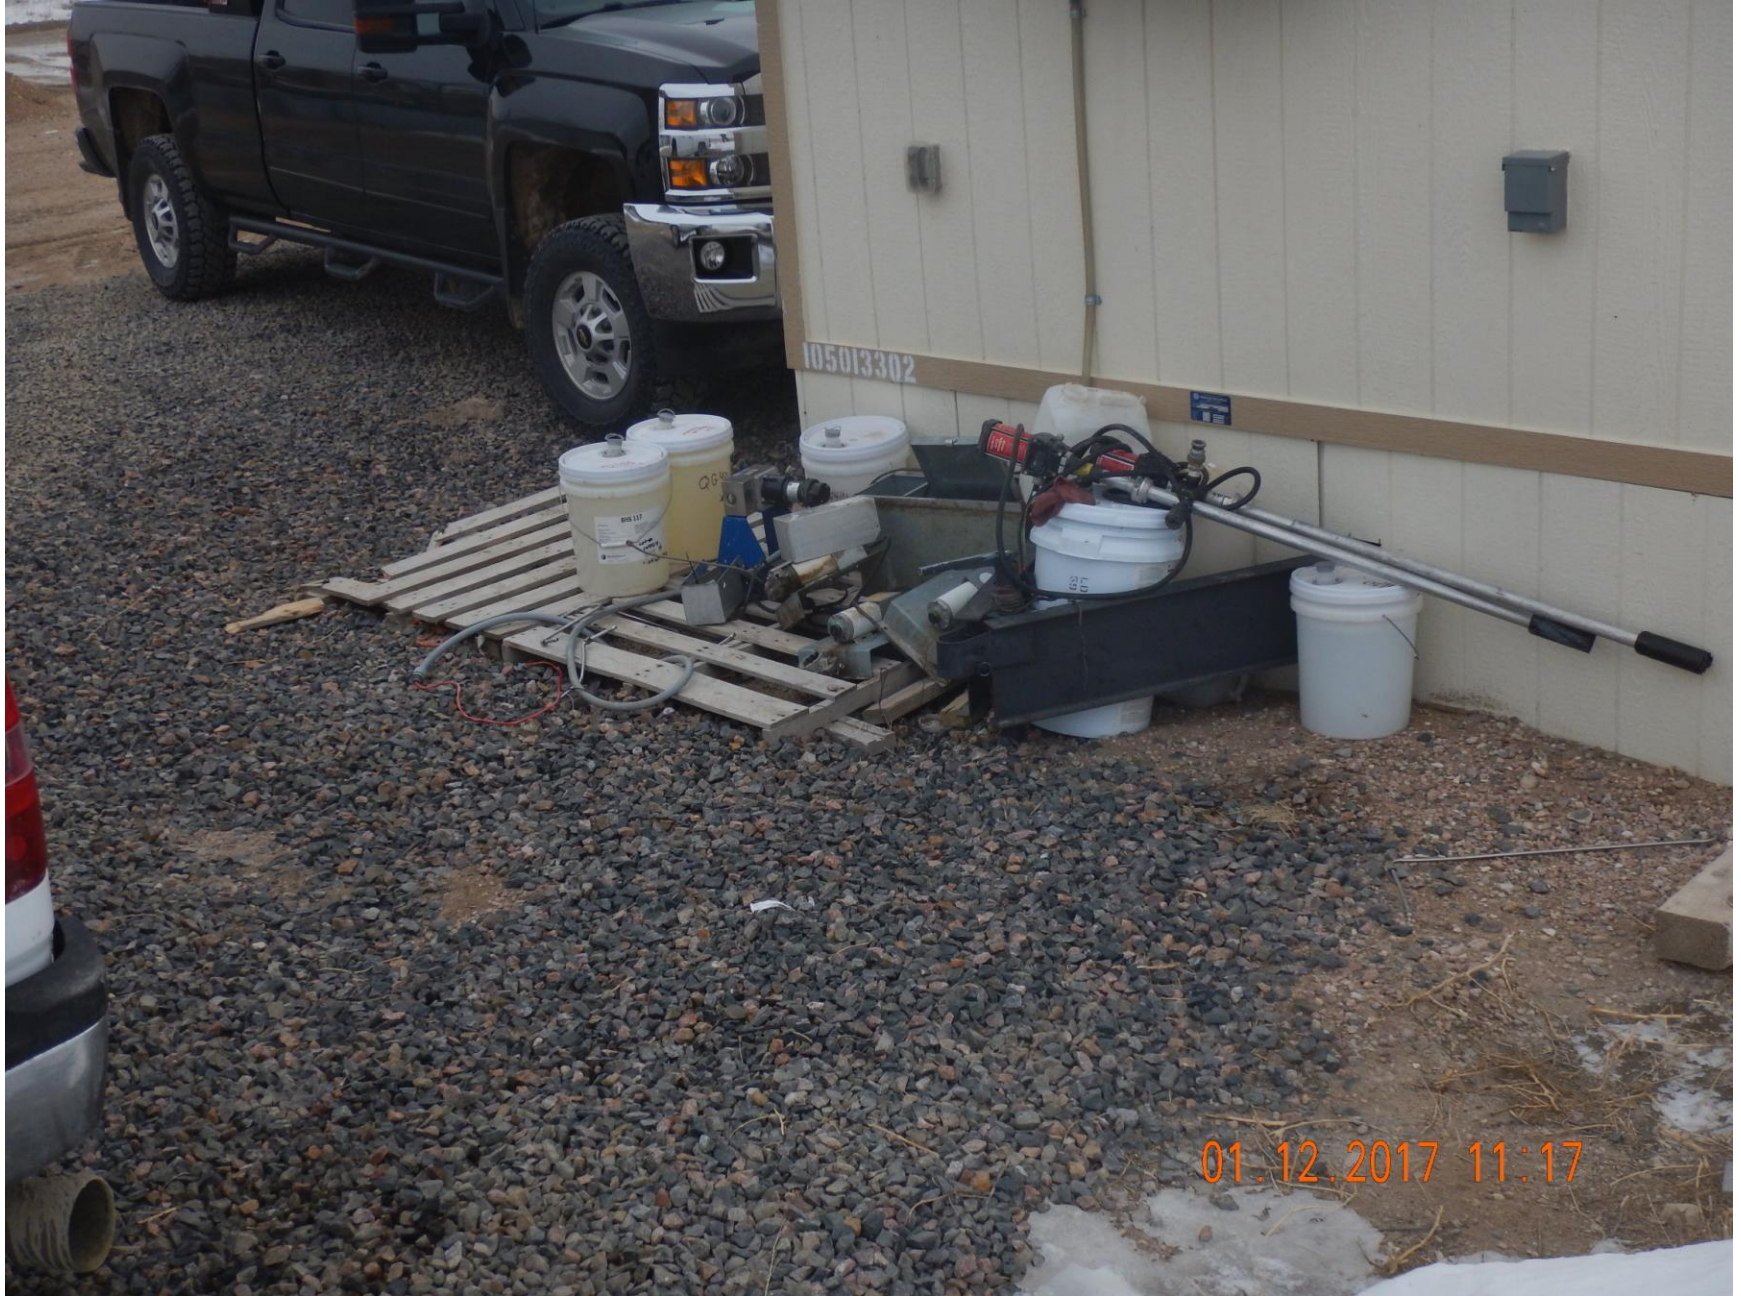
Figure 13: Photo taken from the west end of the location. Photo shows trash, debris and equipment being stored behind buildings on the west end of the location and need to be removed.

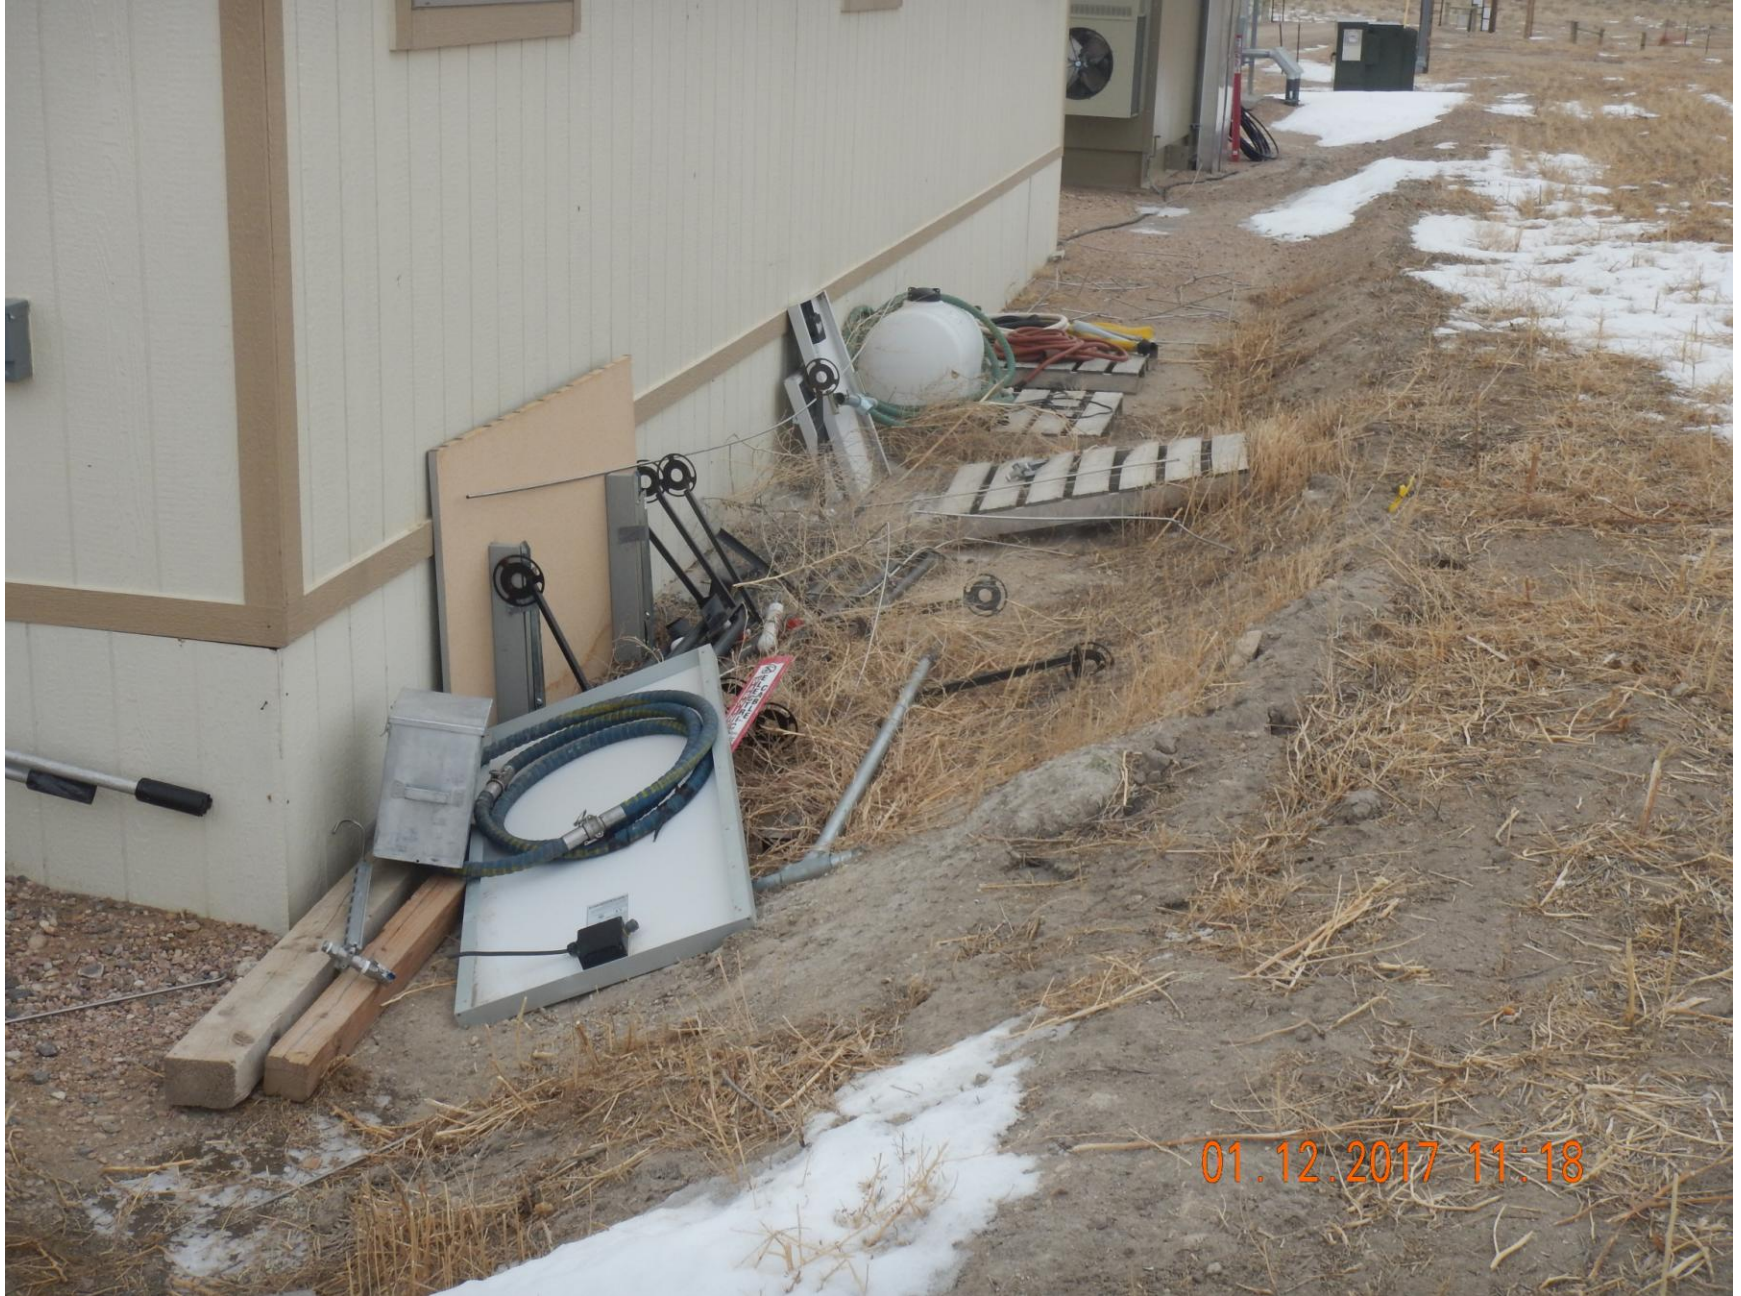
Figure 14: Photo taken from the west end of the location. Photo shows trash, debris and equipment being stored behind buildings on the west end of the location and need to be removed.

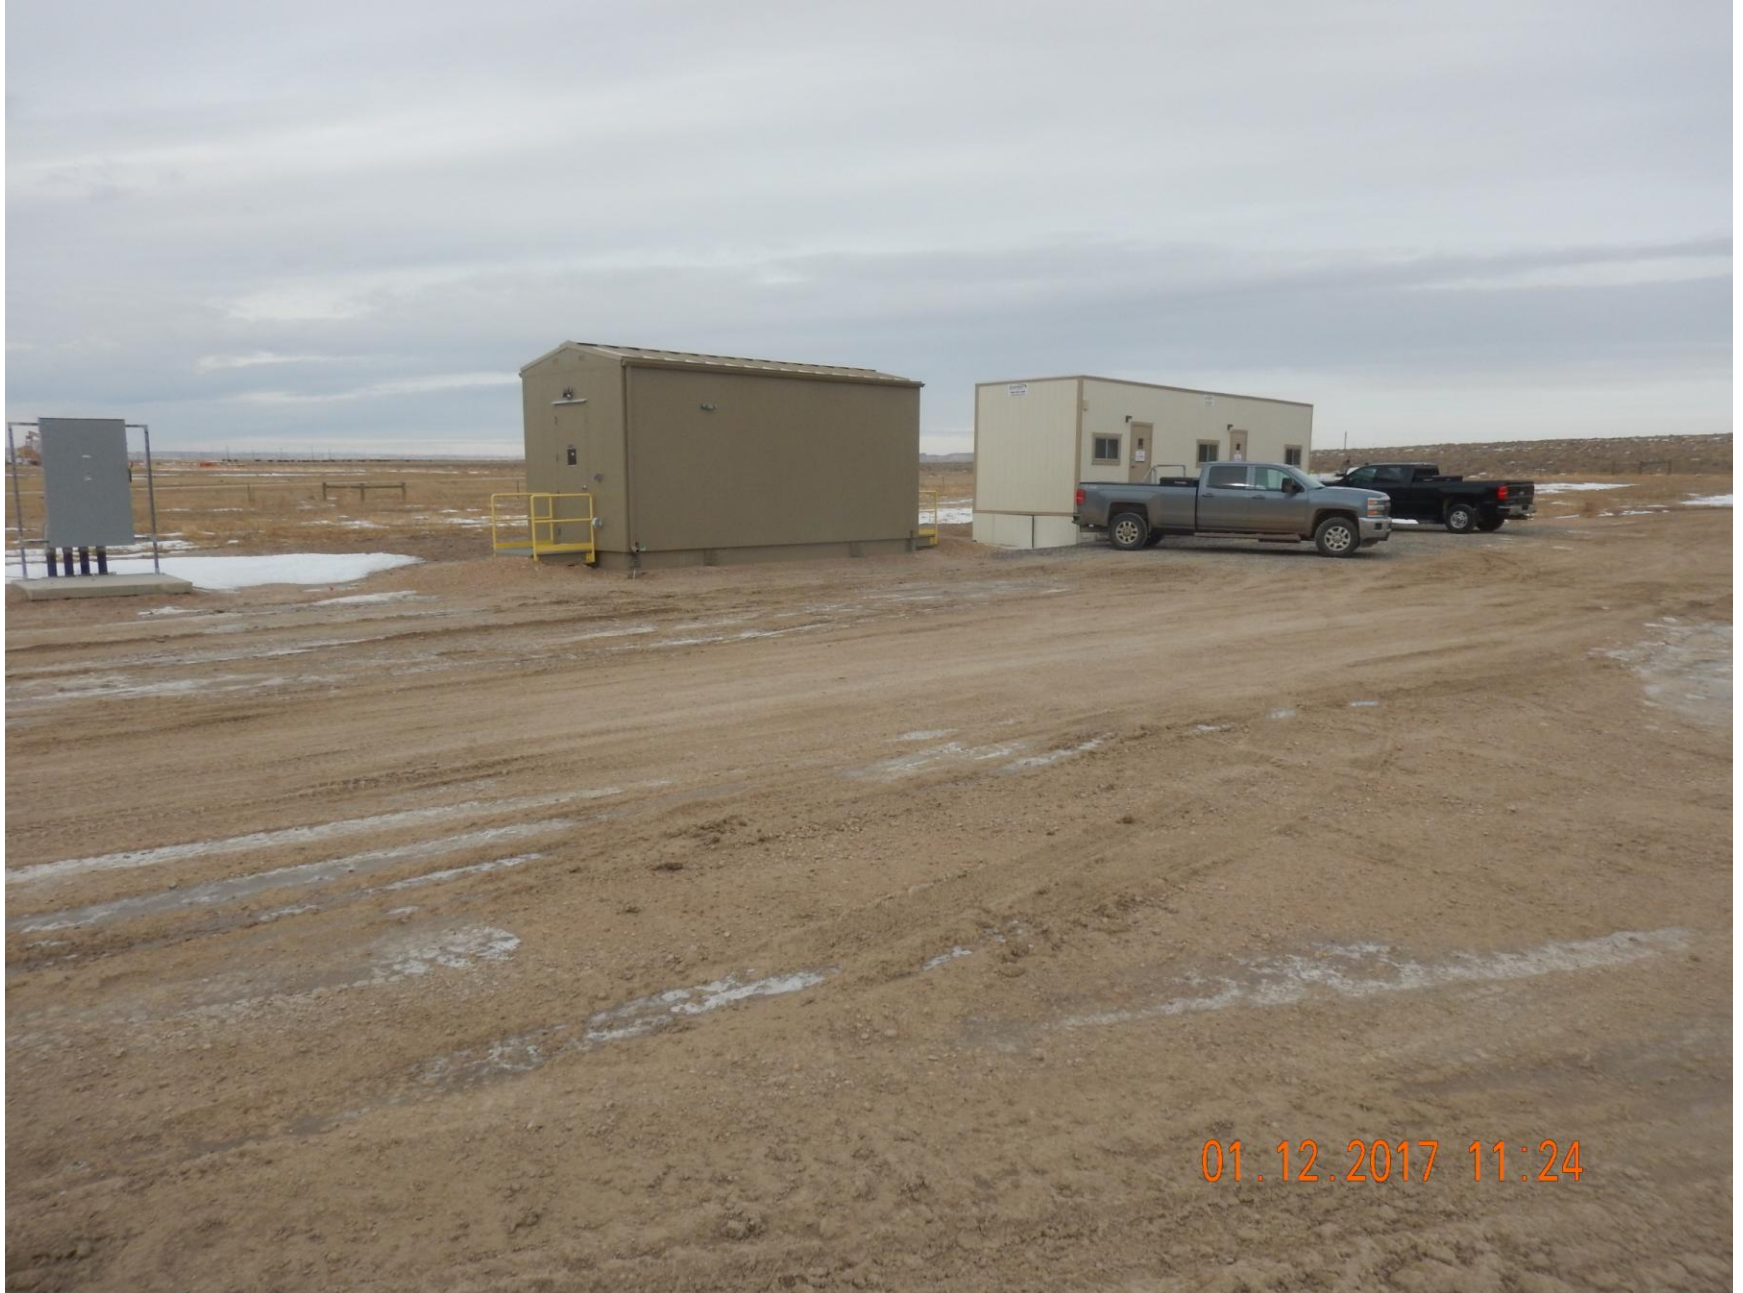
Figure 15: Photo taken from the west end of the location, west northwest. Photo shows building and facilities on location.

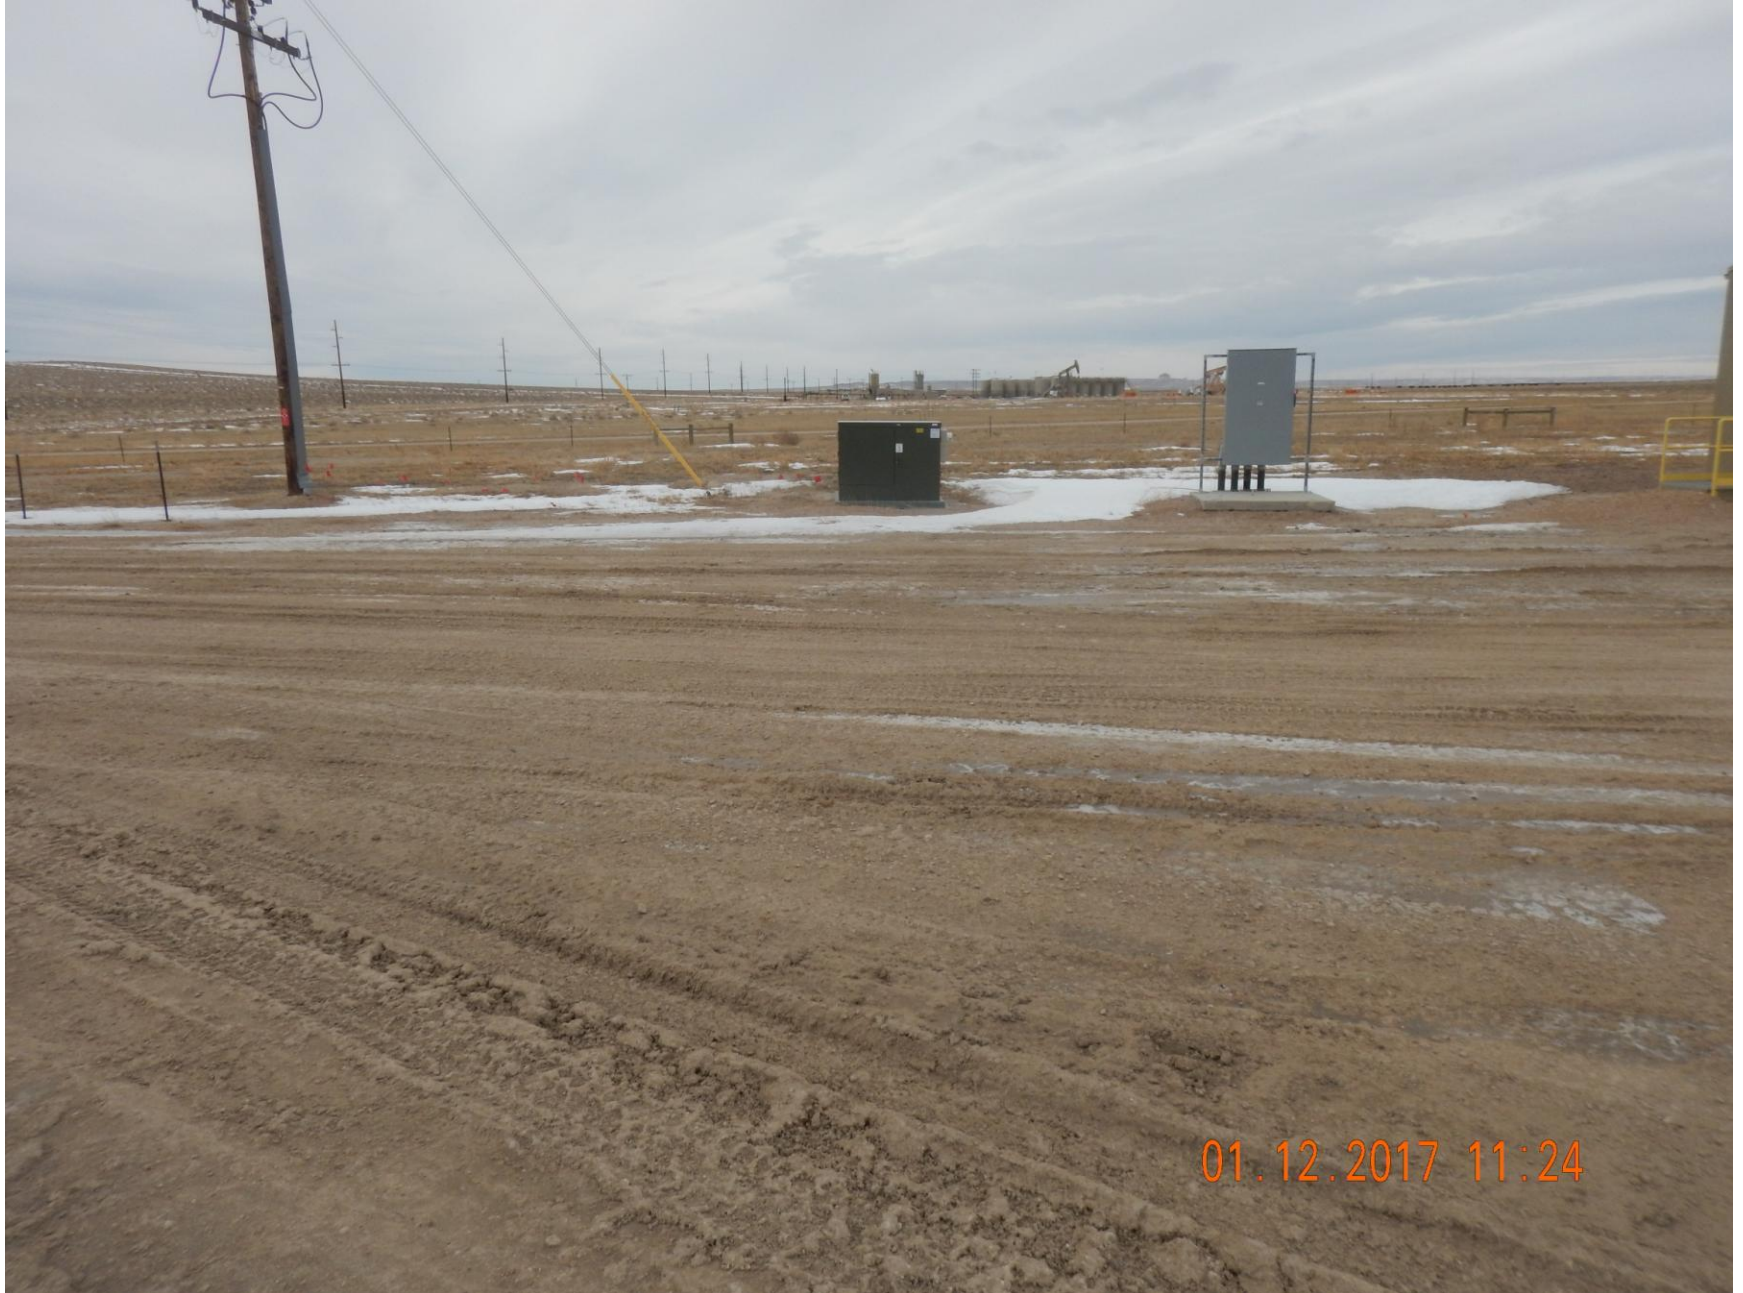
Figure 16: Photo taken from the southwest end of the location, facing west. Photo shows electrical equipment on the location

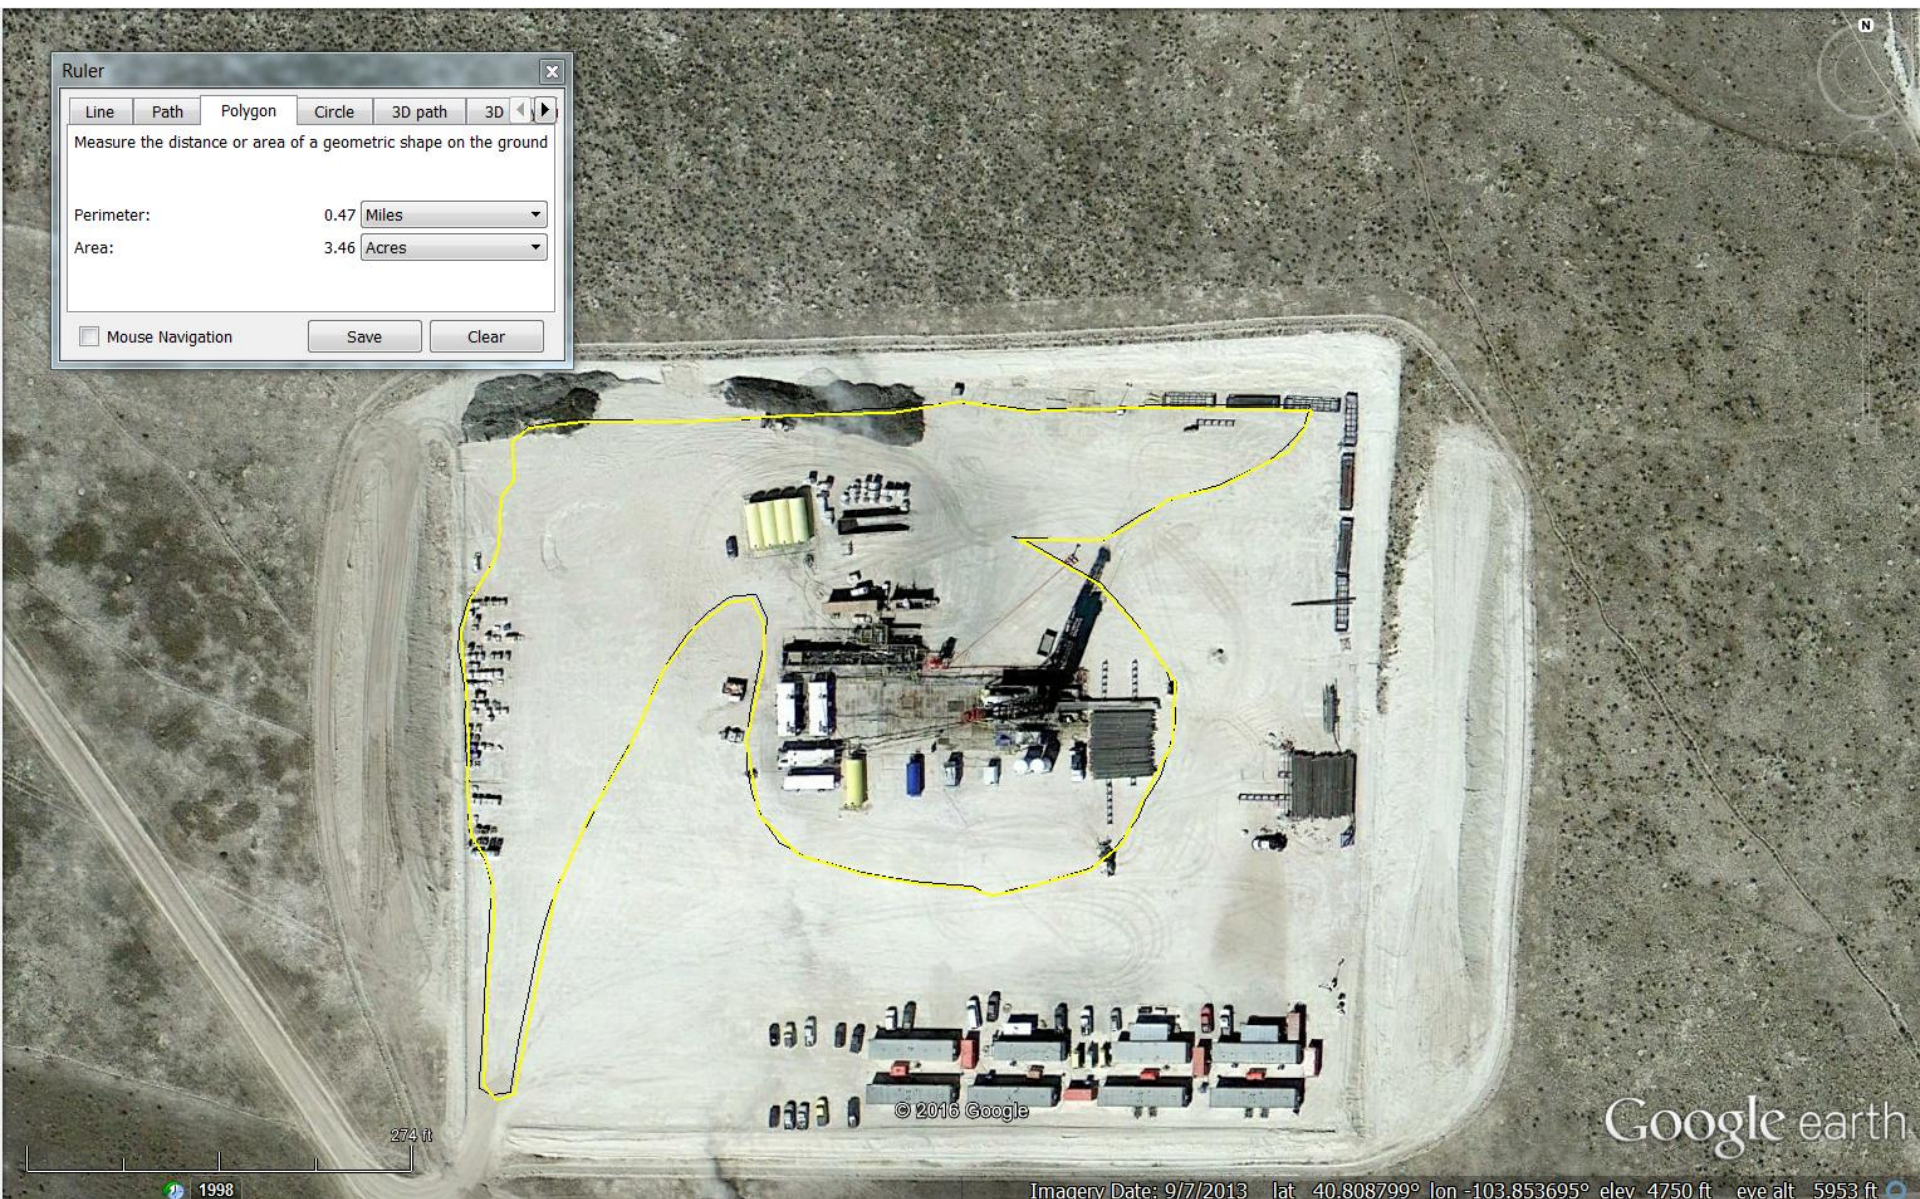
Figure 17: 2013 Google Earth imagery. Yellow polygon represents the current perimeter of the production area (confirmed by GPS on the ground). Current size of production area is 3.46 acres.

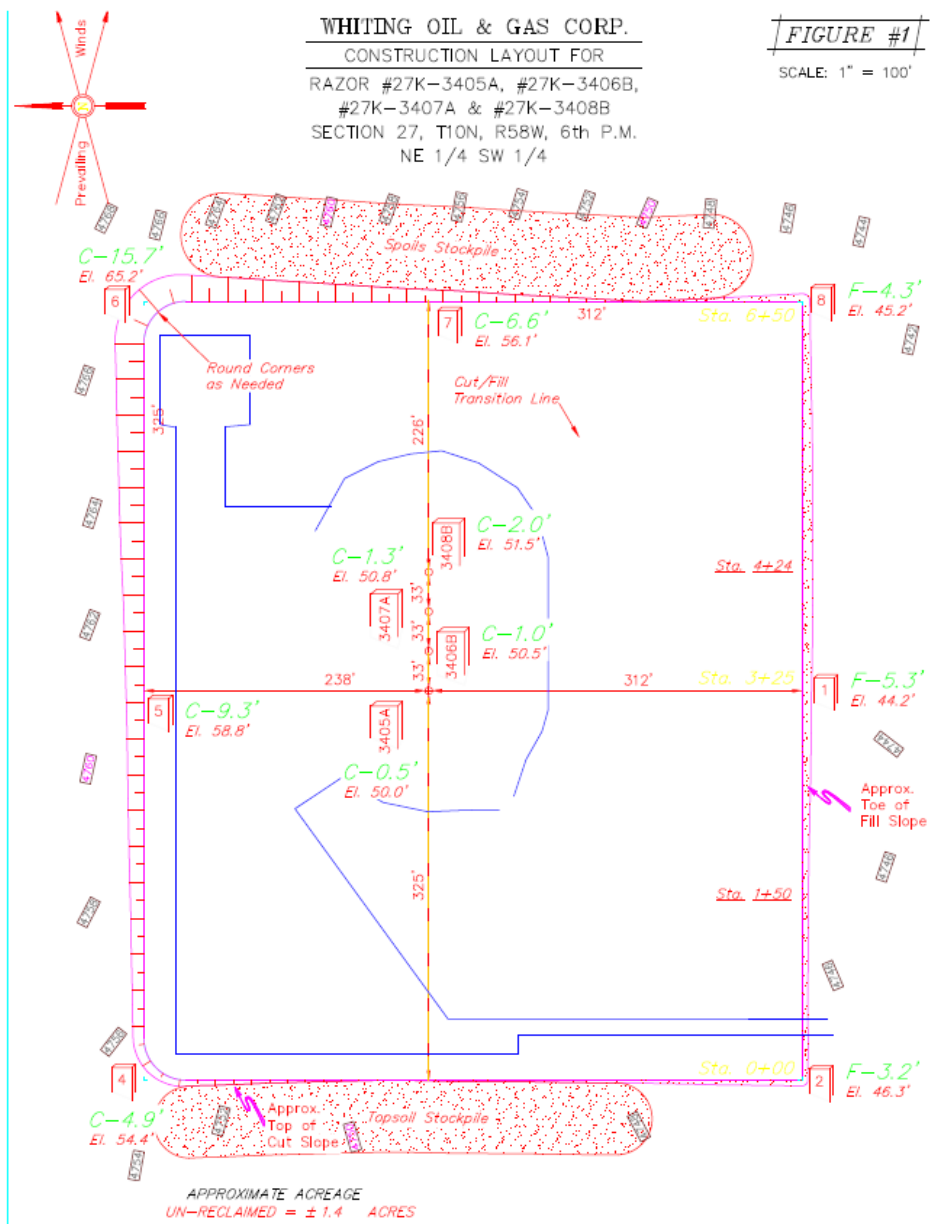
Figure 18: Clip of page 14 of Whiting's Reclamation Plan (Doc. #401018121). According to the reclamation plan, size of the location post IR was to be 1.4 acres in size. Also, note that the only facilities show to be on the location according to this plan are the 4 pump jacks/wells.
