January 12, 2017

Inspection Photos: Encana Loc#335200 N Parachute

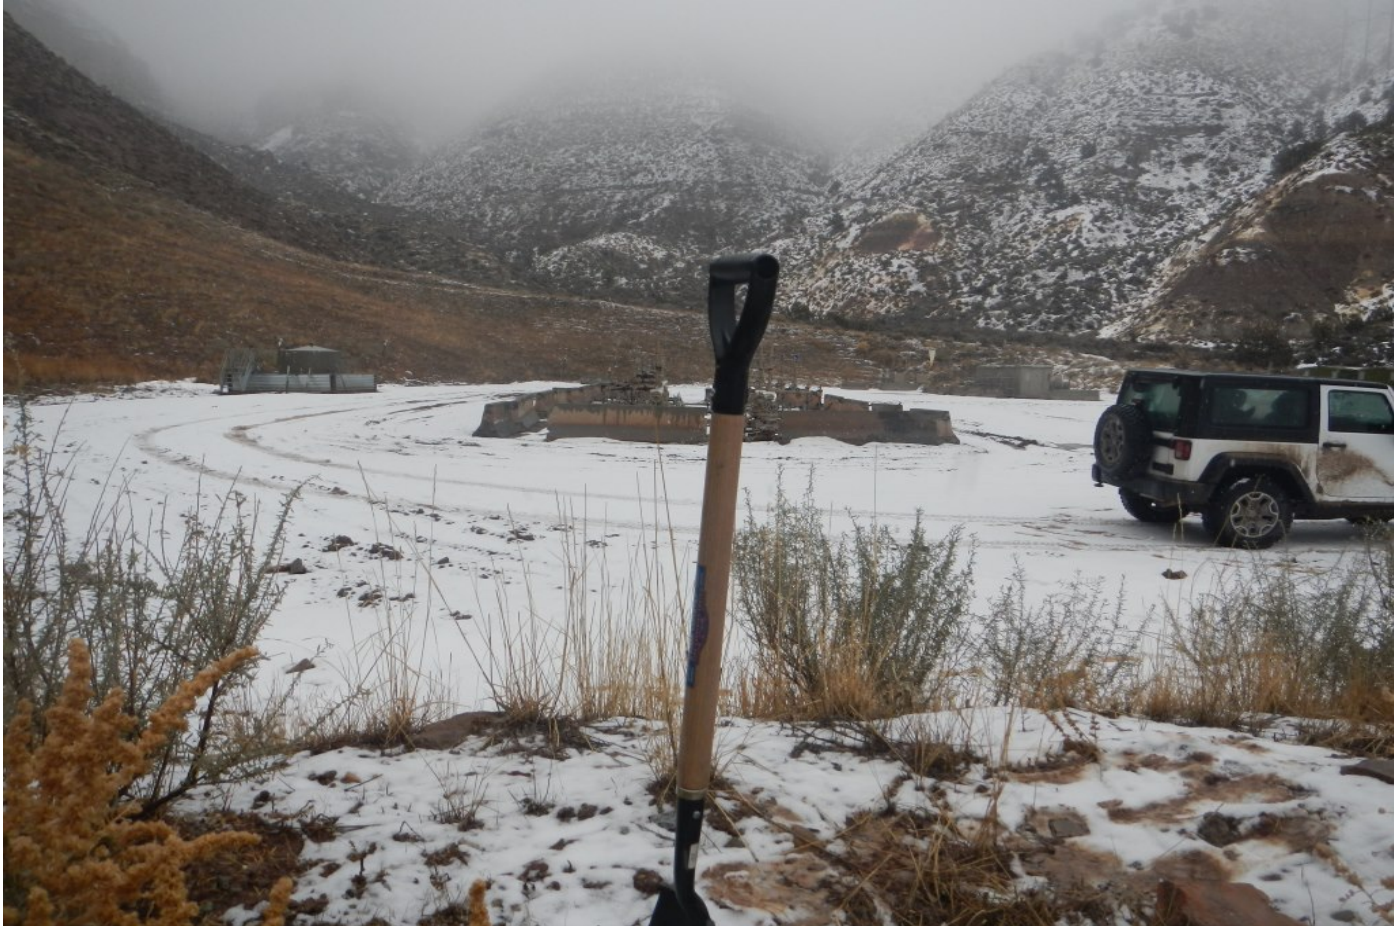
Photo#1: Overview of Location to North from Interim Reclamation Area.

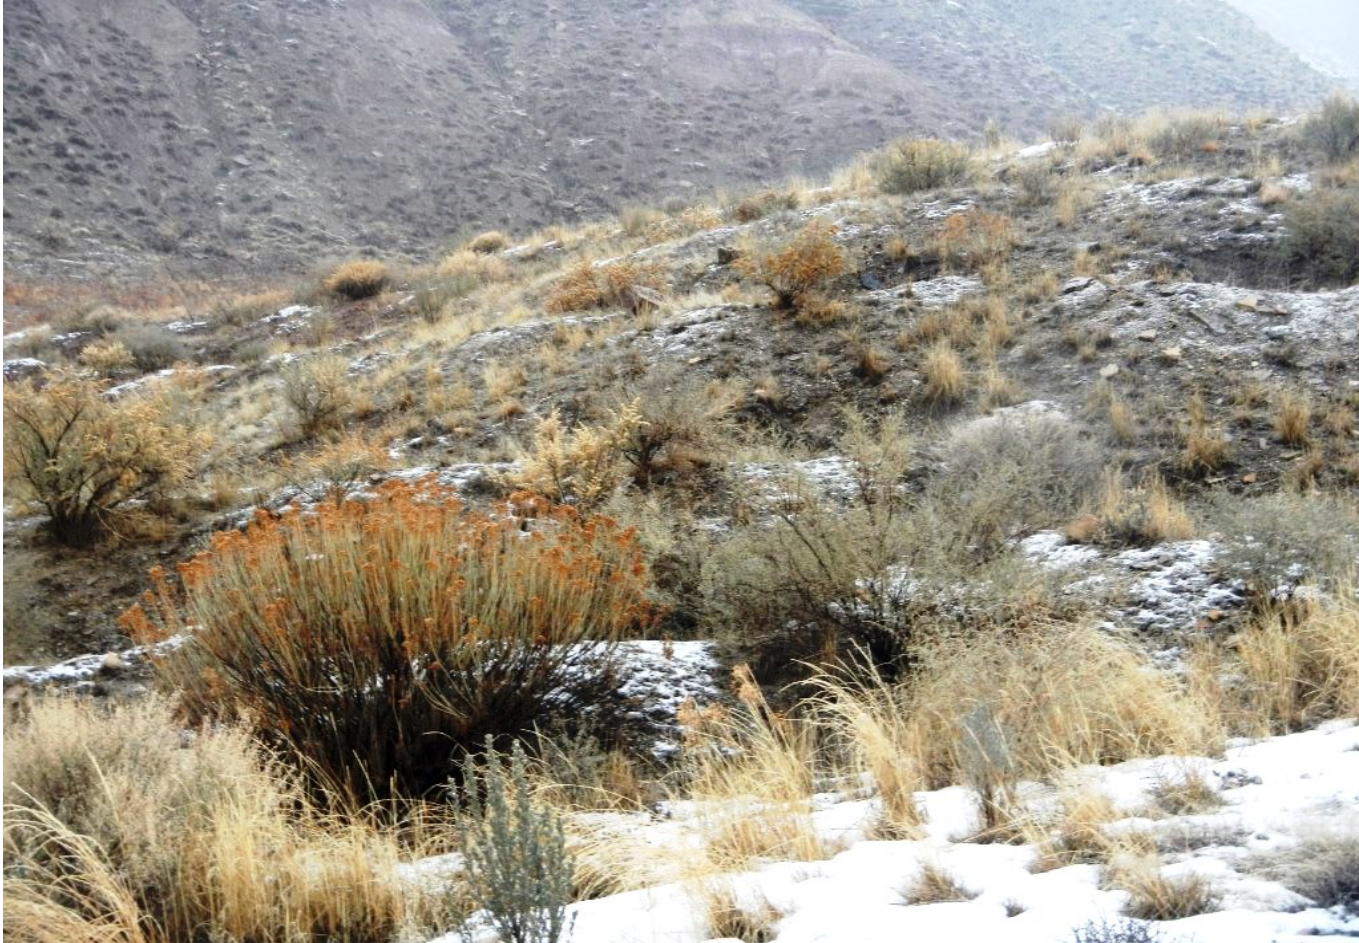
Photo#2: Well Vegetated Fill Slope at west side of Location Entry.

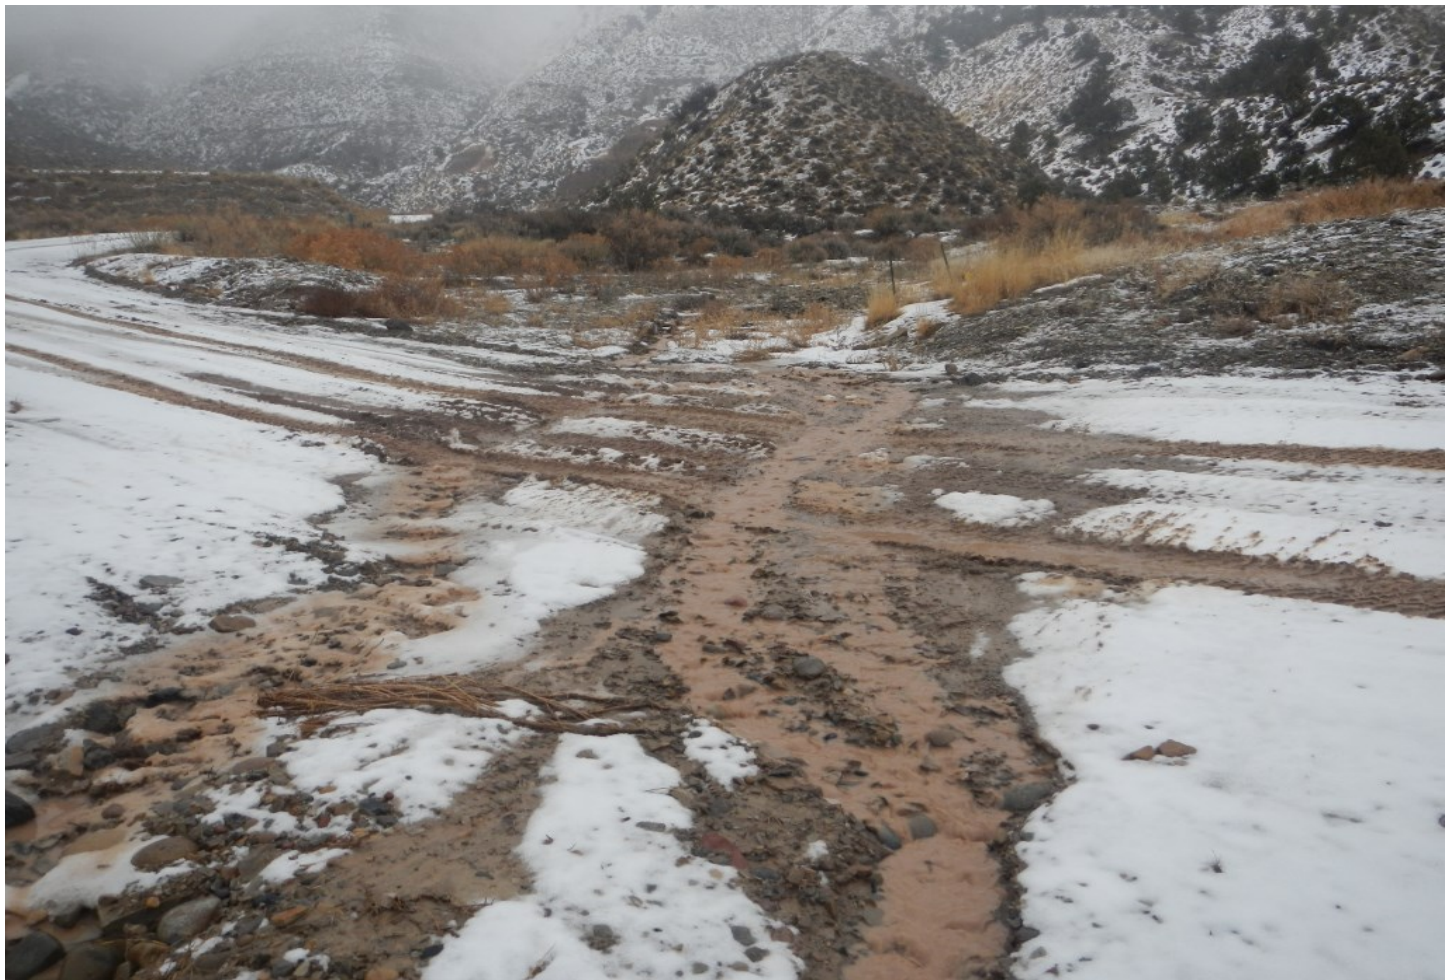
Photo#3: SW Cutting across Access Road from NE.

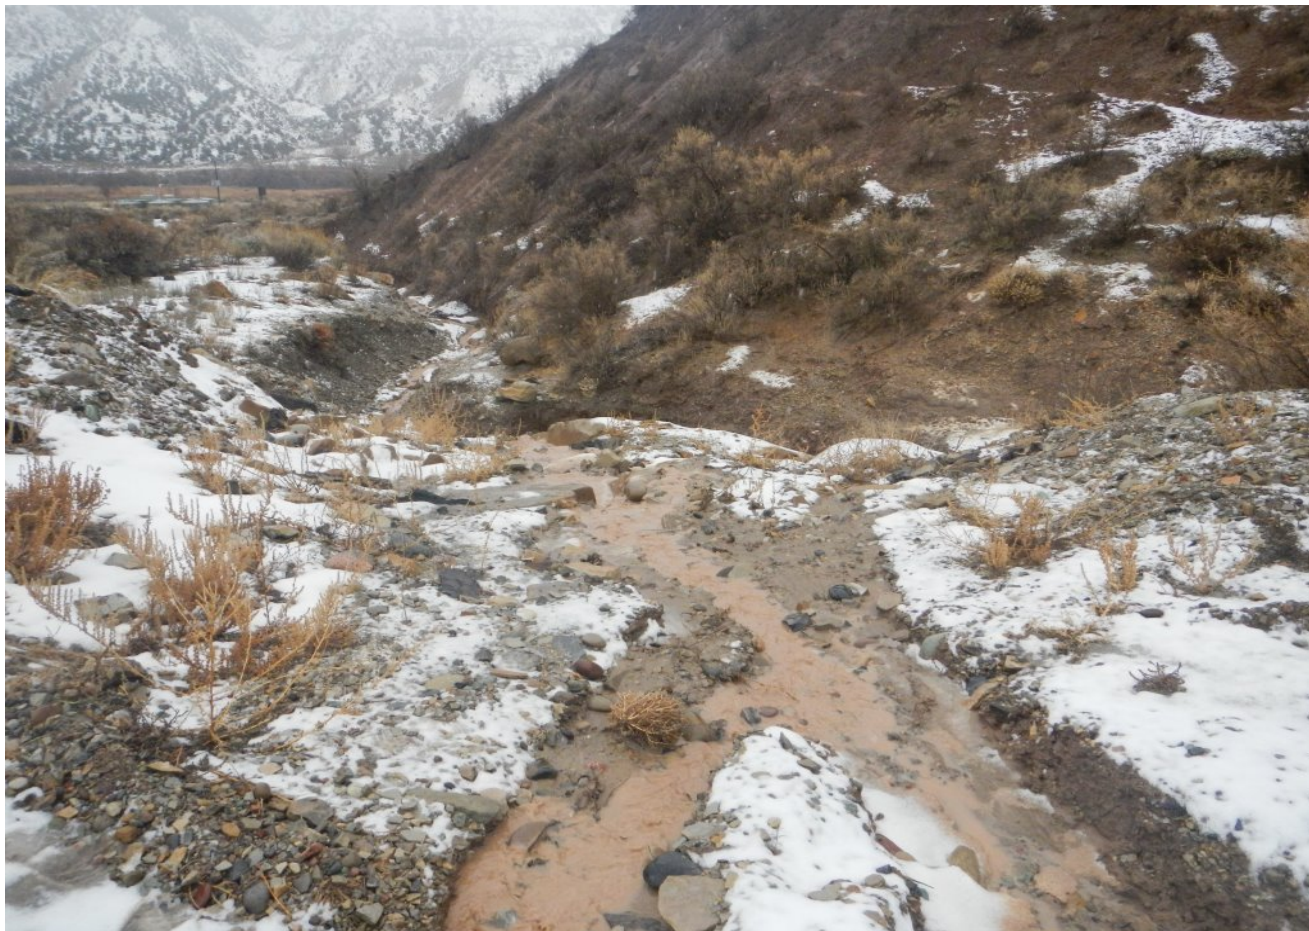
Photo#4: Water flow to SW

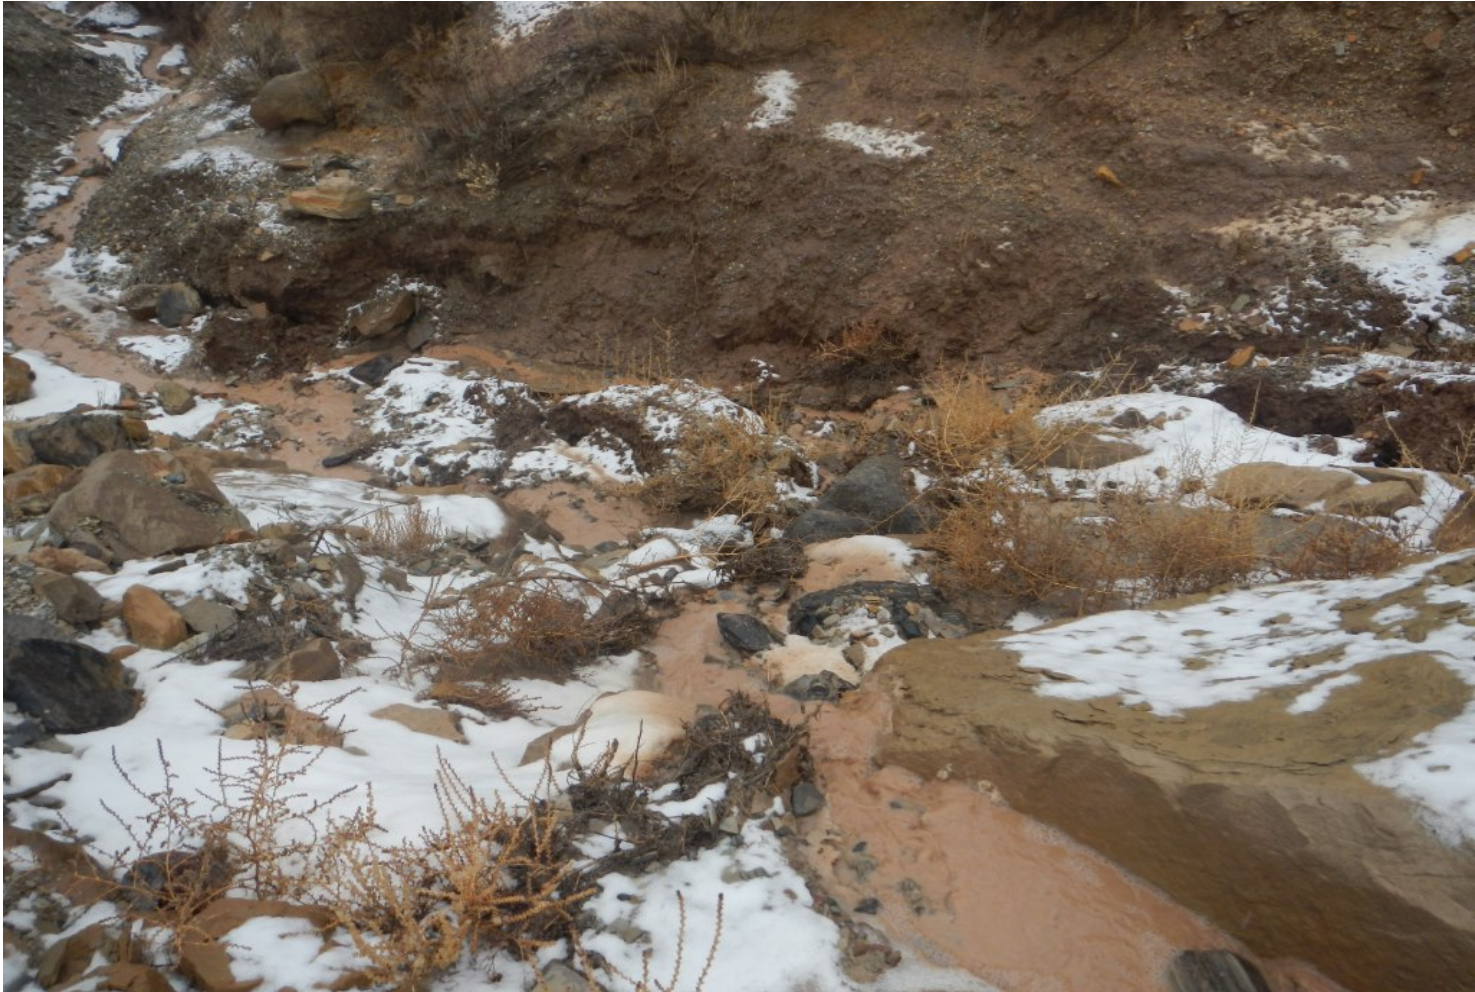
Photo#5: Water discharging into Drainage.
