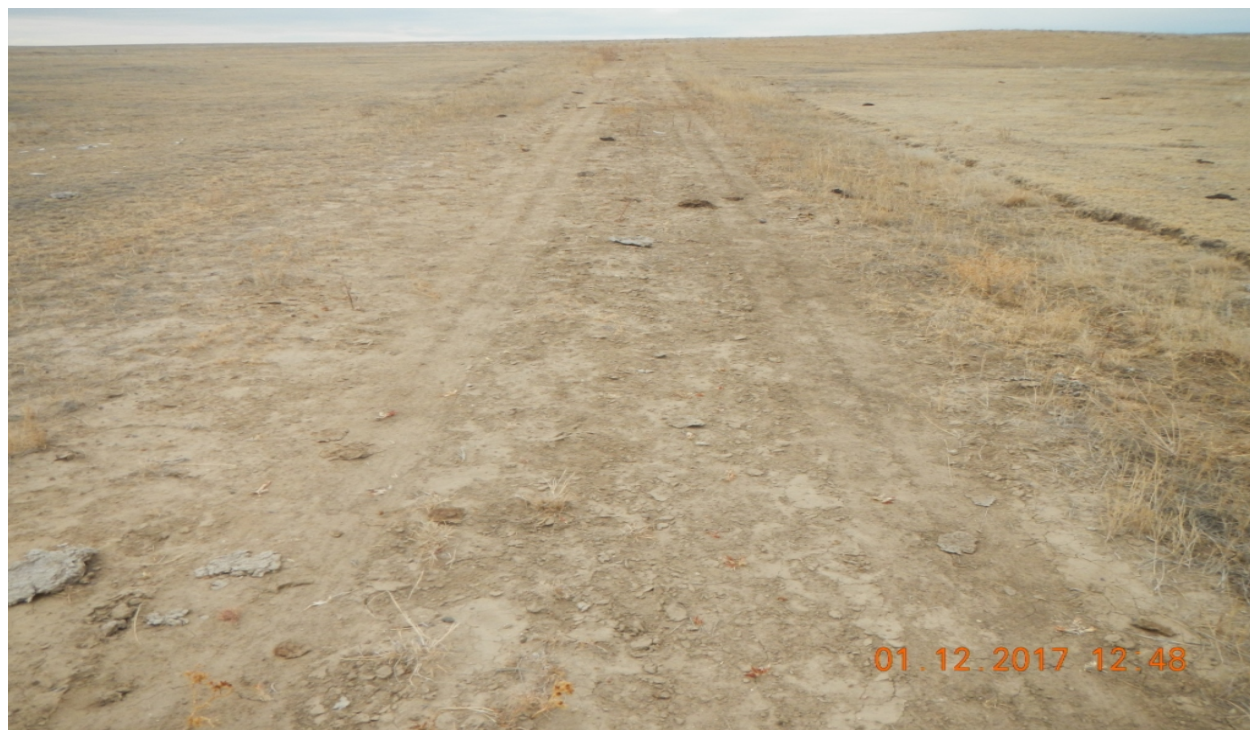
photo 1: Facing west along the access road. The road is not contoured and regraded.

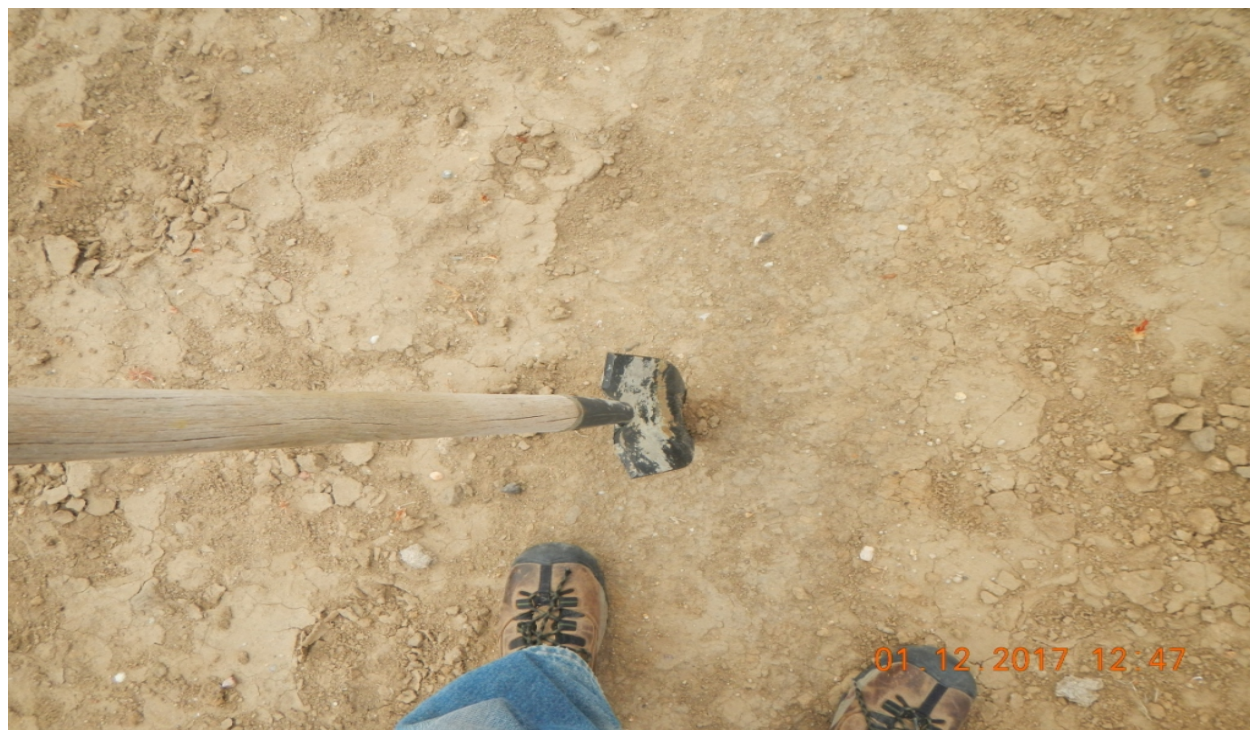
photo 2: The soils along the access road are compacted and vegetation has not established.

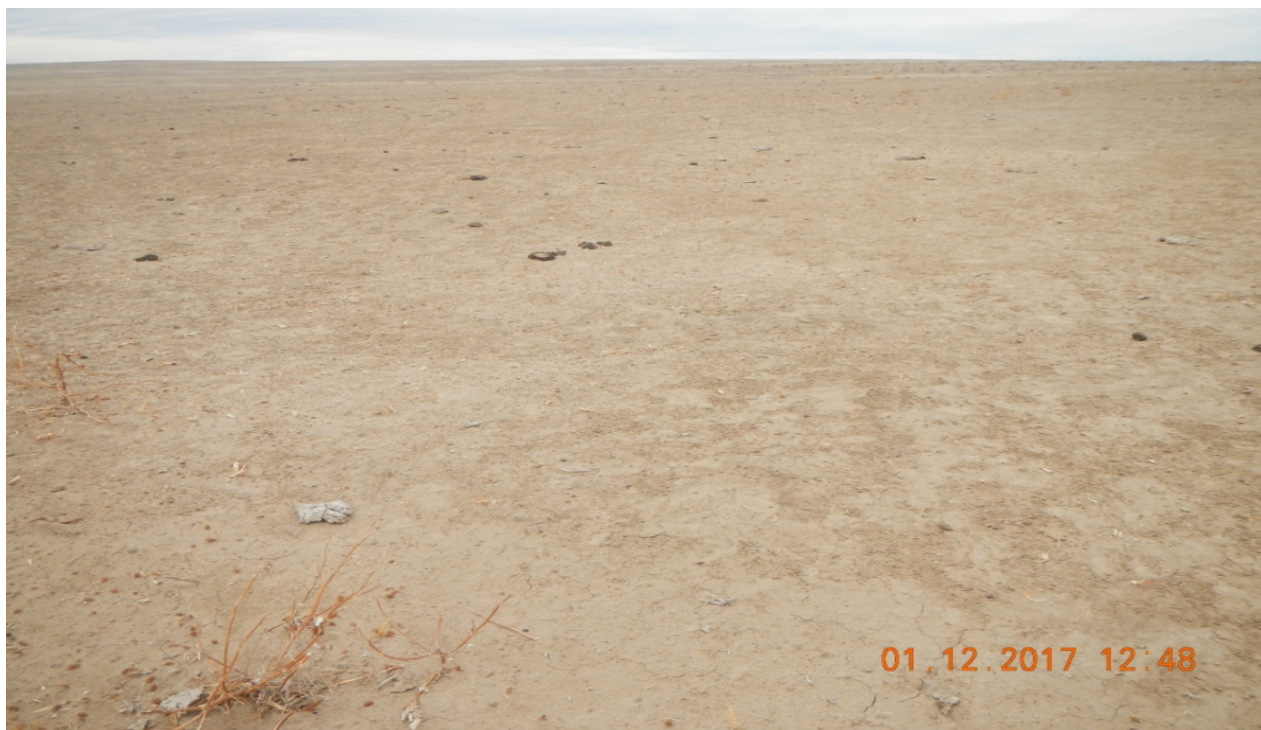
photo 3: Facing west toward the location.

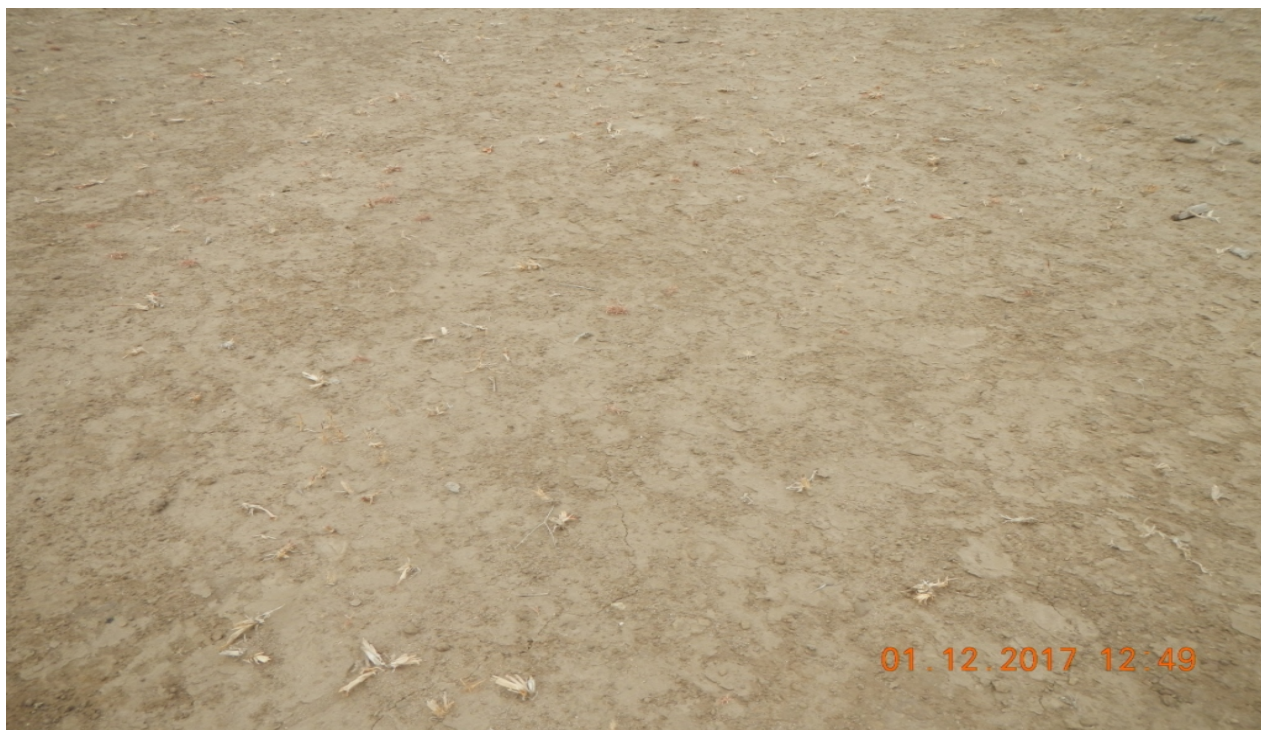
photo 4: Vegetation has not adequately established at the location and the soils seem to be compacted.

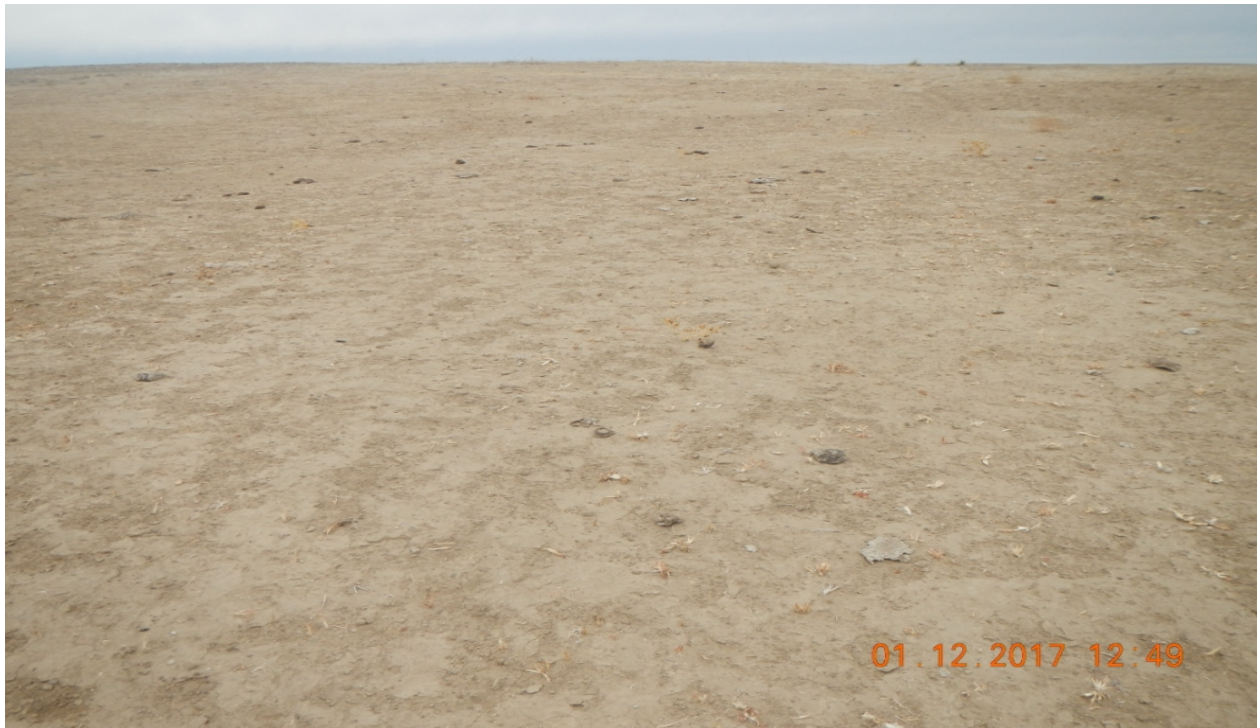
photo 5: Center of the location facing north.

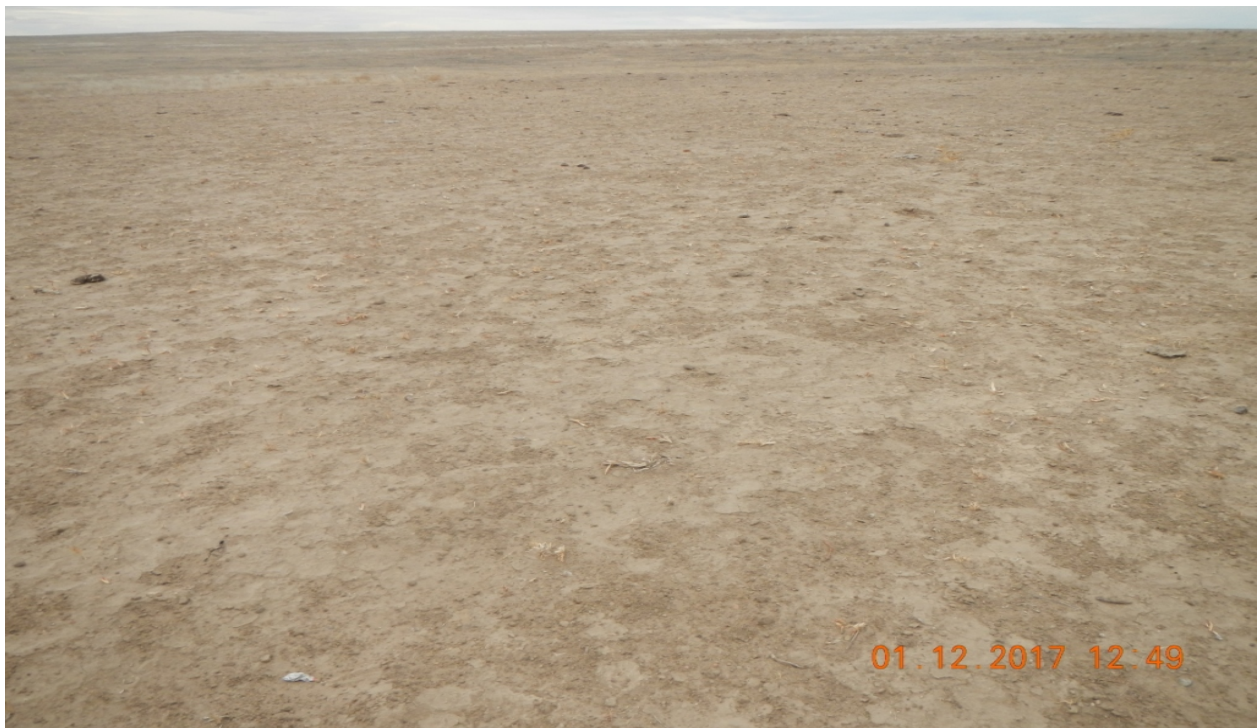
photo 6: Center of the location facing west.

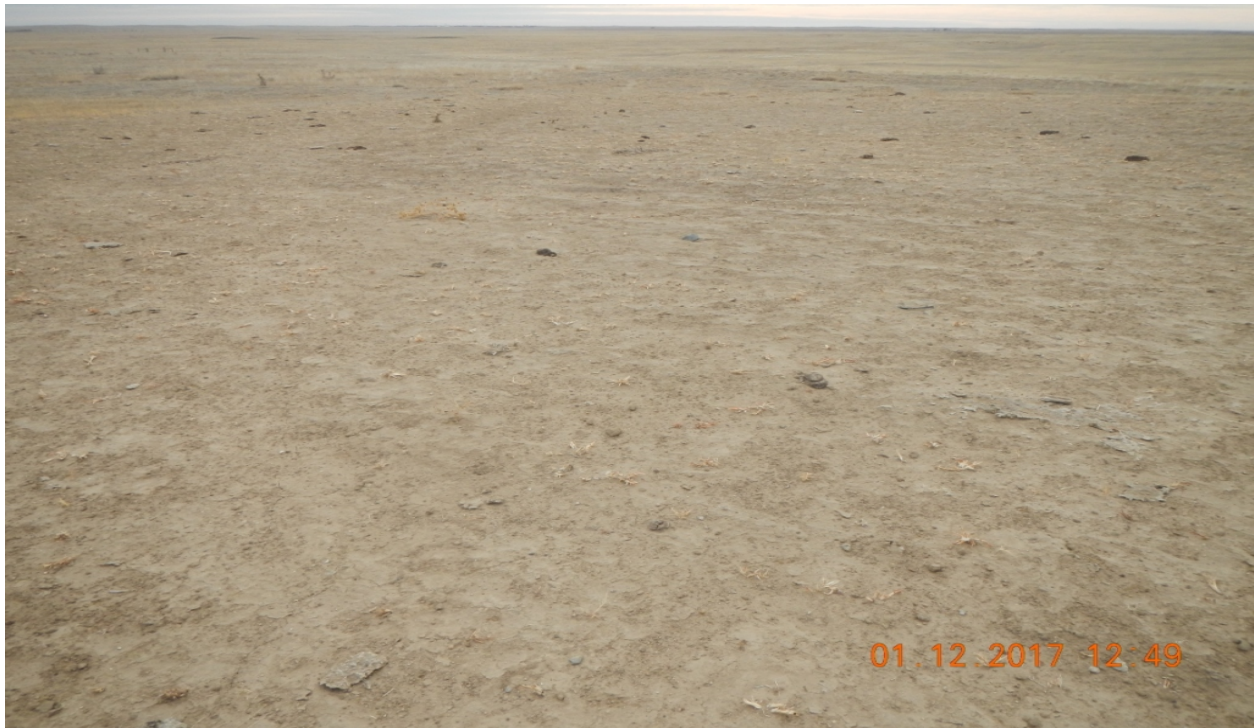
photo 7: Center of the location facing south.

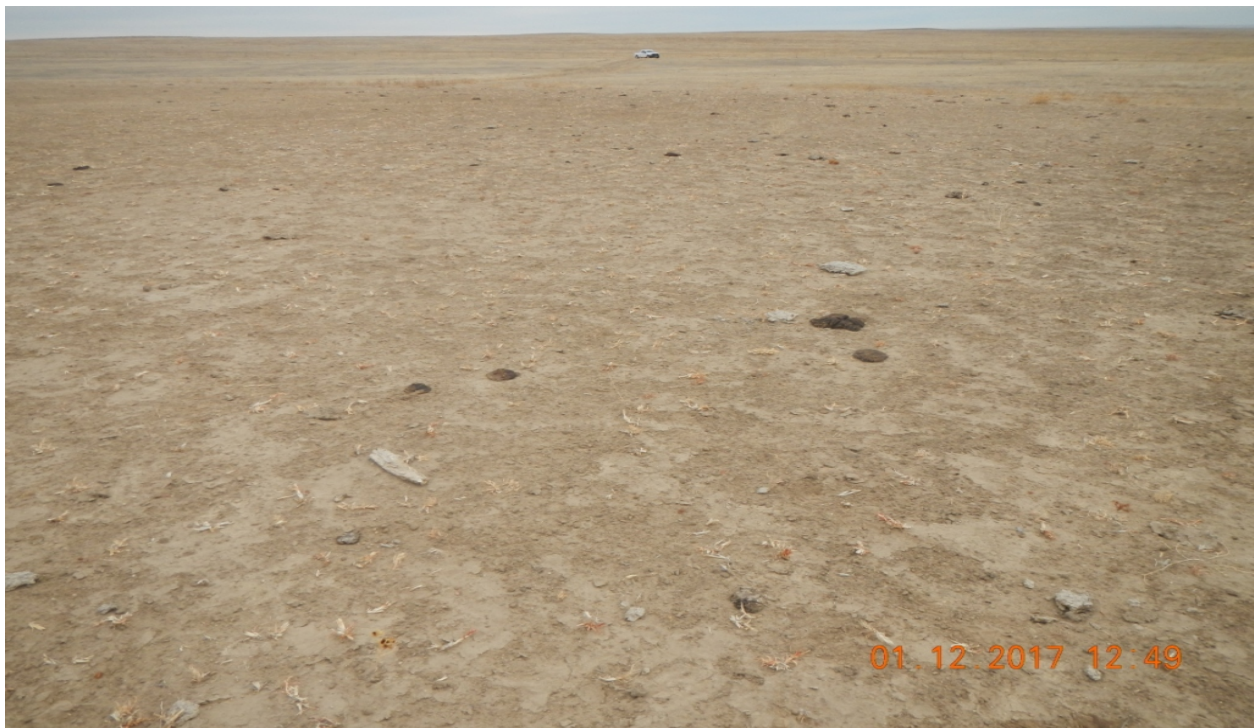
photo 8: Center of the location facing east.

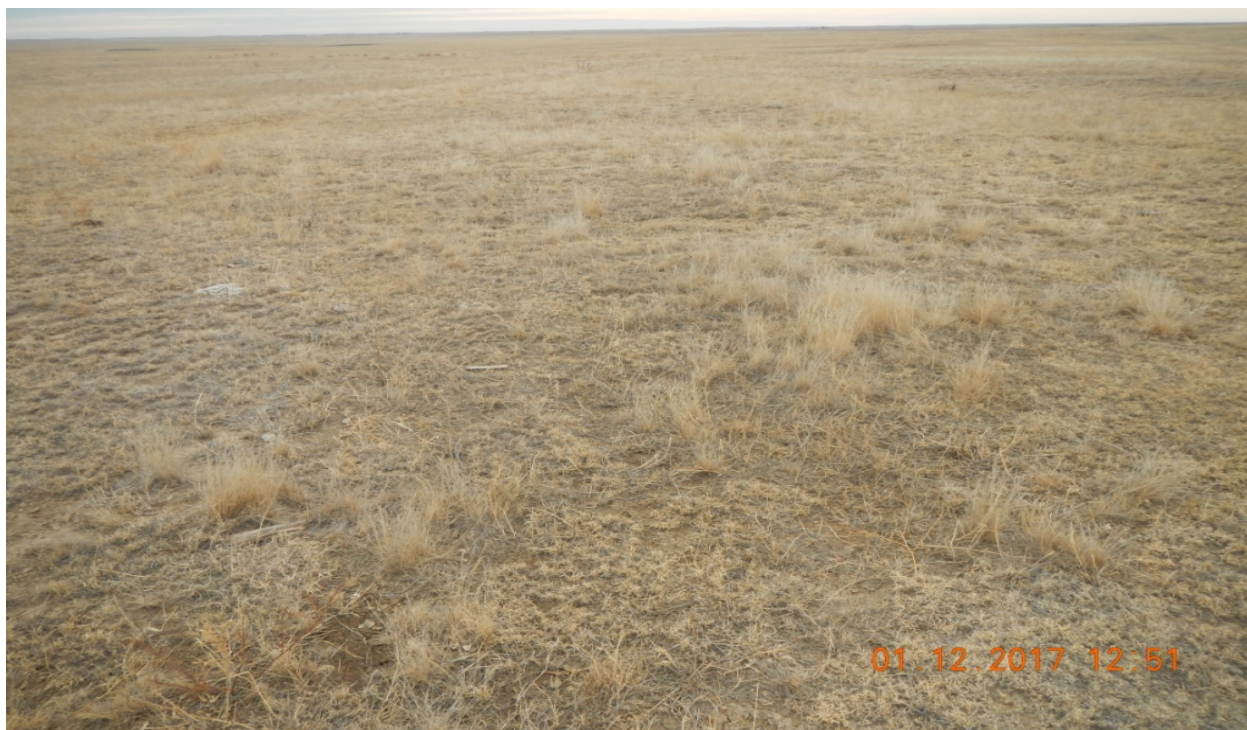
photo 9: Facing south toward the surrounding undisturbed pasture (reference area).
