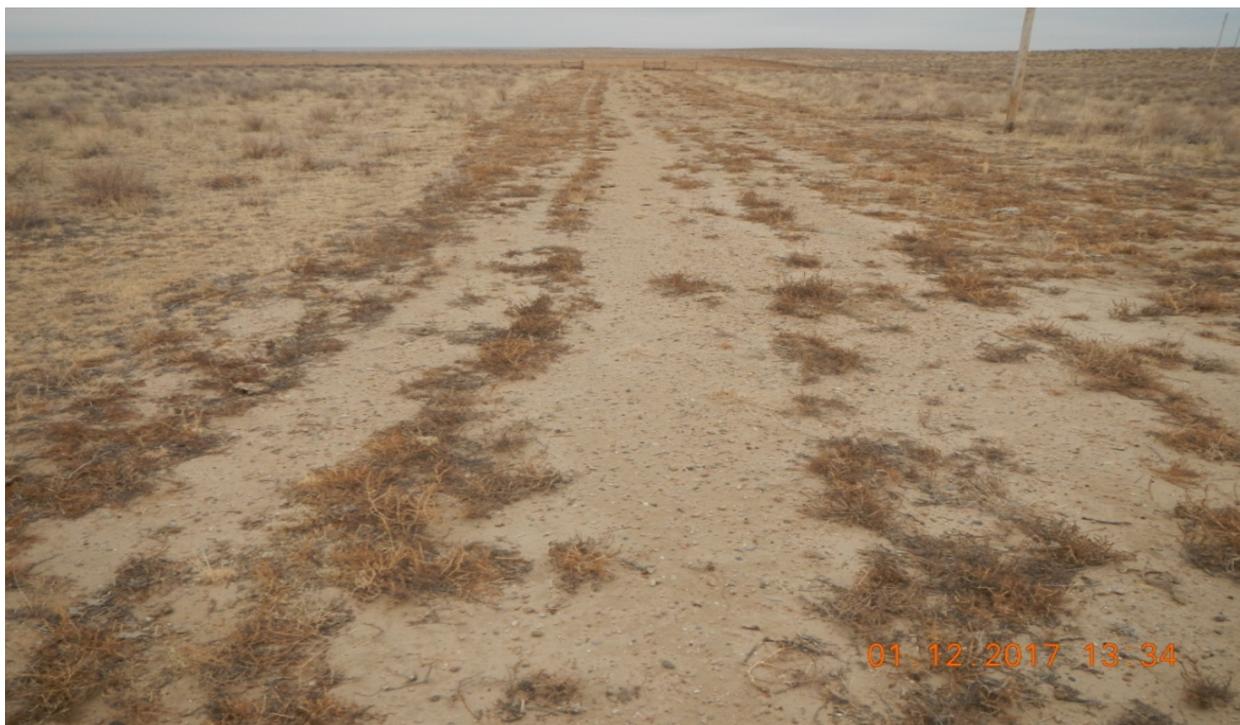
photo 1: Facing northeast along the former access road.

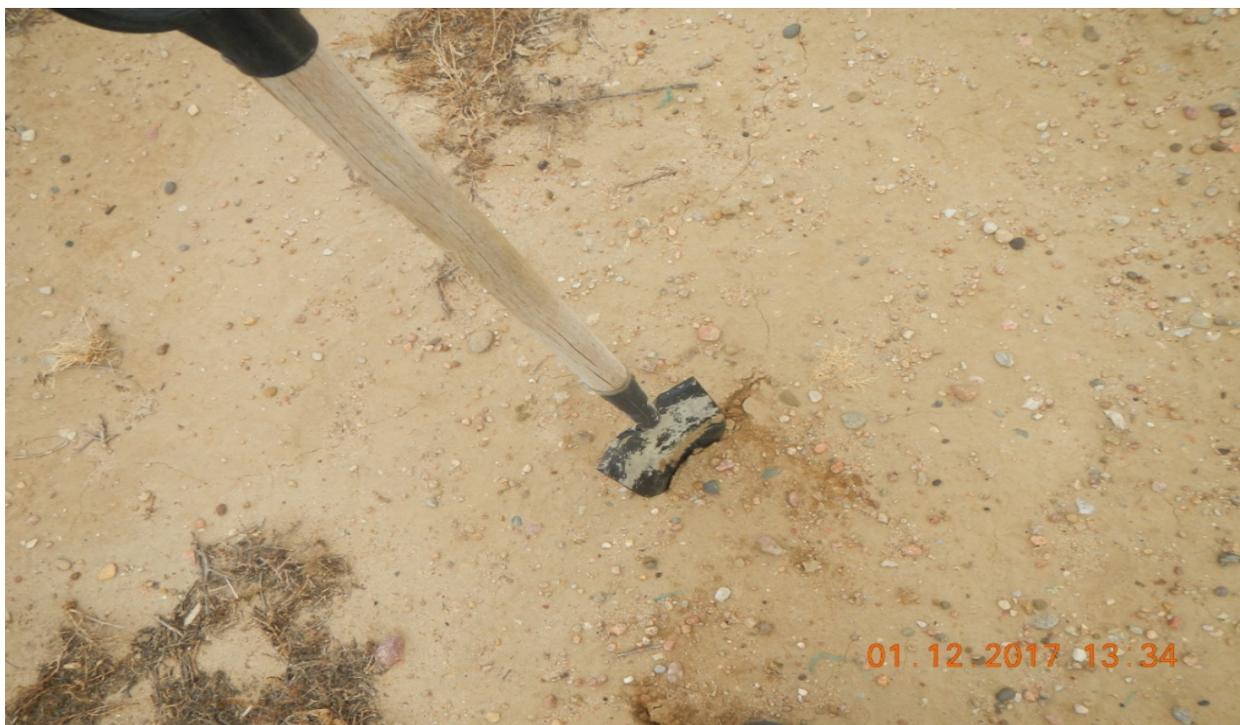
photo 2: The soils along the access road seem to be compacted and vegetation has not established.

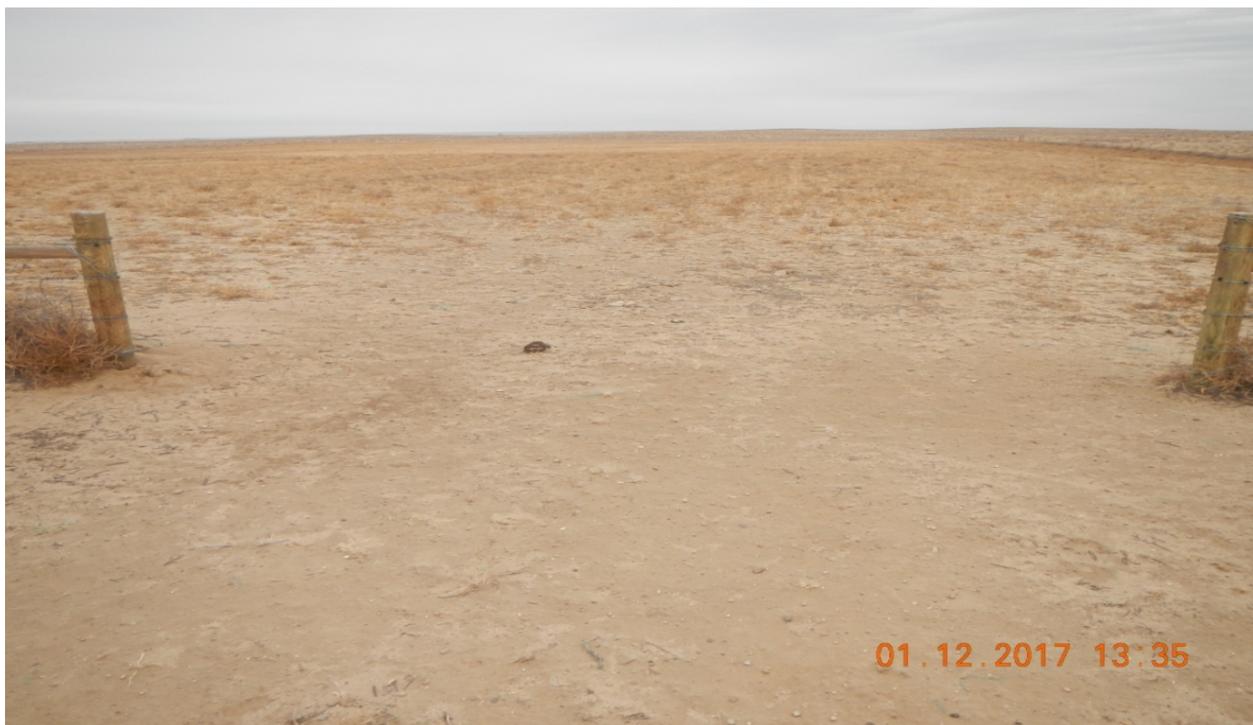
photo 3: Facing northeast toward the location. The gate is down to the fenced location.

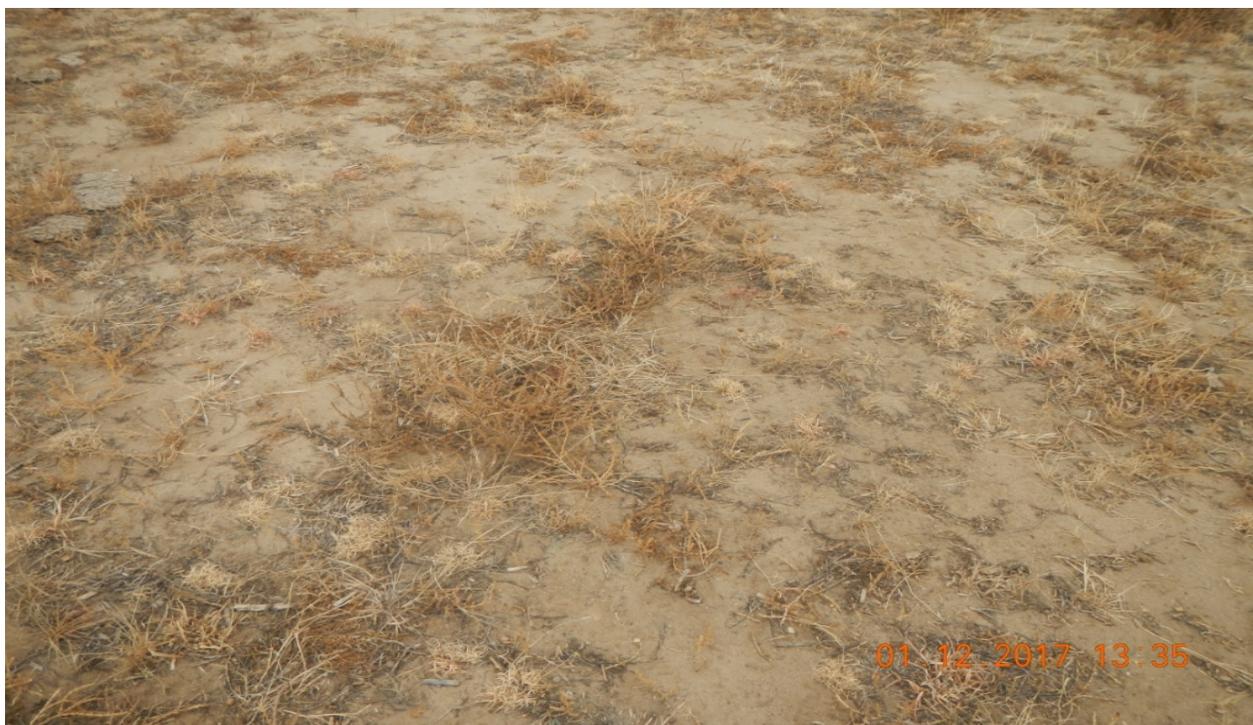
photo 4: The vegetation appears to be establishing in areas of the location.

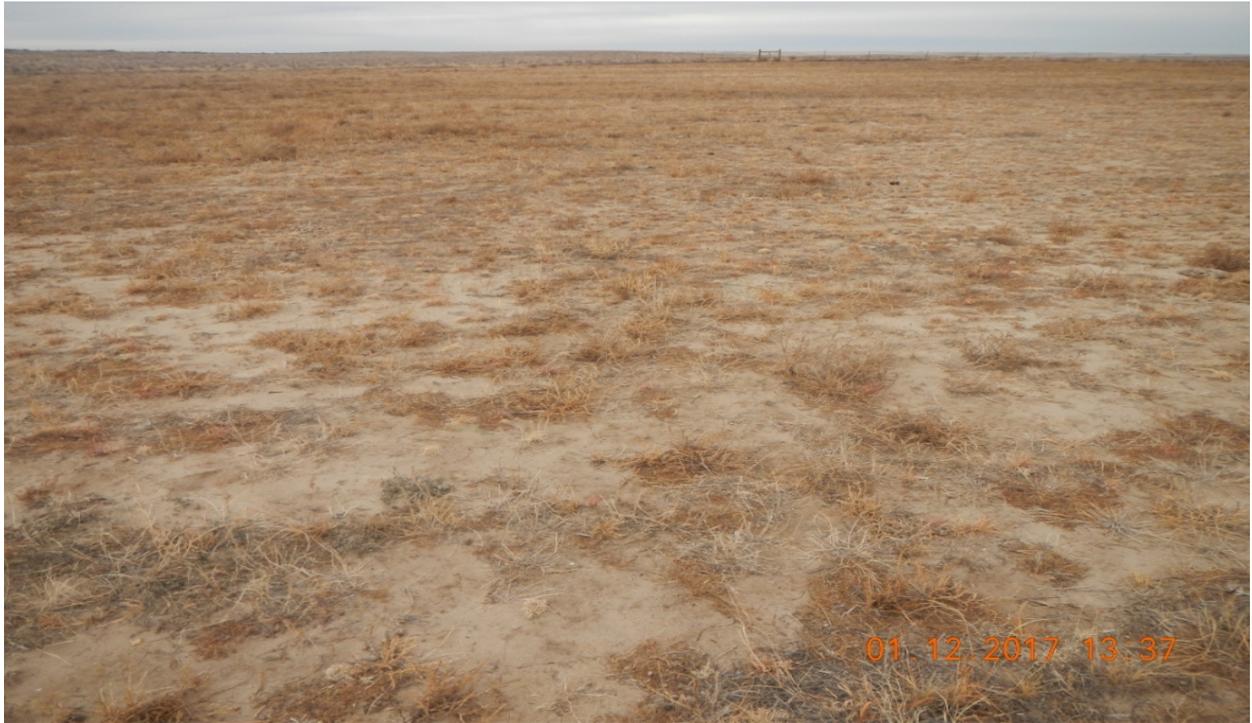
photo 5: Center of the location facing north.

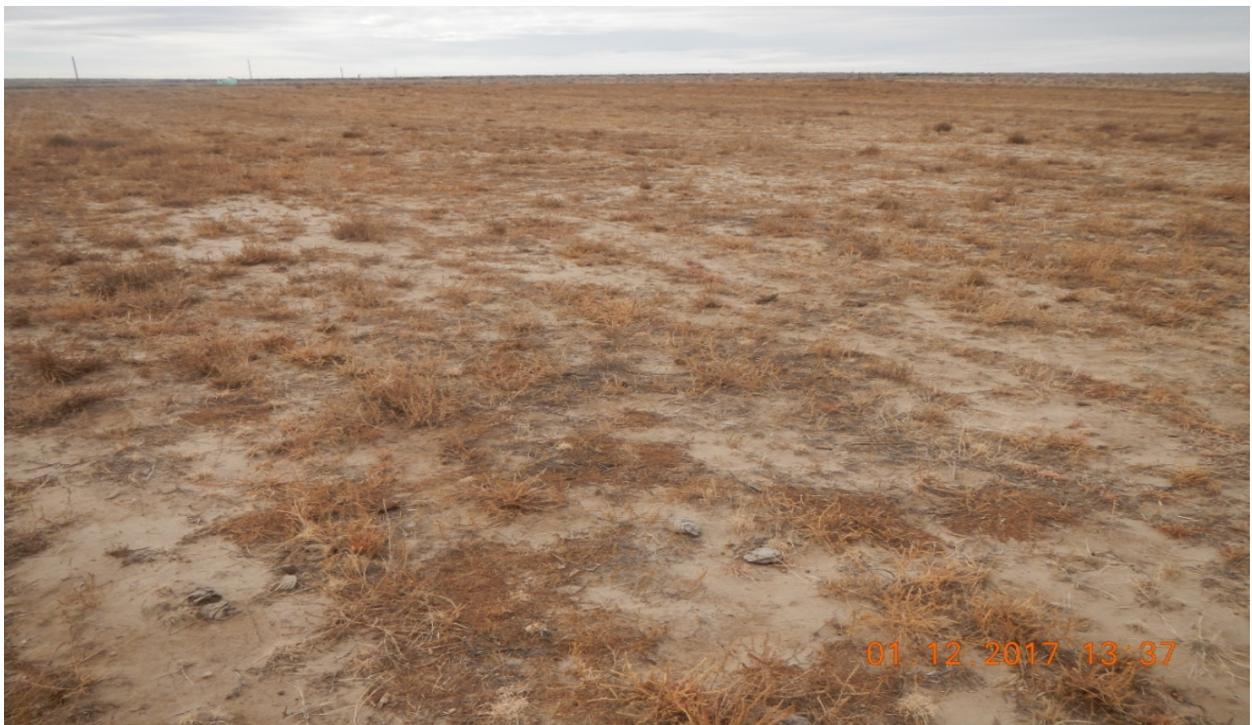
photo 6: Center of the location facing west.

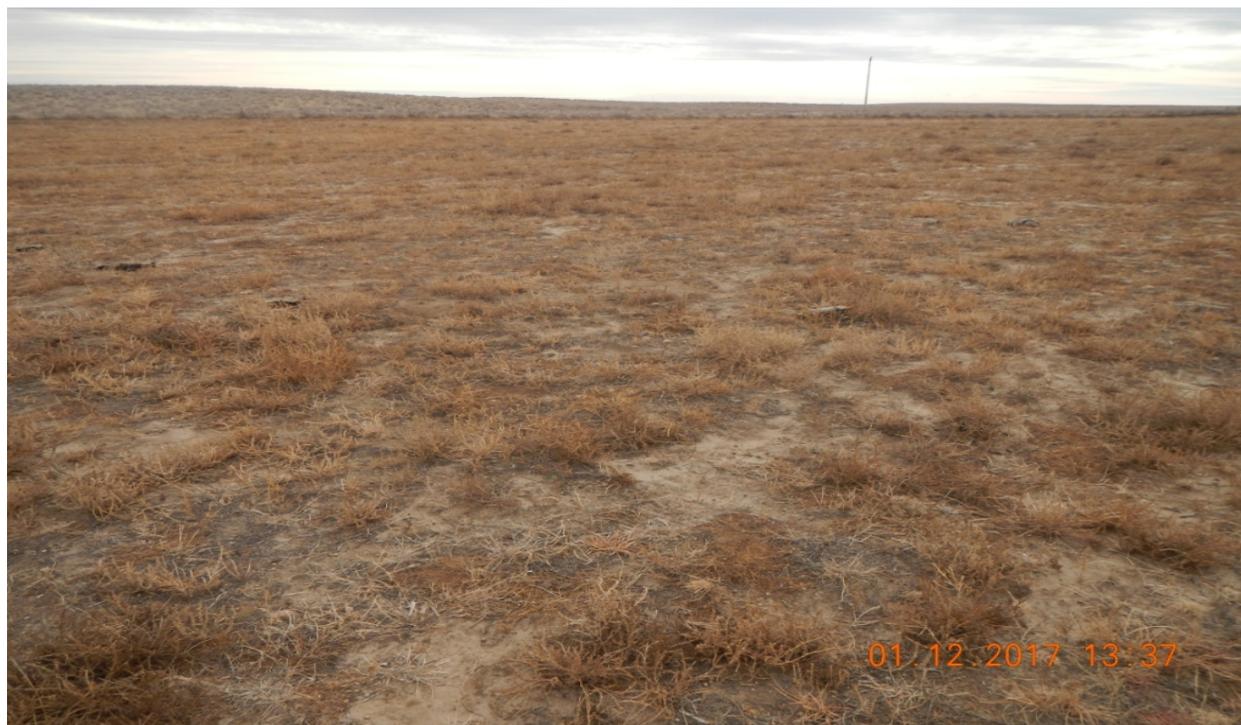
photo 7: Center of the location facing south.

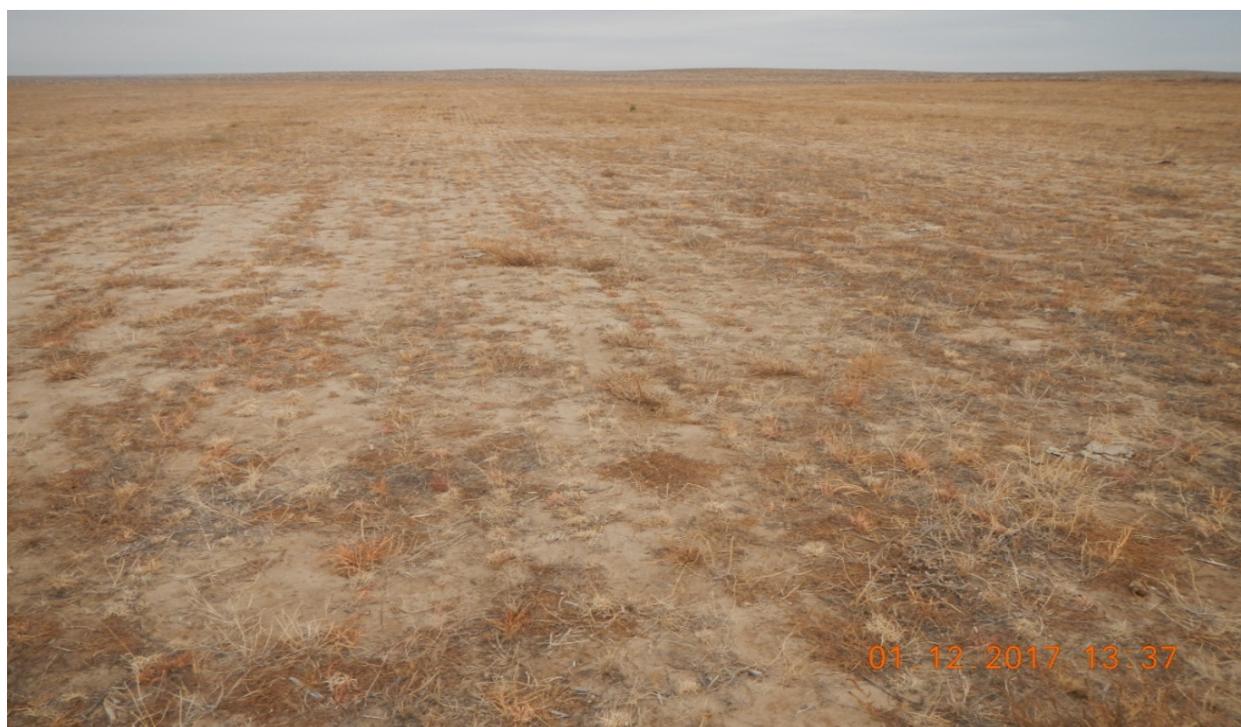
photo 8: Center of the location facing east.
