Construction and Stormwater Inspection- Overview

Kiteley 21-I Pad location drawing overlaid on Google Earth aerial imagery illustrating the approved 11.42 acre disturbance area.

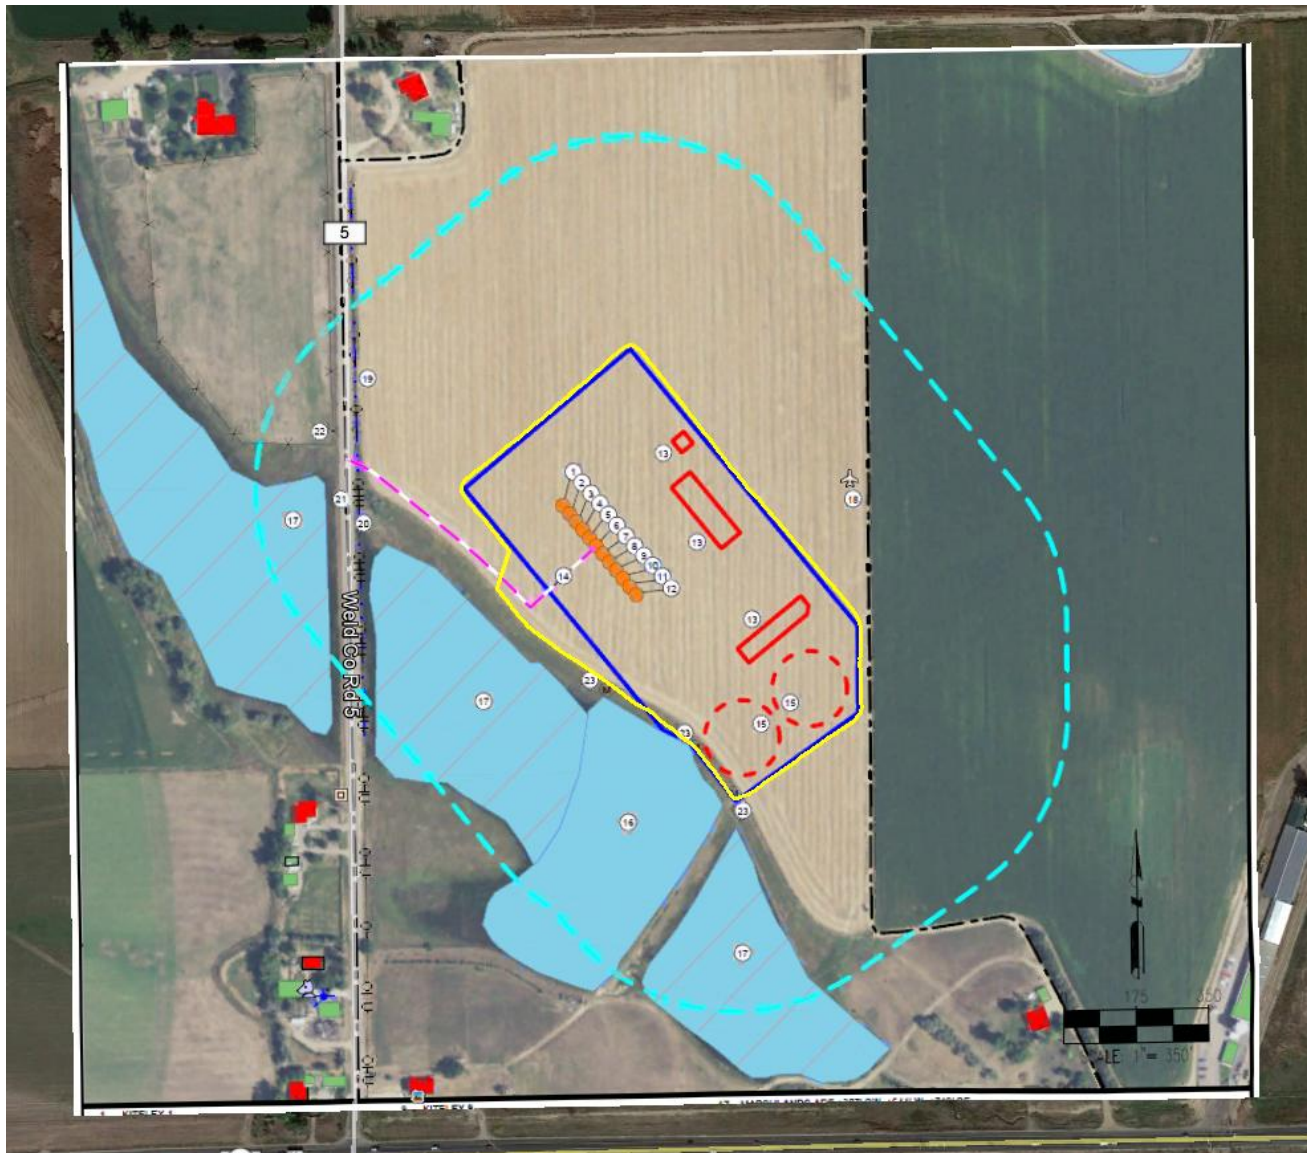
Kiteley 21-I Pad location drawing overlaid on Google Earth aerial imagery. The disturbance area of 12.56 acres was mapped on 1/19/2017 using a Trimble Juno 3B handheld device and highlighted in yellow. Appears the location may have been constructed outside of the permitted area.

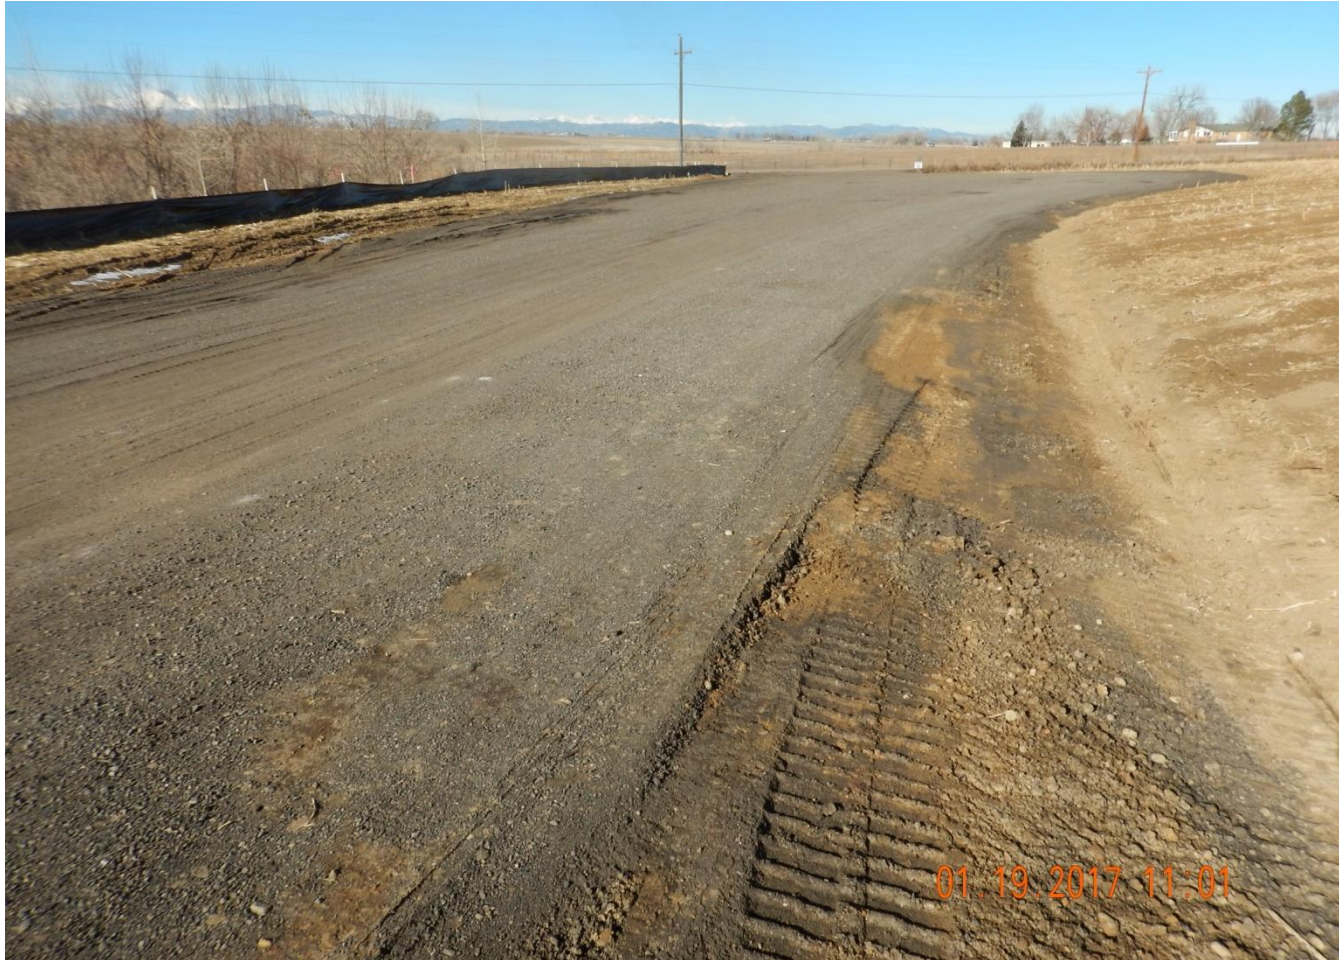
Photo 1. Photo taken from the entrance of location, facing Northwest. Vehicle tracking pad BMP installed. Did not observe any vehicle tracking onto the public road. Silt fence BMP installed at the entrance of location which extends to the southwest corner of location. A ditch- shallow along portions of the western location- and berm, and check dams installed around the perimeter of the location.

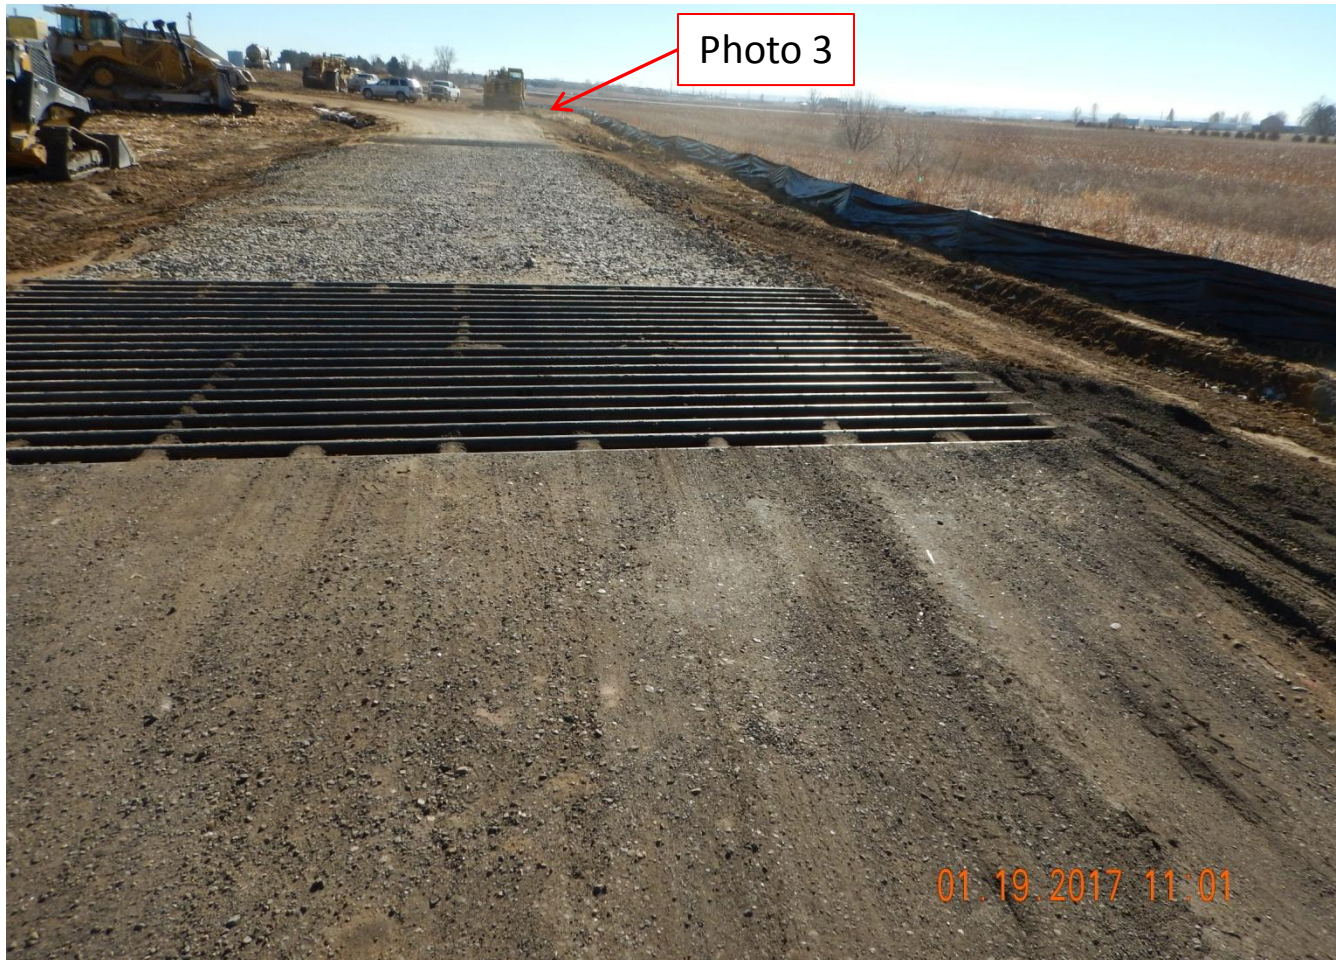
Photo 2. Photo taken from the entrance of location, facing Southwest. Vehicle tracking pad and device BMPs installed.

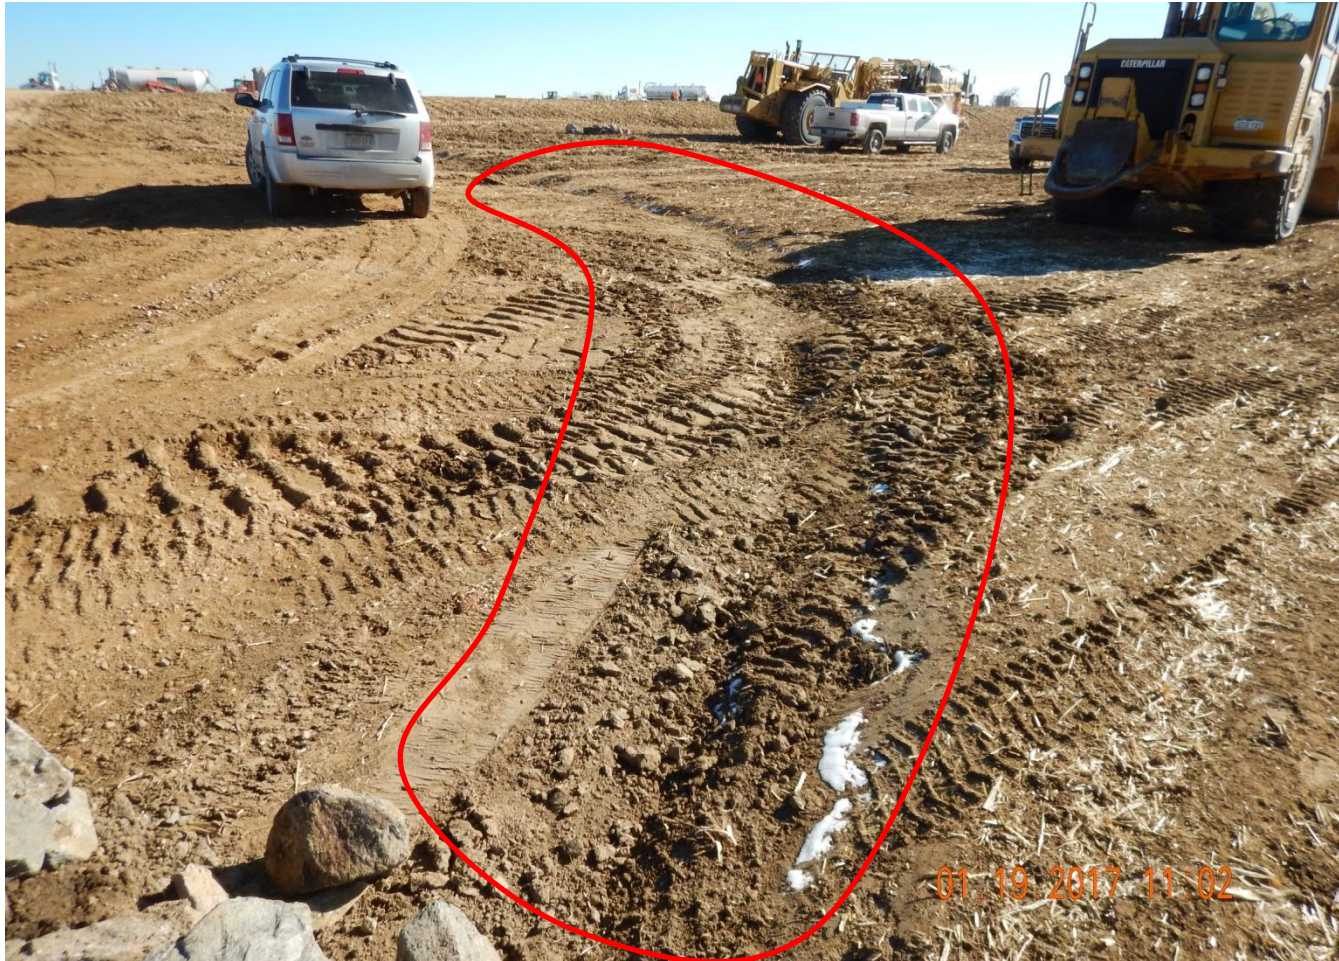
Photo 3. Photo taken from the western location, facing East. Equipment traffic should be kept off BMPs to ensure BMP properly functions. Need to maintain BMPs at all times.

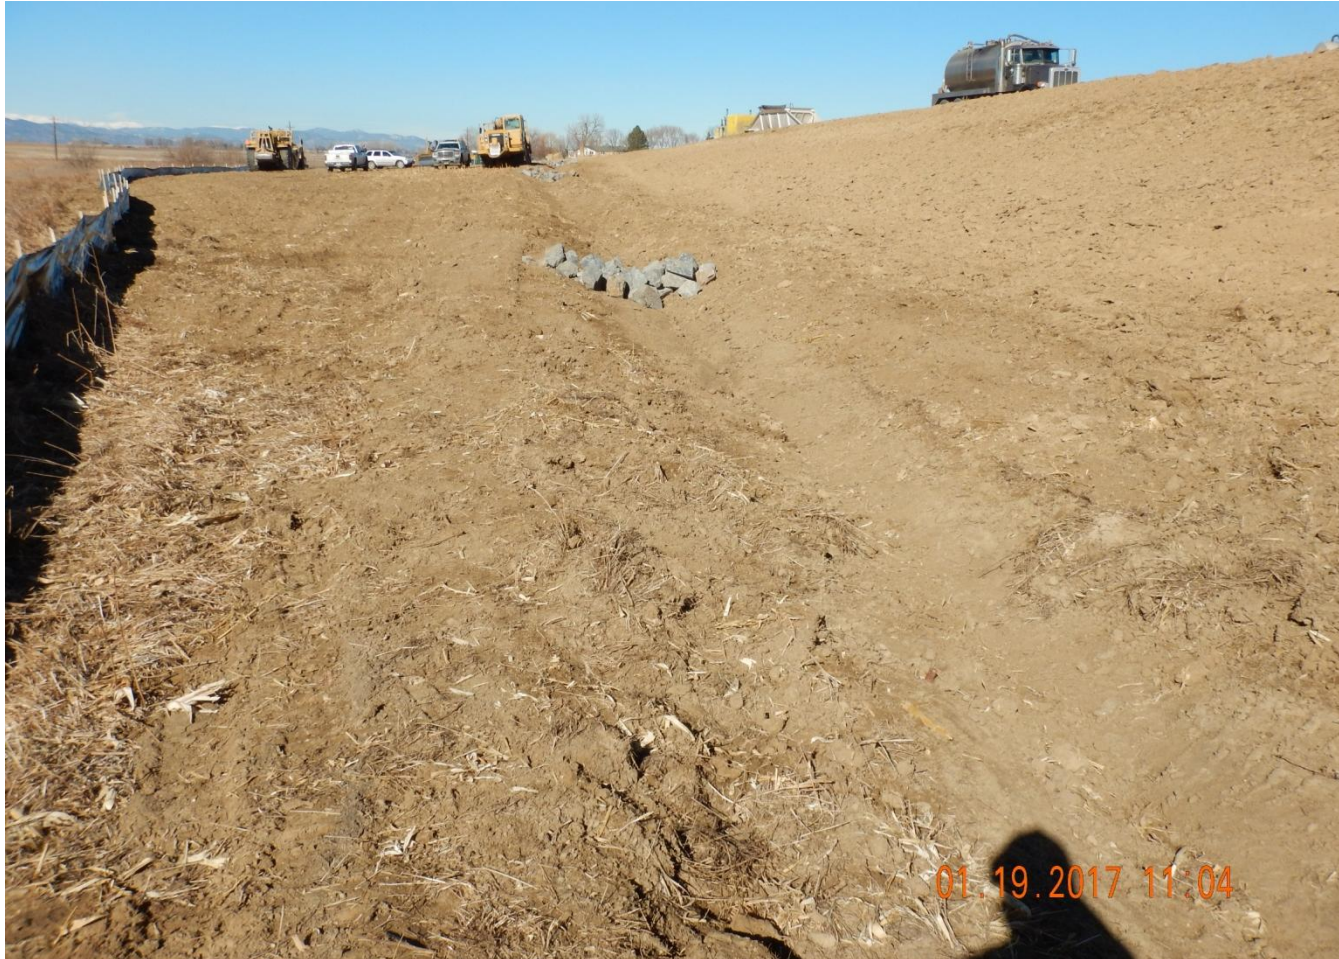
Photo 4. Photo taken from the western location, facing North. Silt fence, ditch and check dam BMPs installed. Fill slope appears to compacted and stabilized.

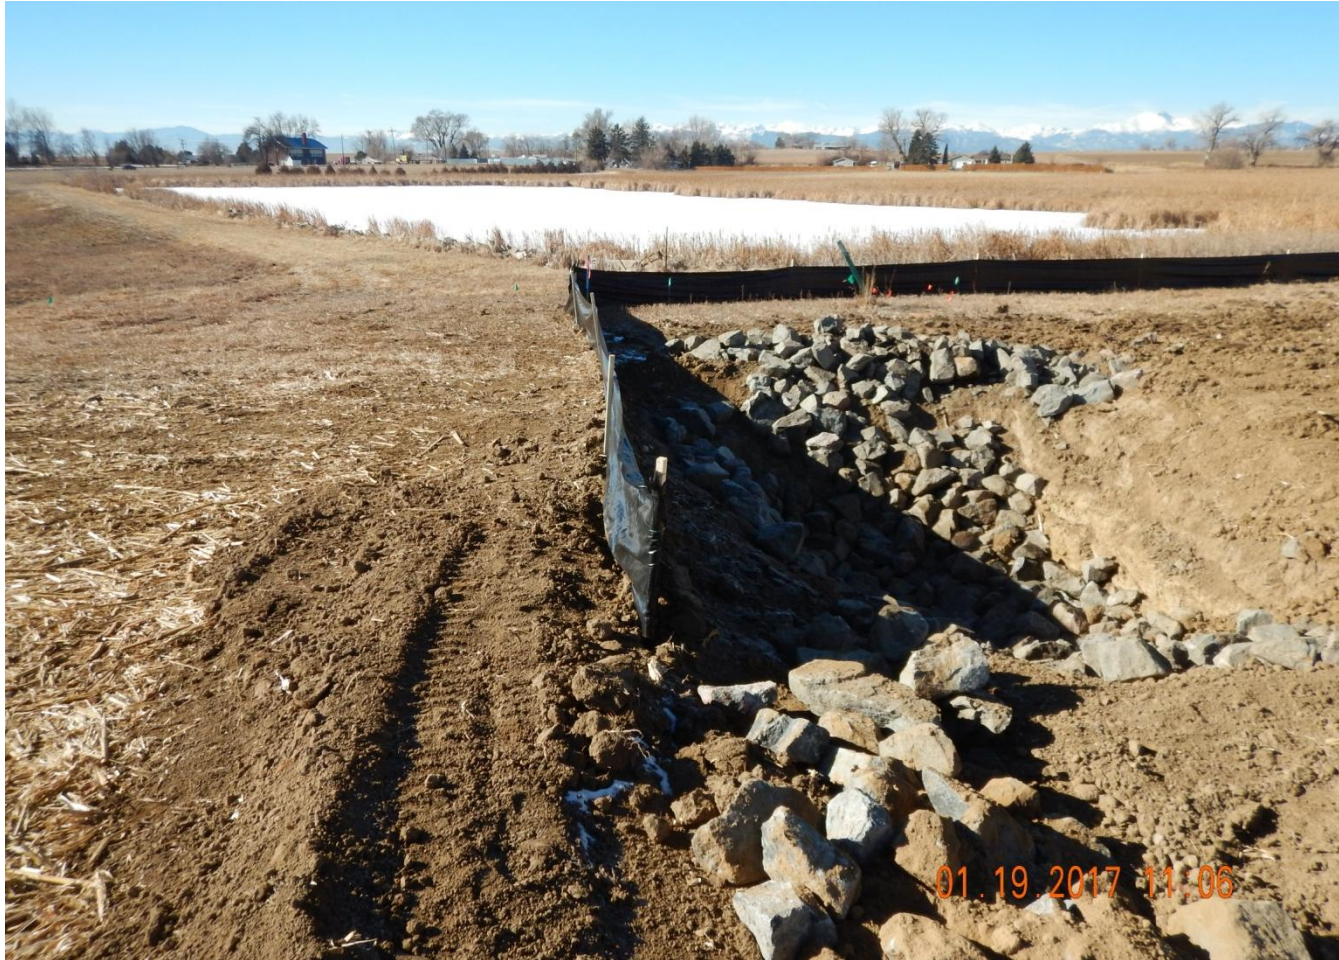
Photo 5. Photo taken from the southwest location, facing West. Sediment trap lined and stabilized in conjunction with silt fence.

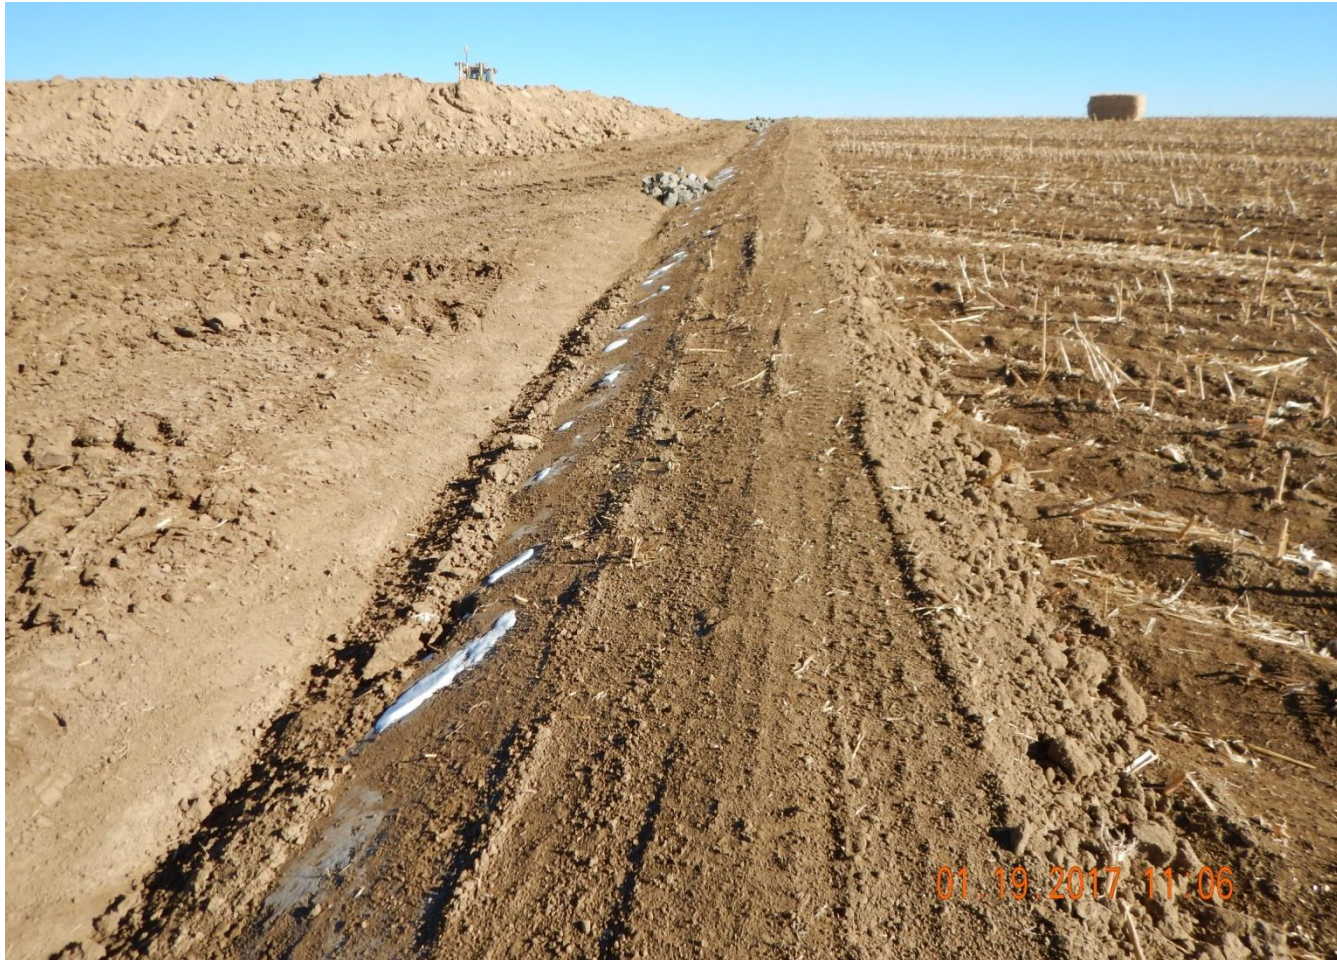
Photo 6. Photo taken from the southwest location, facing Northeast. Ditch and berm BMP installed in conjunction with check dams. Location IN-PROCESS of being stabilized. Fill slope still needs to be stabilized.

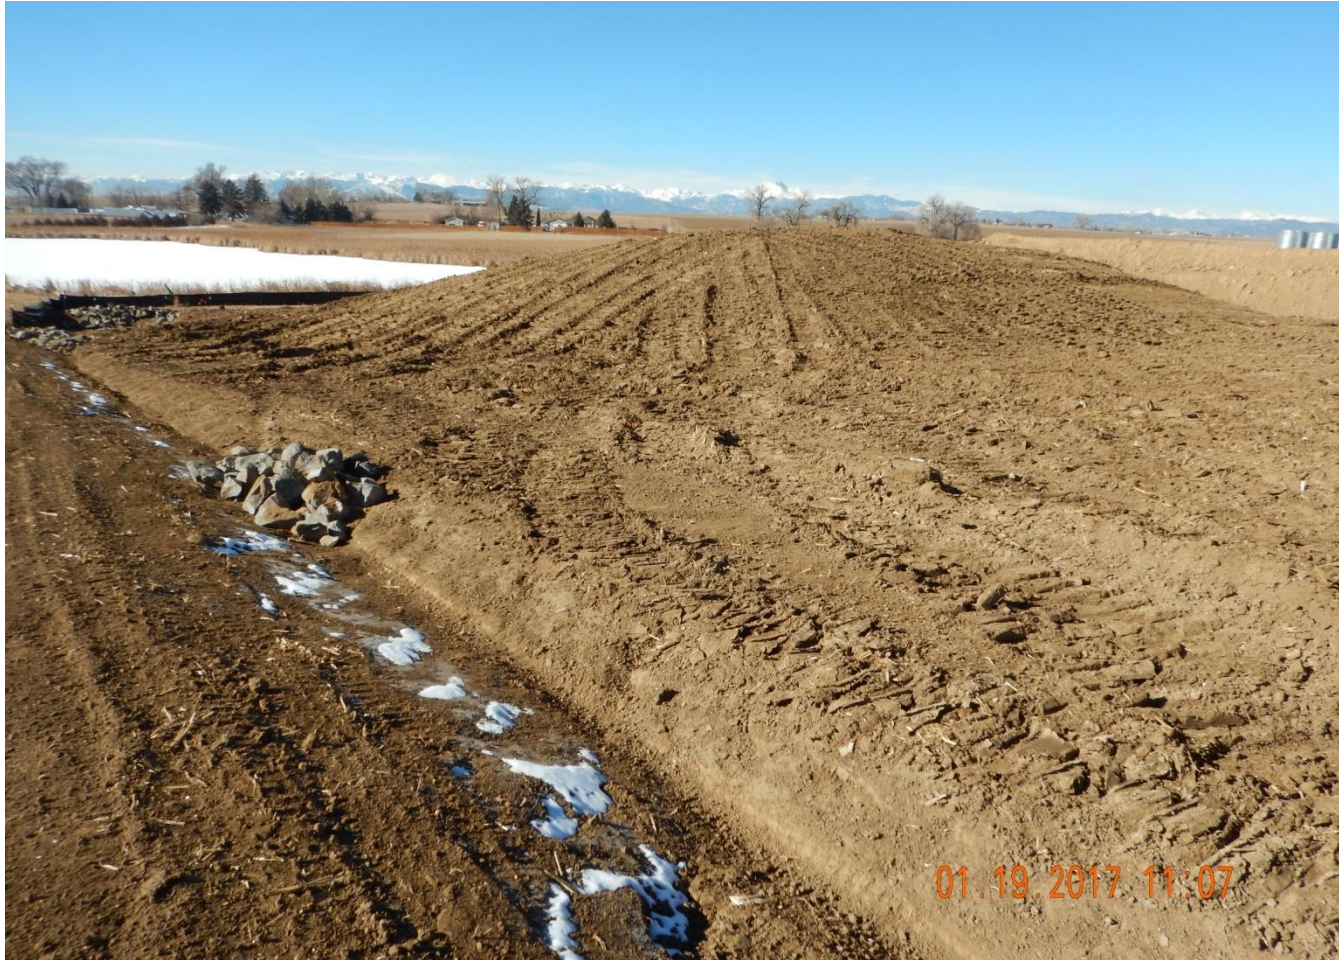
Photo 7. Photo taken from the southwest location, facing West. Topsoil stockpile stored along southwest location and temporarily stabilized (i.e., tracked).

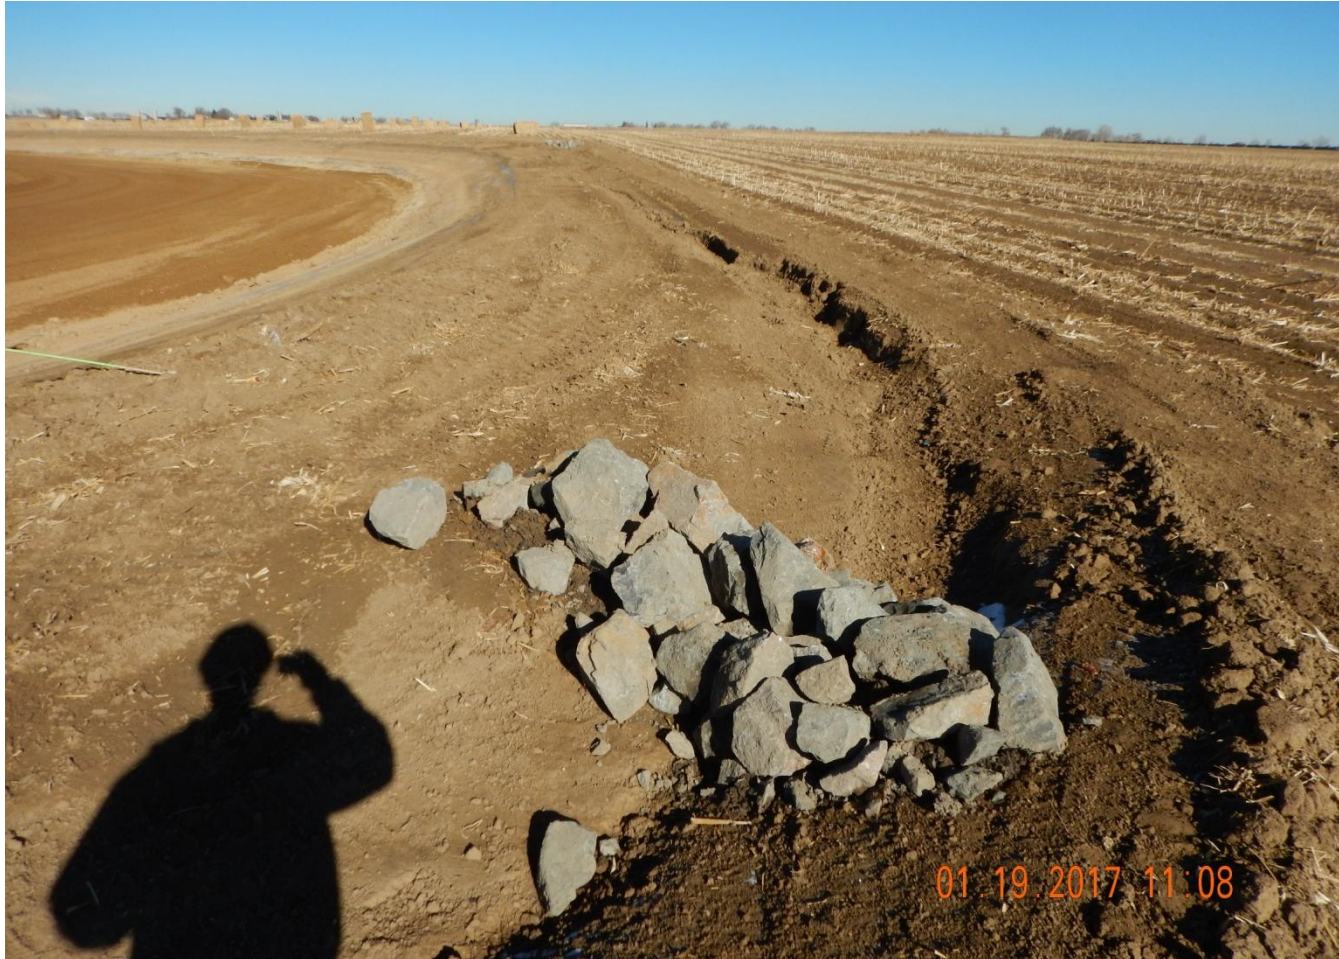
Photo 8. Photo taken from the southeast location, facing North. Ditch and berm BMP installed in conjunction with check dams. Cut slope along the southeast, east and northeast location appear to be stabilized.

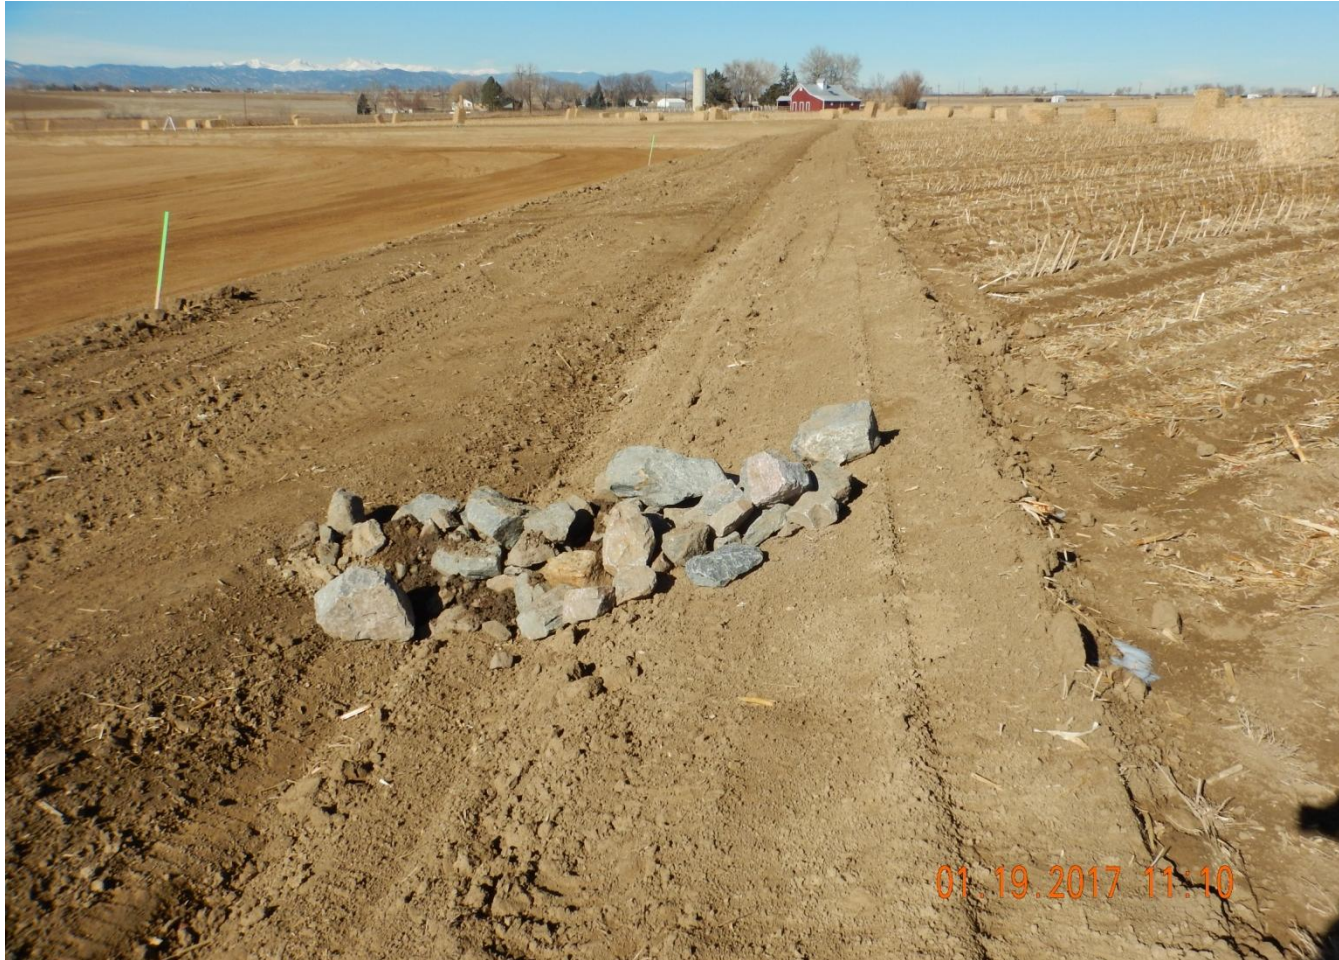
Photo 9. Photo taken from the eastern location, facing Northwest. Ditch and berm BMP installed in conjunction with check dams.

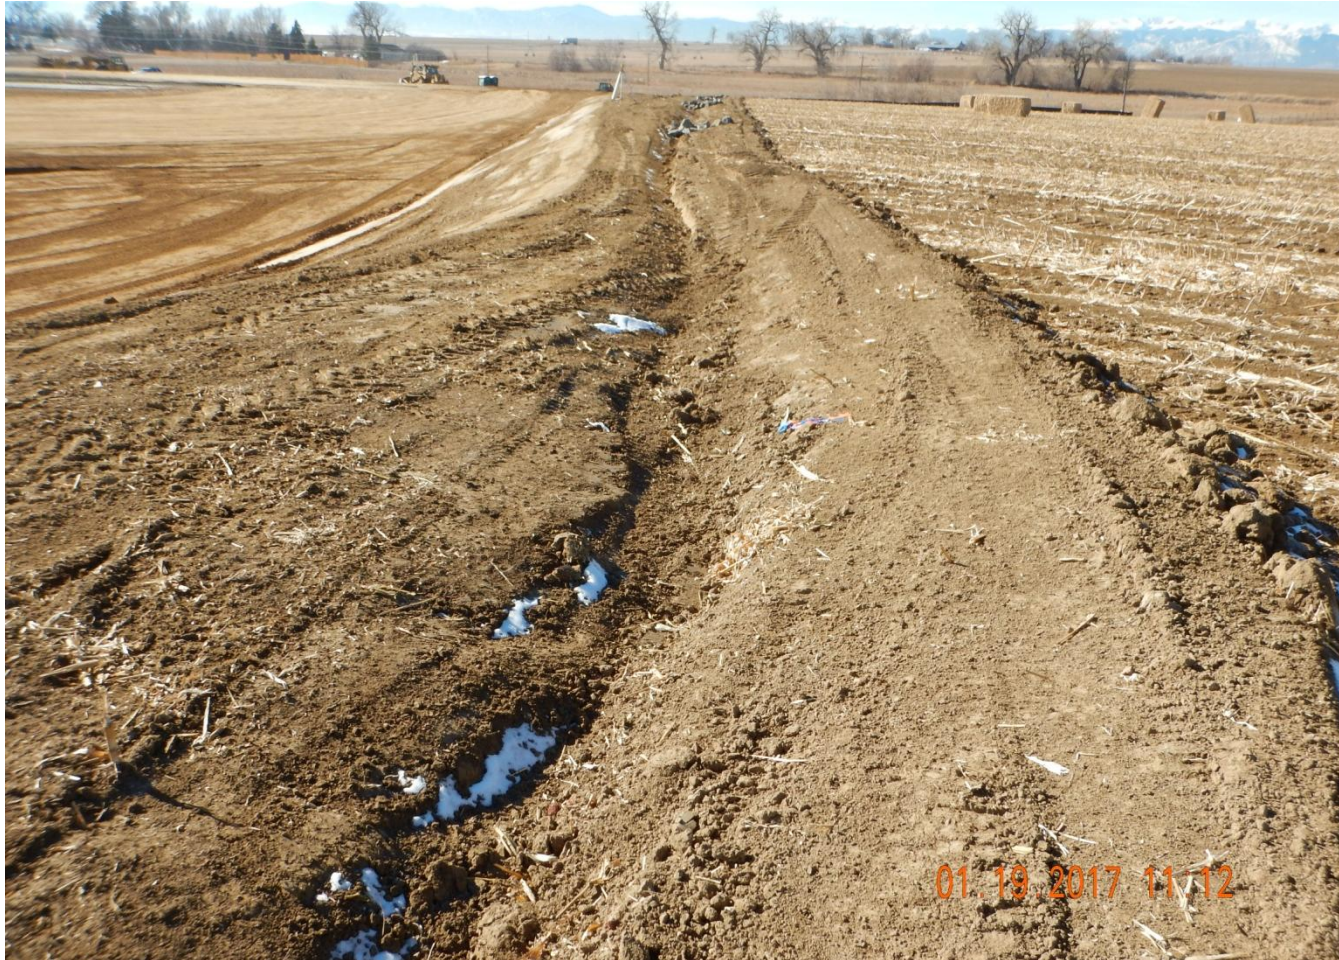
Photo 10. Photo taken from the northeast location, facing Southwest. Ditch and berm BMP installed in conjunction with check dams.

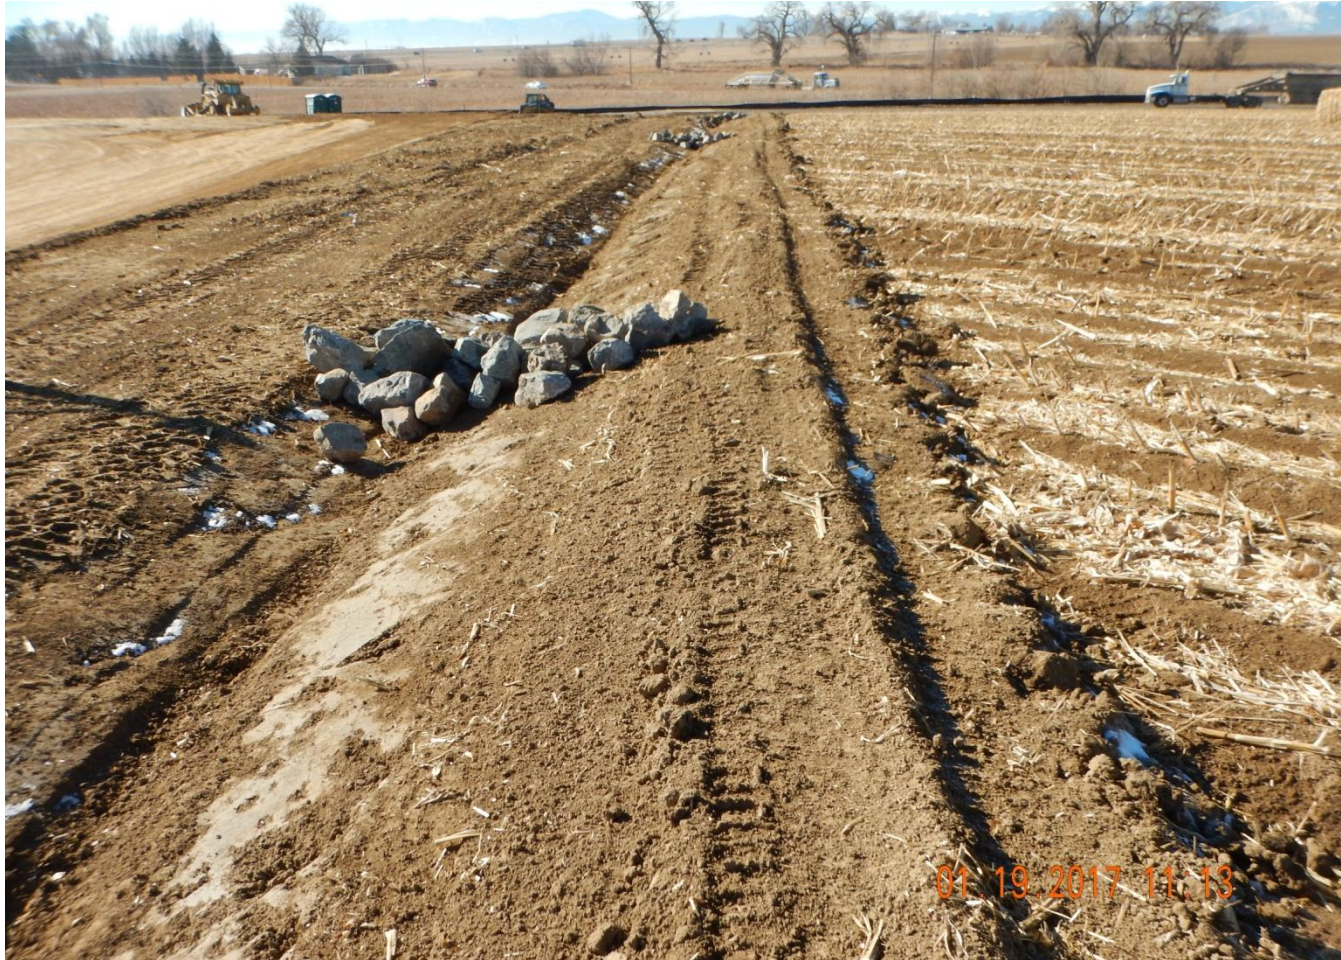
Photo 11. Photo taken from the northern location, facing Southwest. Ditch and berm BMP installed in conjunction with check dams.

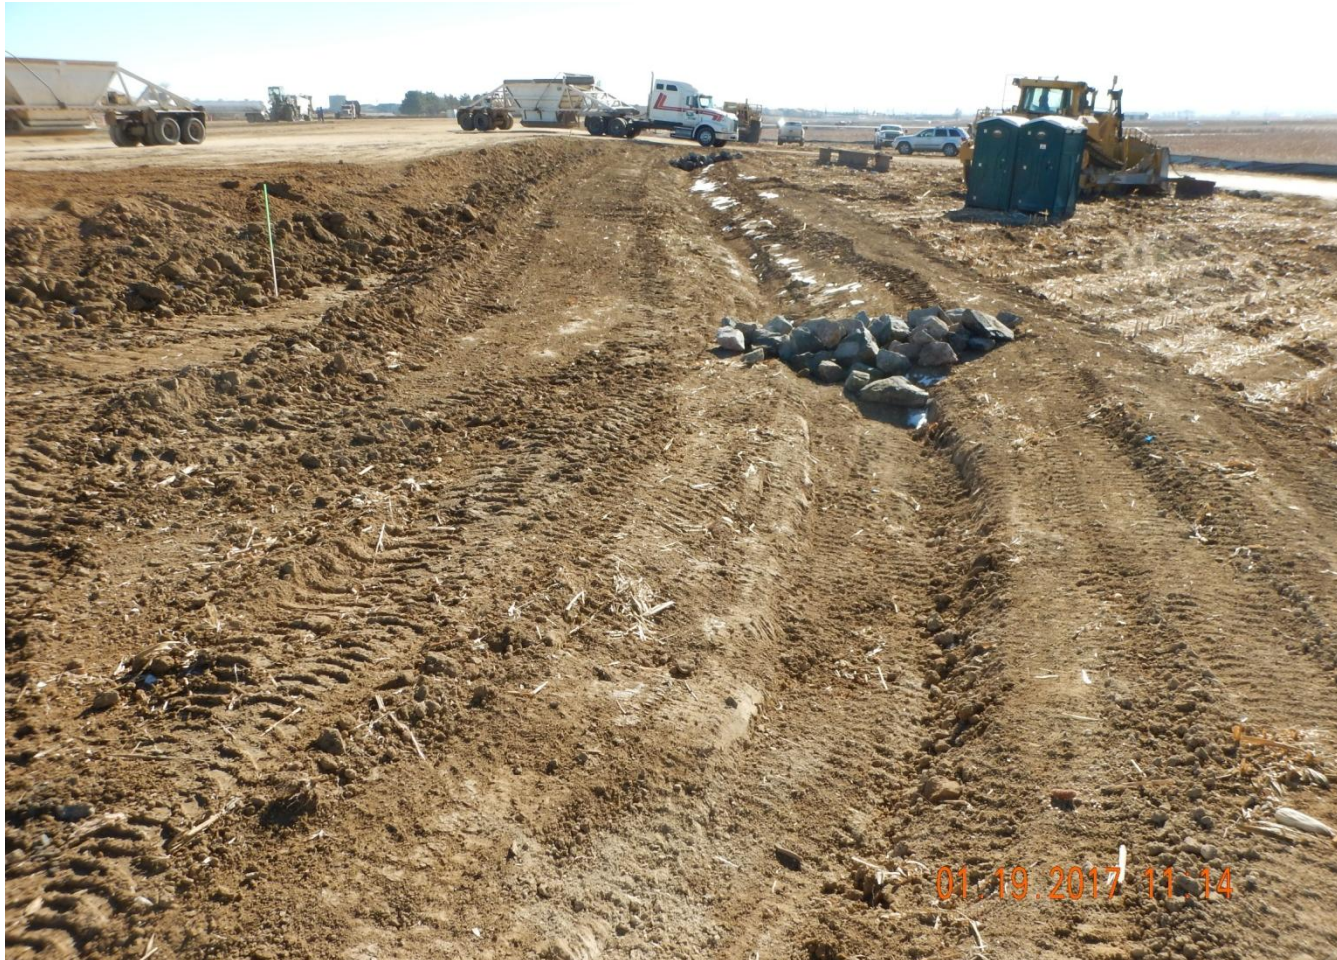
Photo 12. Photo taken from the northwest location, facing South. Ditch and berm BMP installed in conjunction with check dams.

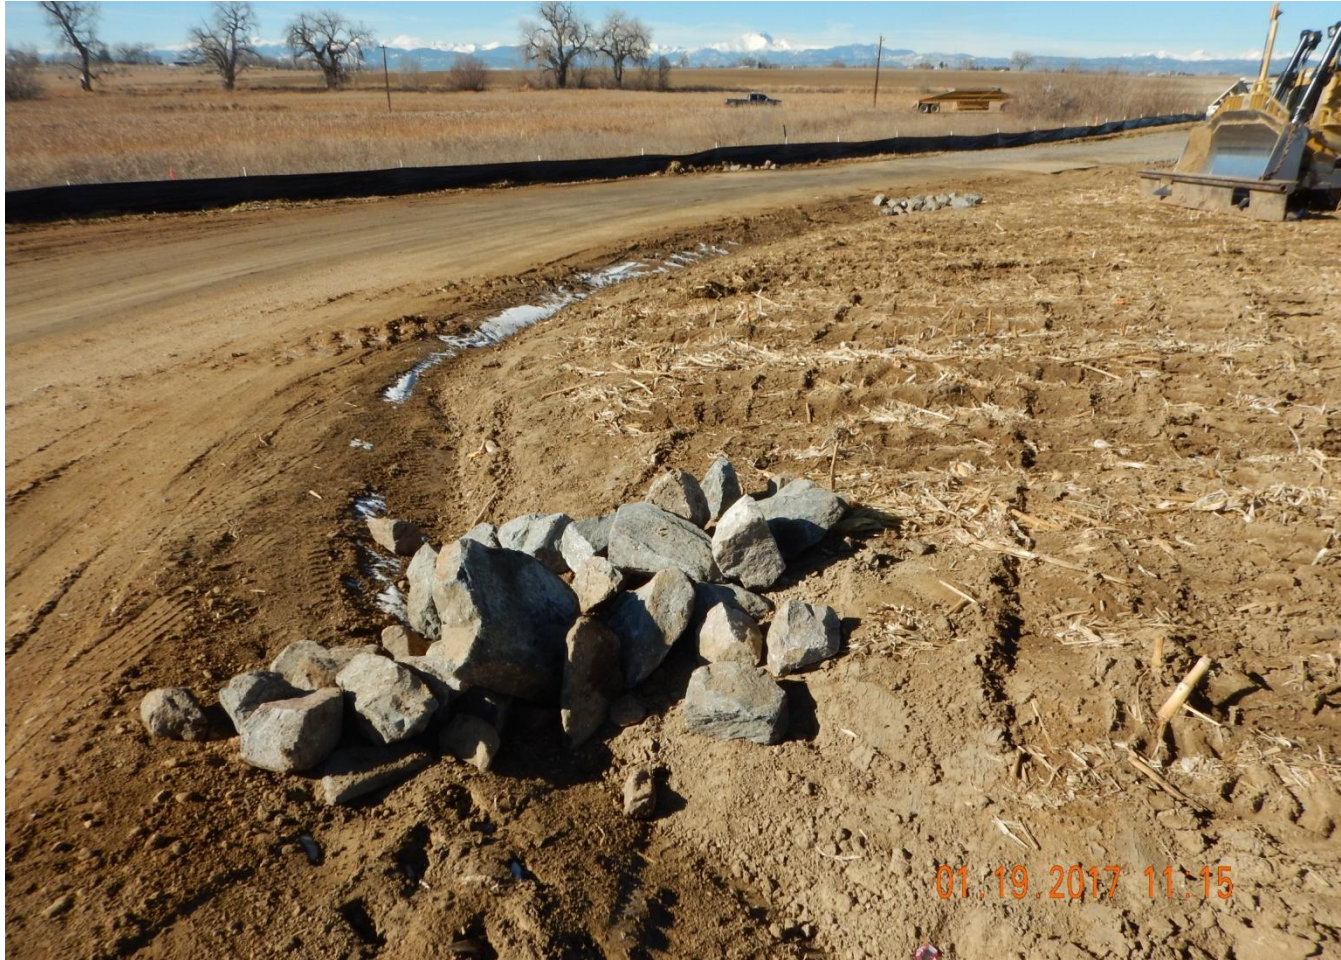
Photo 13. Photo taken from the western location, facing West. Ditch and berm BMP installed in conjunction with check dams.
