Interim Reclamation and Stormwater Inspection

01/26/2017

Operator: Bonanza Creek

Location ID: 427275

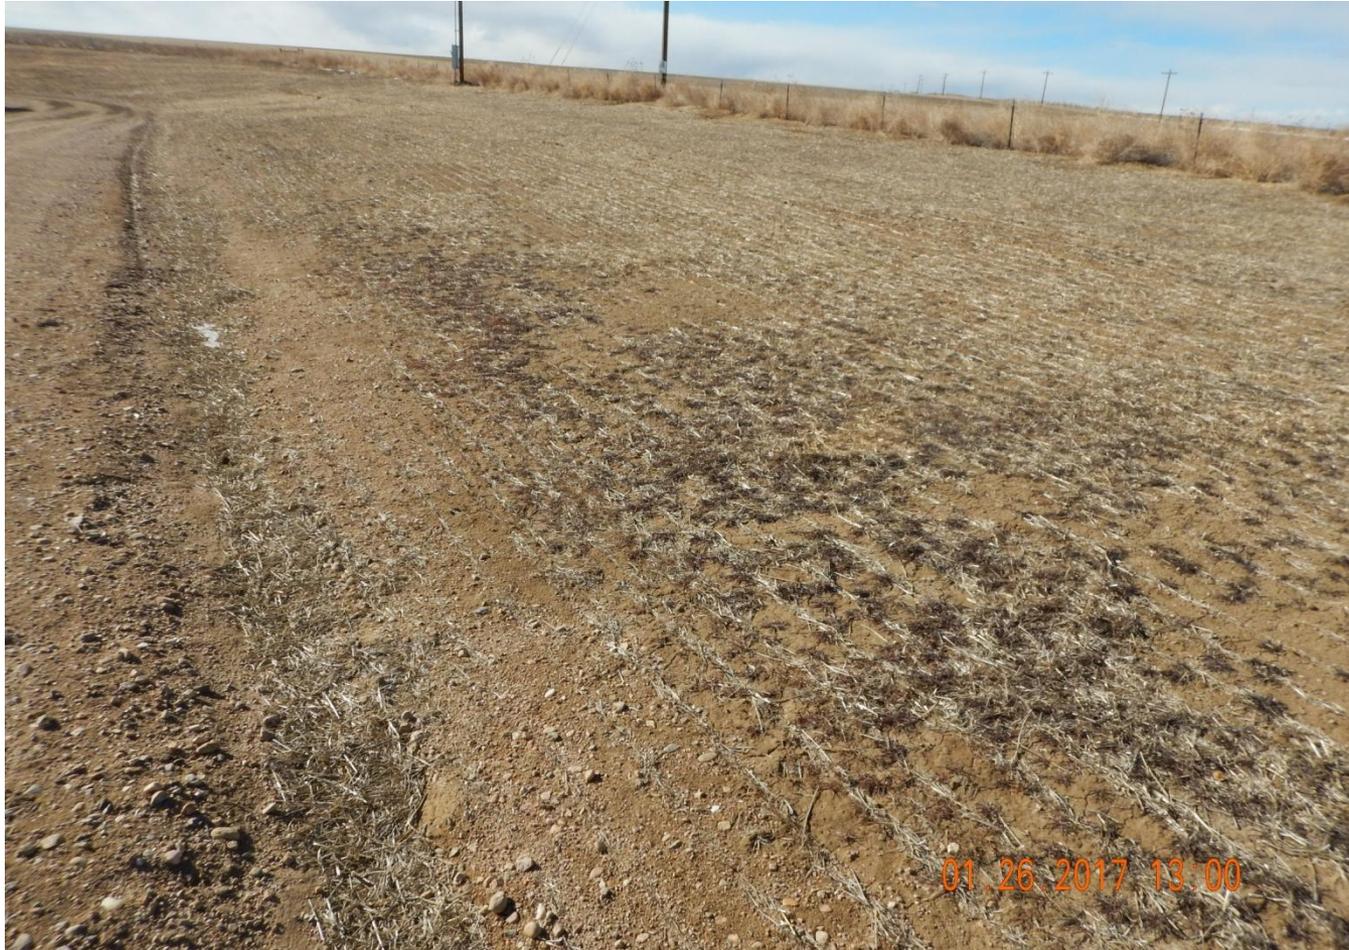
Photo 1. Photo taken from the northern interim area, facing West. Germination apparent throughout most of the interim area.

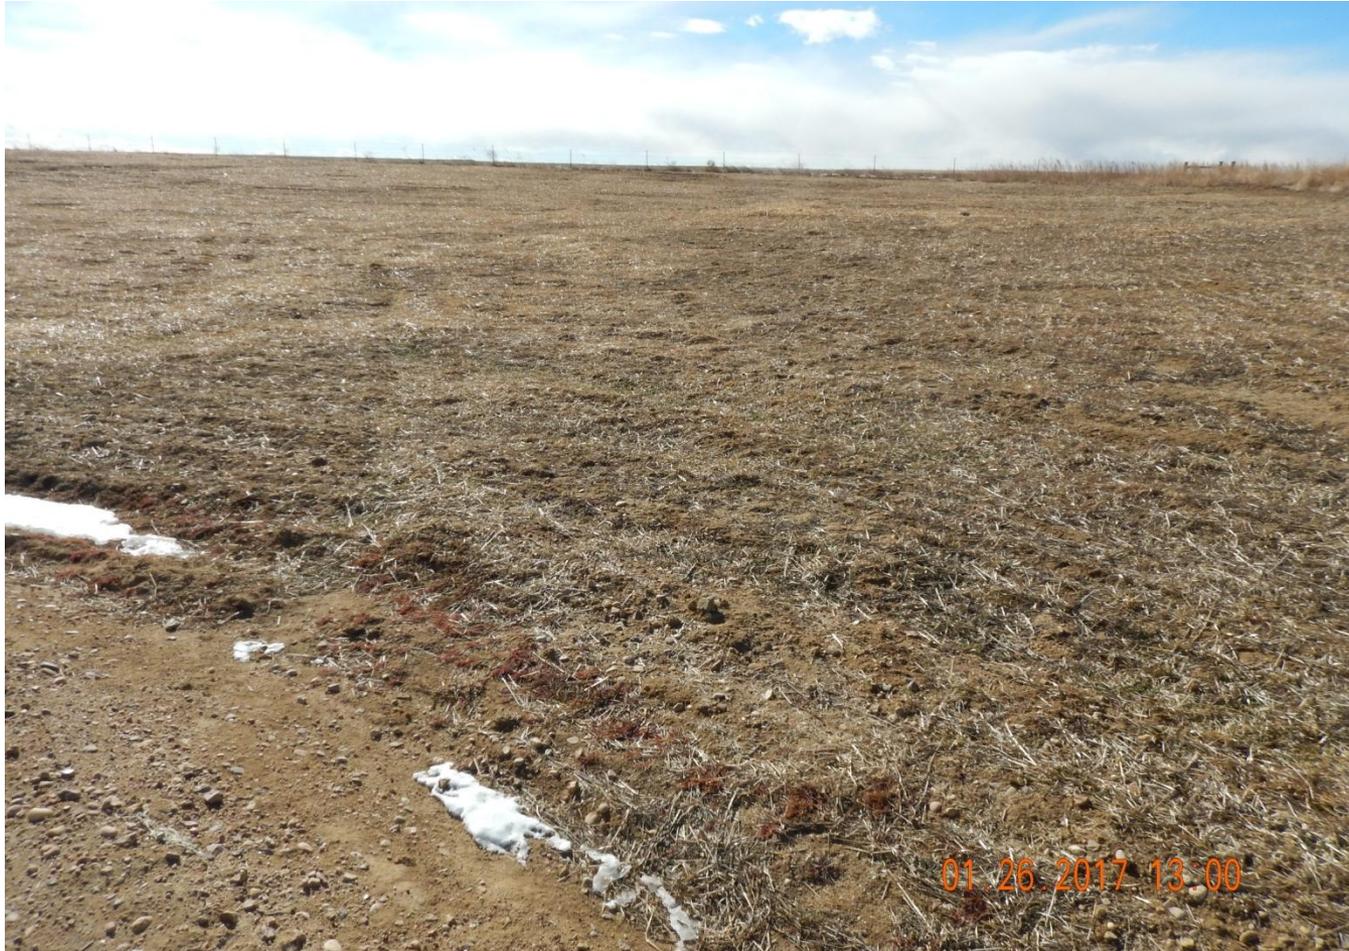
Photo 2. Photo taken from the northwest production area, facing West. Germination apparent throughout most of the interim area.

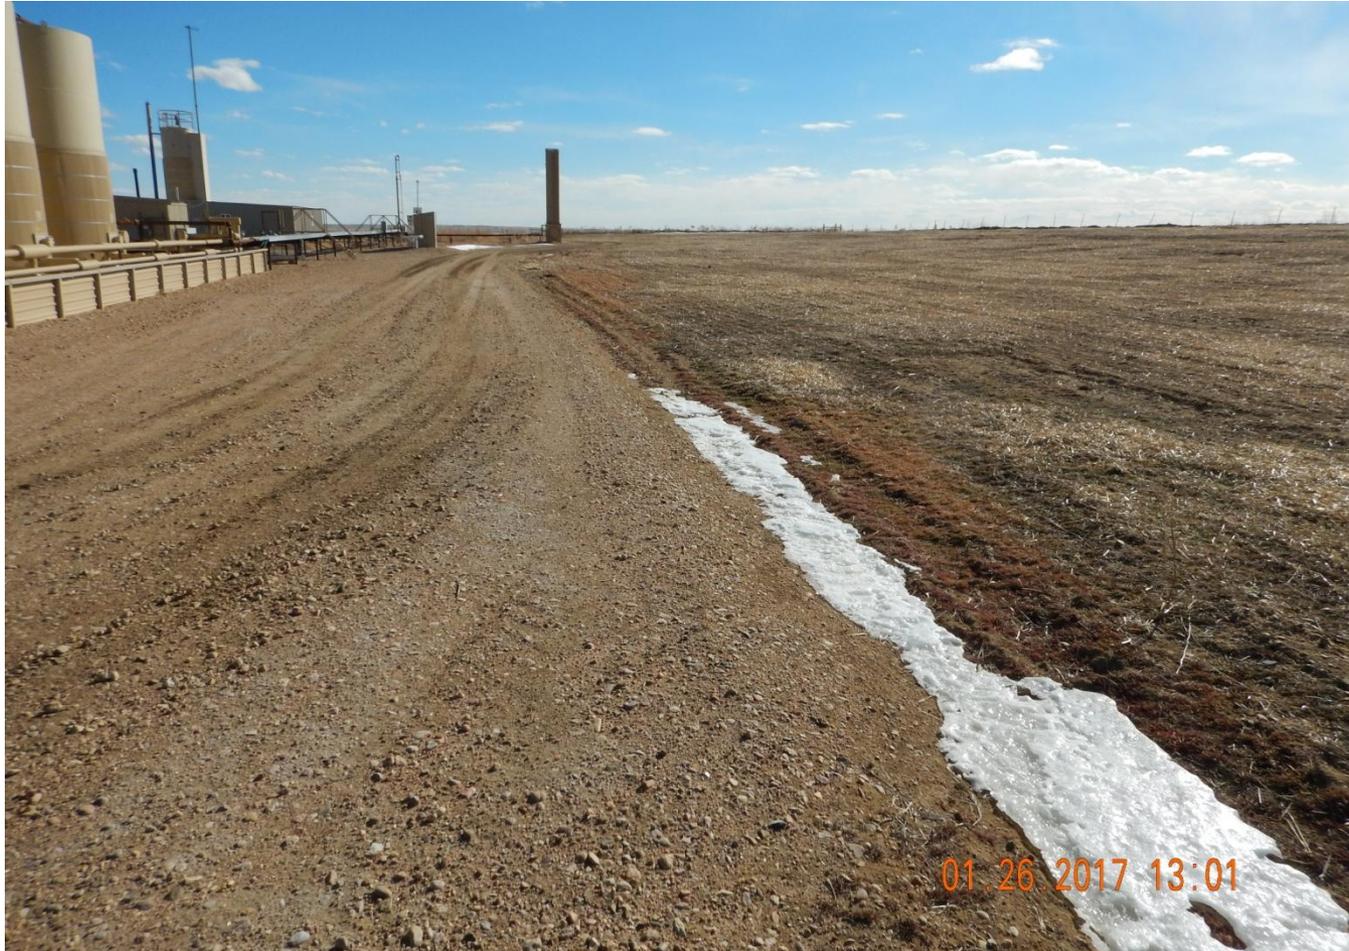
Photo 3. Photo taken from the northwest production area, facing South. Germination apparent throughout most of the interim area.

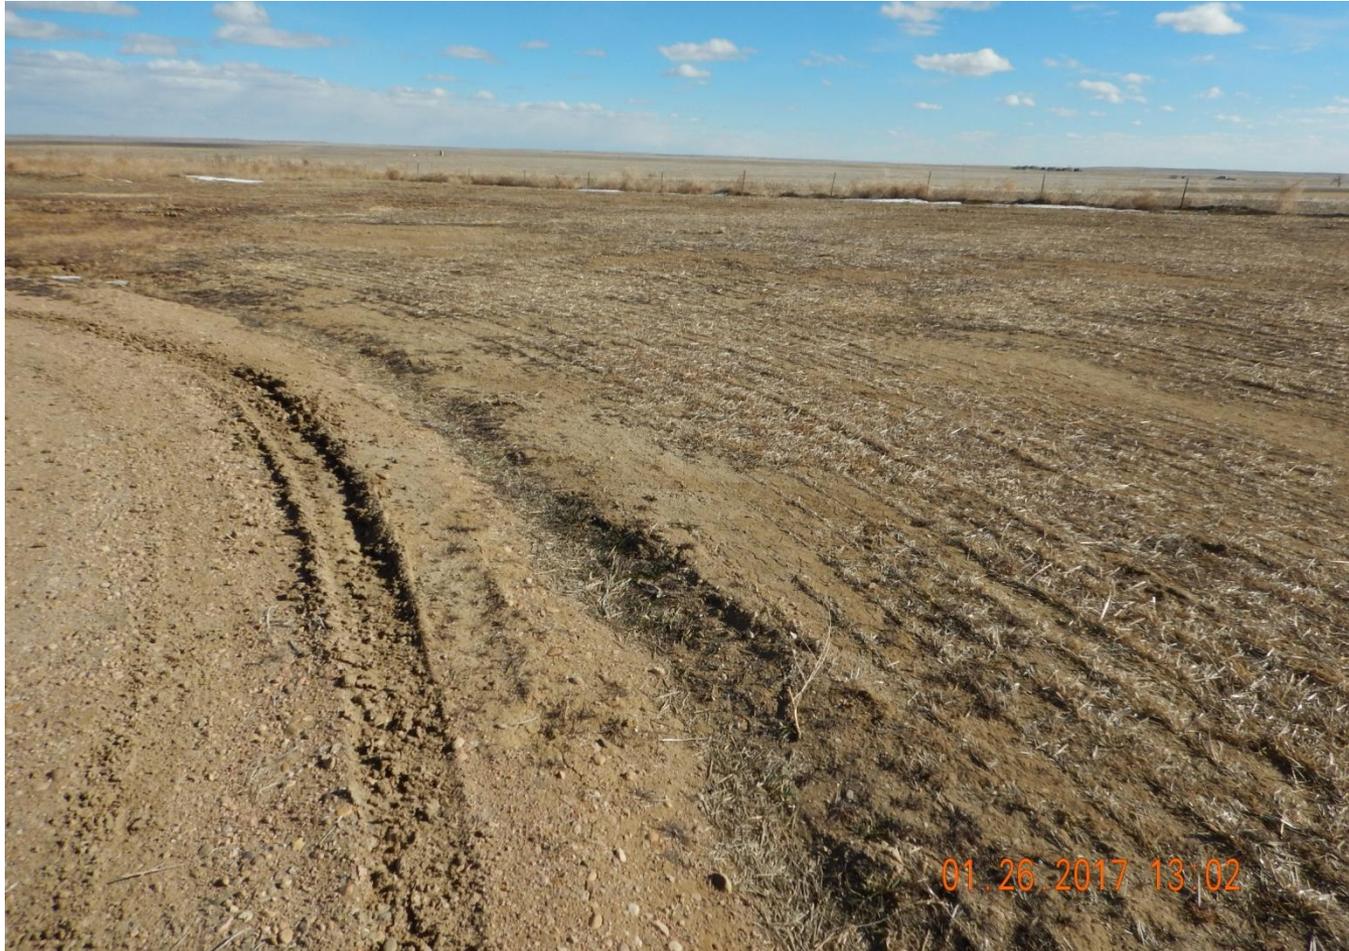
Photo 4. Photo taken from the southern production area, facing East. Germination apparent throughout most of the interim area. Germination lacks along portions of this interim area. May need additional reclamation activities to be performed to achieve Rule 1003 standards.

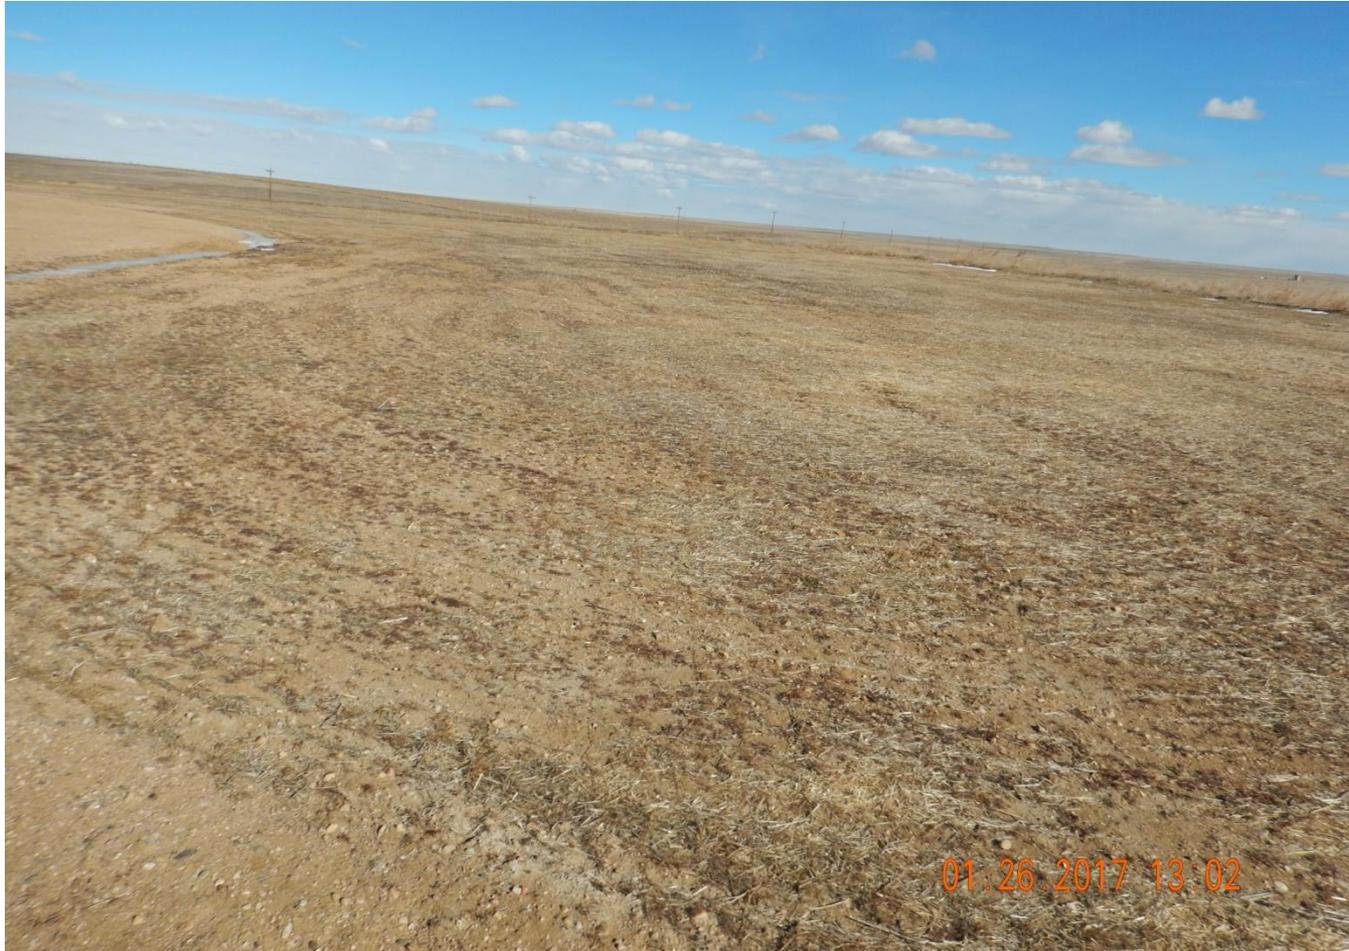
Photo 5. Photo taken from the southeast production area, facing East. Germination apparent throughout most of the interim area.

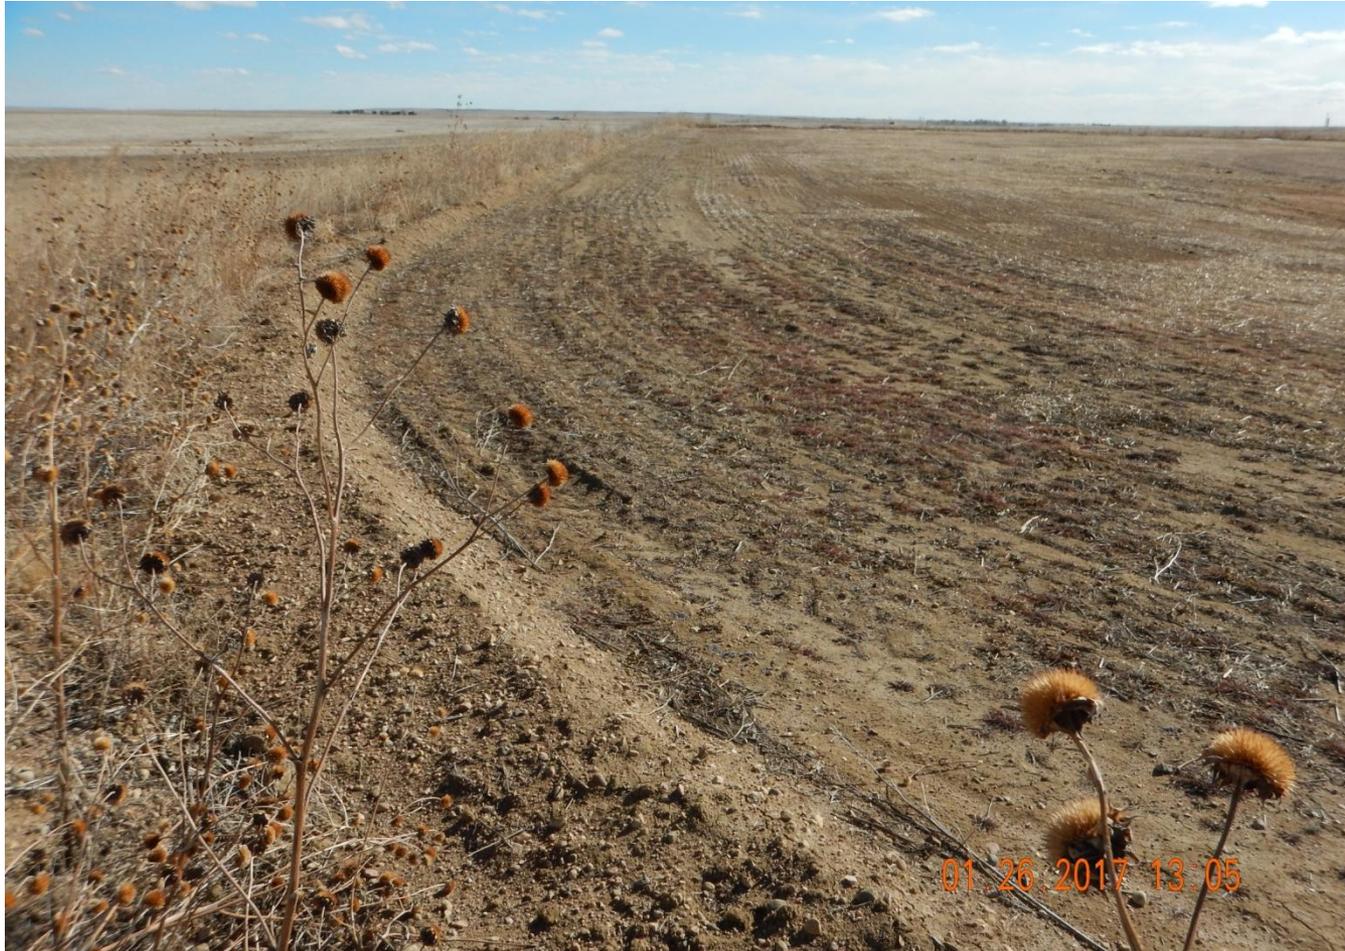
Photo 6. Photo taken from the northeast location, facing South. Germination apparent throughout most of the interim area. Germination lacks along portions of this interim area. May need additional reclamation activities to be performed to achieve Rule 1003 standards.

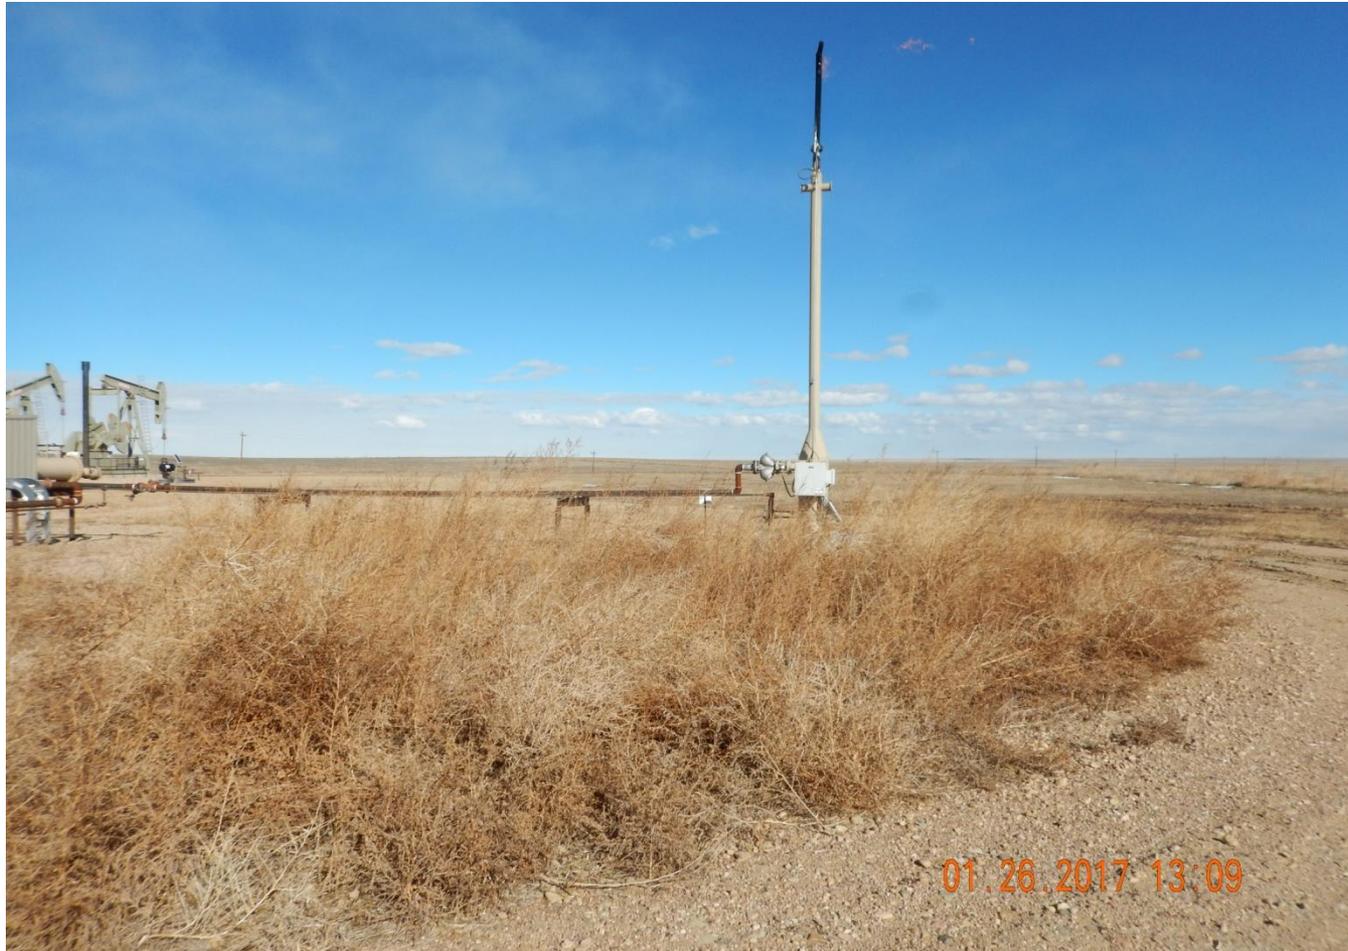
Photo 7. Photo taken from the southern location, facing East, towards the flare. Kochia weeds next to the flare pose a fire hazard.
