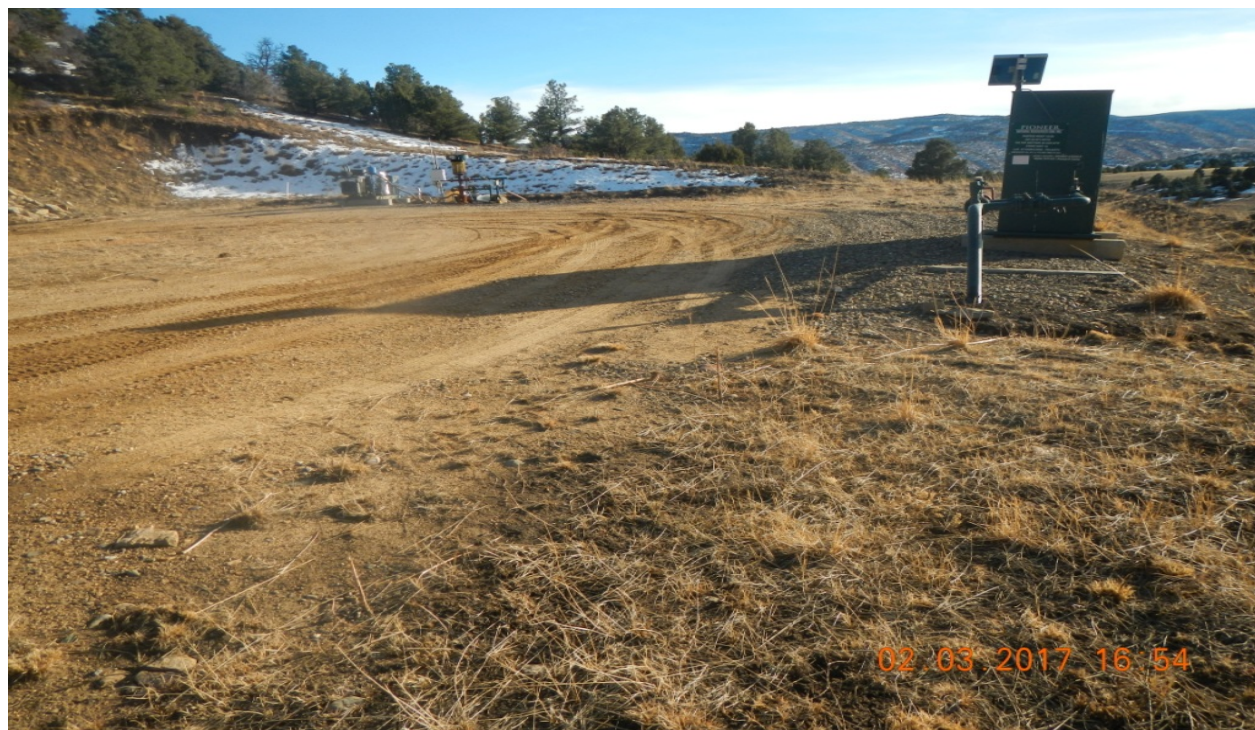
photo 1: Facing south toward the location.

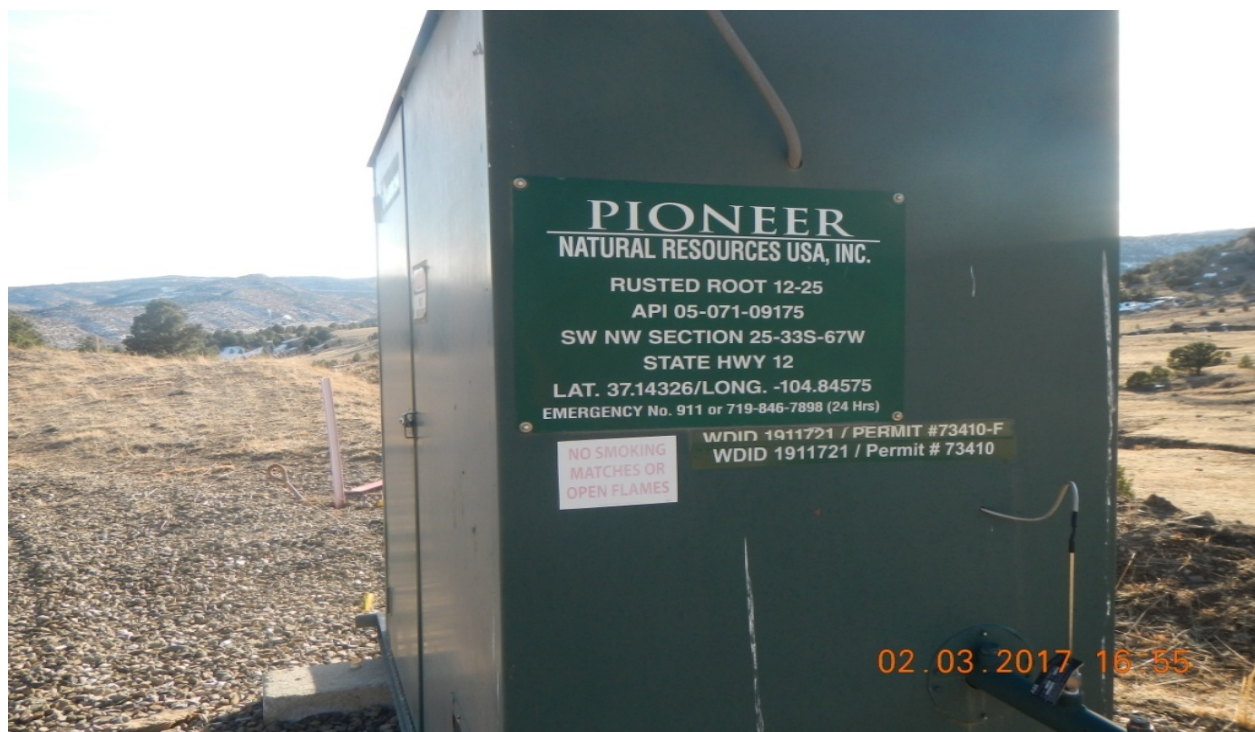
photo 2: Well sign at the location.

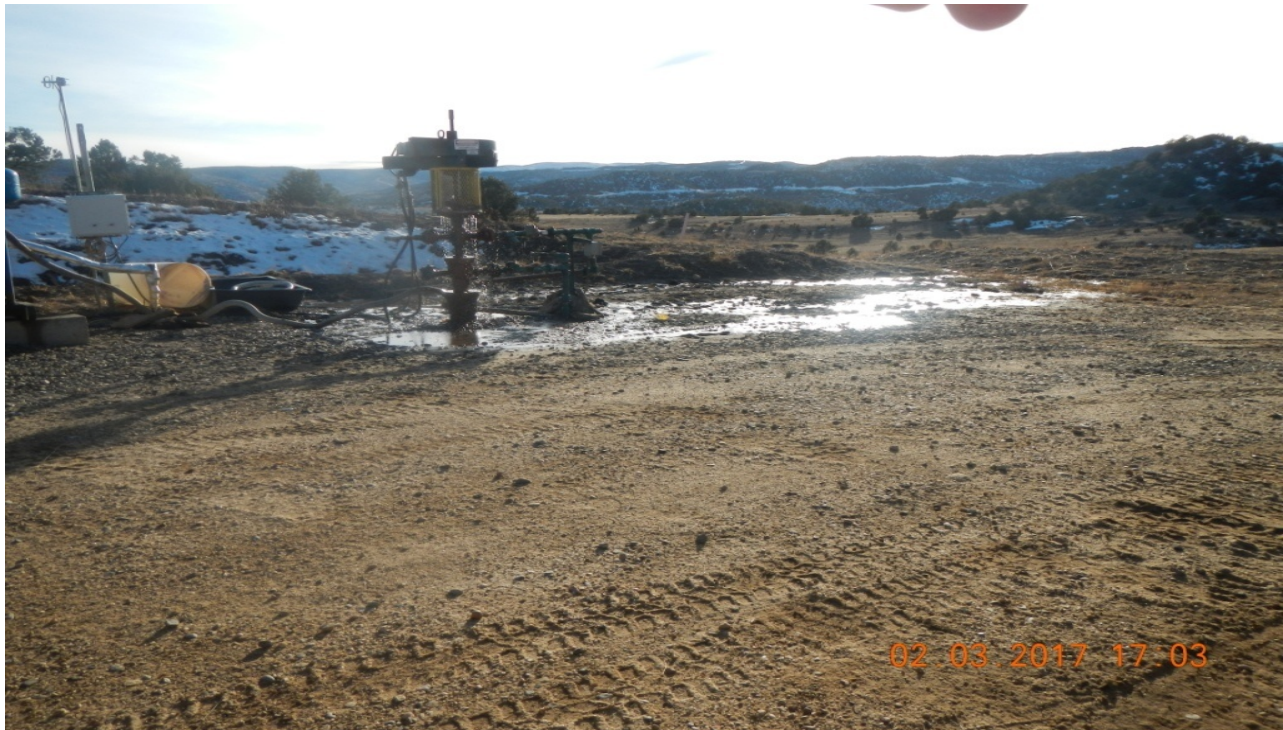
photo 3: Facing toward the wellhead.

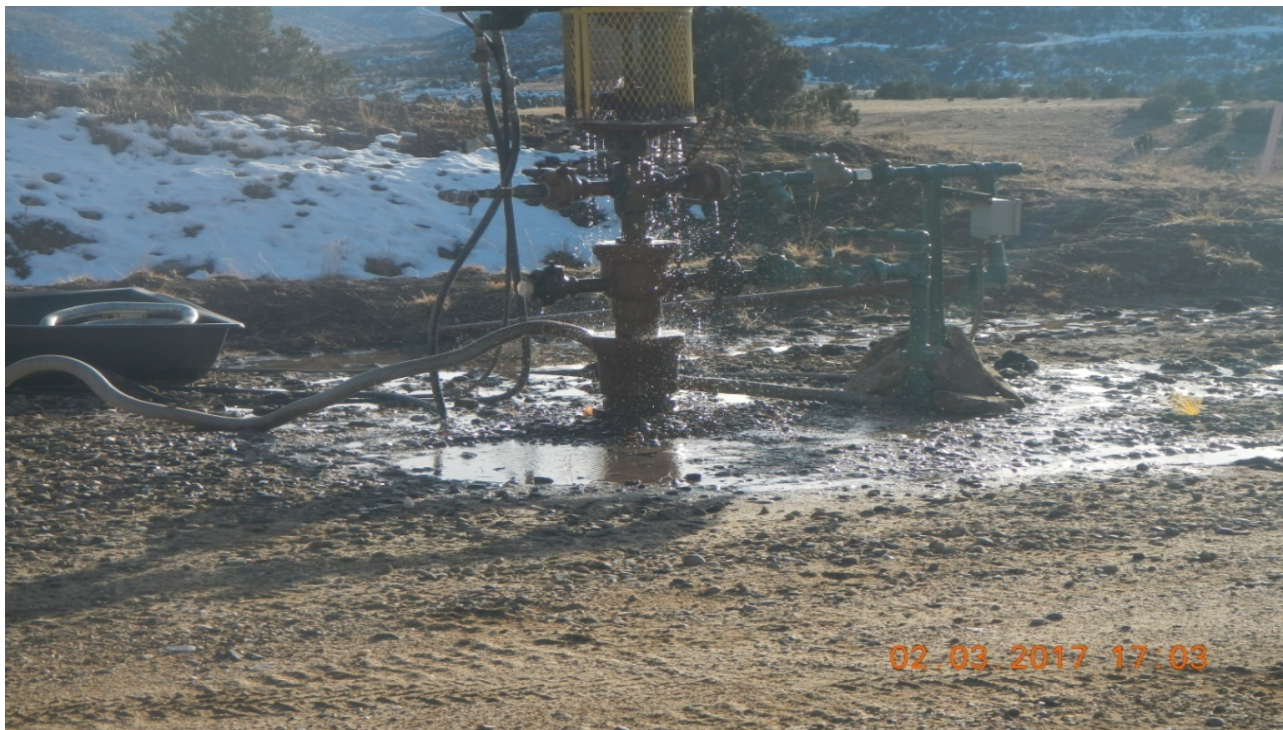
photo 4: Water was leaking from the wellhead.

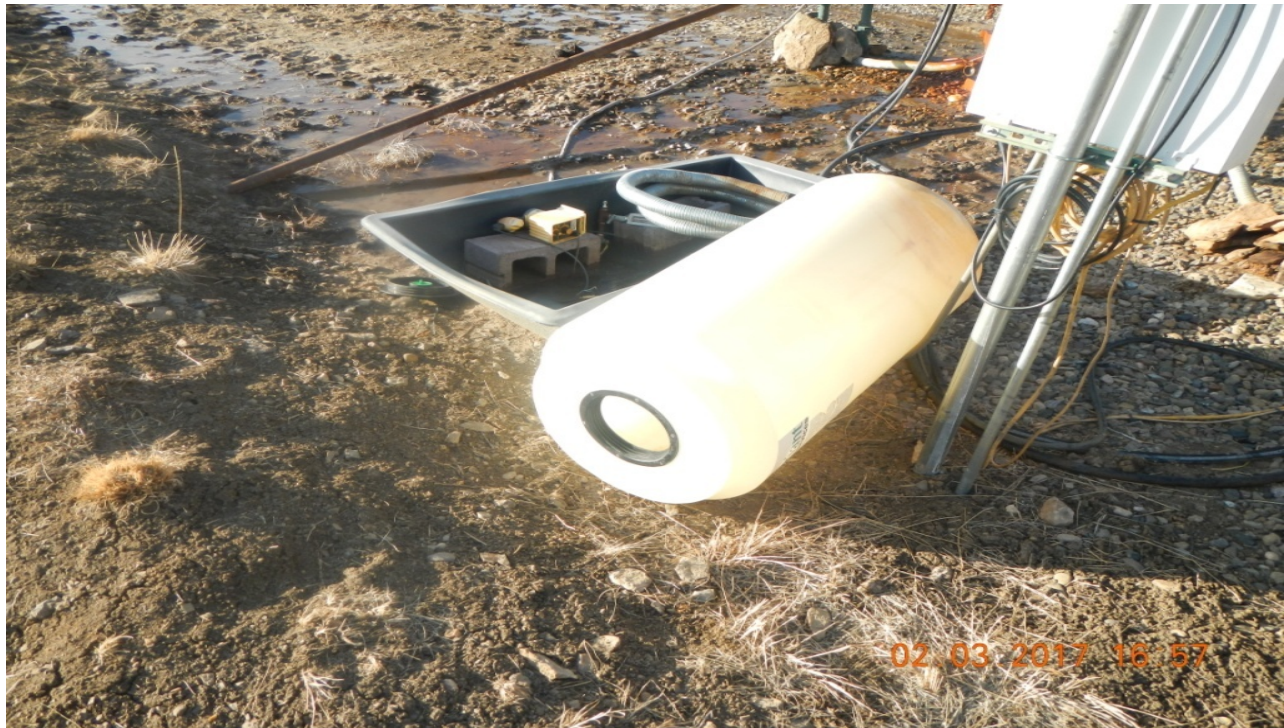
photo 5: A barrel labeled Clarient Oil service was tip over.

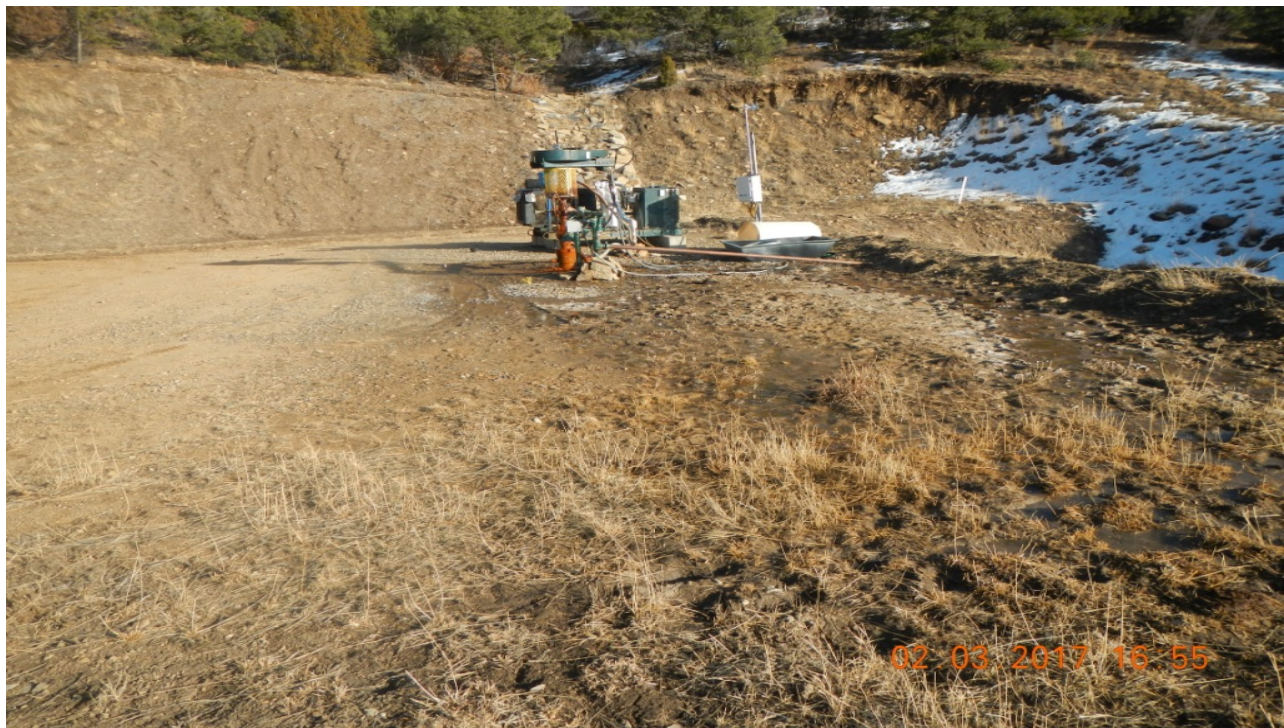
photo 6: Facing east toward the wellhead.
