**Inspection Photos**  
**Location Name: Mahoney #1**  
**API: 05-123-08110**

**Inspection Photos**  
**Location Name: Dier 62N67W 8SESW**  
**API: 05-123-1464**

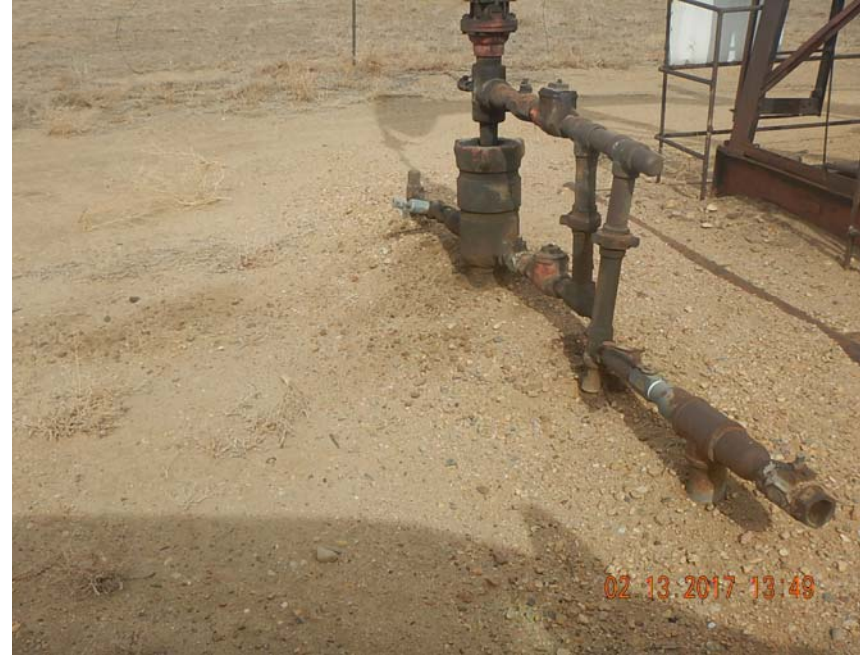
**Photo 1: Stained soil around wellhead, bradenhead not plumbed to surface**

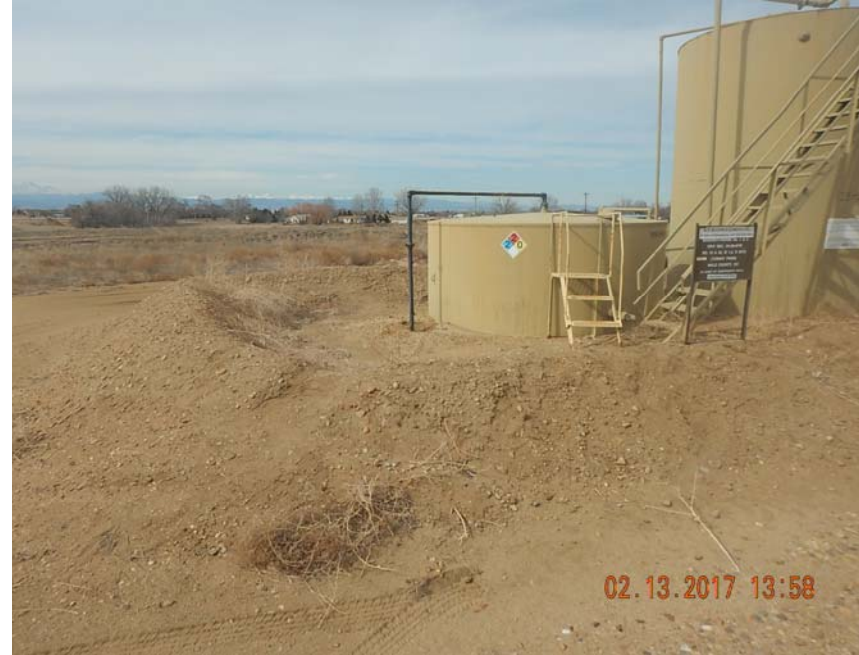
**Photo 2: Location looking W, some weeds and detritus at wellhead**

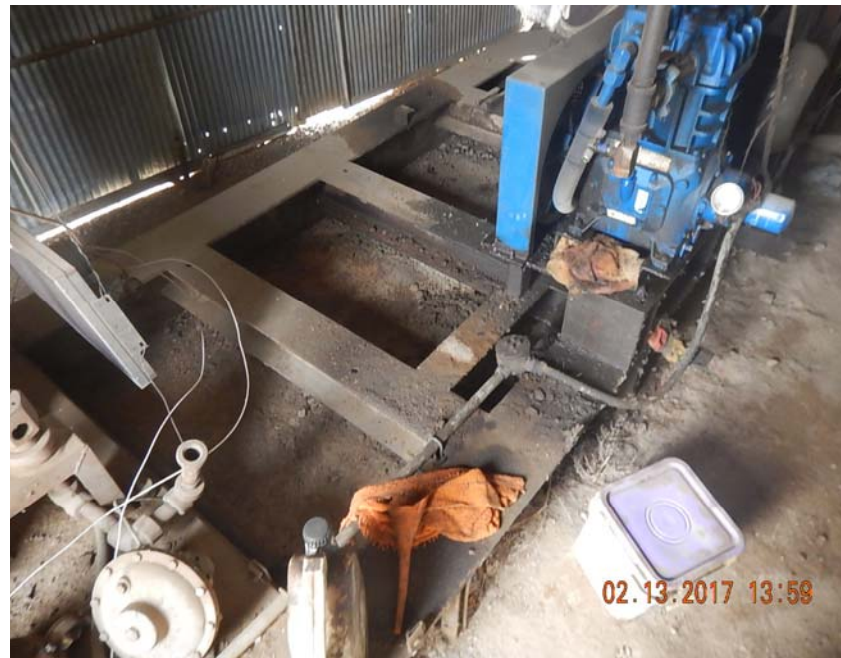
**Photo 3: Stained soil in compressor house**

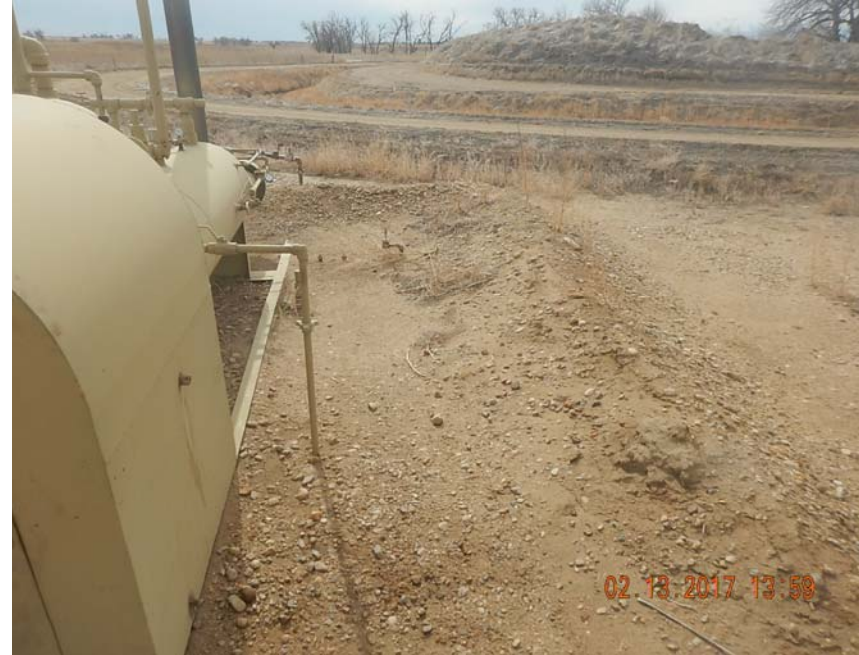
**Photo 4: Weeds controlled at separator**

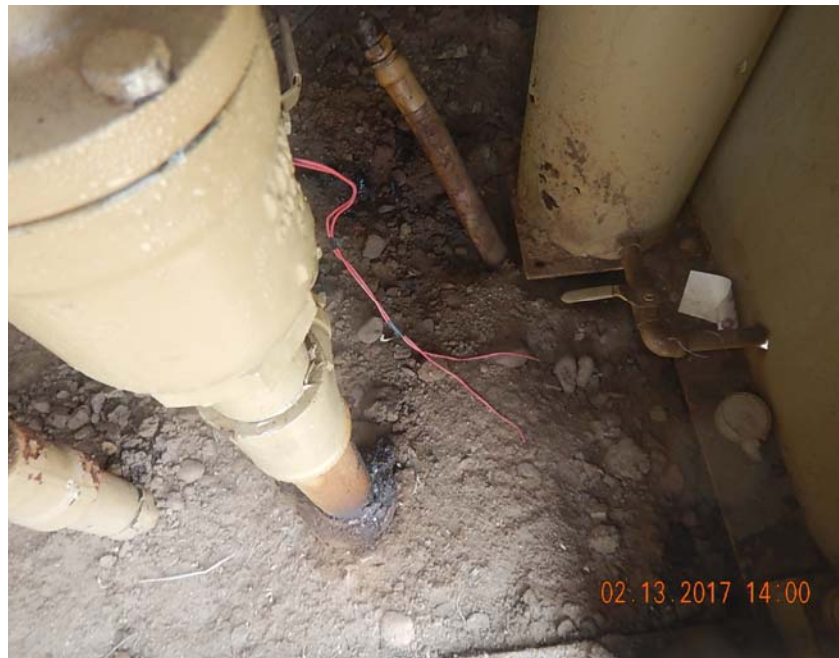
**Photo 5: Stained soil in separator house**

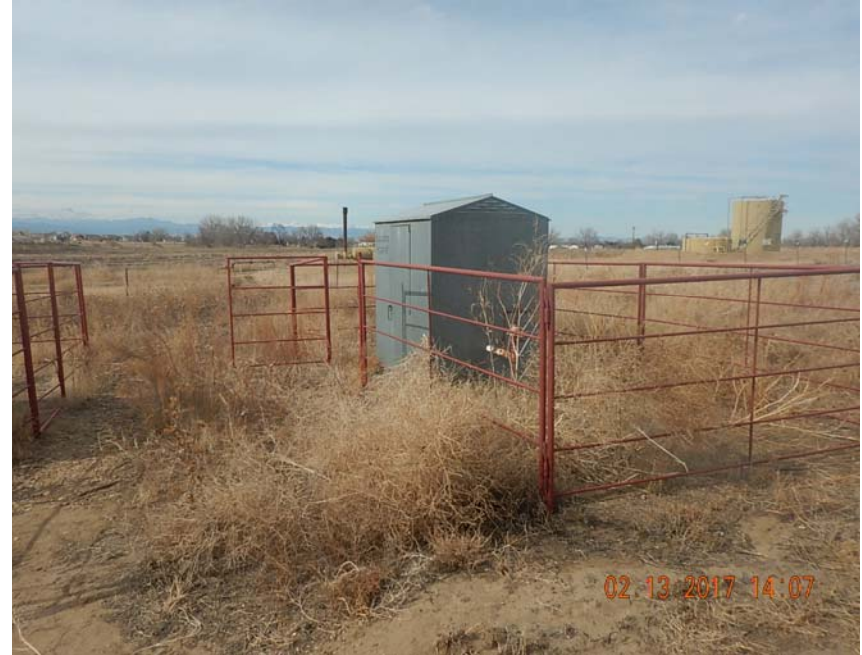
**Photo 6: Weeds at meter, facing W**
