Reclamation Inspection

02/13/2017

Operator: Niobrara Illuminating Gas Associates LLC
#63380

Location ID: 403658

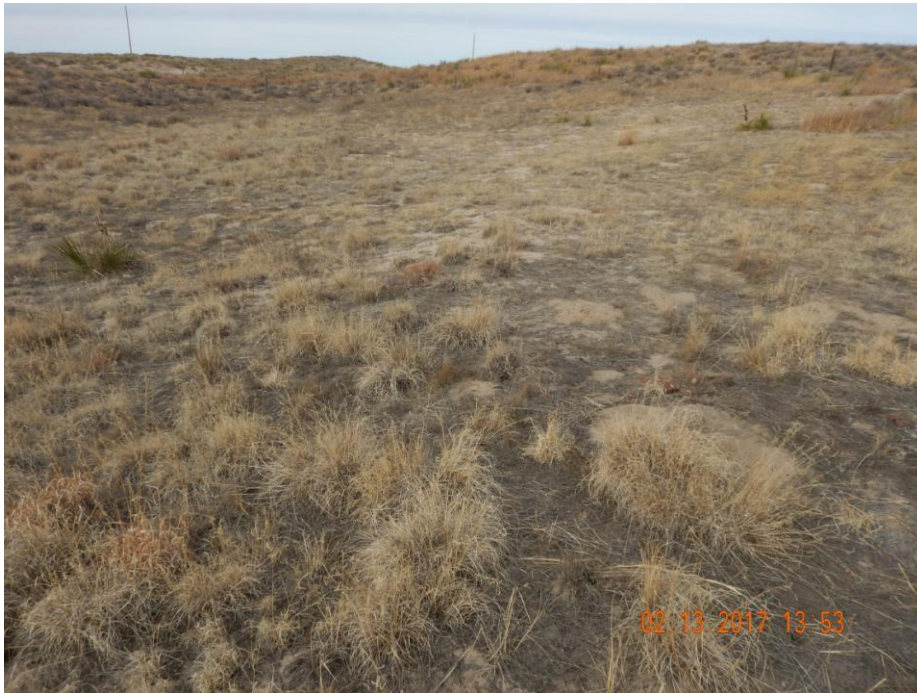
Photo 1: Photo taken from the location, facing north. Photo shows vegetation at the well location.

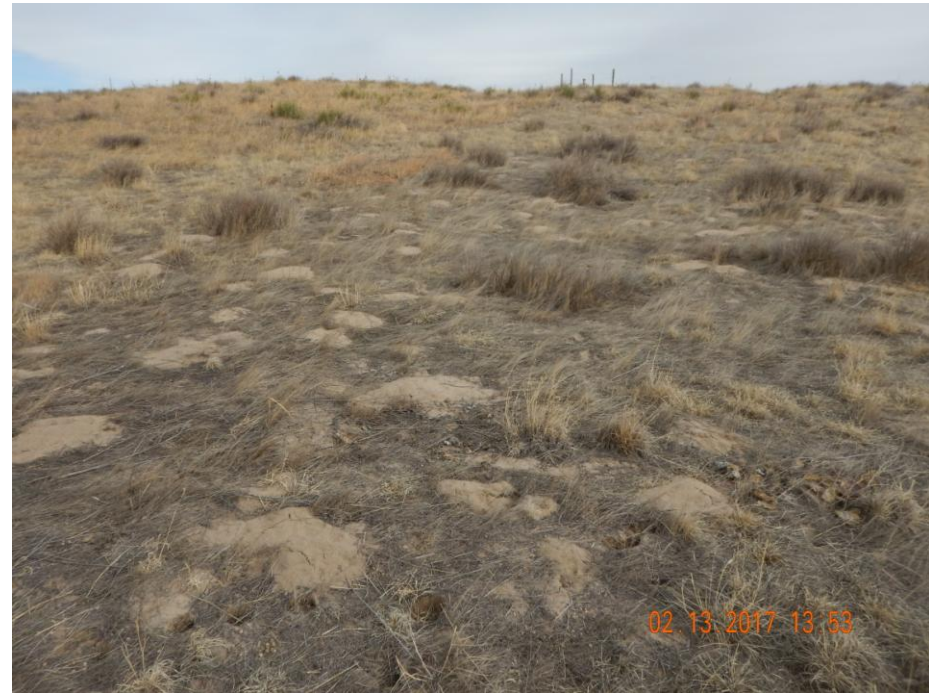
Photo 2: Photo taken from the location, facing east. Photo shows vegetation at the well location.

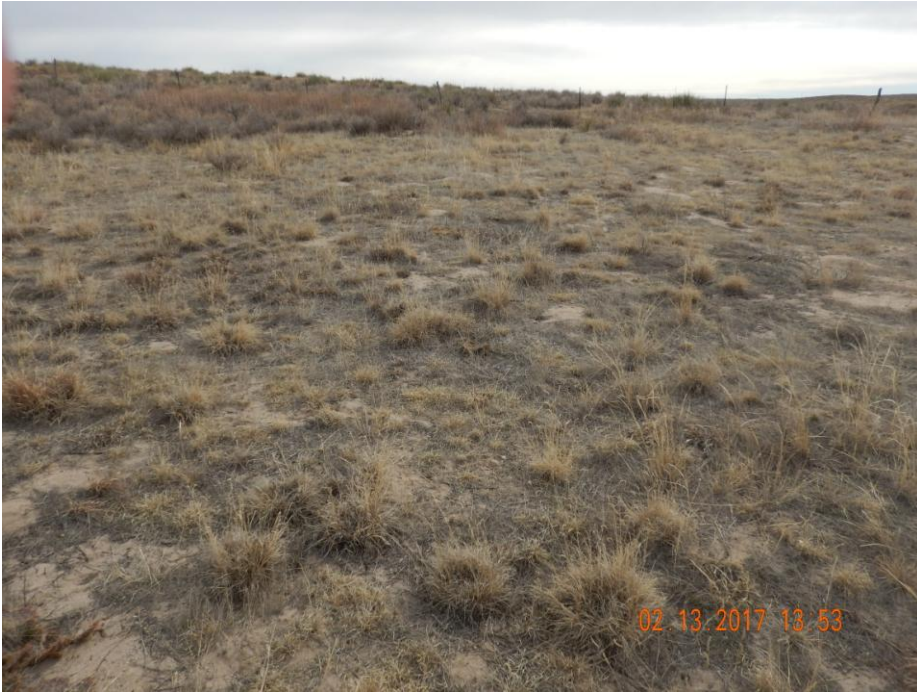
Photo 3: Photo taken from the location, facing south. Photo shows vegetation at the well location.

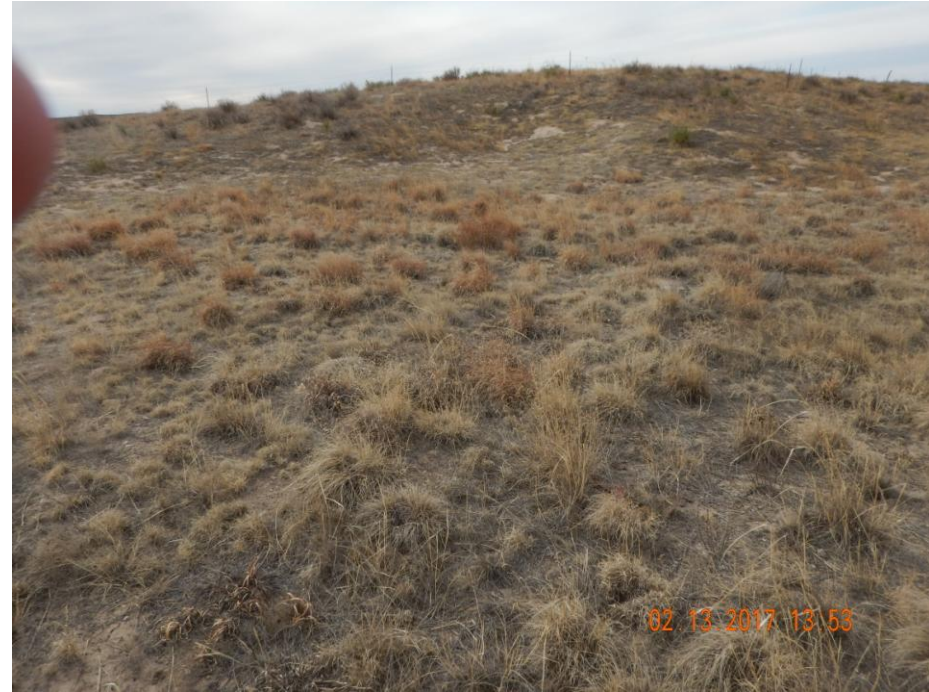
Photo 4: Photo taken from the location, facing west. Photo shows vegetation at the well location.

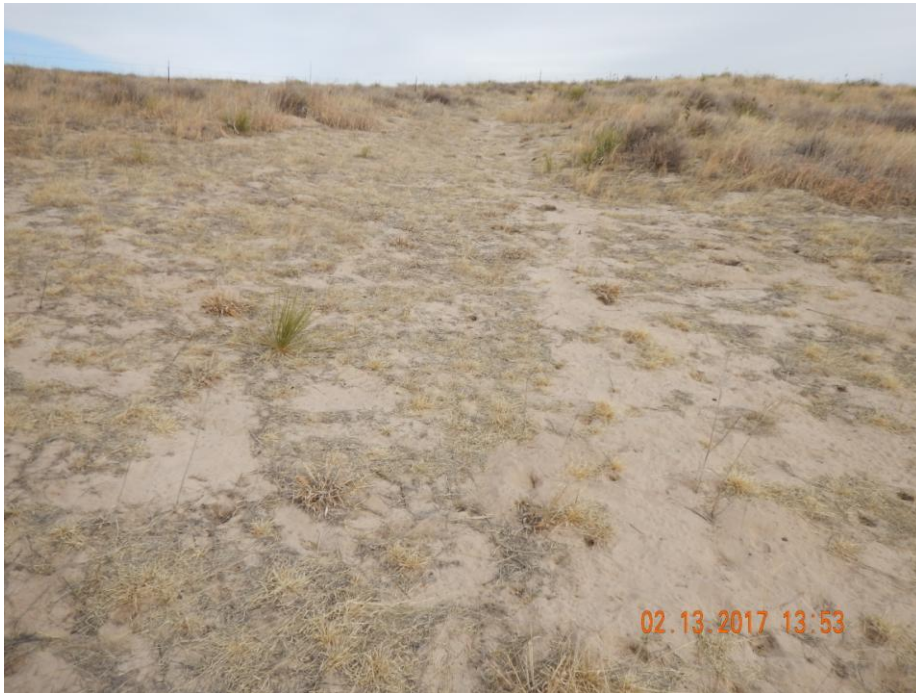
Photo 5: Photo taken from the north end of the location, facing east. Photo shows area of location remains predominantly bare and exposed soil, with very little desirable perennial vegetative cover. Location has not been stabilized, erosion evident.

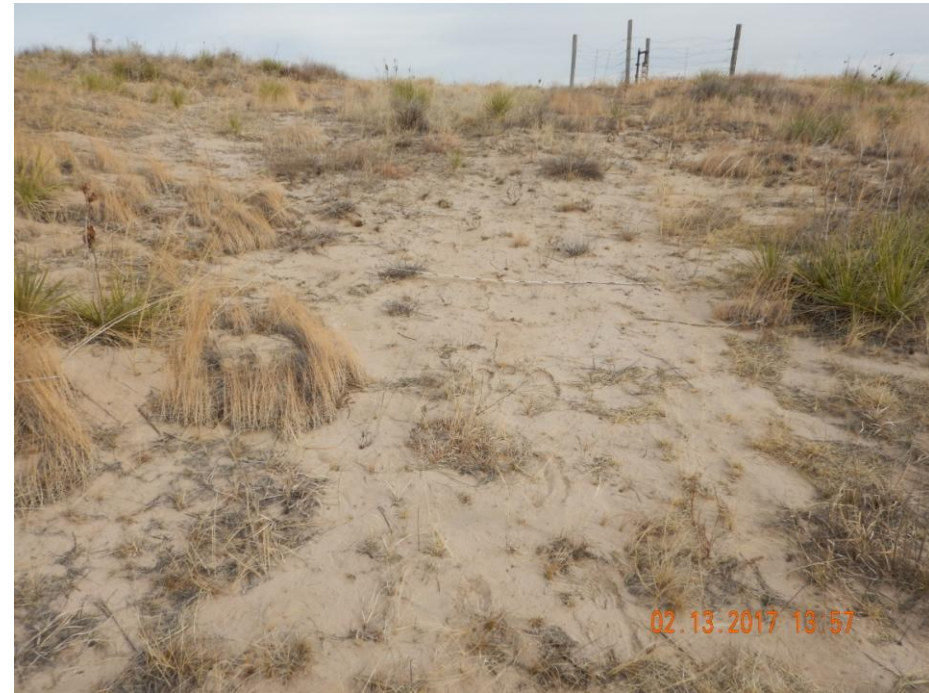
Photo 6: Photo taken from the west facing slope on the east end of the location, facing east. Photo shows areas of location that has not been stabilized, erosion evident. Photo also shows areas of location remain predominantly bare and exposed soil

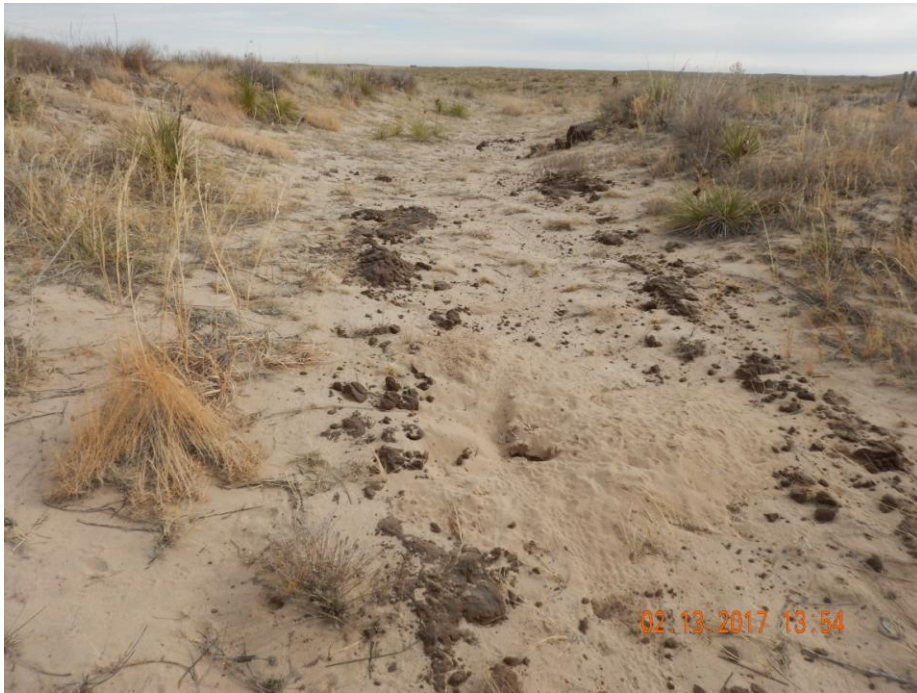
Photo 7: Photo taken from the east end of the location, facing south. Photo shows portions of the access road on location have not been reclaimed per reclamation rules. Erosion evident. Dark, stained soil exists and will need to be remediated.

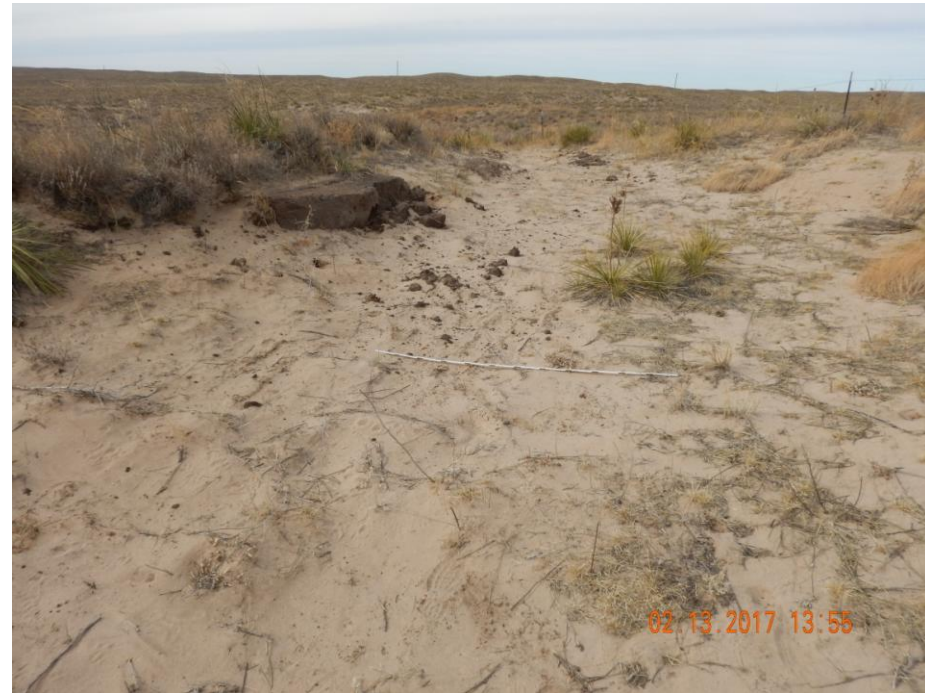
Photo 8: Photo taken from the east end of the location, facing north. Photo shows portions of the access road on location have not been reclaimed per reclamation rules. Erosion evident. Dark, stained soil exists and will need to be remediated. 6' measuring stick for reference.

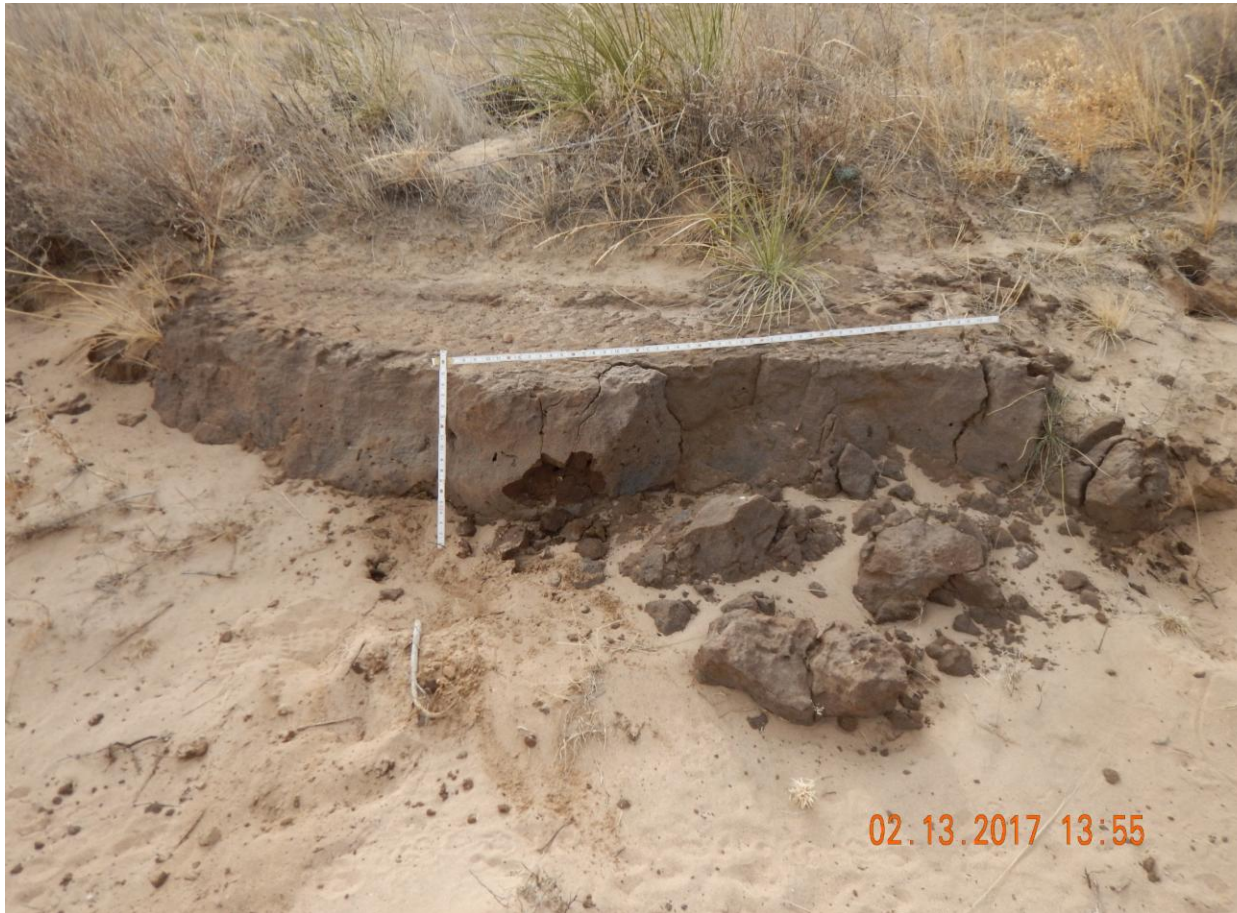
Photo 9: Photo taken from the east end of the location (refer to figures 7 and 8). Photo shows large portions of discolored and rigid soil. These soils need to be remediated or removed. 6' measuring stick for reference.

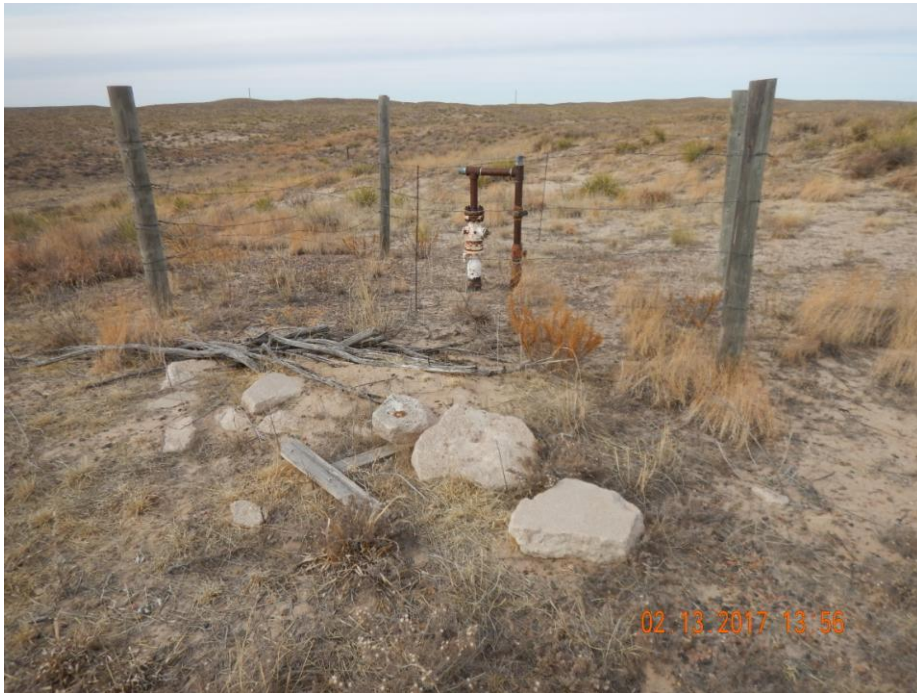
Photo 10: Photo taken from the southeast end of the location, facing north. Photo shows pipe riser, fence and debris remaining on location. Inspection Doc. # 673709790 identified this as a “Gasline tie/well”. Equipment and debris need to be removed.

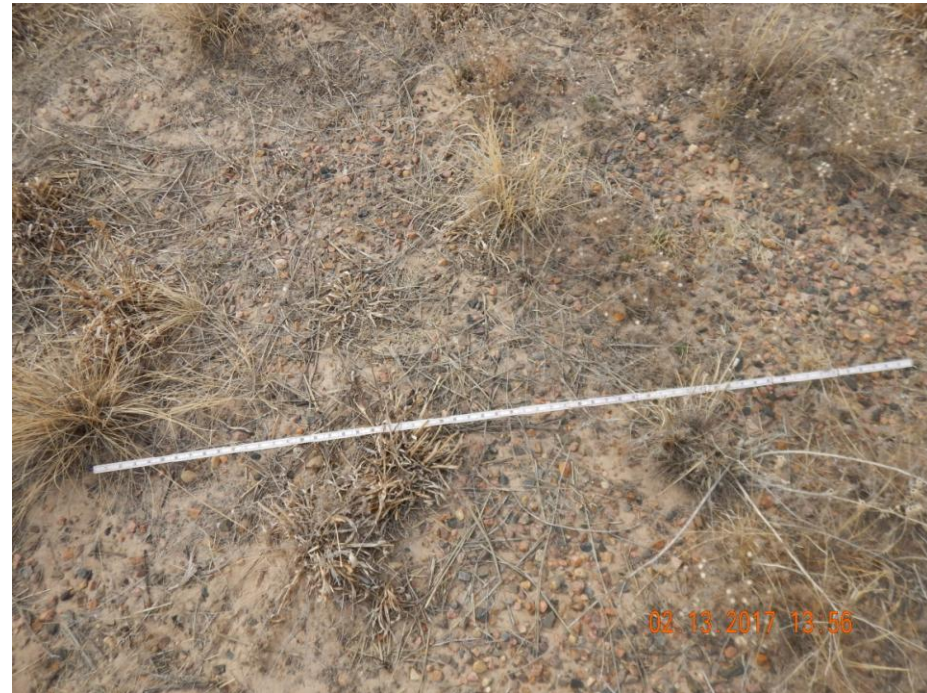
Photo 11: Photo taken from the southeast end of the location, facing north. Photo shows gravel and debris remaining on location at the “Gasline tie/well”. Equipment and debris need to be removed.
