Inspection Photos  
Location Name: Josey 12-8 (1)  
API: 05-123-10206

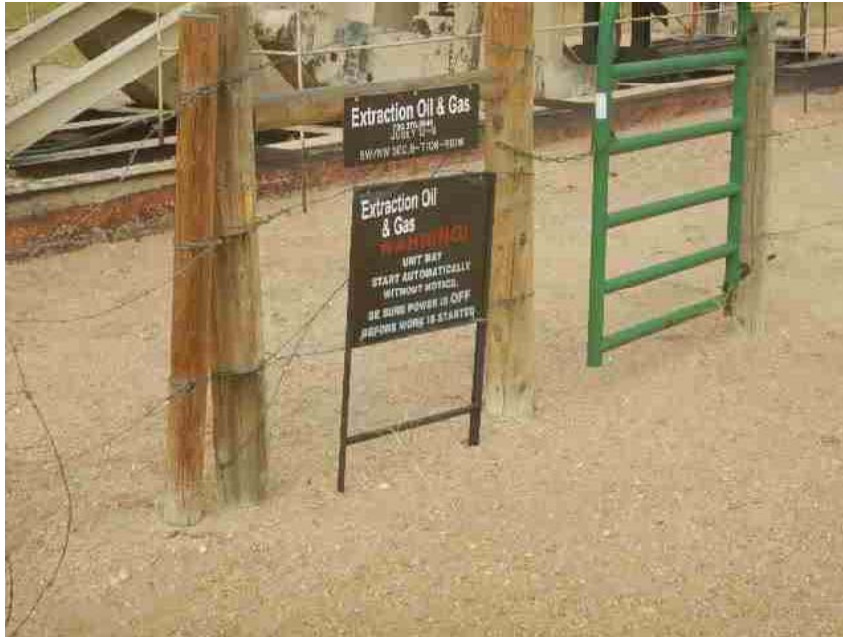
Photo from prior inspection for comparison purposes

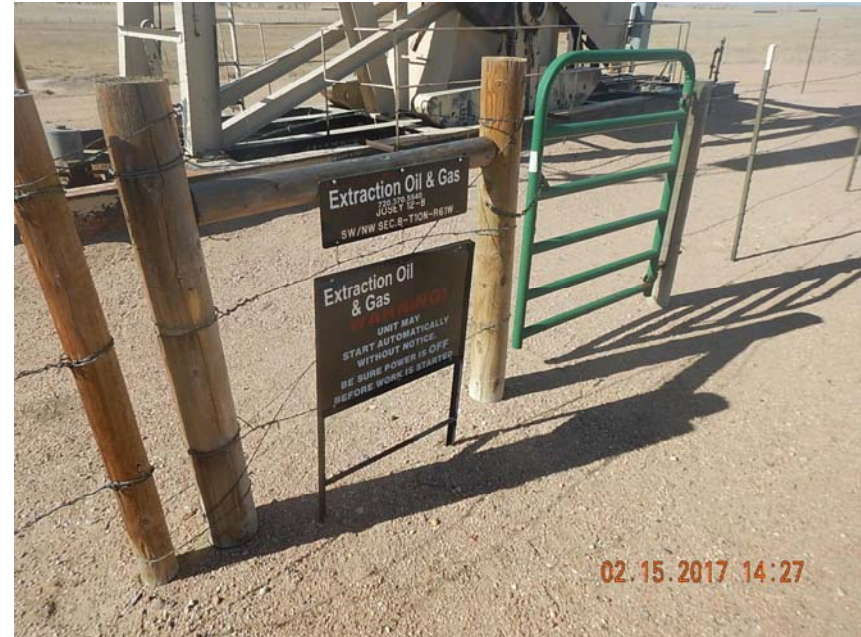
Photo 1: Signage is for prior operator

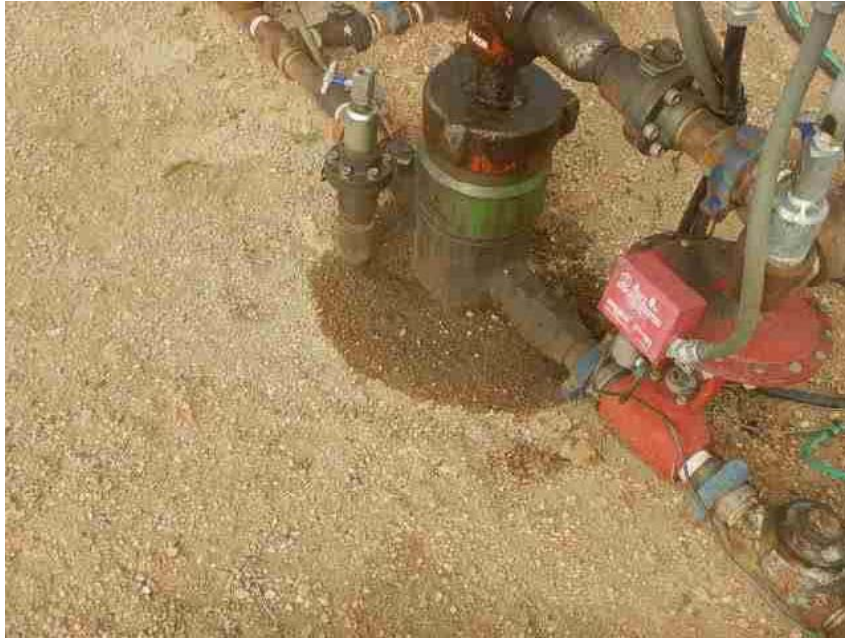
**Photo from prior inspection for comparison purposes**

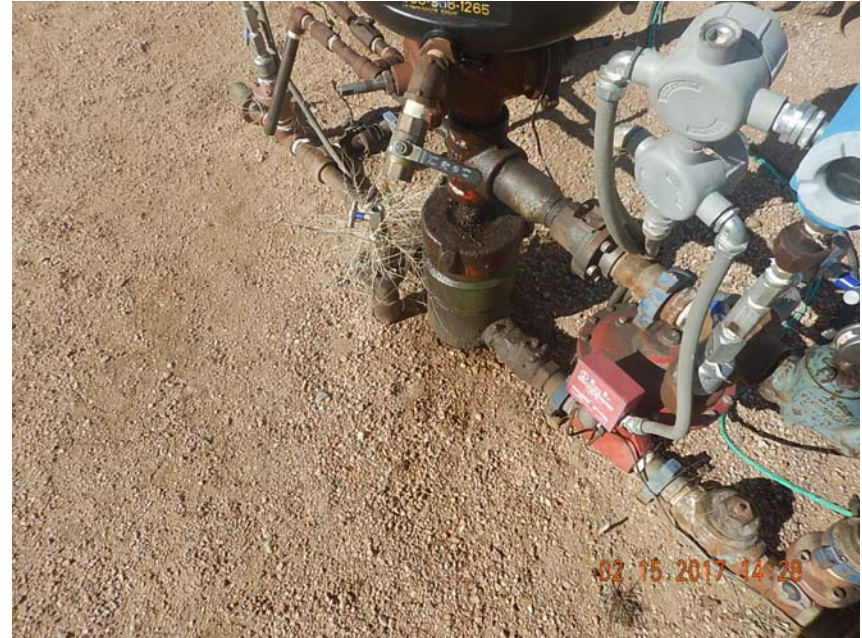
**Photo 2: Soil at wellhead has been treated**

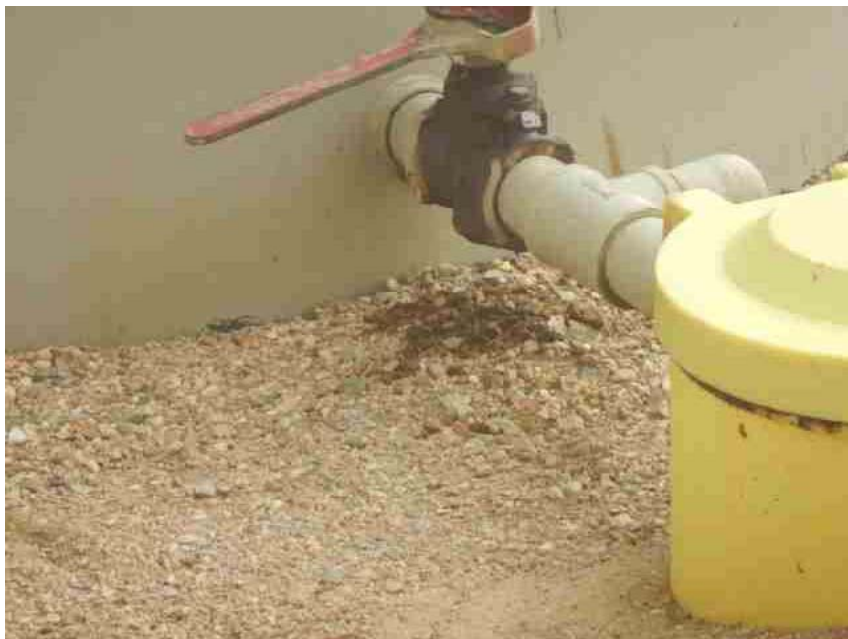
**Photo from prior inspection for comparison purposes**

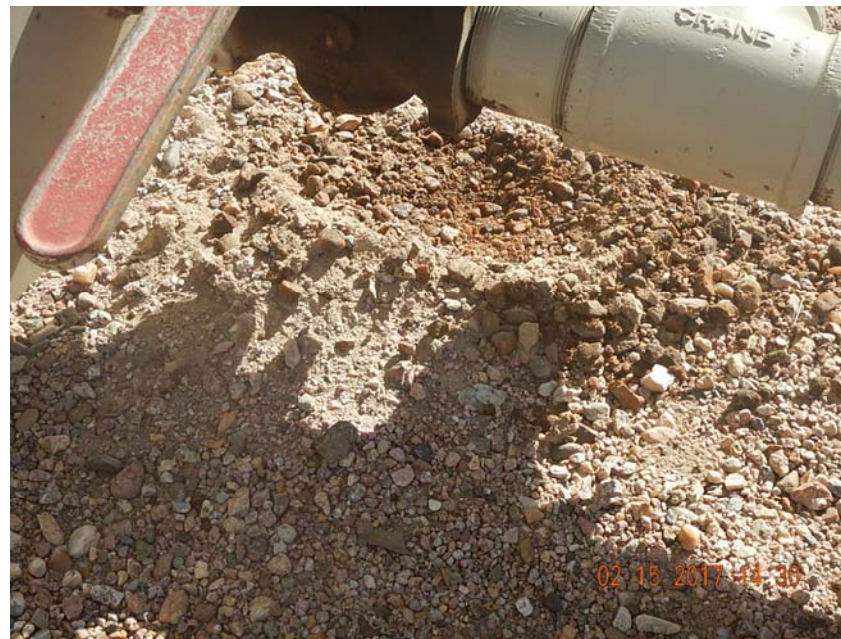
**Photo 3: Stained soil at loadout**

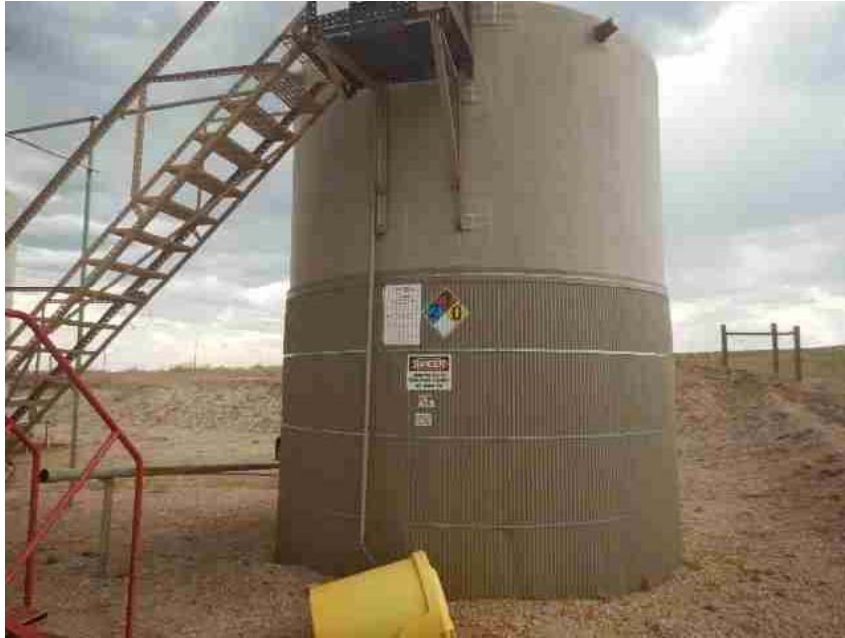
**Photo from prior inspection for comparison purposes**

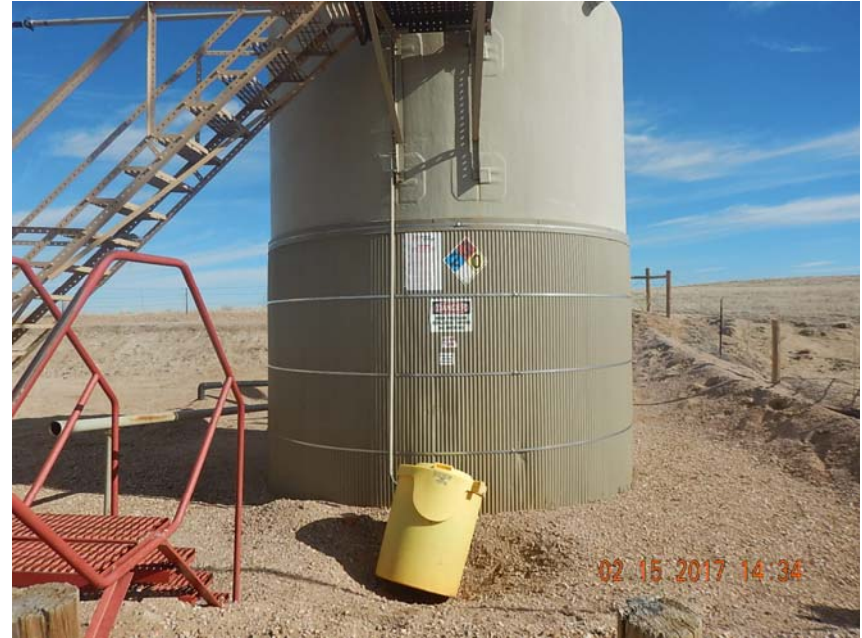
**Photo 4: No contents on production tank**

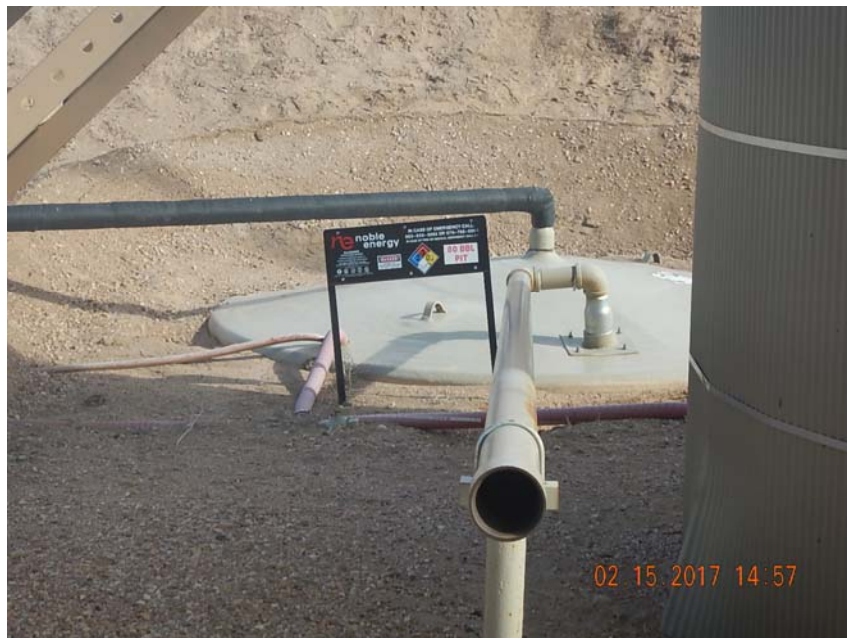
**Photo 5: Sign is for Noble**
