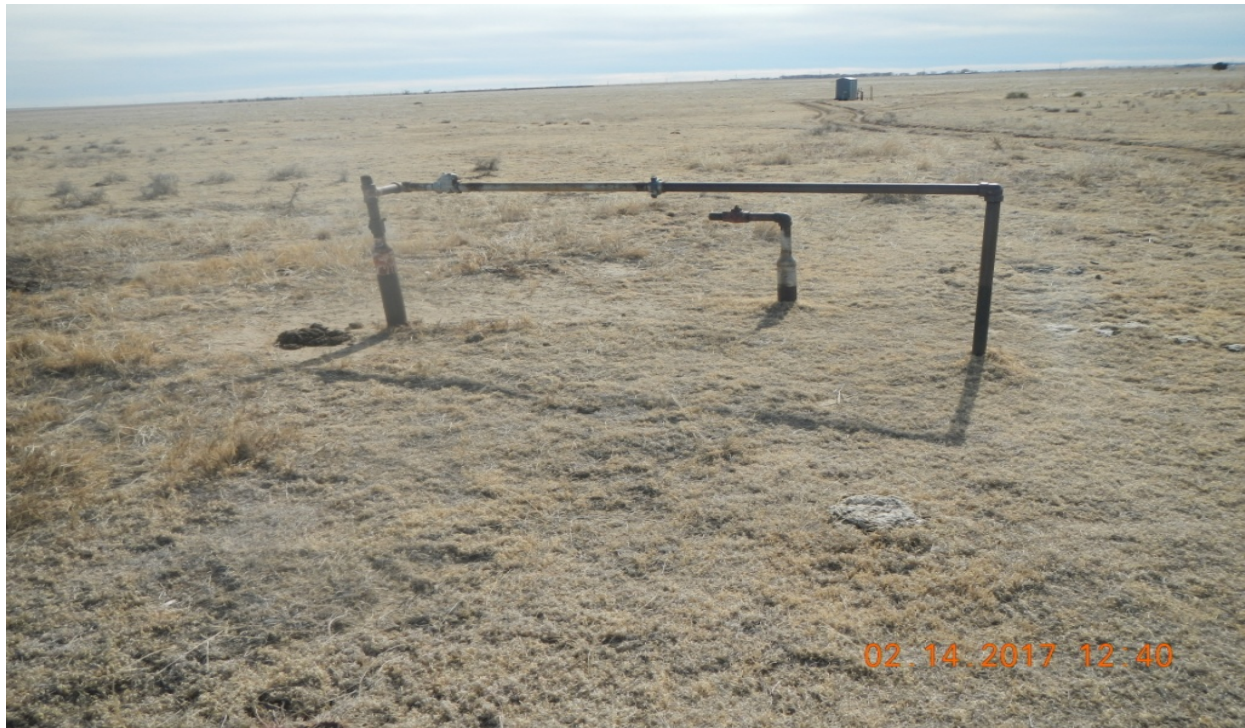
photo 1: Pipe risers remain at the location.

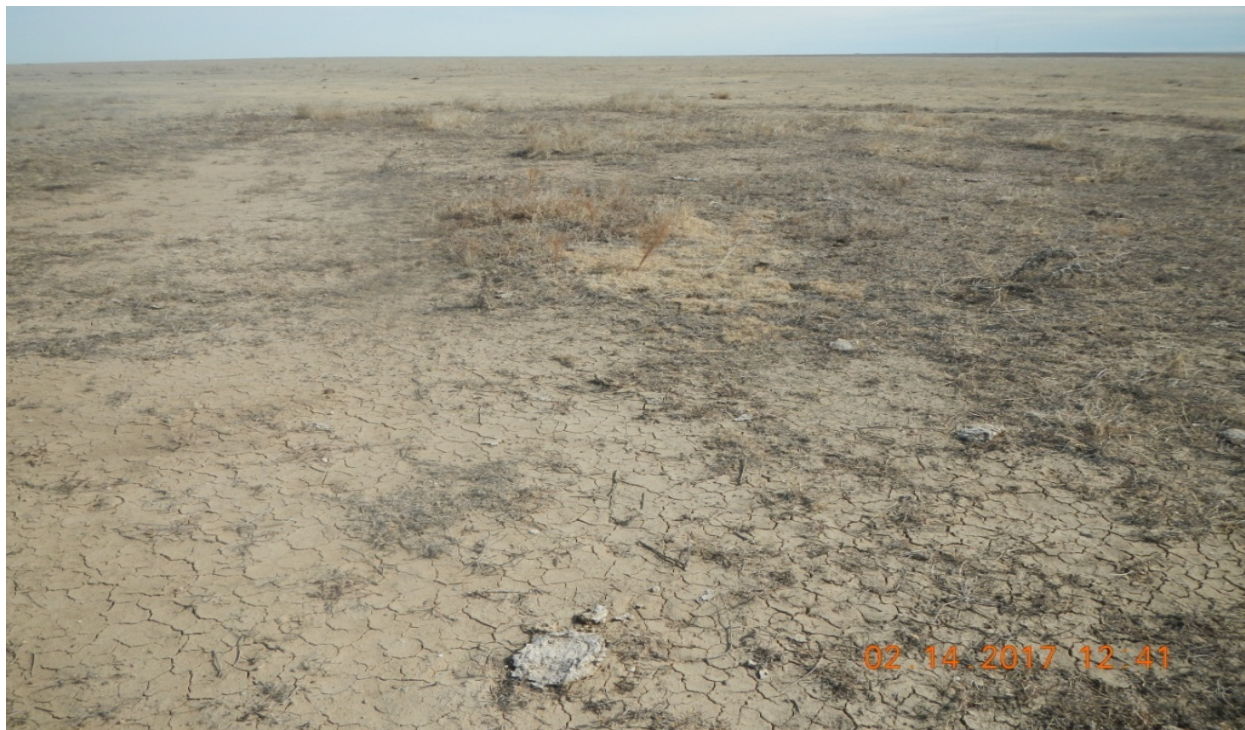
photo 2: Facing east at the location. The vegetation is not established in this area.

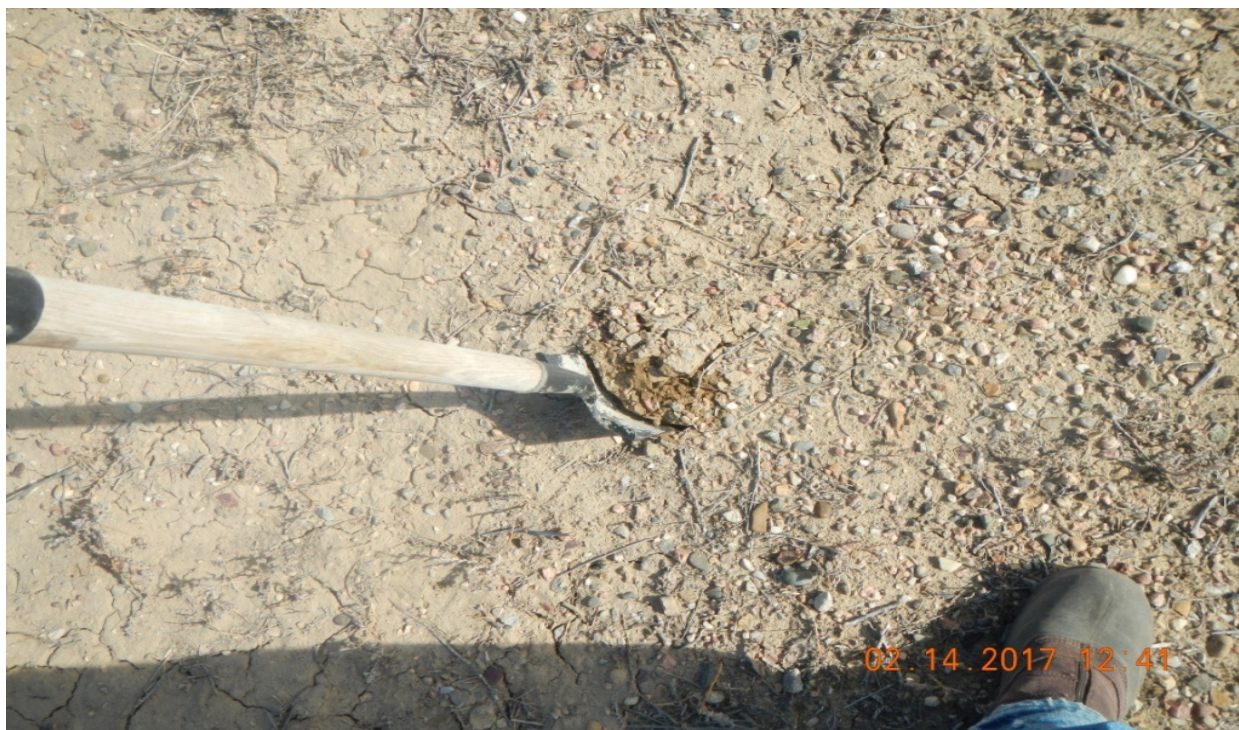
photo 3: The soils appeared to be compacted in the area where vegetation is not established.

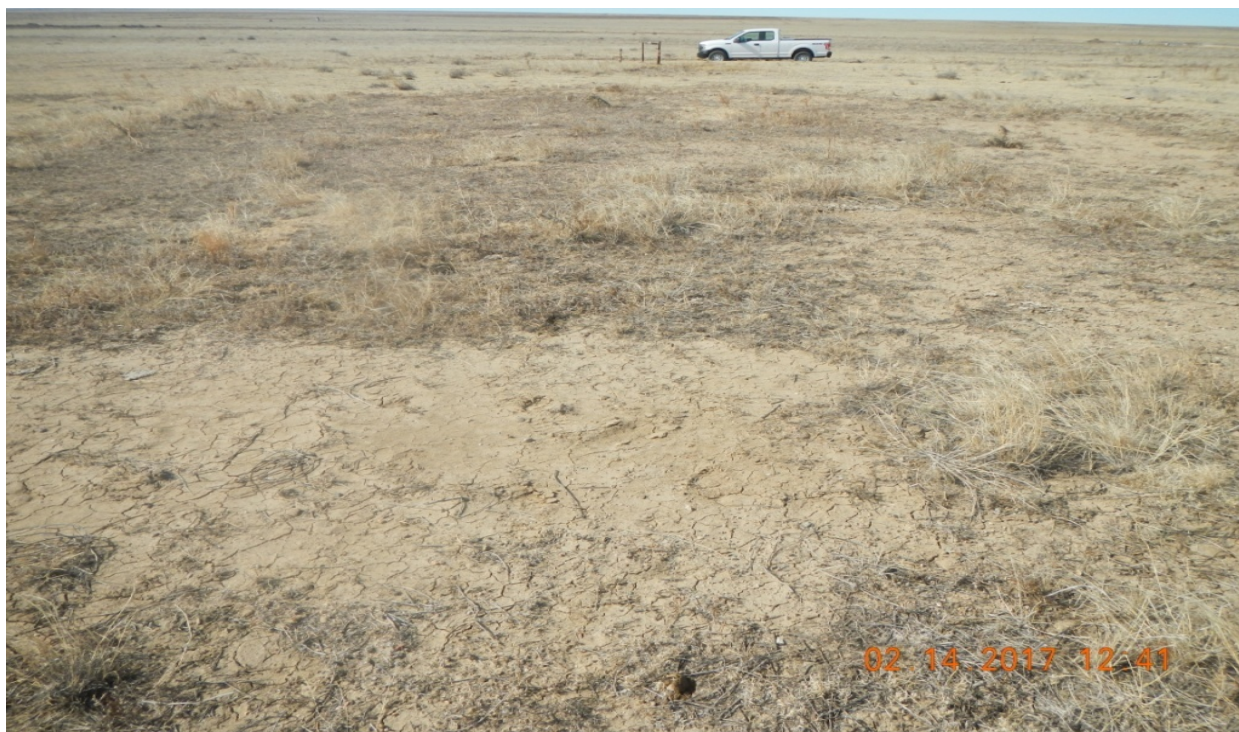
photo 4: East side of the location facing west.

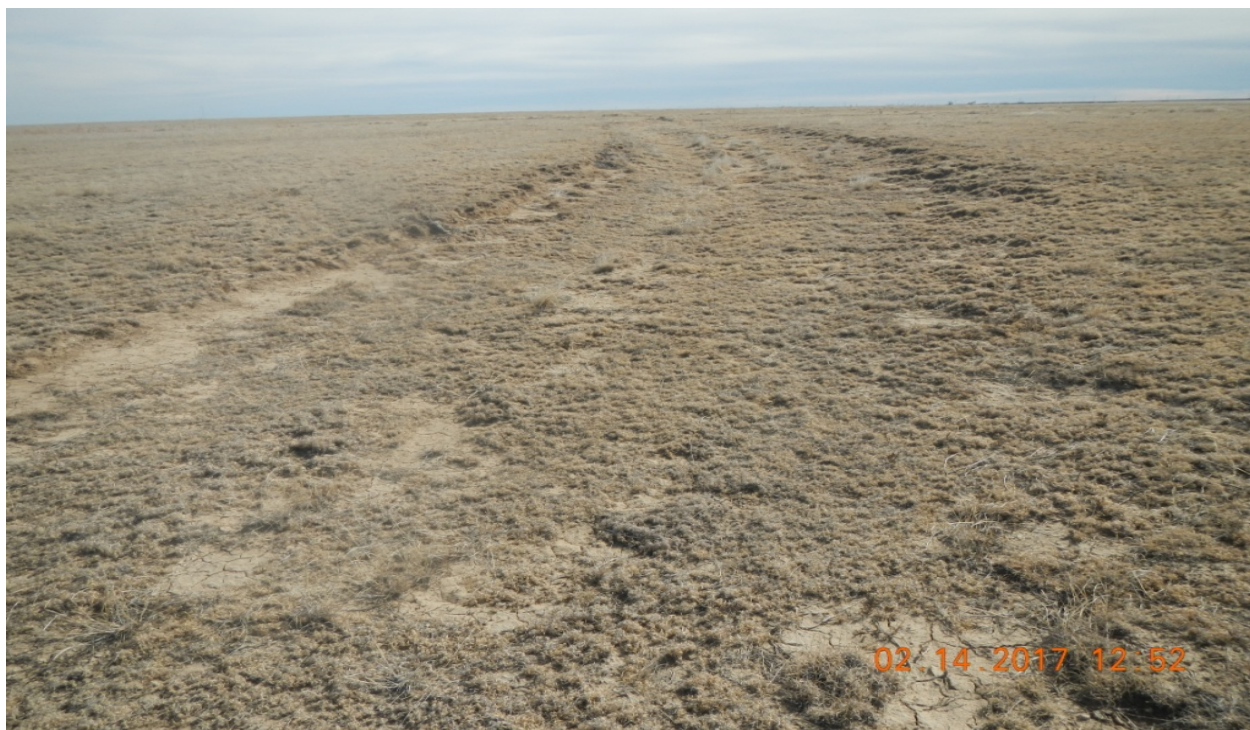
photo 5: The former access road is not recontoured however, vegetation appears to have reestablished.

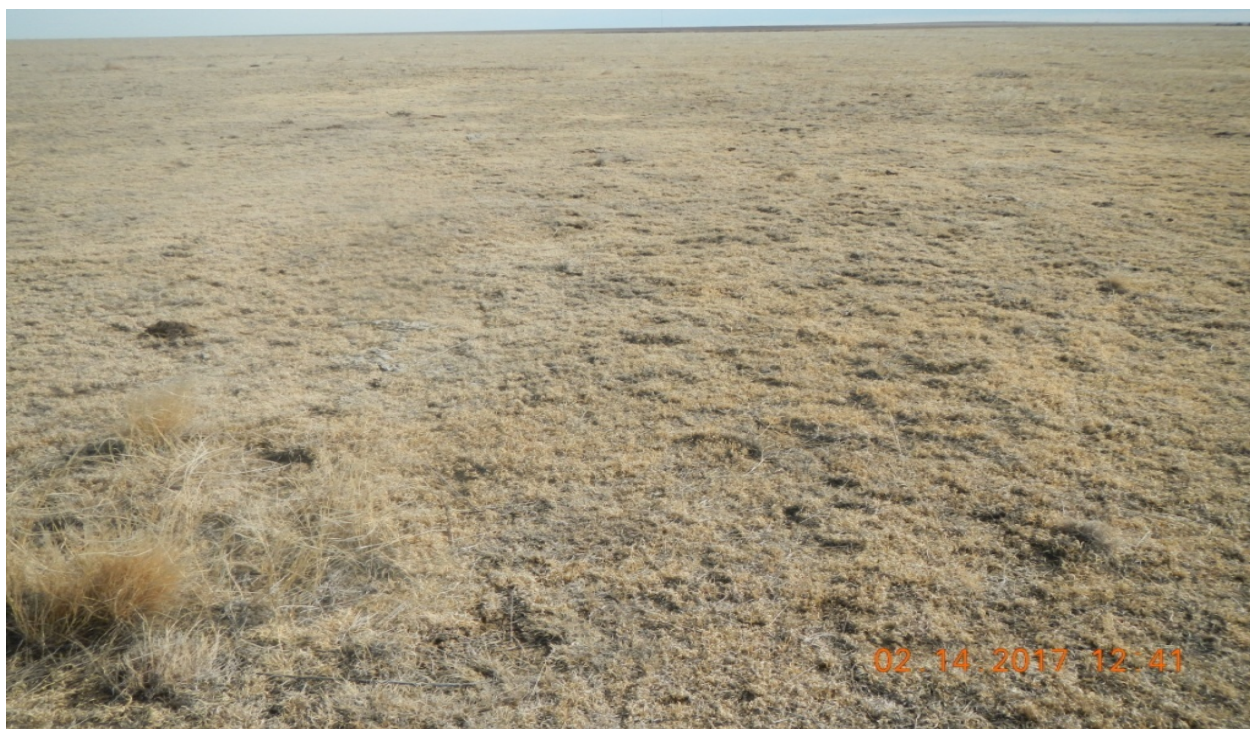
photo 6: Facing east toward the surrounding undisturbed vegetation.
