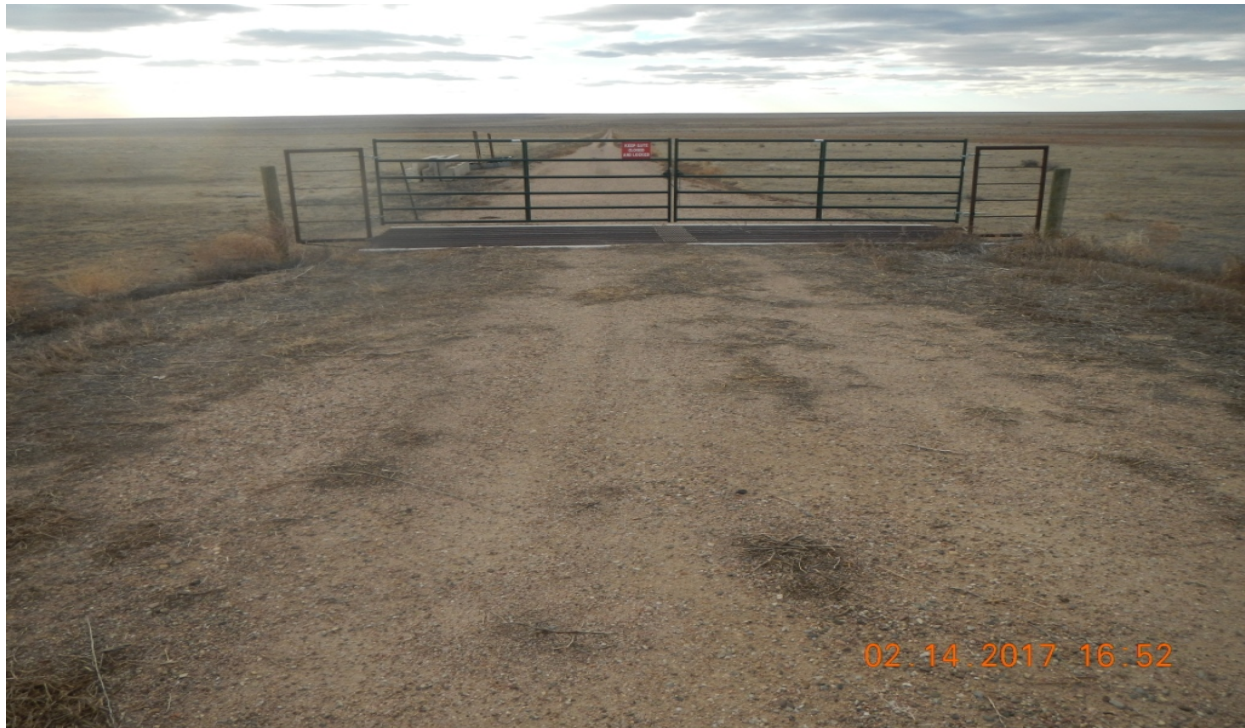
photo 1: Facing west at the beginning of the access road. The gate and cattle guard remains.

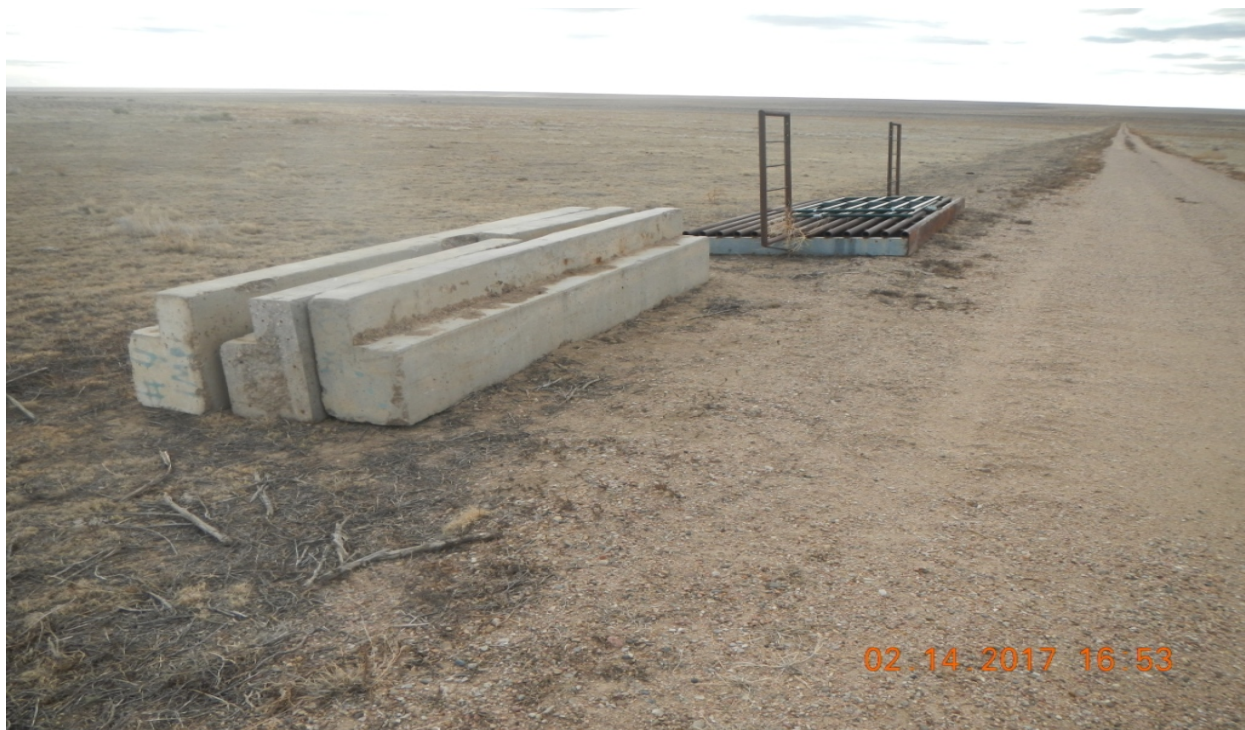
photo 2: A cattle guard and cement structures remain near the beginning of the access road.

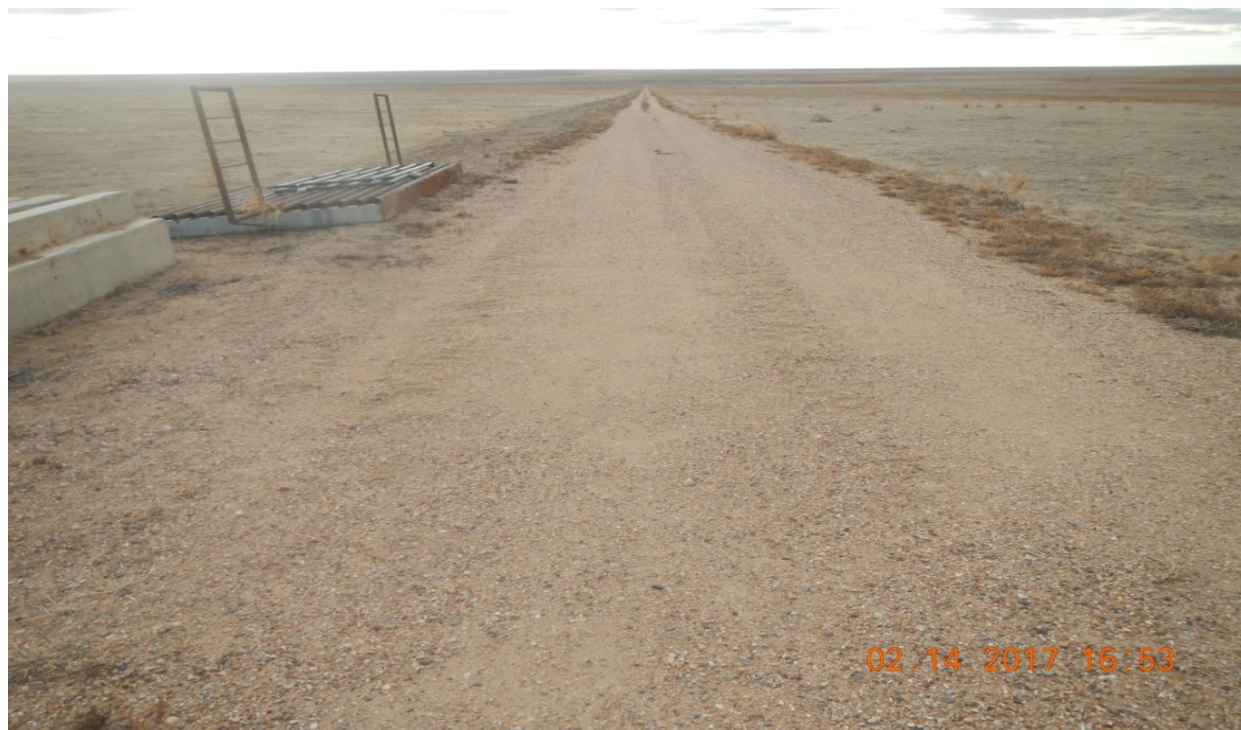
photo 3: Facing west. The access road has not been reclaimed and gravel remains.

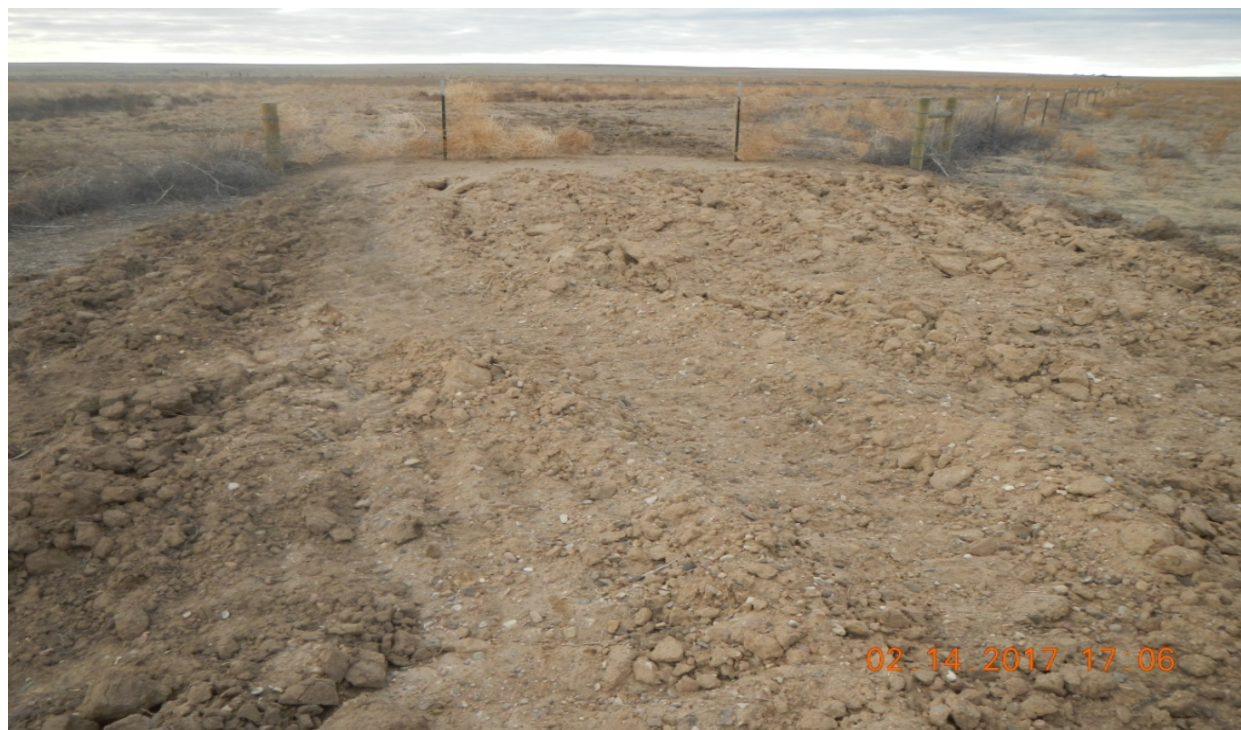
photo 4: Facing northwest toward the location. The location is fenced and soils have been ripped and partially contoured.

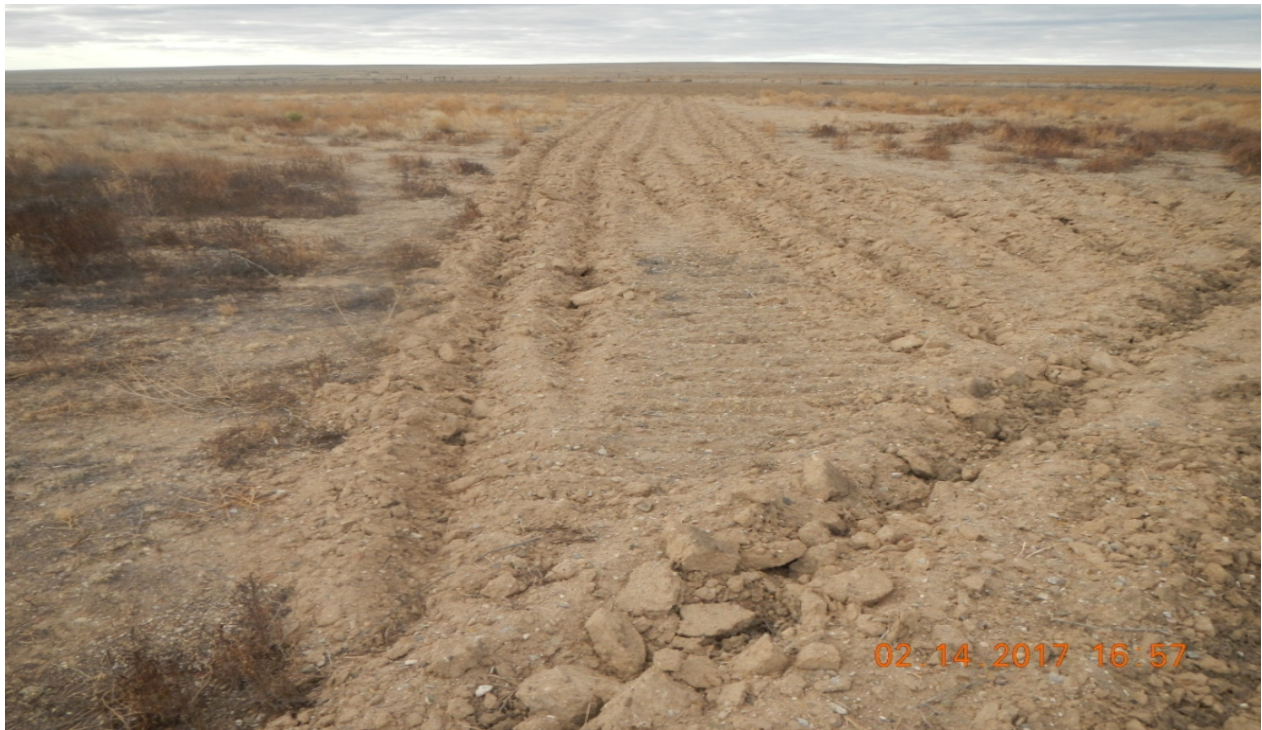
photo 5: Facing northwest toward the location. Portions of the location have been ripped.

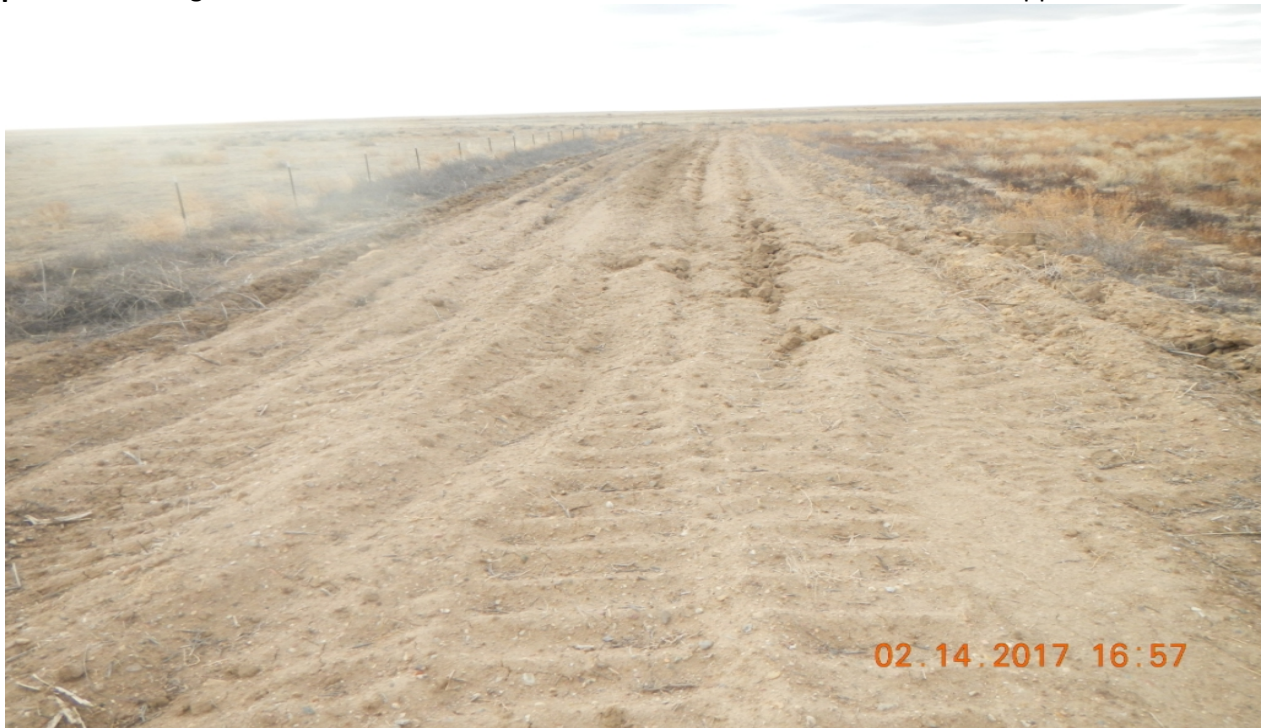
photo 6: Facing west along the south side of the location.

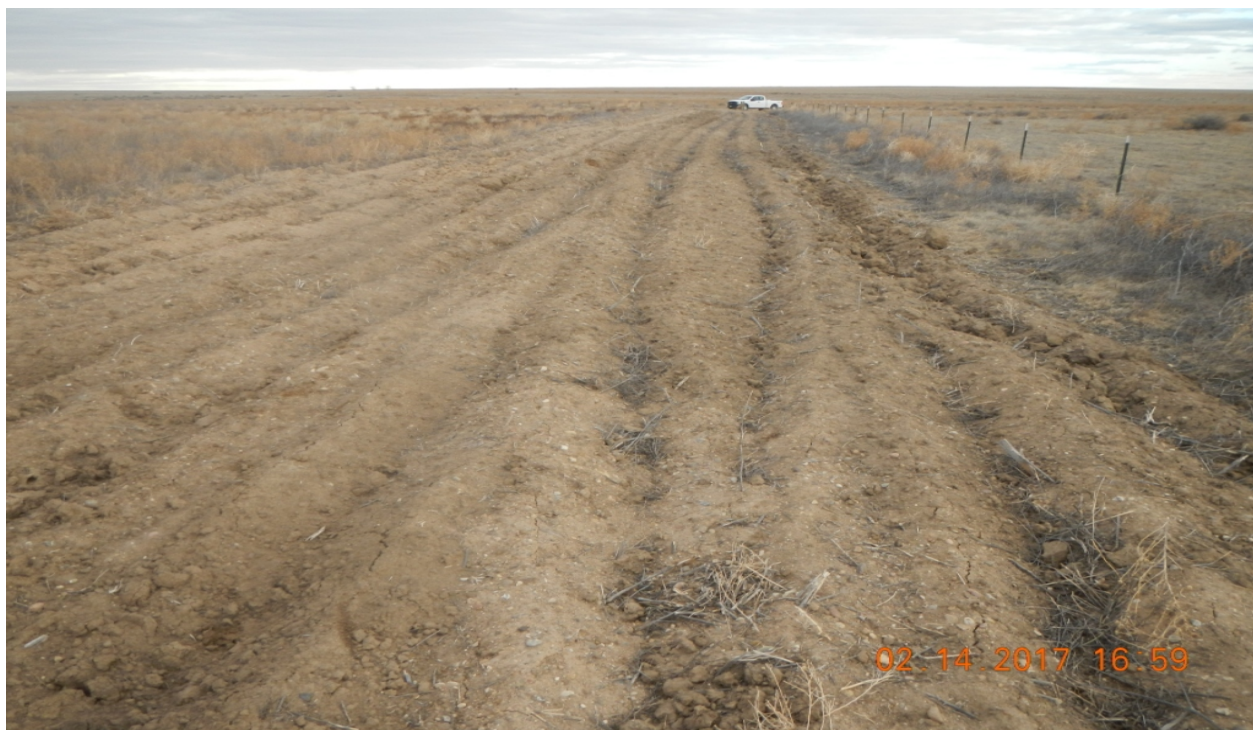
photo 7: Facing back toward the east along the south side of the location.

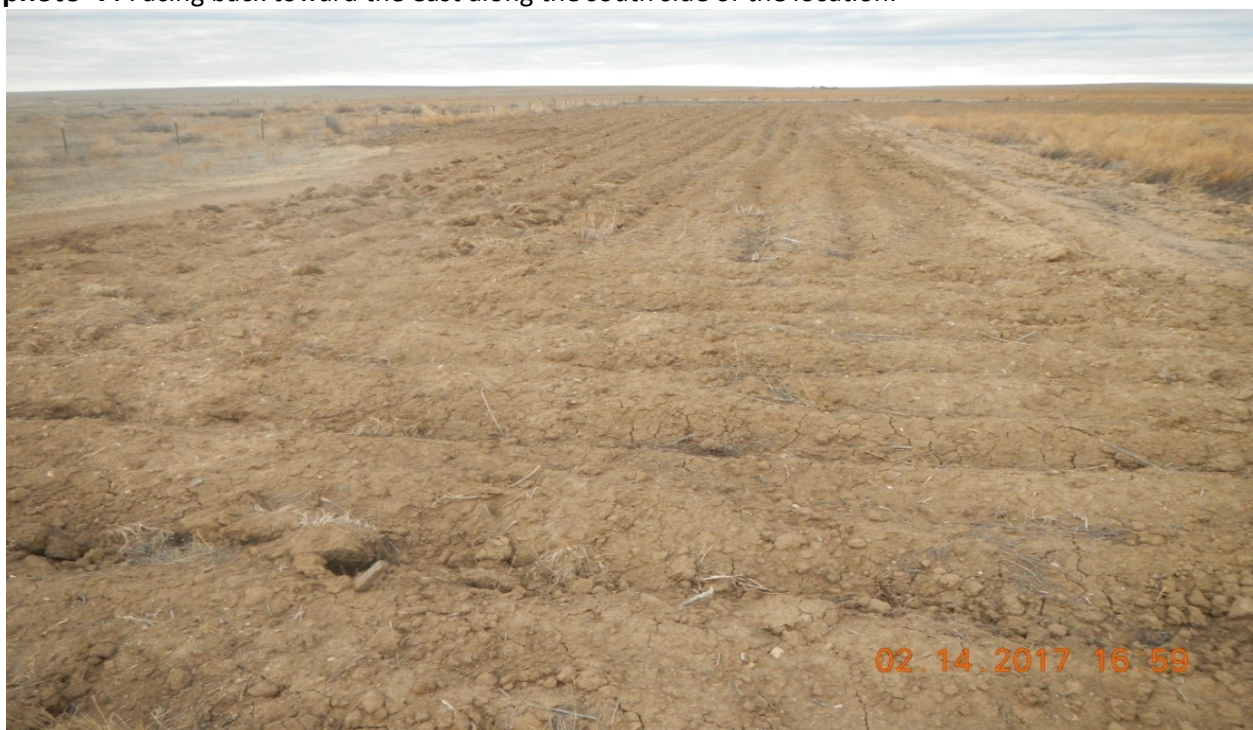
photo 8: Facing north along the west side of the location.

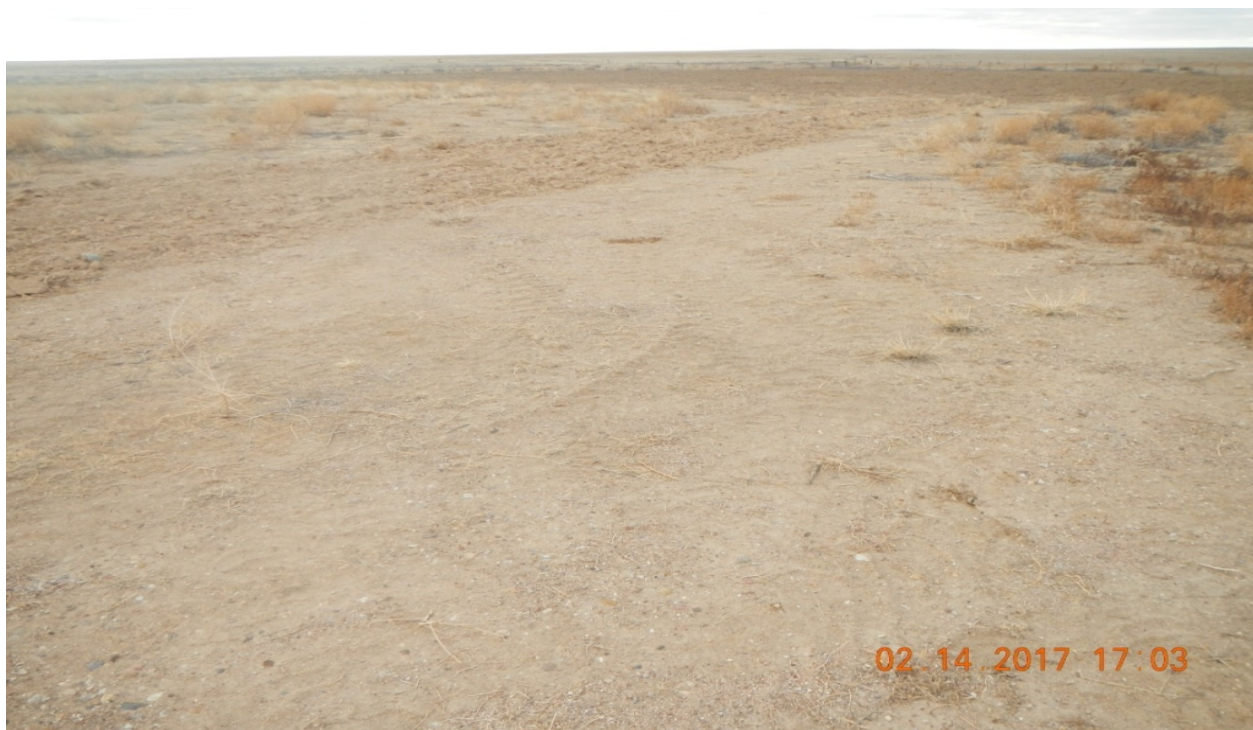
photo 9: Center of the location facing northwest.

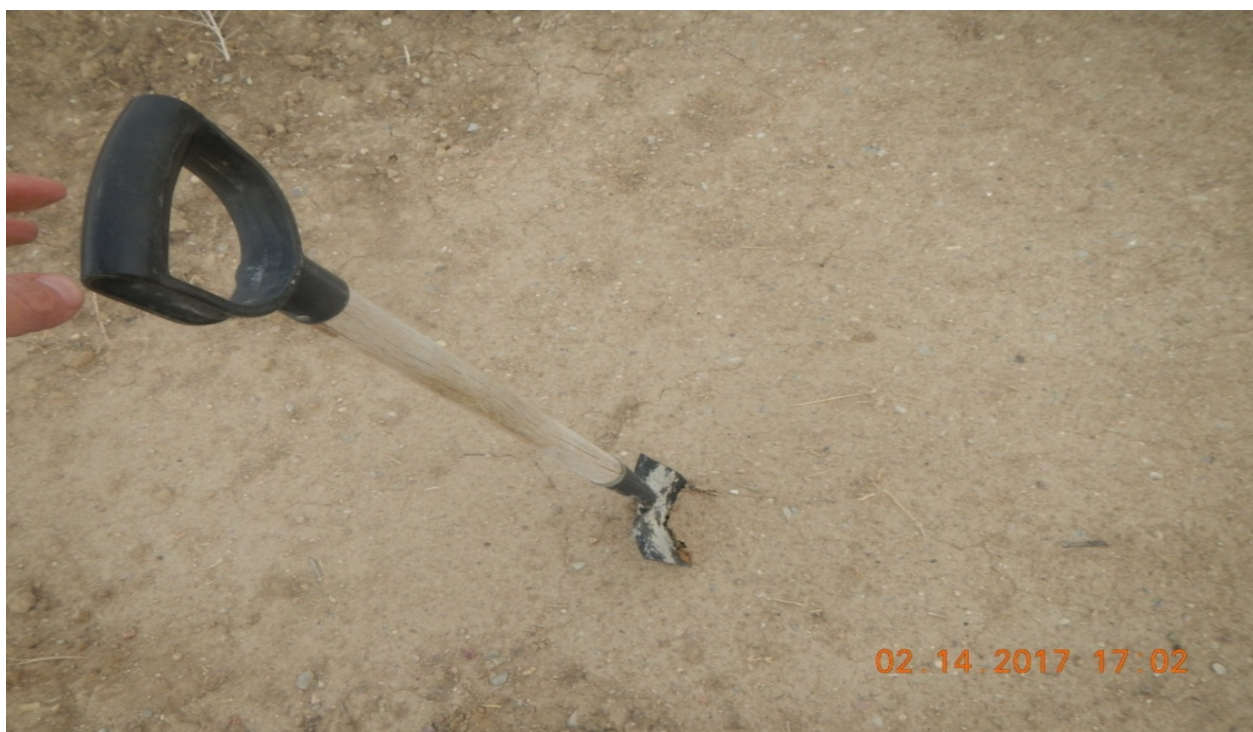
photo 10: There are areas at the center of the location where soils appear to be compacted.

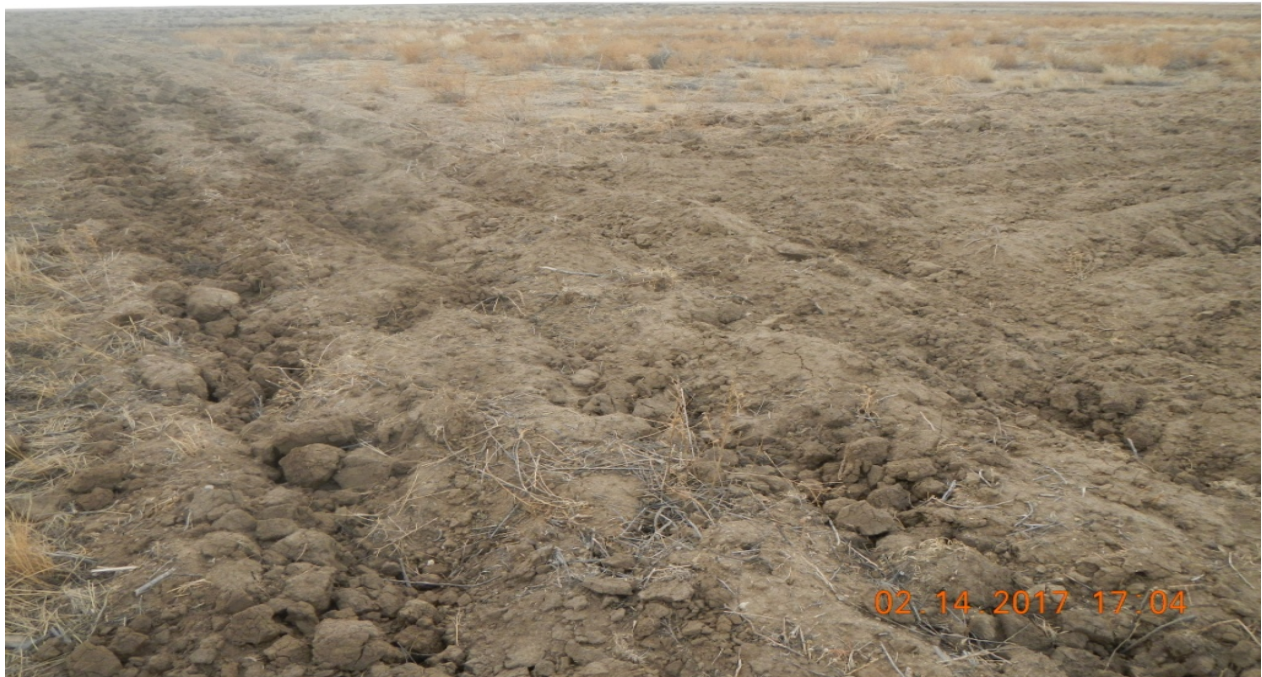
photo 11: Northeast corner facing southwest.

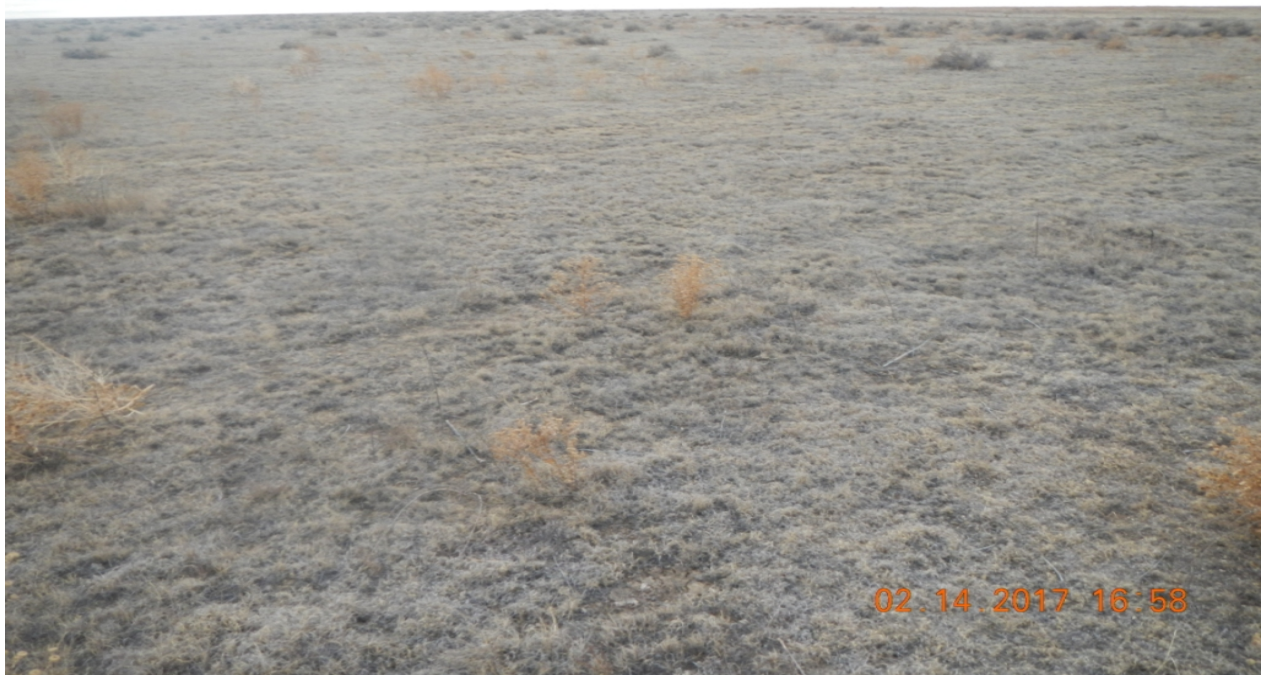
photo 12: Facing south toward the surrounding undisturbed vegetation.
