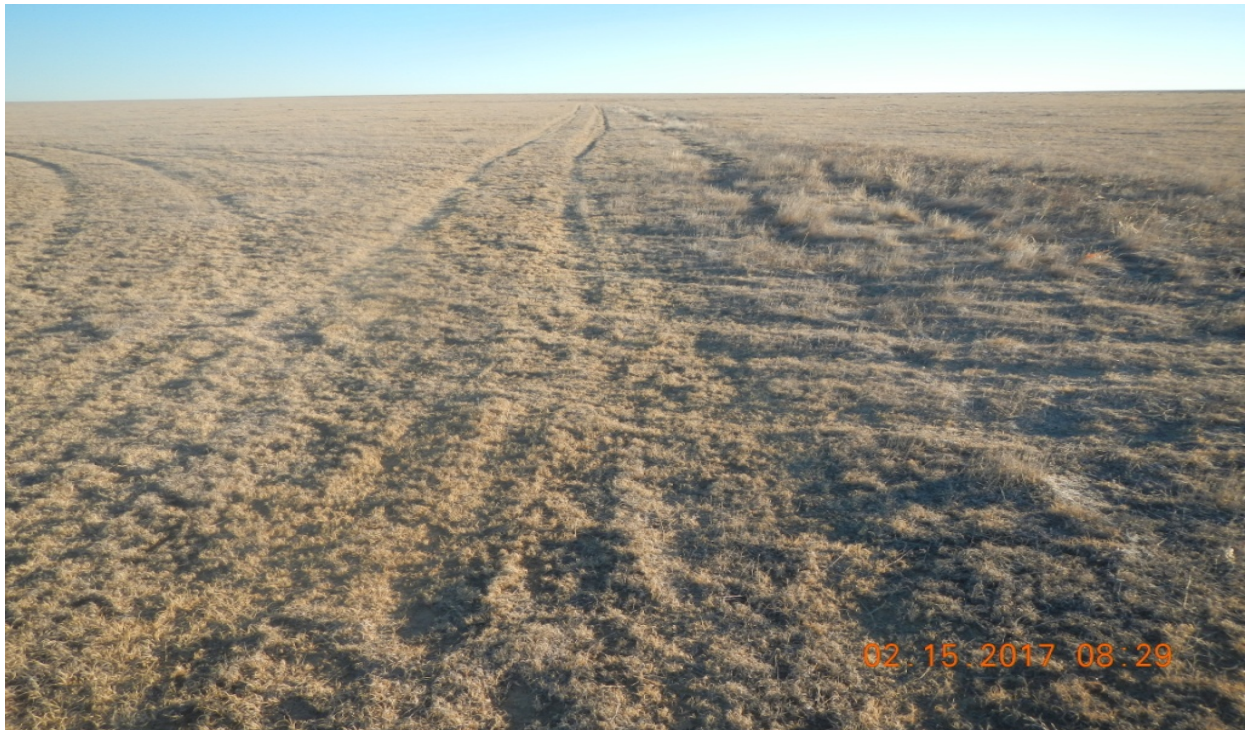
photo 1: The former access road is adequately established with vegetation.

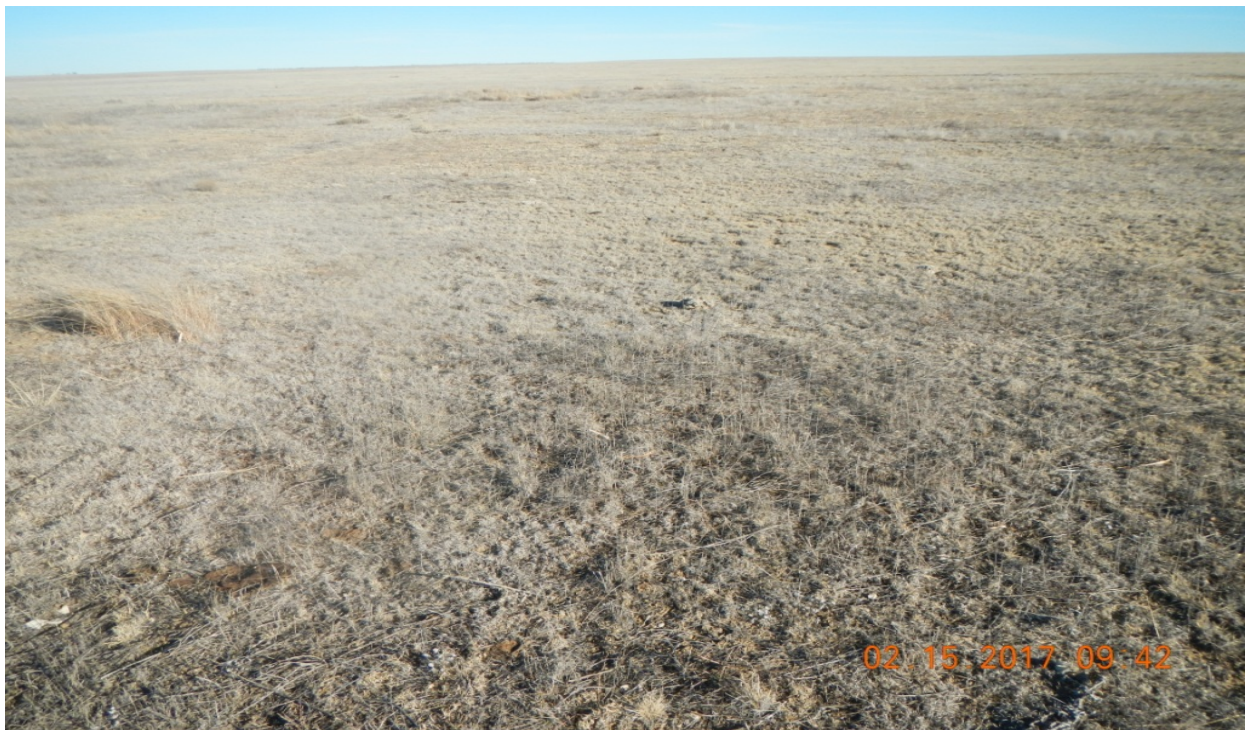
photo 2: South side of the location facing north.

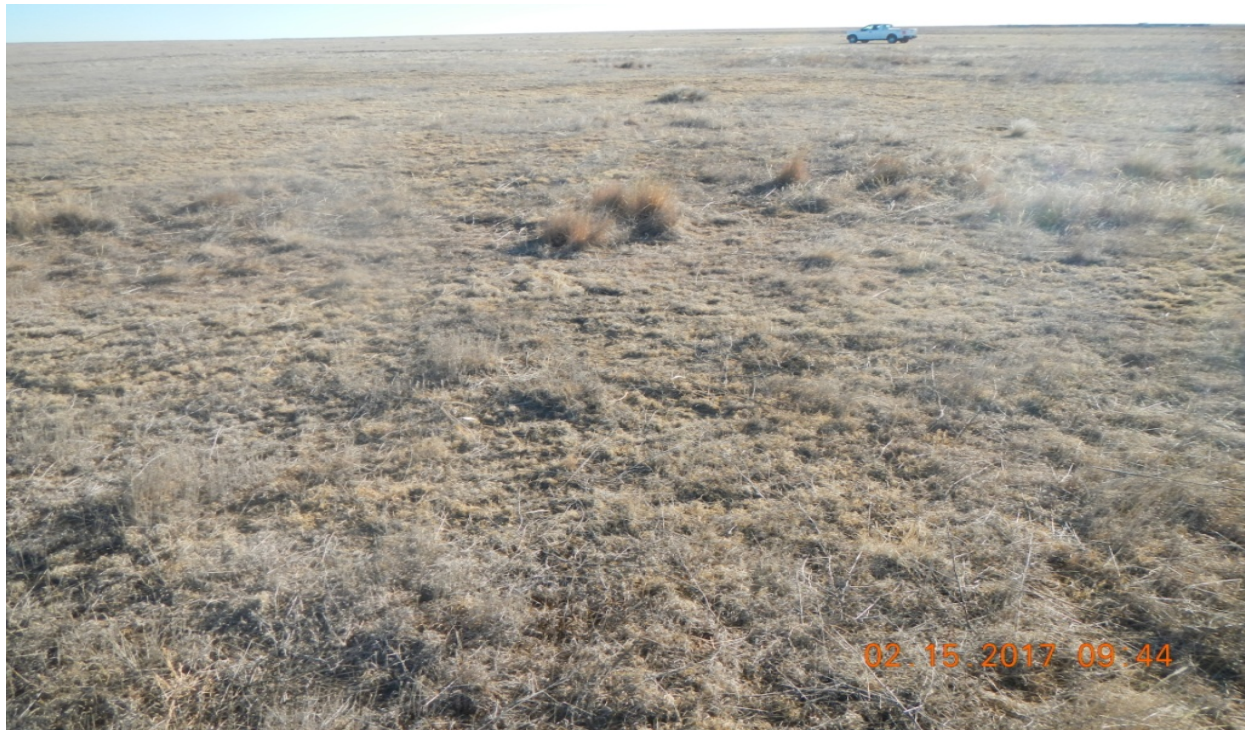
photo 3: West side of the location facing east.

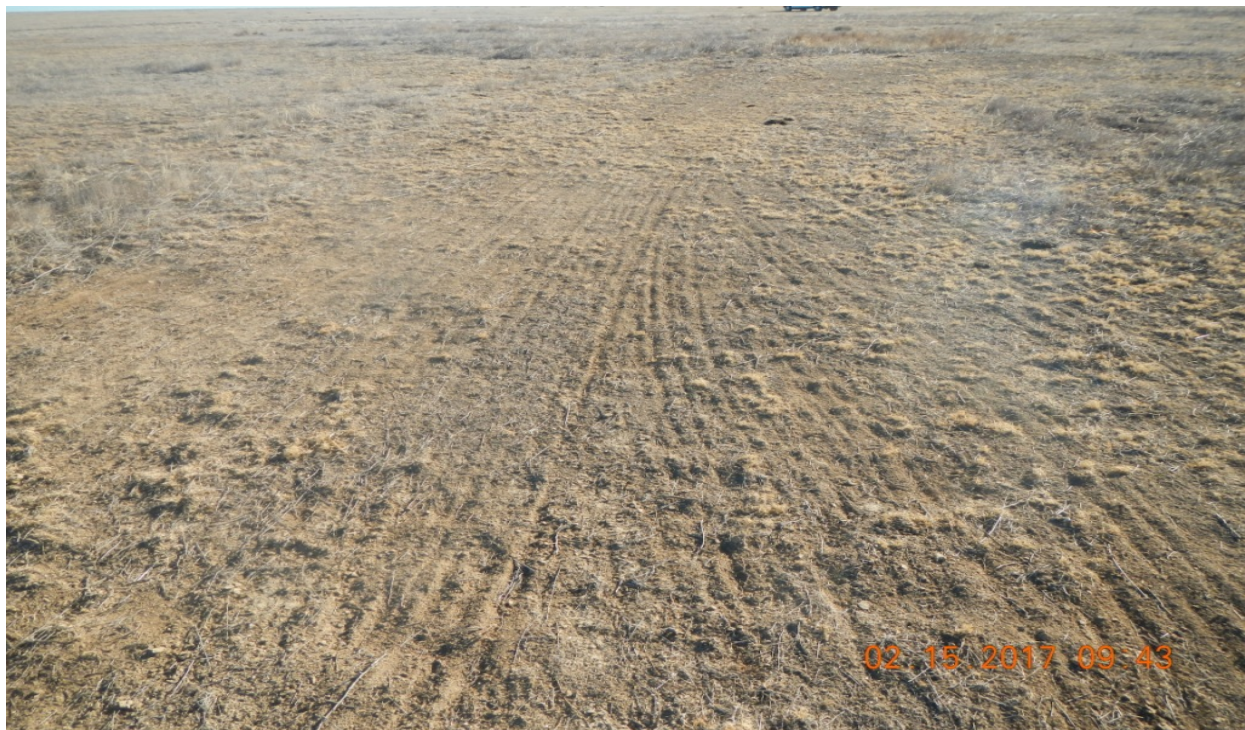
photo 4: It appears that areas with less vegetation cover were recently drill seeded.

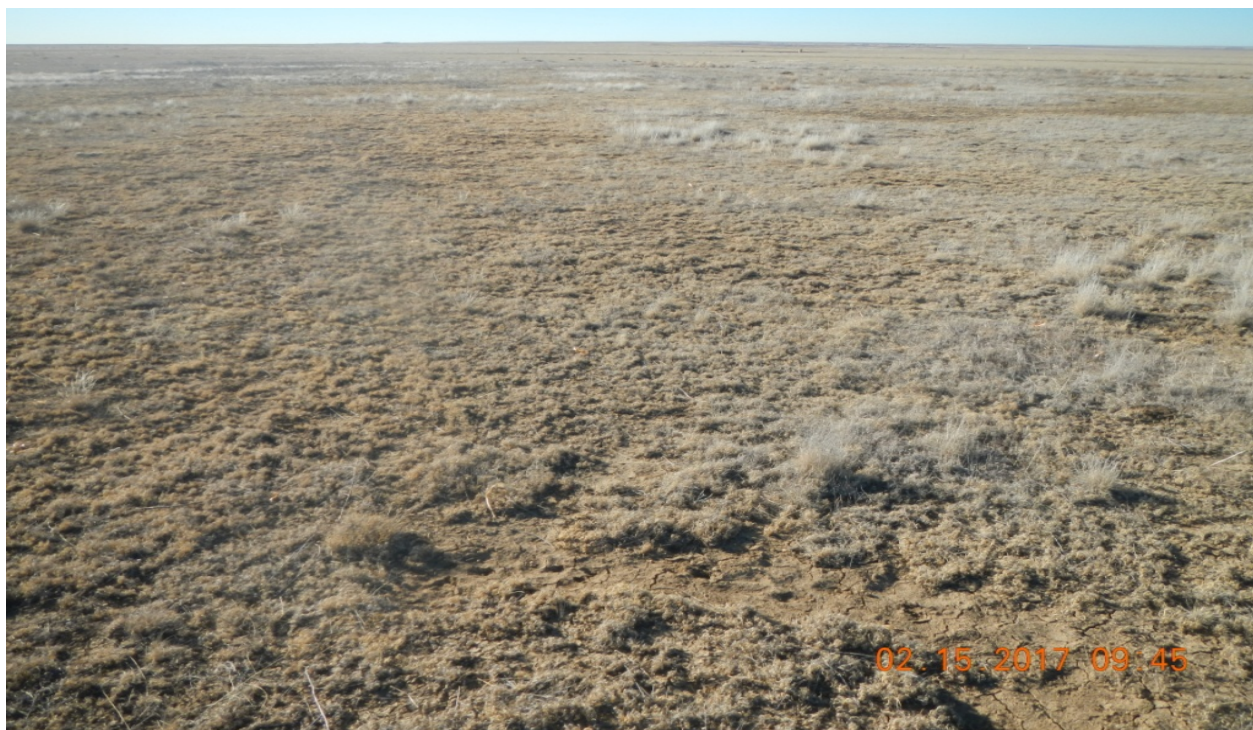
photo 5: North side of the location facing south toward the location.

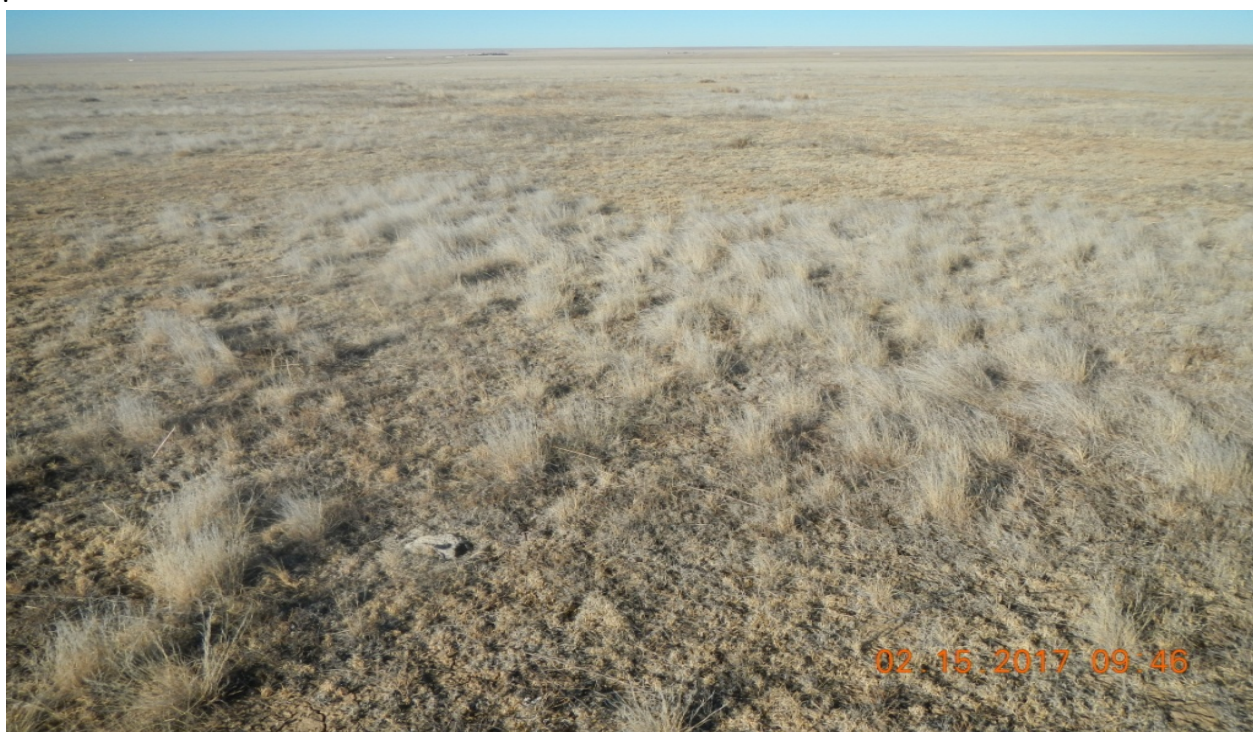
photo 6: East side of the location facing west toward the location.
