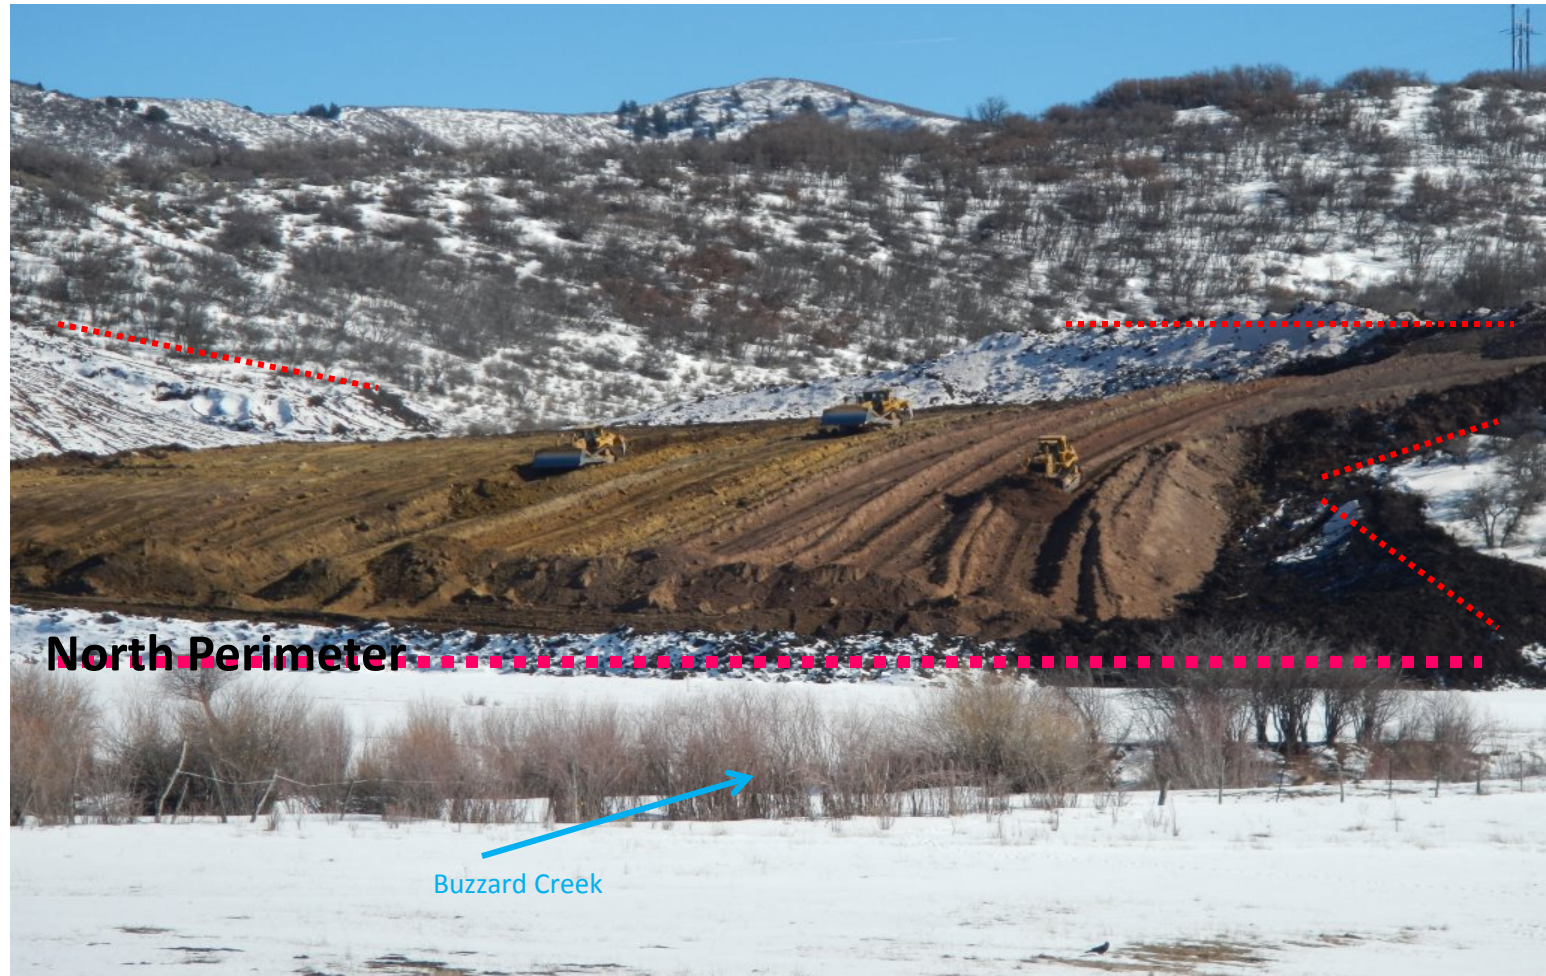
Photo#1:

View of Location From 330 E Rd to SE. Red dotted lines indicate Top soil salvaged & stored around Location Perimeter. BMPs have not been installed along outside base of Soil piles to prevent Run-off / Sediment Migration to nearby surface water or any drainages leading to surface water. North Perimeter is of most Concern

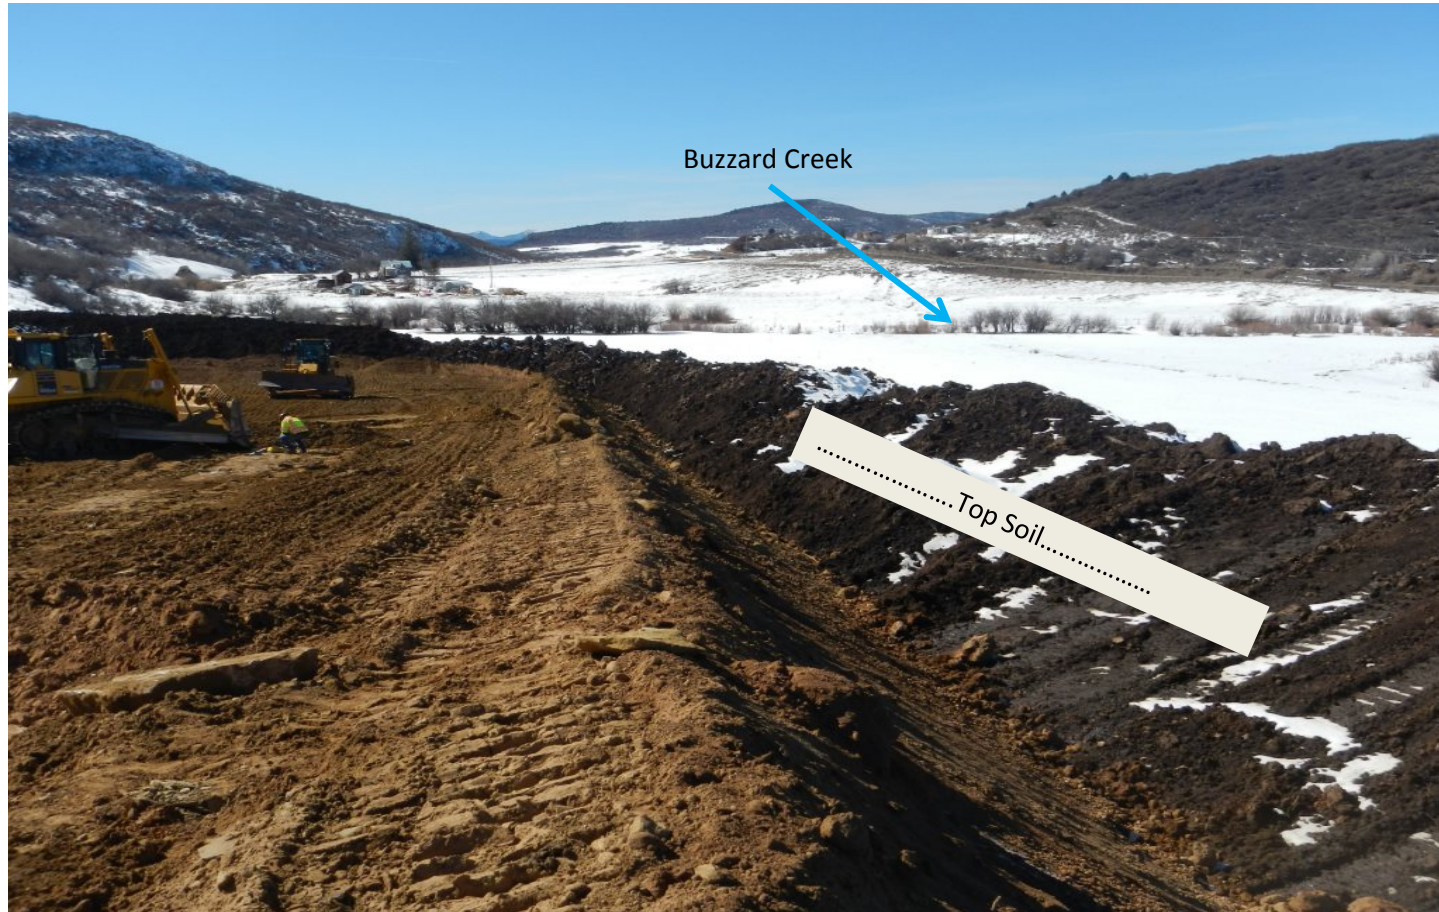
Photo#2:

View from Location Edge to NW.

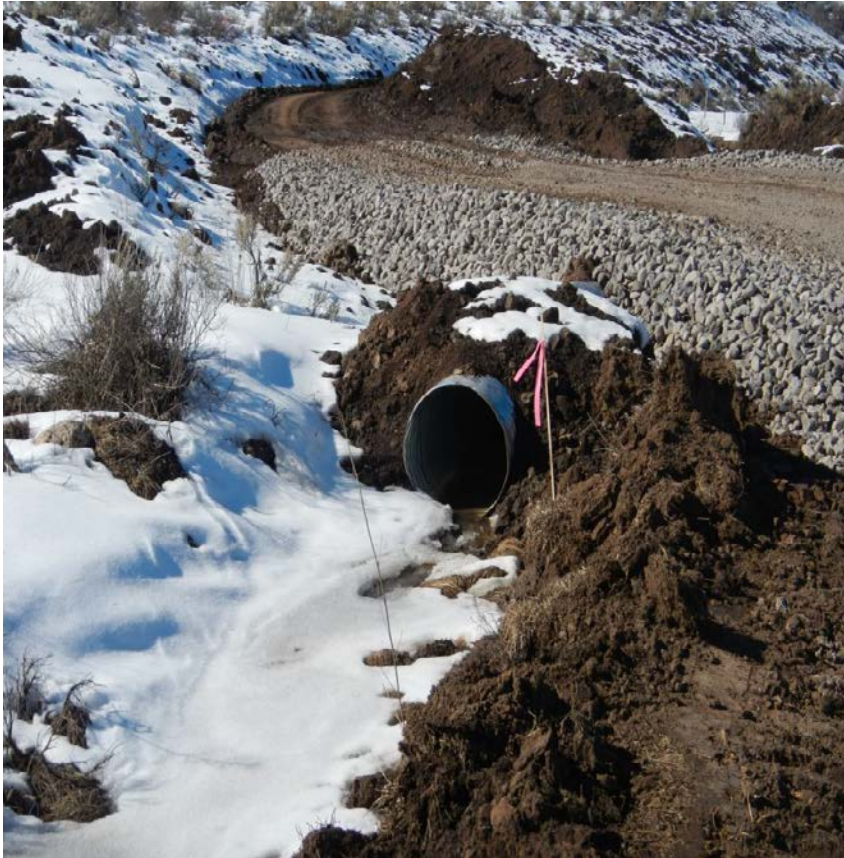
Photo#3:

Culvert , Gravel & Wattles Installed at beginning of Access Rd at point where it diverts off Local, Ground Hog Gulch Rd.

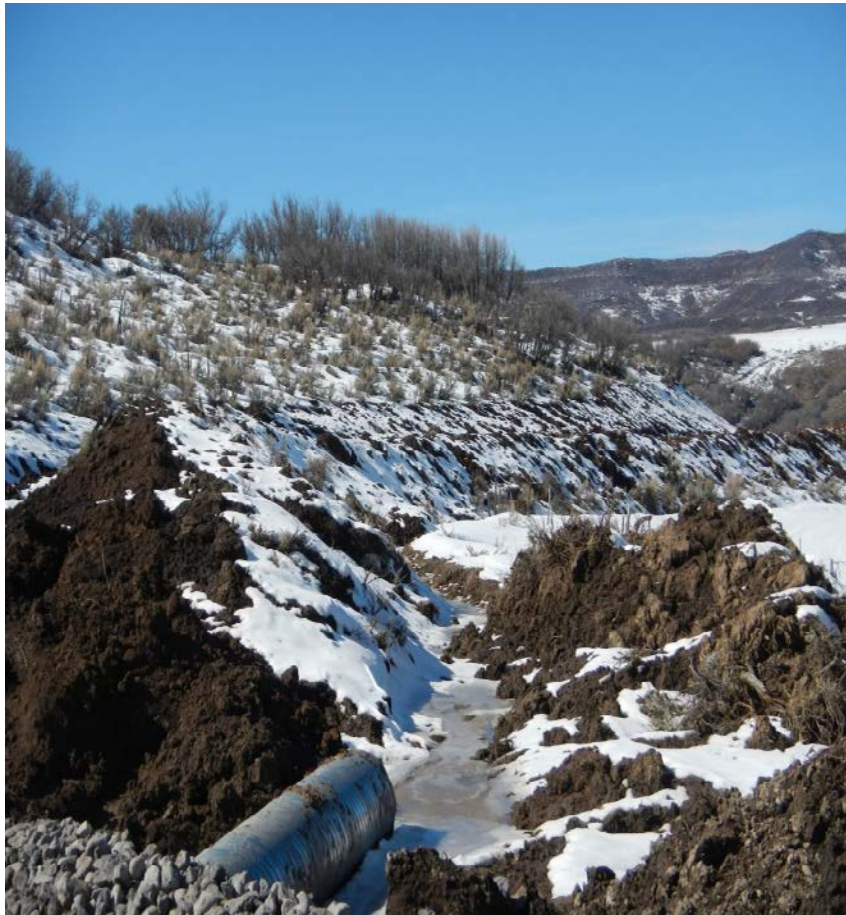
Photo#5:

Culvert empties into Ditch that runs along base of Access Rd.

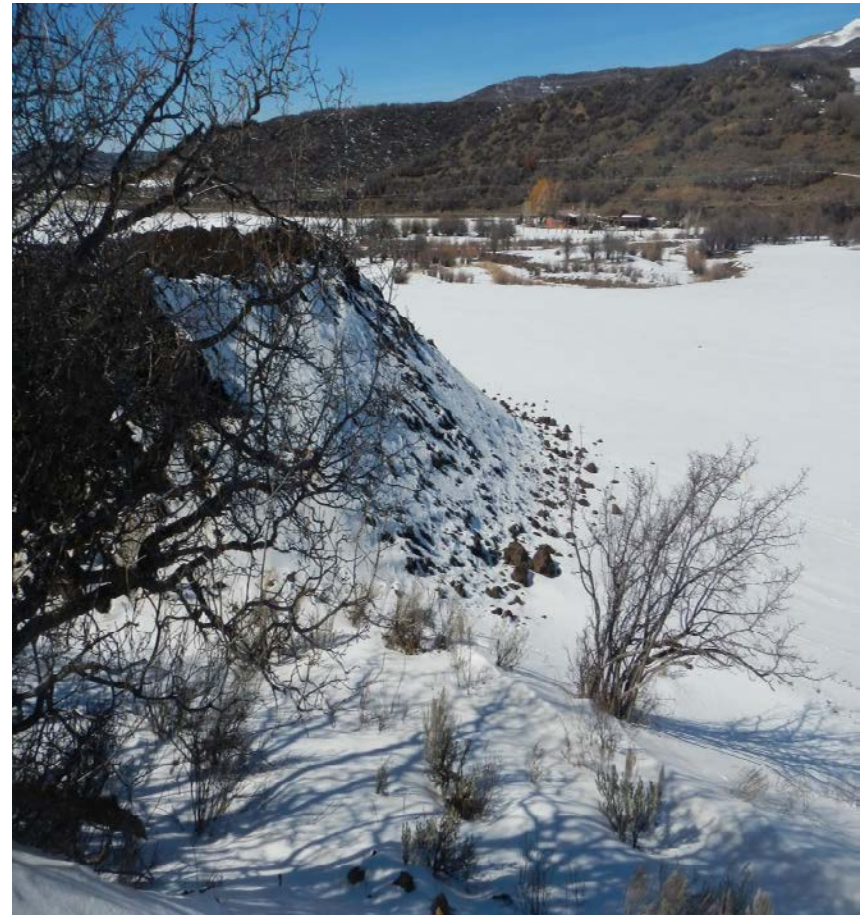
Photo#6:

No BMPs contain Top Soil around perimeter of Location or Access Rd.

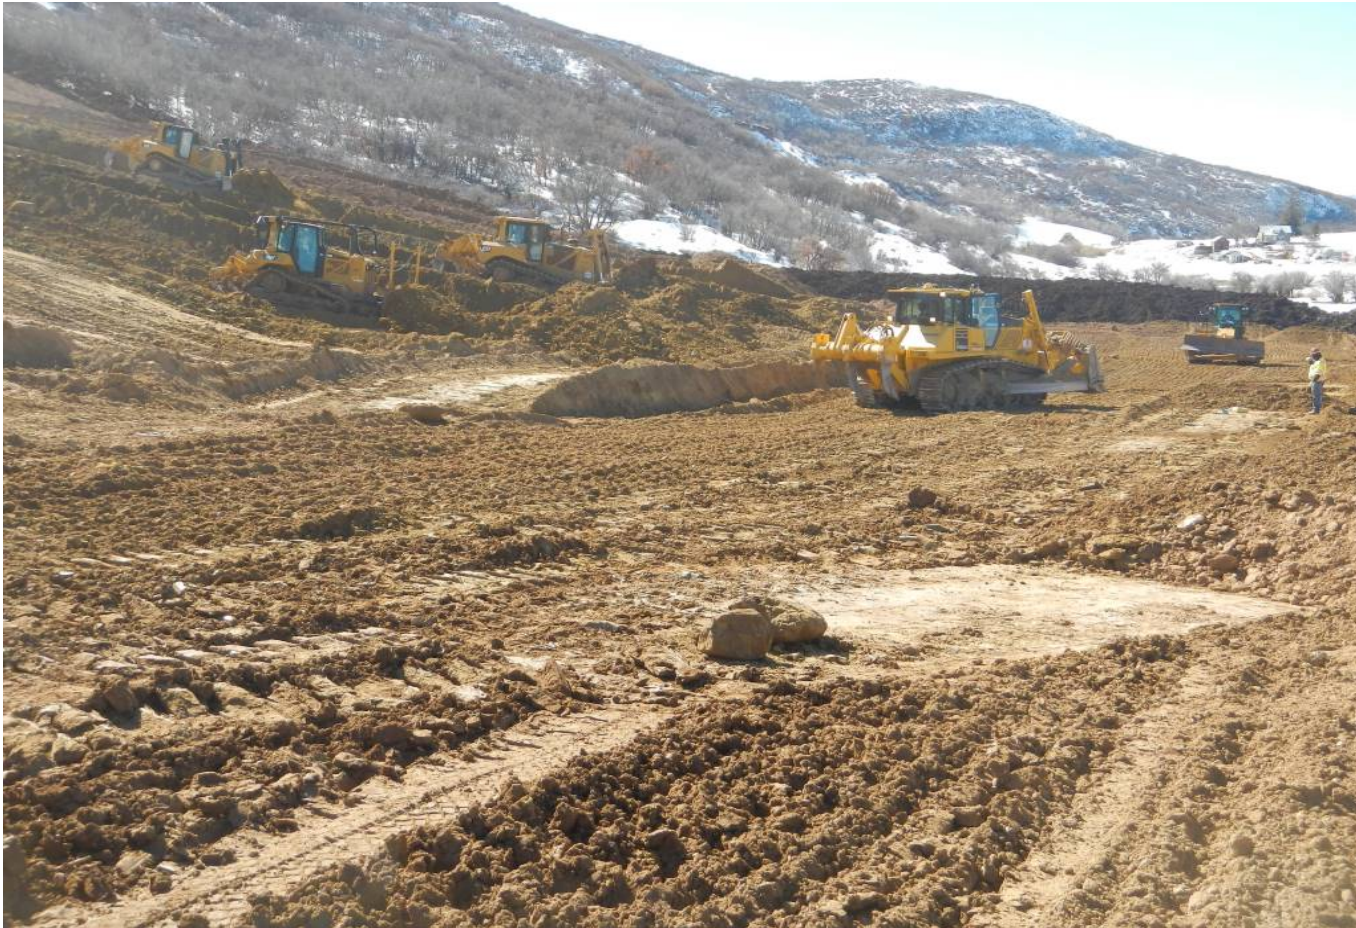
Photo#7:
Overview of Work on Location to SW.
