# Final Reclamation and Stormwater Inspection

March 21, 2017

Operator: ENERGY SEARCH CO ADBA ENERGY  
SEARCH CO INC - #27635

API: 001-08787

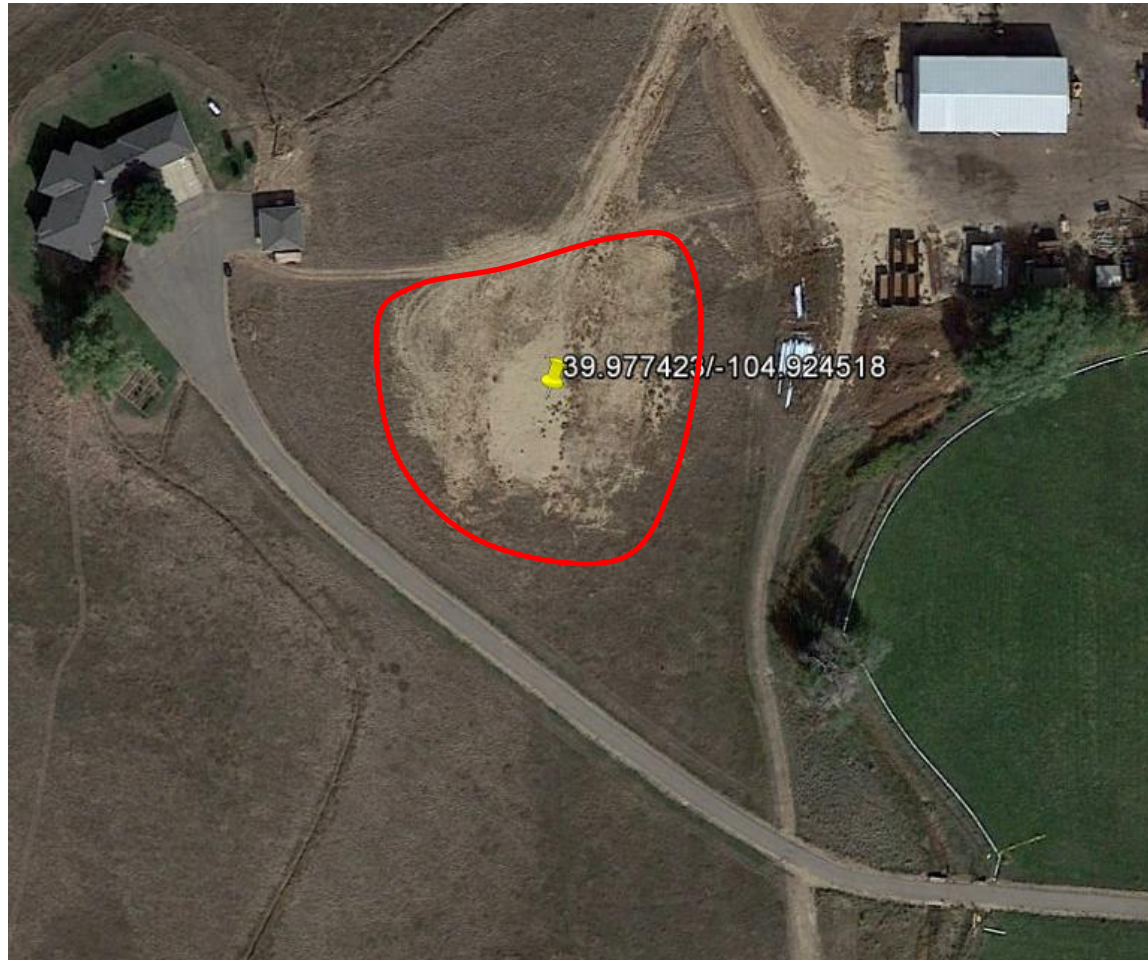
Google Earth aerial imagery taken October 9, 2015 of the Wierman #5 location area, illustrating the approximate disturbance area (highlighted in red) that does not meet Rule 1004 standards.

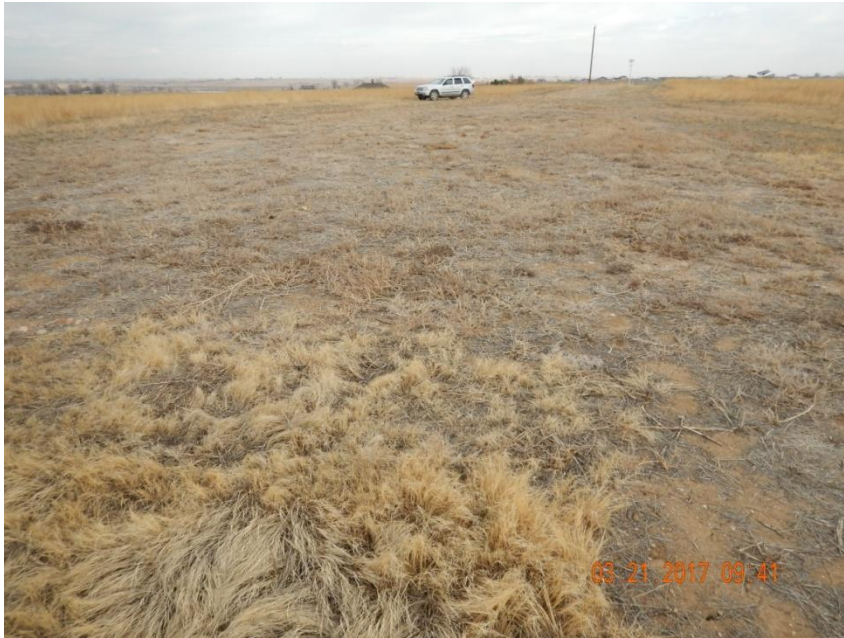
**Photo 1.** Photo taken from the southern location, facing North. Disturbance of the location is evident and does not meet Rule 1004 standards. Weedy, annual vegetative growth dominates location area.

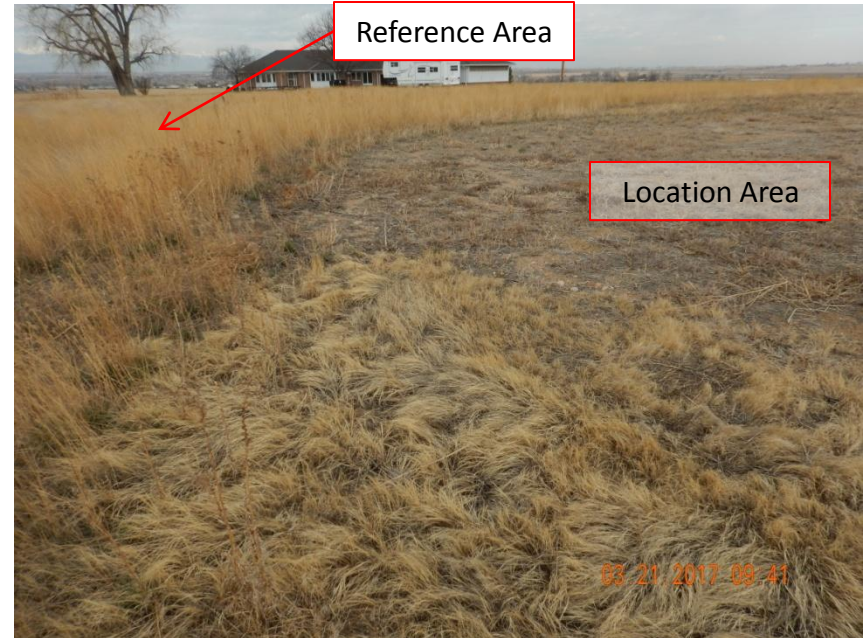
**Photo 2.** Photo taken from the southern location, facing West. Disturbance of the location is evident and does not meet Rule 1004 standards. Weedy, annual vegetative growth dominates location area. Reference area vegetation is mostly comprised of Crested wheatgrass (*Agropyron cristatum*).

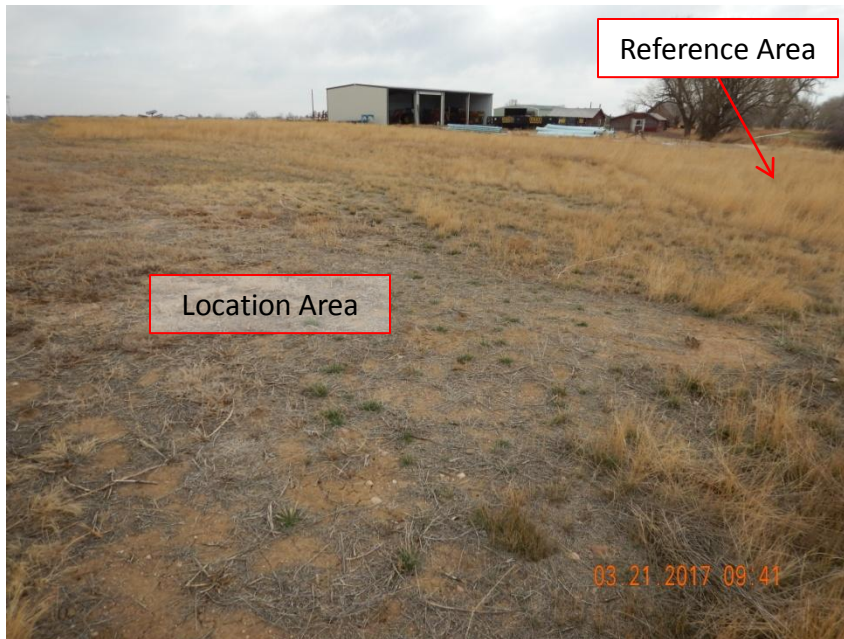
**Photo 3.** Photo taken from the southern location, facing East. Disturbance of the location is evident and does not meet Rule 1004 standards. Weedy, annual vegetative growth dominates location area. Reference area vegetation is mostly comprised of Crested wheatgrass (*Agropyron cristatum*).

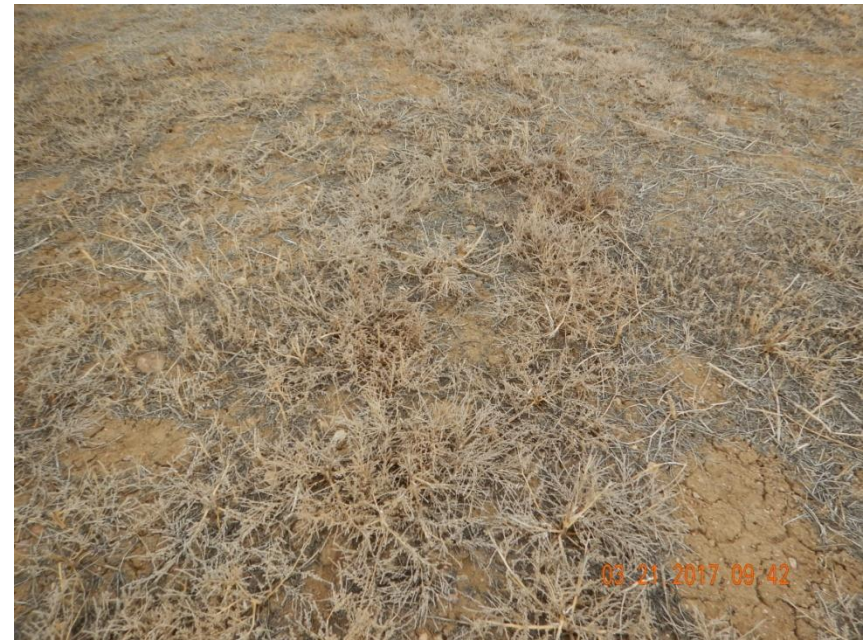
**Photo 4.** Photo taken from the location area, illustrating the weedy, annual vegetation shown here as *Kochia sp.*
