Inspection Photos

03/24/2017

Operator: Bill Barrett Corp #10071

Location ID: 449306

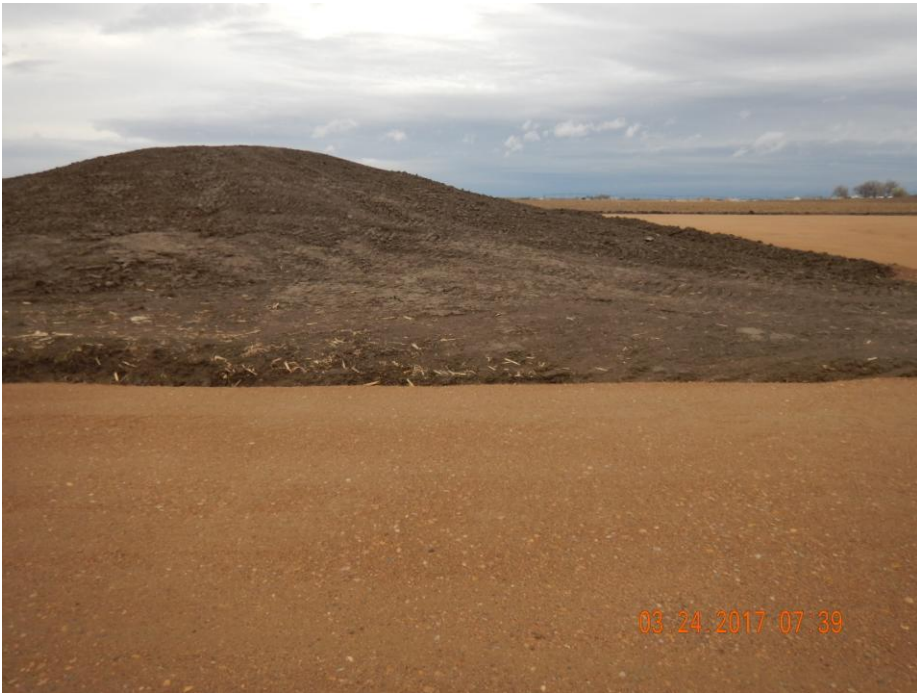
Photo 1: Photo taken from the north end of the location facing east. Photo shows top soil stock pile on the northeast end of the location.

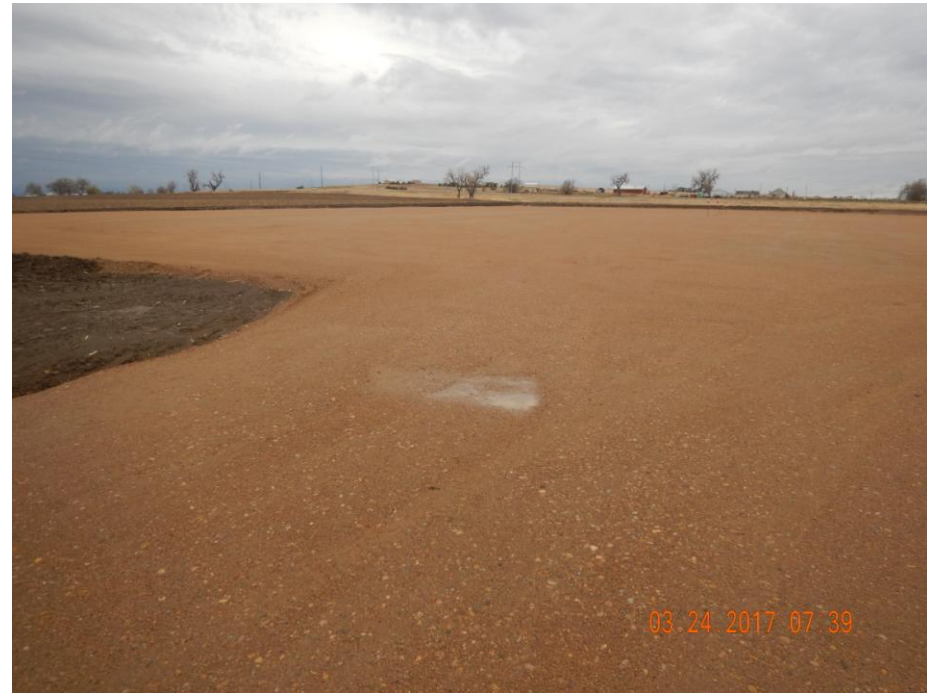
Photo 2: Photo taken from the north end of the location facing southeast. Photo shows pad has largely been stabilized with initial pad construction activities appearing to have been completed.

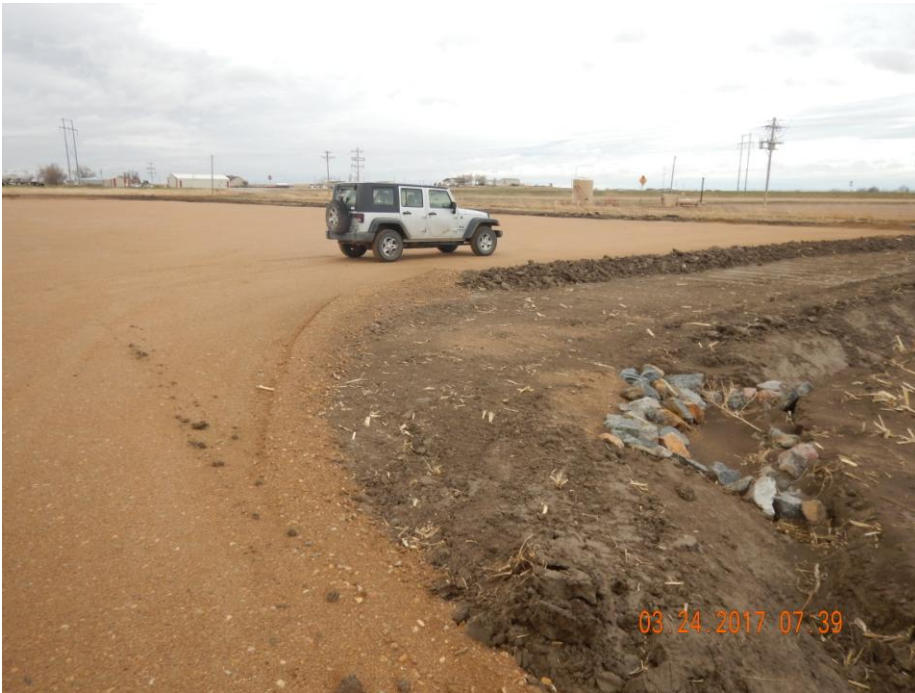
Photo 3: Photo taken from the north end of the location facing southwest. Photo shows pad has largely been stabilized with initial pad construction activities appearing to have been completed.

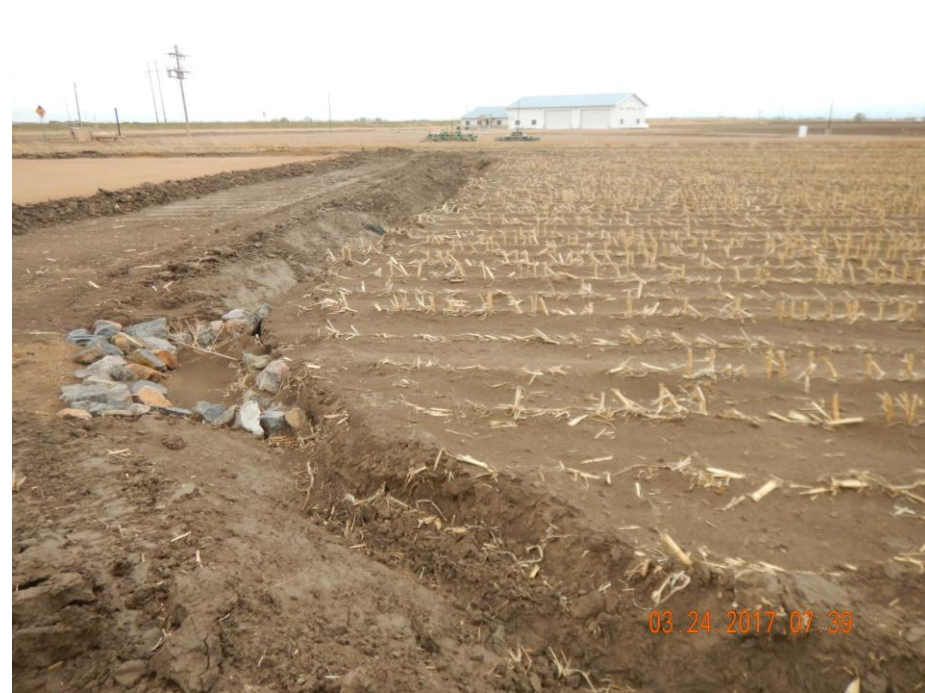
Photo 4: Photo taken from the north end of the location facing west. Photo shows perimeter stormwater control ditch and rock sediment trap BMPs

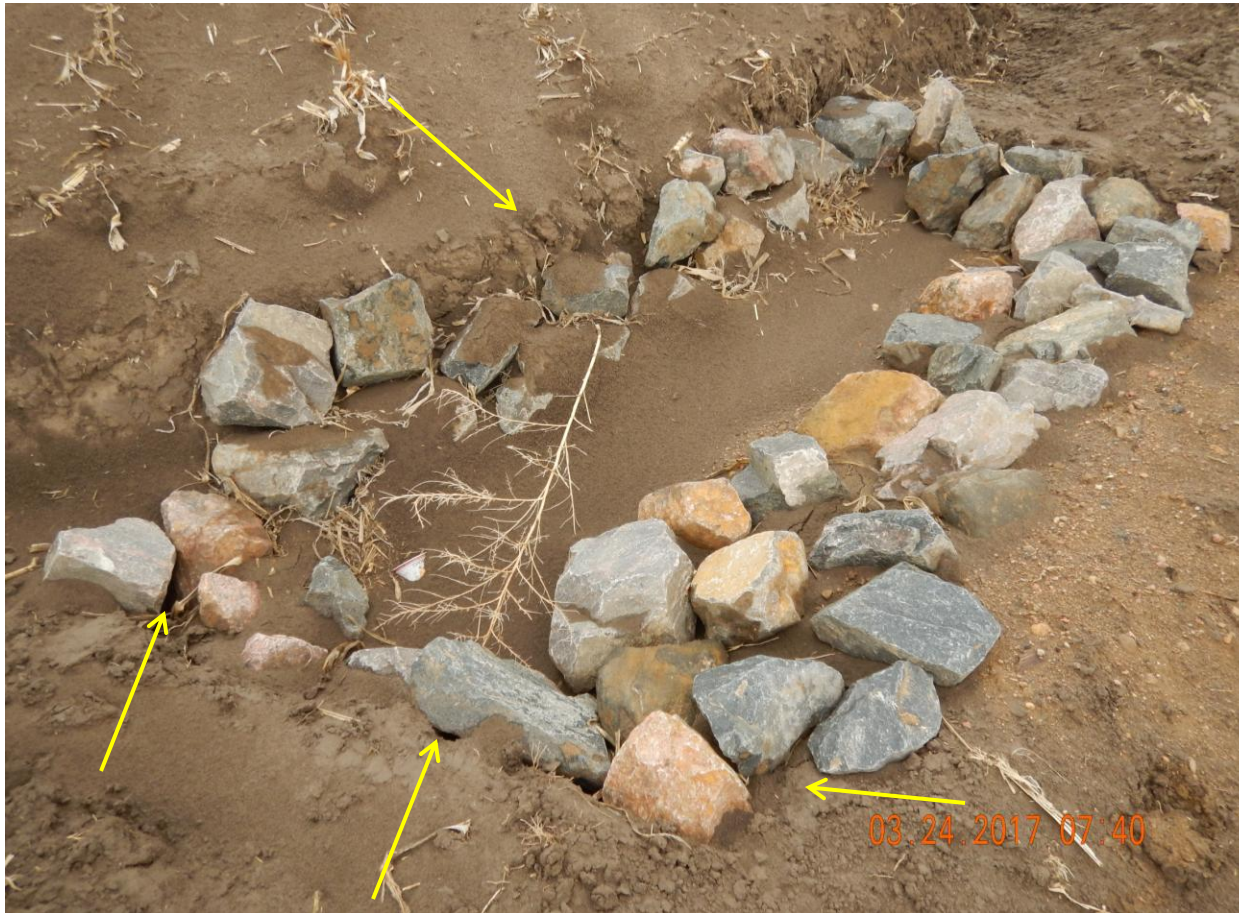
Photo 5: Photo taken from the northwest end of the location. Photo shows sediment trap BMP. BMP has filled with sediment and will require maintenance. It appears only large-sized rock aggregate have been utilized to construct the BMP; using only large aggregates can contribute to erosion degradation as stormwater can be accelerated around or under the material, expanding stormwater impacts and rendering the BMP inadequate. This is becoming evident in areas shown by the yellow arrows

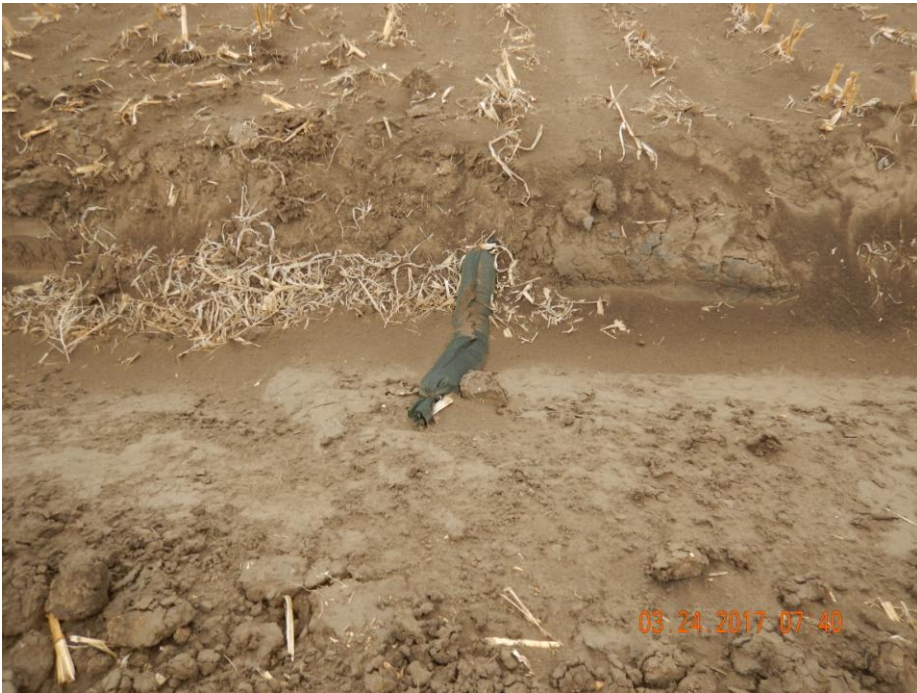
Photo 6: Photo taken from the stormwater control ditch on the north end of the location. Photo shows wattle BMP has filled with sediment and will require maintenance.

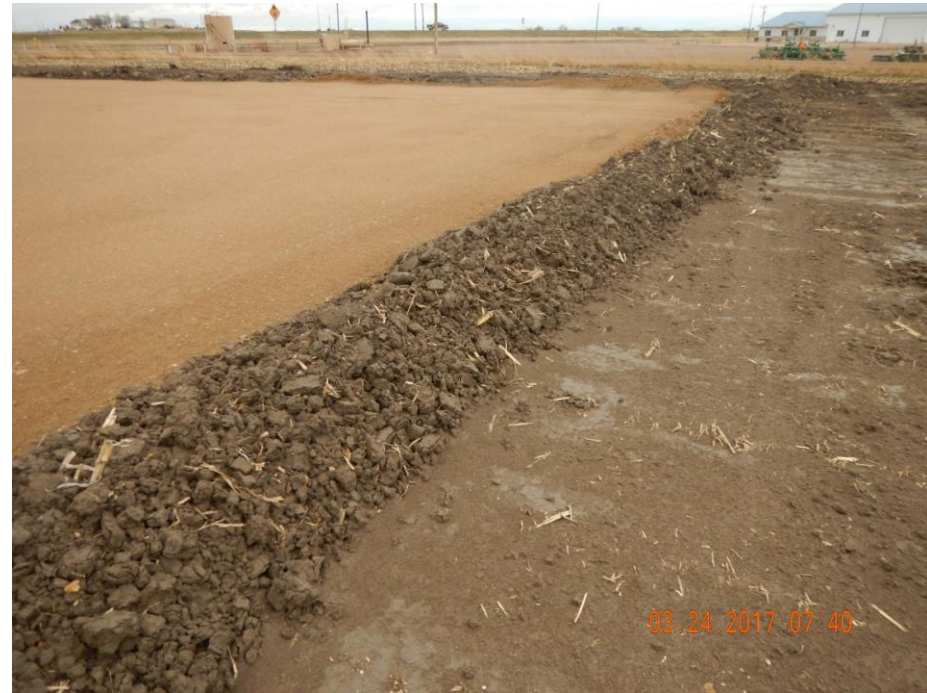
Photo 7: Photo taken from the north end of the location, facing west. Photo shows berm on the north end has not been consolidated and not in proper functioning condition. Without proper consolidation berms along the location perimeter will increase the sediment laden stormwater runoff from the location.

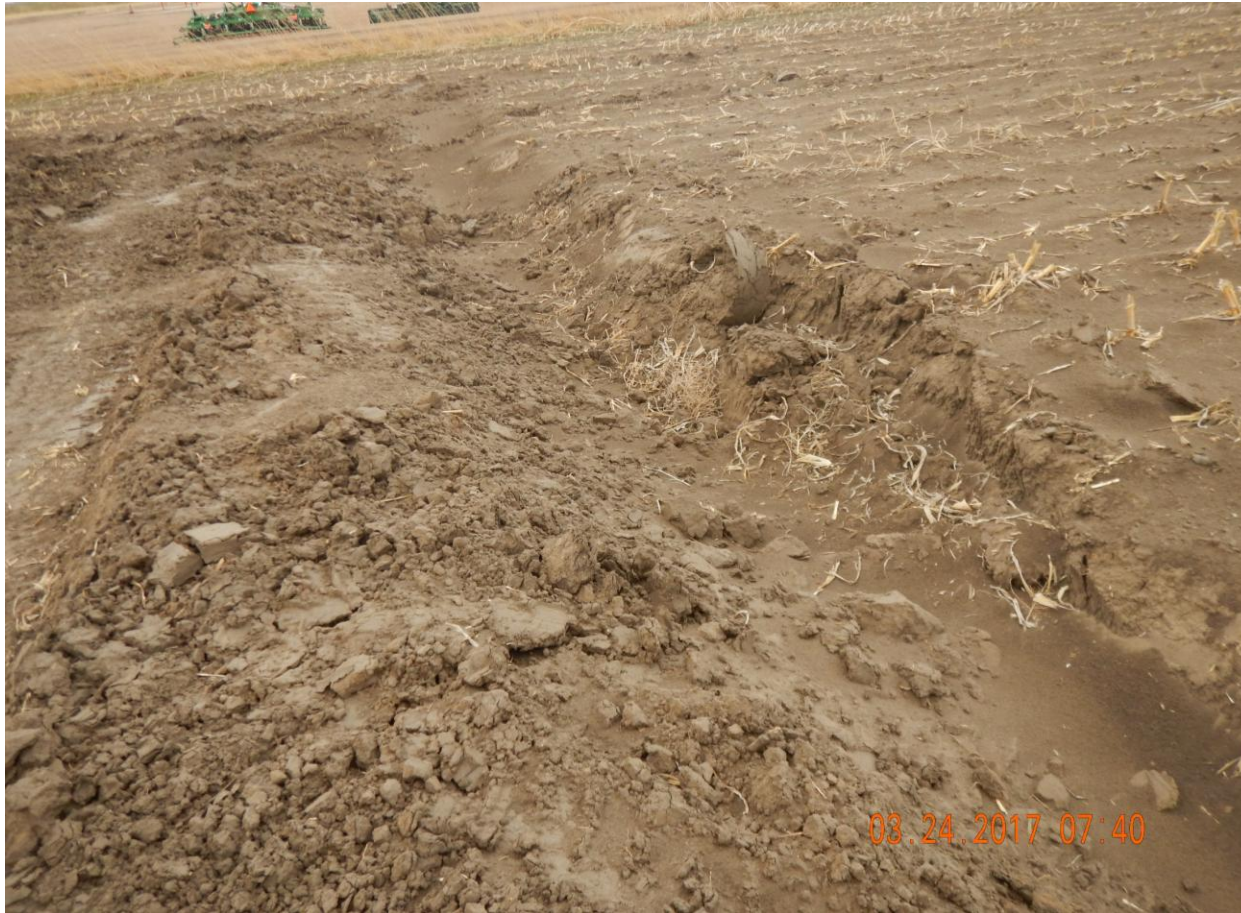
Photo 8: Photo taken from the north end of the location. Photo shows stormwater ditch has filled with sediment and will require maintenance. Stormwater ditch has not been consolidated. Without proper consolidation this ditch will increase the sediment laden stormwater runoff from the location.

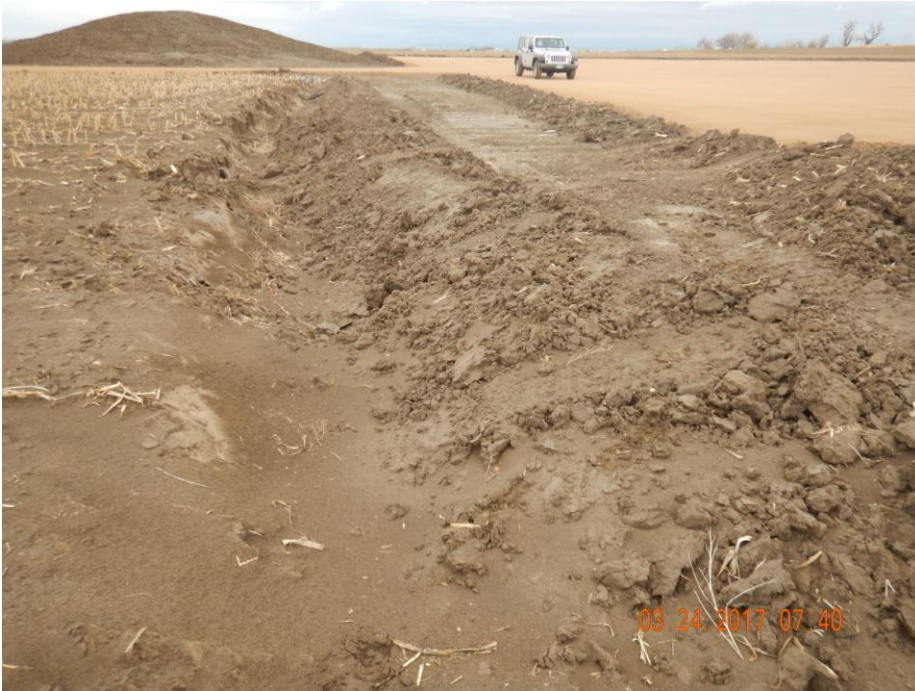
Photo 9: Photo taken from the northwest corner of the location, facing east. Photo shows stormwater ditch has filled with sediment and will require maintenance. Stormwater ditch has not been consolidated. Without proper consolidation this ditch will increase the sediment laden stormwater runoff from the location.

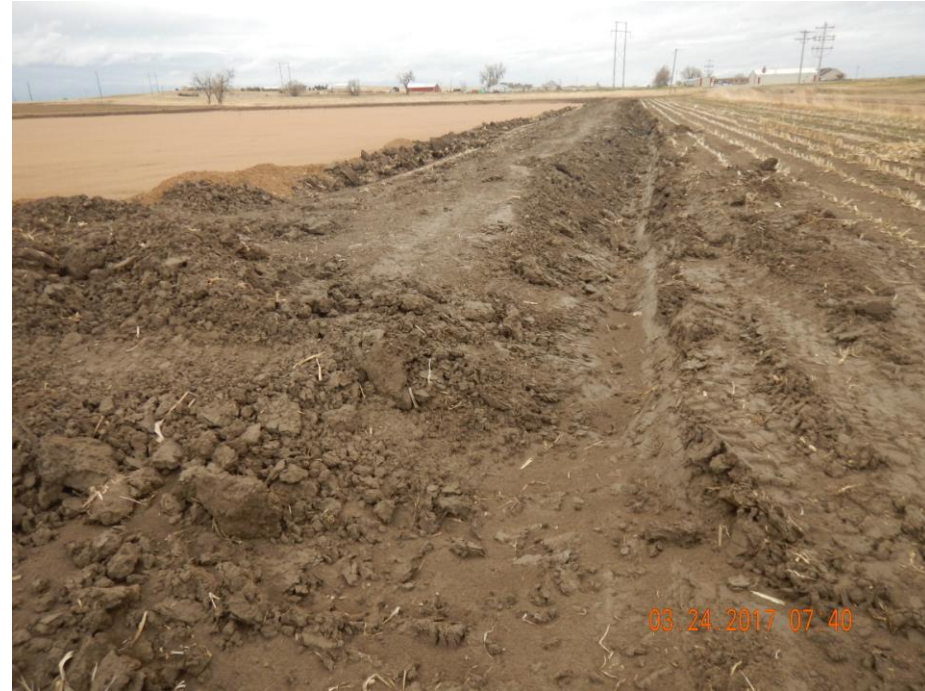
Photo 10: Photo taken from the northwest corner of the location, facing south. Photo shows stormwater ditch; Stormwater ditch has not been consolidated. Without proper consolidation this ditch will increase the sediment laden stormwater runoff from the location.

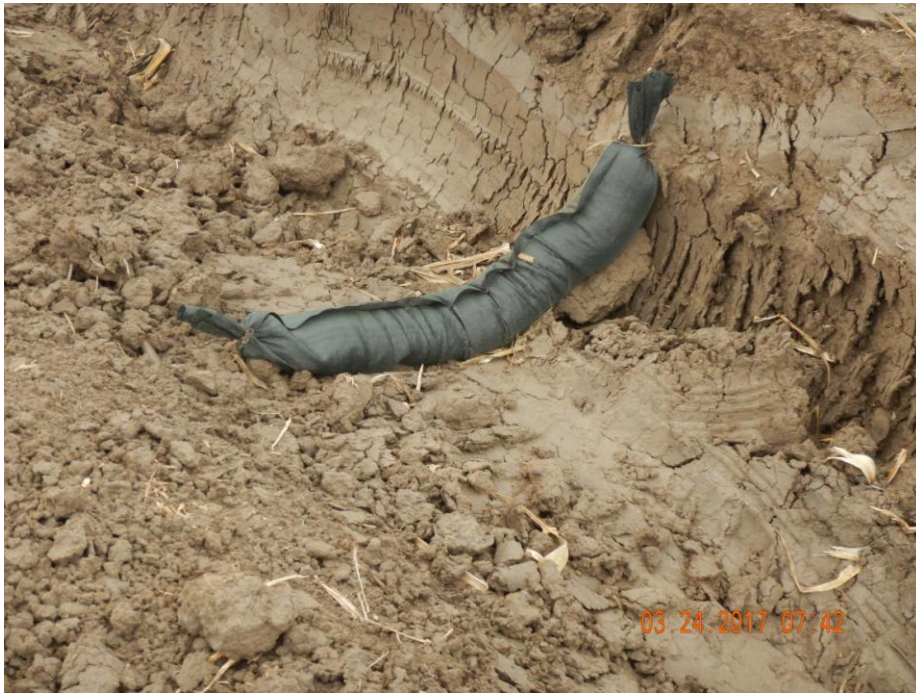
Photo 11: Photo taken from the west end of the location. Photo shows wattle used as a stormwater and sediment control BMP. Wattle BMP has not been properly installed by trenching and backfilling the wattle.

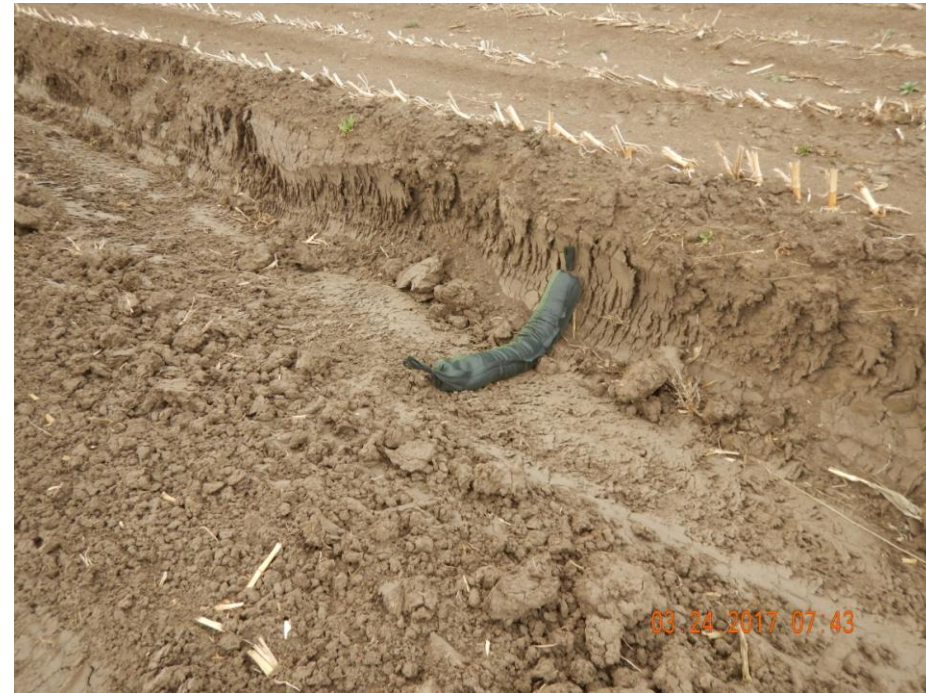
Photo 12: Photo taken from the west end of the location. Photo shows wattle used as a stormwater and sediment control BMP. Wattle BMP has not been properly installed by trenching and backfilling the wattle. Photo also shows stormwater ditch has not been consolidated and has been constructed with a steep grade. Without proper consolidation and grade this ditch will increase the sediment laden stormwater runoff from the location. CDOT recommends ditches be constructed with a grade of 2:1.

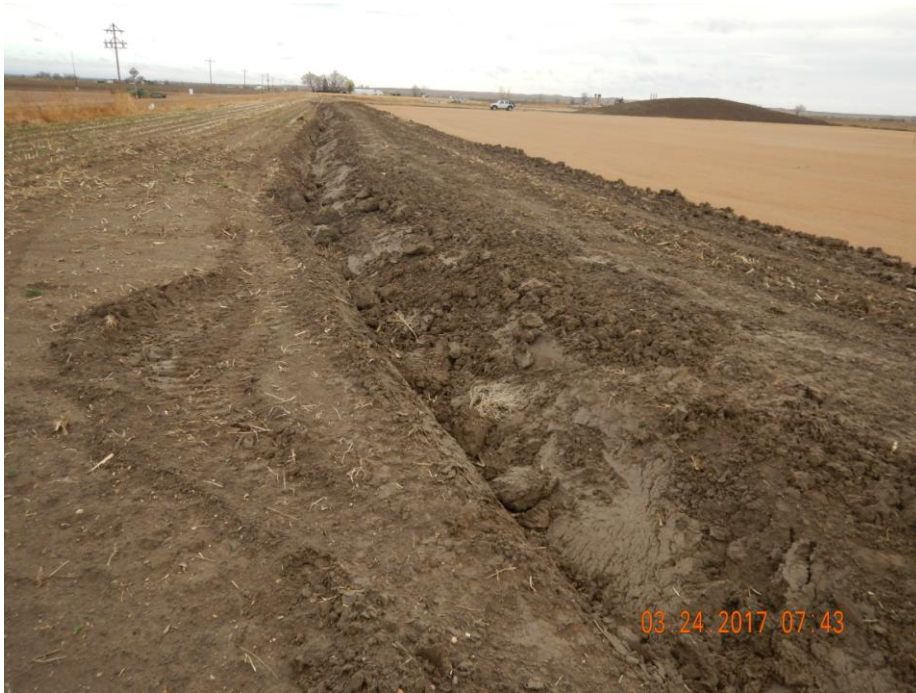
Photo 13: Photo taken from the southwest corner of the location, facing north. Photo shows stormwater ditch; Stormwater ditch has not been consolidated. Without proper consolidation this ditch will increase the sediment laden stormwater runoff from the location.

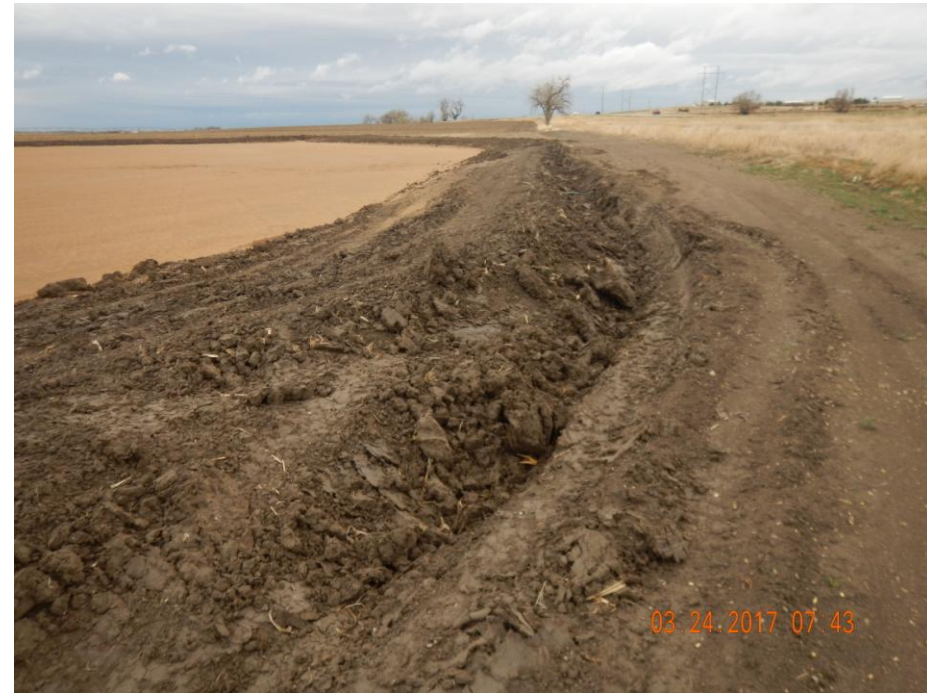
Photo 14: Photo taken from the southwest corner of the location, facing north. Photo shows stormwater ditch; Stormwater ditch has not been consolidated. Without proper consolidation this ditch will increase the sediment laden stormwater runoff from the location.

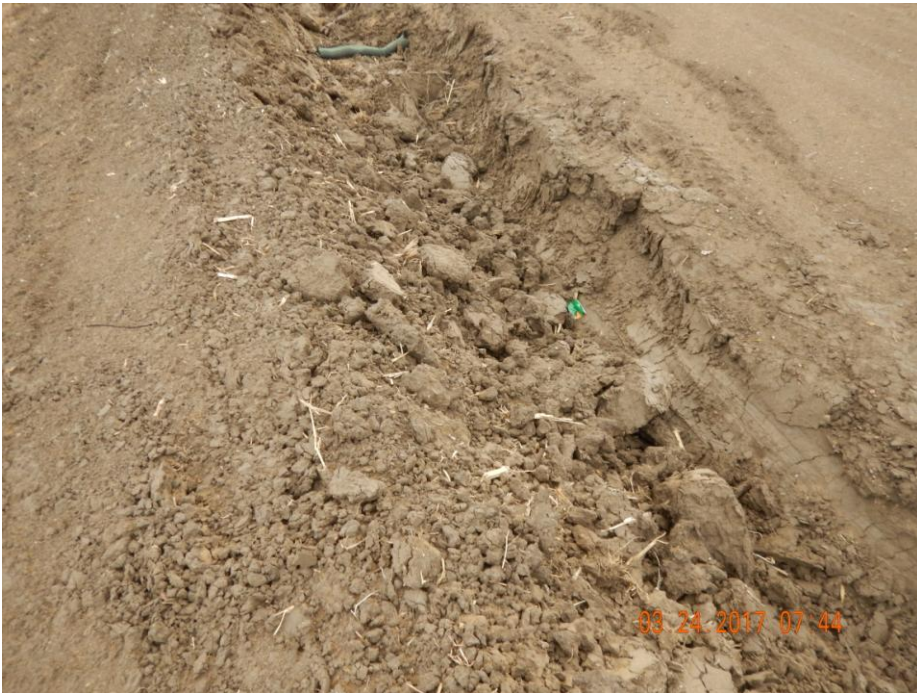
Photo 15: Photo taken from the north end of the location. Photo shows stormwater ditch has not been consolidated. Without proper consolidation this ditch will increase the sediment laden stormwater runoff from the location.

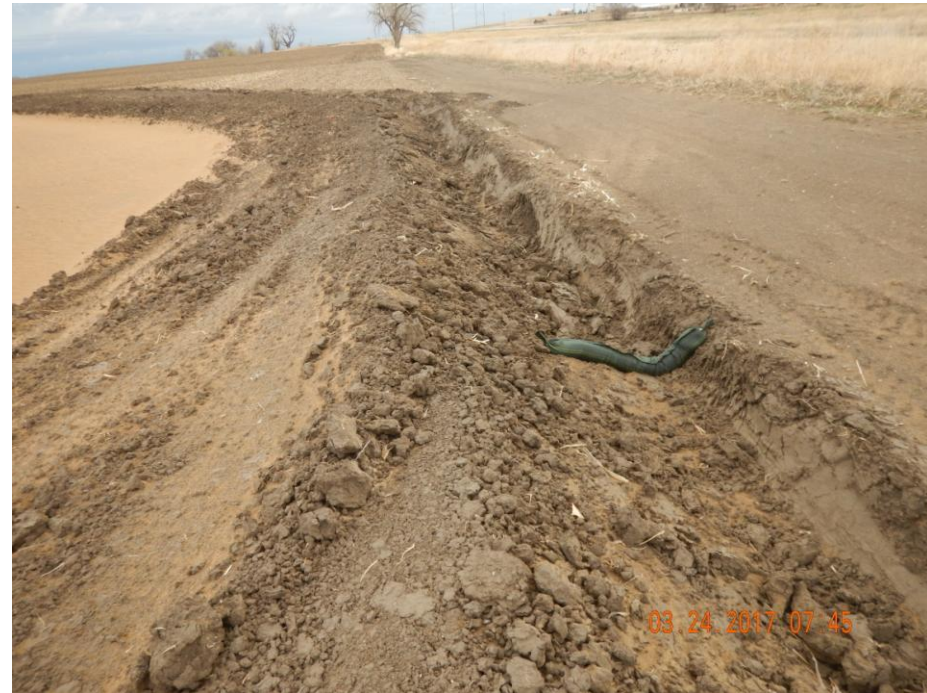
Photo 16: Photo taken from the north end of the location. Photo shows stormwater ditch has not been consolidated. Without proper consolidation this ditch will increase the sediment laden stormwater runoff from the location. Photo also shows wattle used as a stormwater and sediment control BMP. Wattle BMP has not been properly installed by trenching and backfilling the wattle.

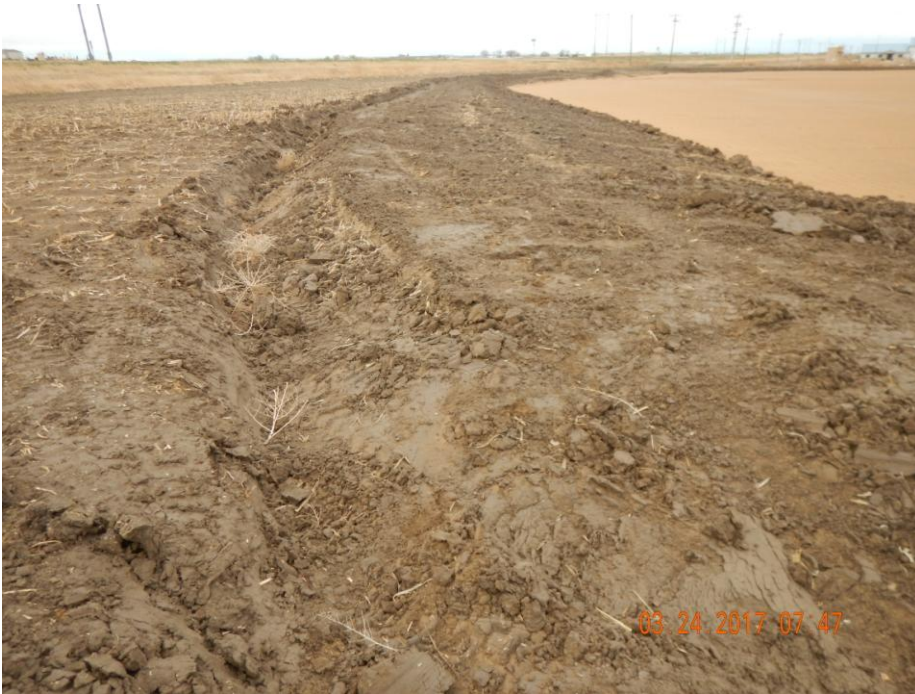
Photo 17: Photo taken from the southeast corner of the location, facing west. Photo shows stormwater ditch; Stormwater ditch has not been consolidated. Without proper consolidation this ditch will increase the sediment laden stormwater runoff from the location.

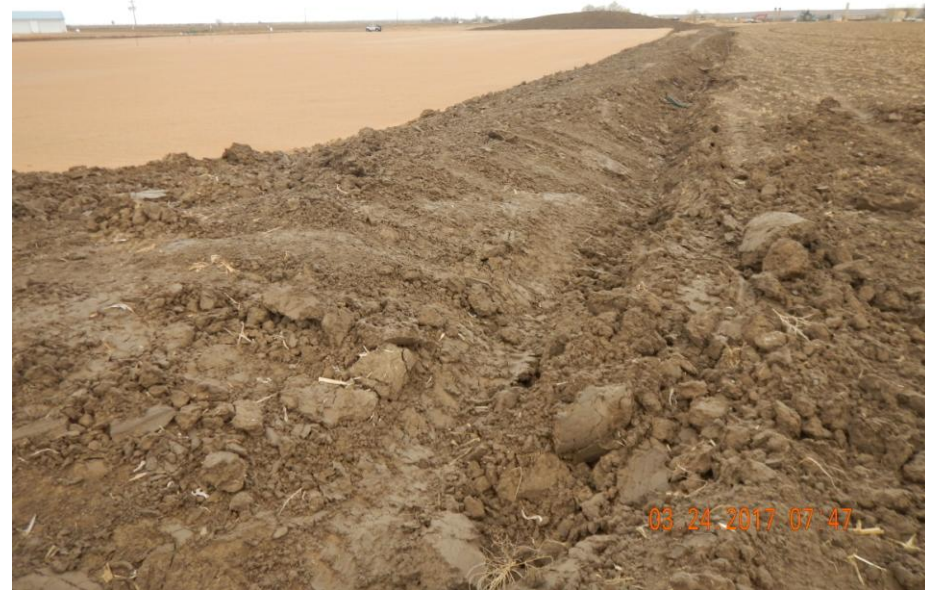
Photo 18: Photo taken from the southeast corner of the location, facing north. Photo shows stormwater ditch; Stormwater ditch has not been consolidated. Without proper consolidation this ditch will increase the sediment laden stormwater runoff from the location.

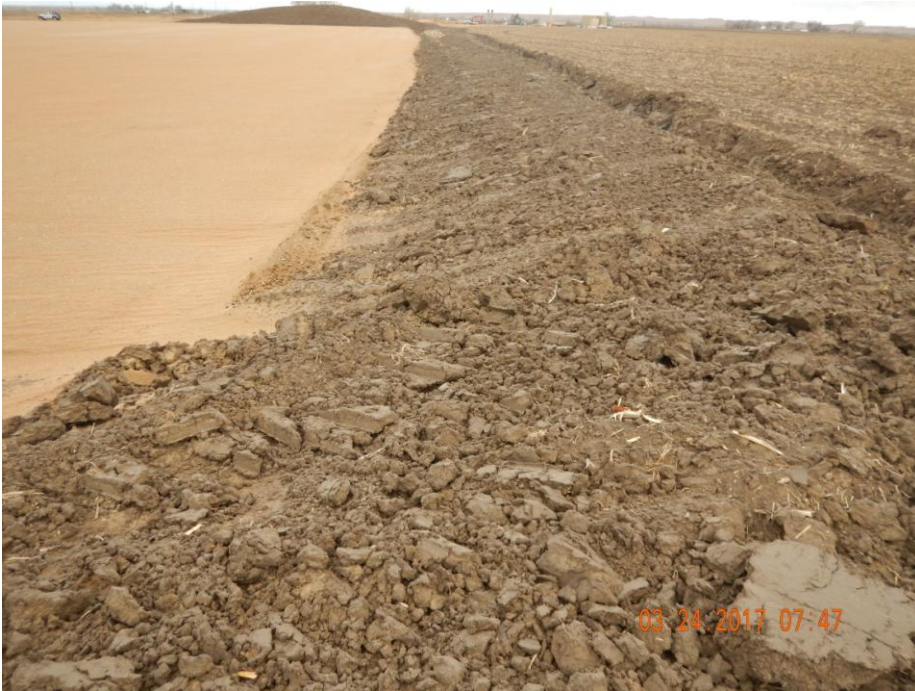
Photo 19: Photo taken from the south east end of the location, facing north. Photo shows slopes on the eastern perimeter of the location have been insufficiently consolidated and improperly tracked.

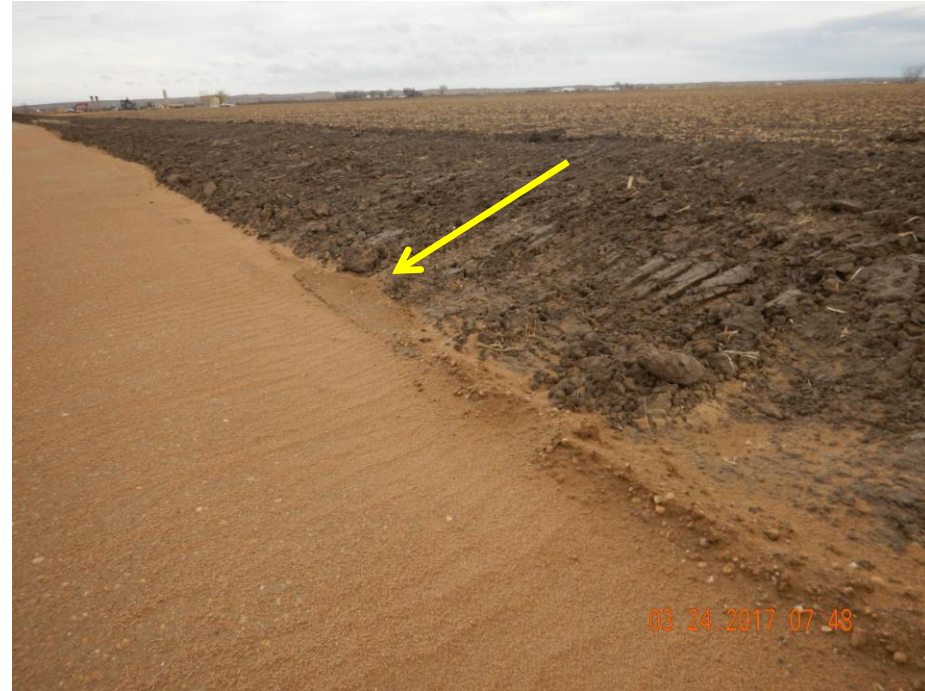
Photo 20: Photo taken from the east end of the location, facing northeast. Photo shows slopes on the eastern perimeter of the location have been improperly tracked. Yellow arrow shows direction of slope. Tracking should be perpendicular to the slope in order to reduce runoff velocity and erosion.

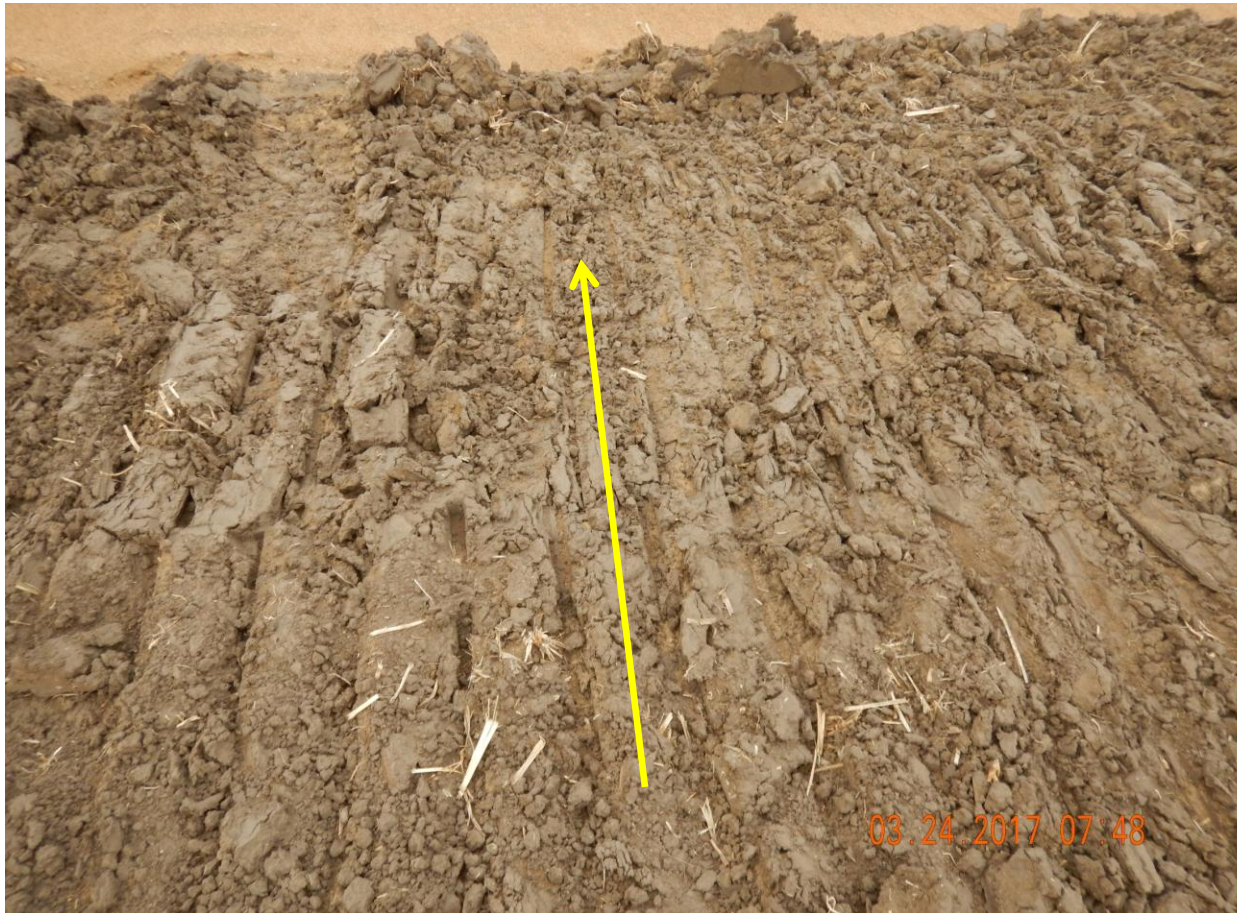
Photo 21: Photo taken from the east end of the location. Photo shows slopes on the eastern perimeter of the location have been improperly tracked. Yellow arrow shows direction of slope. Tracking should be perpendicular to the slope in order to reduce runoff velocity and erosion.

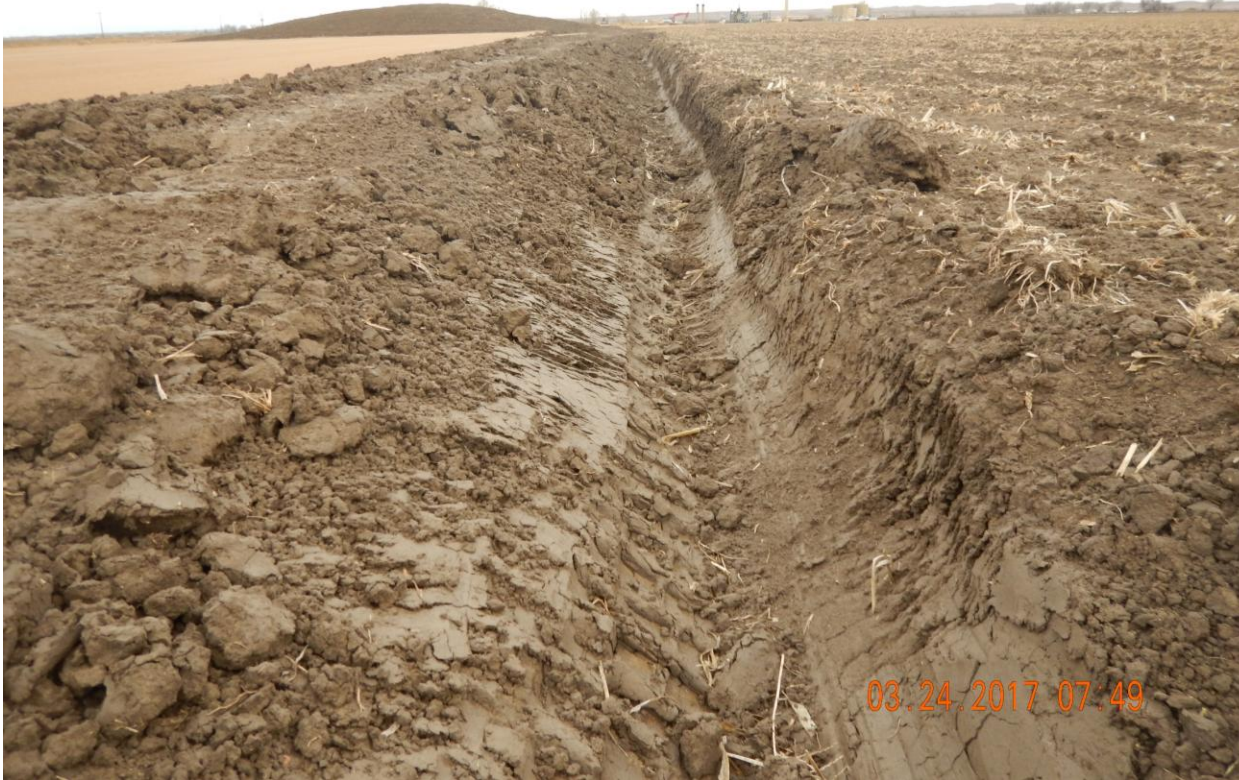
Photo 22: Photo taken from the stormwater ditch on the east end of the location. Photo shows stormwater ditch has not been consolidated and has been constructed with a steep grade. Without proper consolidation and grade, ditch will increase the sediment laden stormwater runoff from the location. CDOT recommends ditches be constructed with a grade of 2:1.

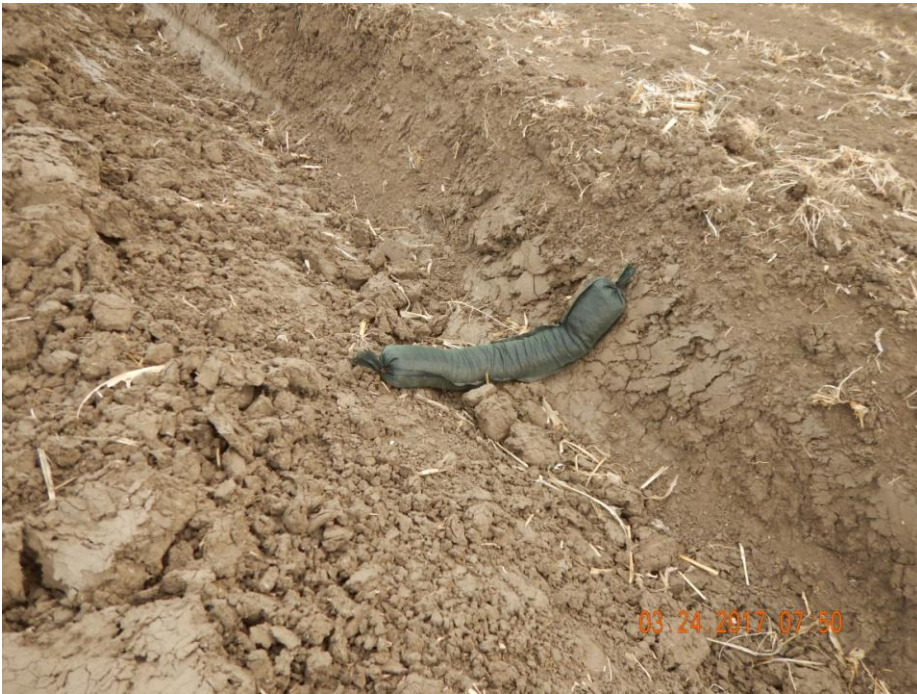
Photo 23: Photo taken from the east end of the location. Photo shows wattle used as a stormwater and sediment control BMP. Wattle BMP has not been properly installed by trenching and backfilling the wattle, and is not in proper functioning condition.

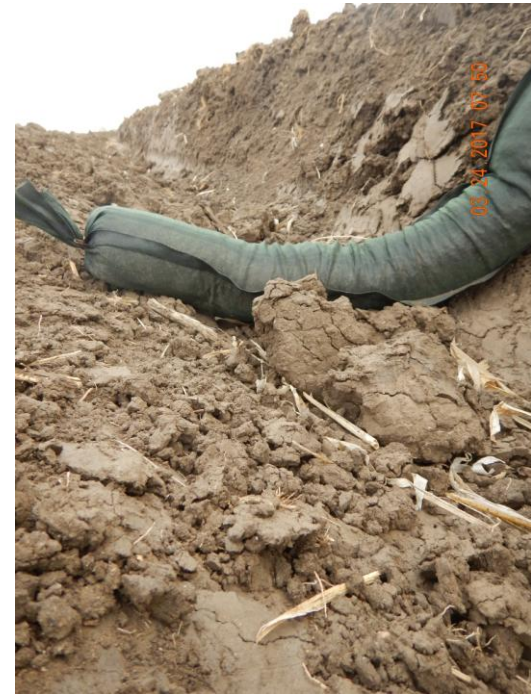
Photo 24: Photo taken from the east end of the location. Photo shows wattle used as a stormwater and sediment control BMP. Wattle BMP has not been properly installed by trenching and backfilling the wattle, and is not in proper functioning condition. Photo also shows stormwater ditch has been constructed with a steep grade. CDOT recommends ditches be constructed with a grade of 2:1.

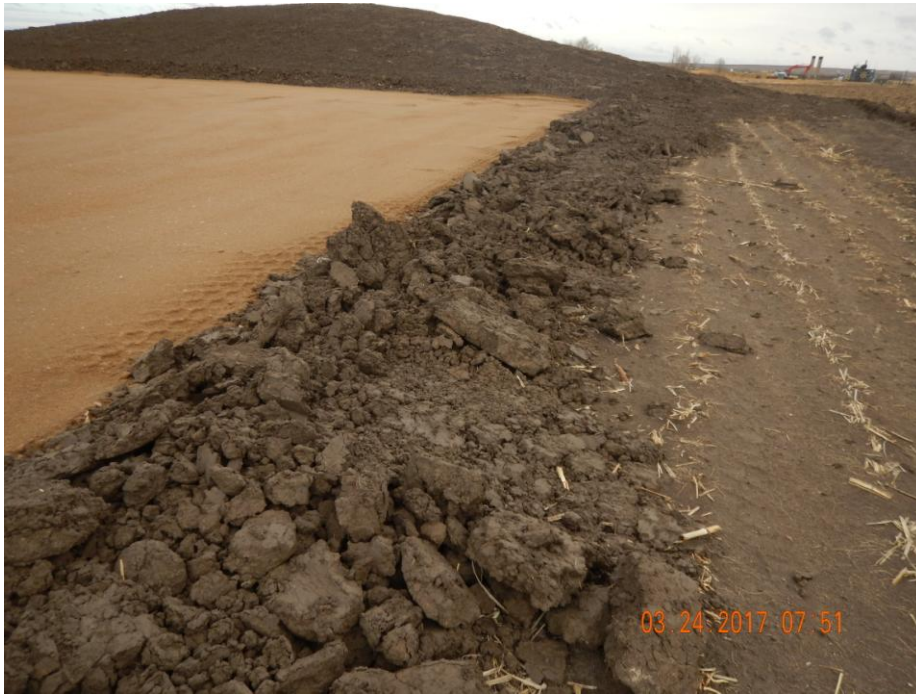
Photo 25: Photo taken from the east end of the location, facing north. Photo shows berm has not been consolidated and not in proper functioning condition. Without proper consolidation berms along the location perimeter will increase sediment laden stormwater runoff from the location.

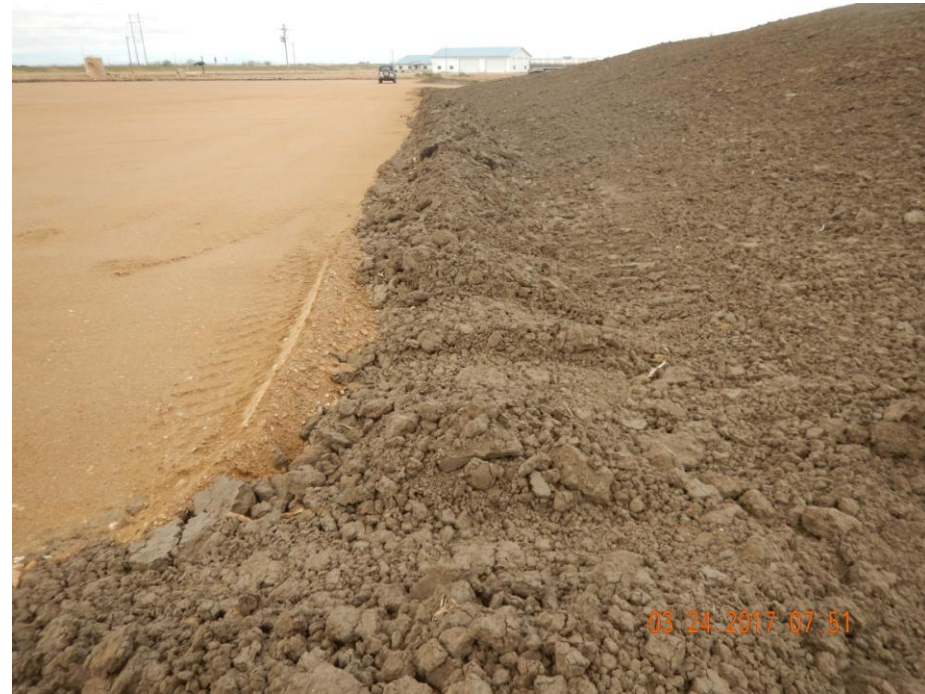
Photo 26: Photo taken from the southeast end of the topsoil pile. Photo shows berm has not been consolidated. Without proper consolidation berms along the location perimeter will increase sediment laden stormwater runoff from the location.

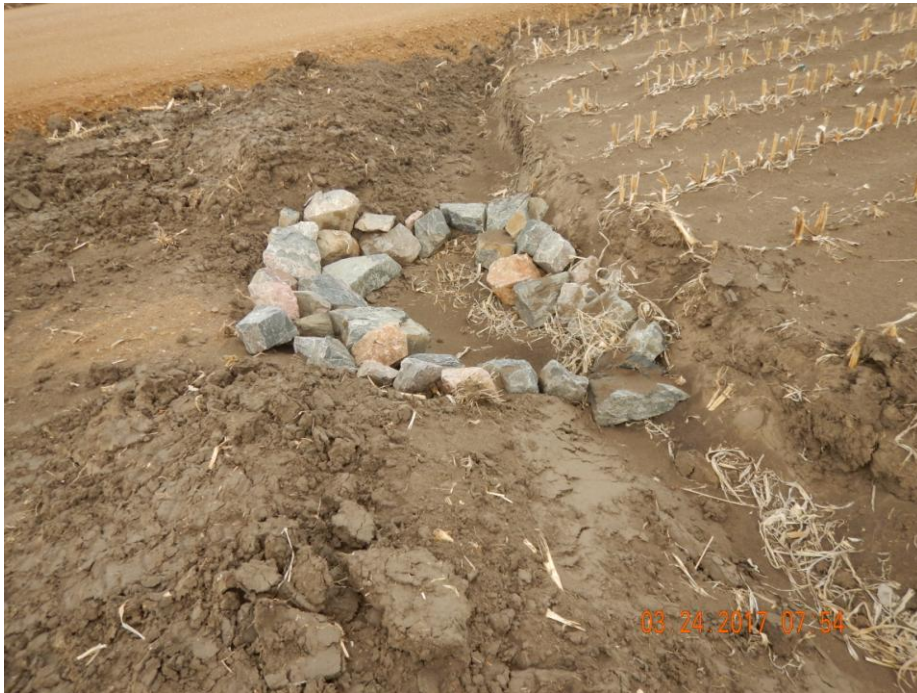
Photo 29: Photo taken from the north end of the location (east of access road). Photo shows sediment trap BMP. BMP has filled with sediment and will require maintenance. It appears only large-sized rock aggregate have been utilized to construct the BMP; using only large aggregates can contribute to erosion degradation as stormwater can be accelerated around or under the material, expanding stormwater impacts and rendering the BMP inadequate. This is becoming evident in areas shown by the yellow arrows

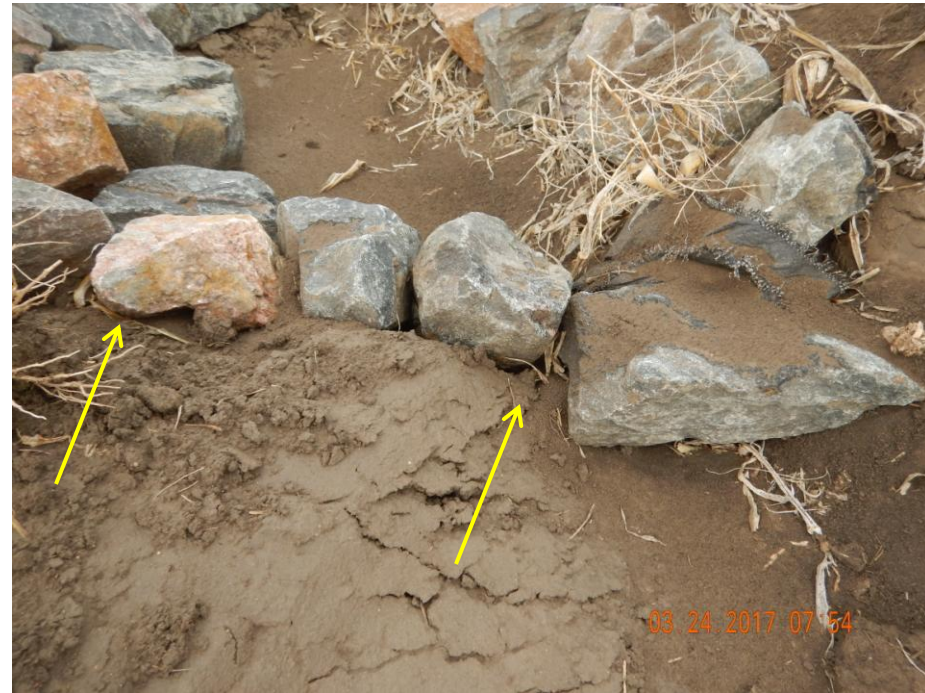
Photo 30: Photo taken from the north end of the location (east of access road). Photo shows sediment trap BMP. BMP has filled with sediment and will require maintenance. It appears only large-sized rock aggregate have been utilized to construct the BMP; using only large aggregates can contribute to erosion degradation as stormwater can be accelerated around or under the material, expanding stormwater impacts and rendering the BMP inadequate. This is becoming evident in areas shown by the yellow arrows

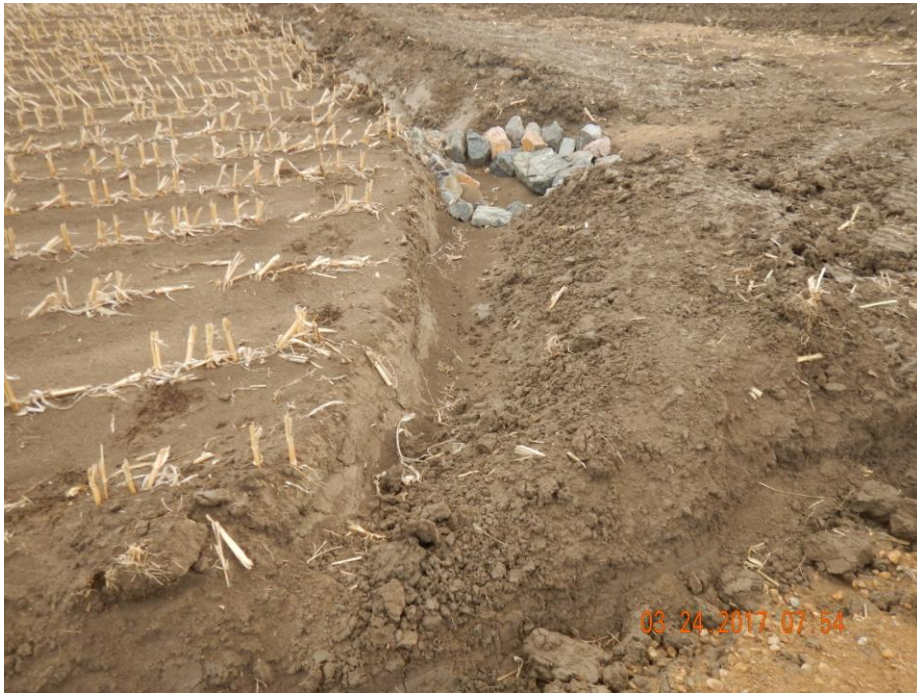
Photo 31: Photo taken from the north end of the location (east of access road). Photo shows sediment trap BMP. BMP has filled with sediment and will require maintenance.

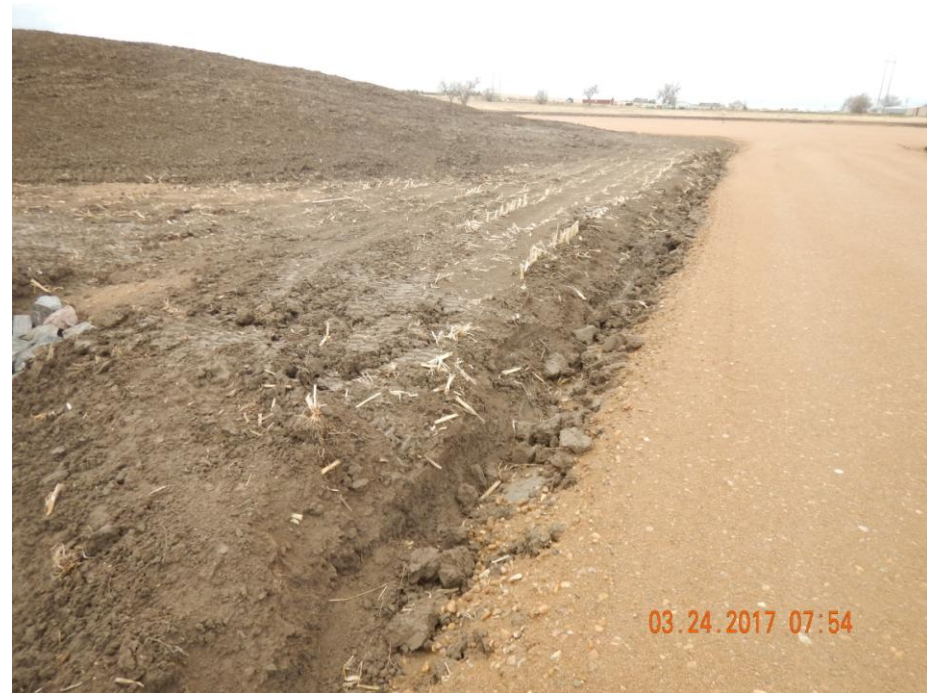
Photo 32: Photo taken from the north end of the location, facing south. Photo shows stormwater ditch has not been consolidated. Without proper consolidation this ditch will increase the sediment laden stormwater runoff from the location.
