Inspection Photos

03/24/2017

Operator: Bill Barrett Corp #10071

Location ID: 449306

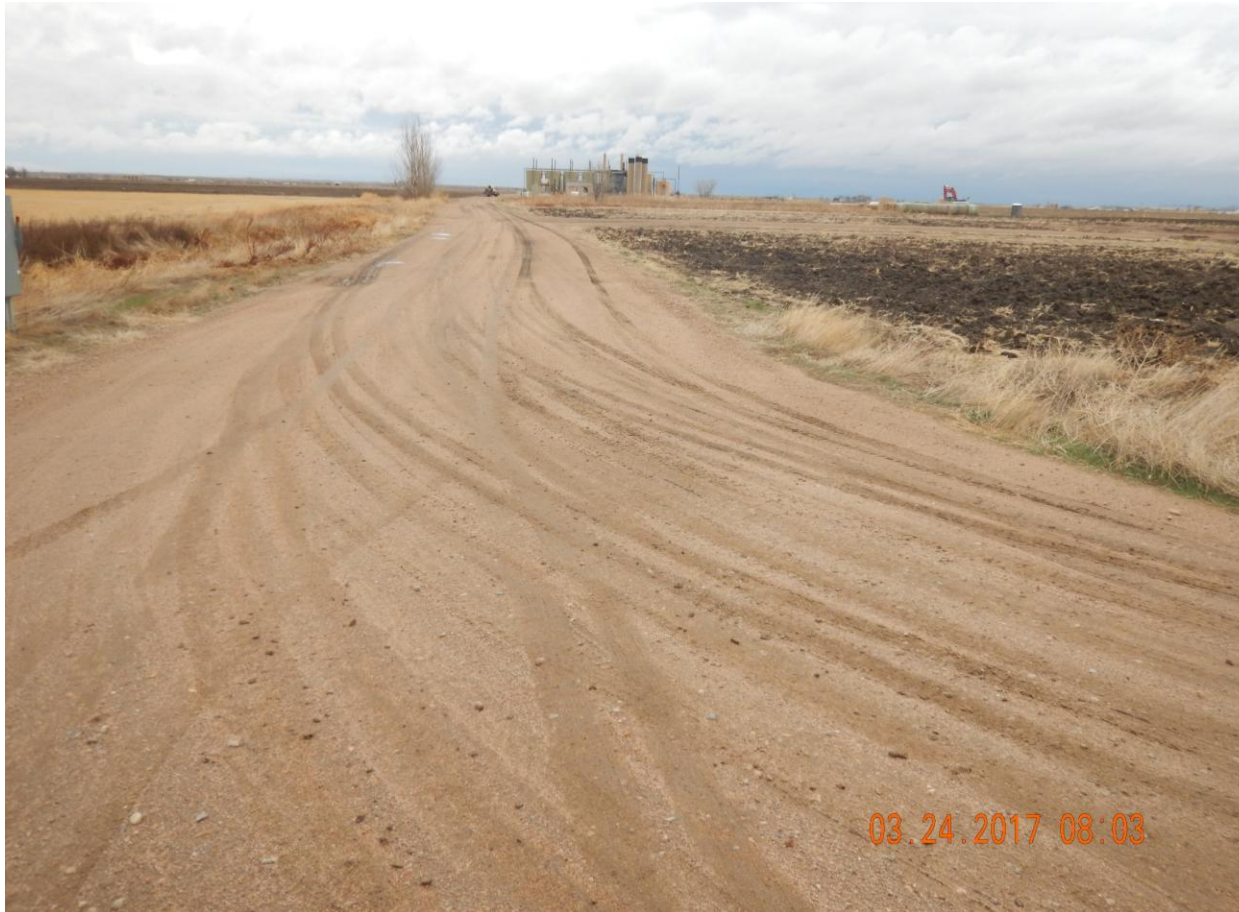
Photo 33: Photo taken from the intersection of CR 63 and the access road. Access road leads to three separate locations operated by BBC. Photo shows no vehicle tracking BMPs has been implemented to mitigate sediment tracked from the construction site, or the locations, onto roadways.
