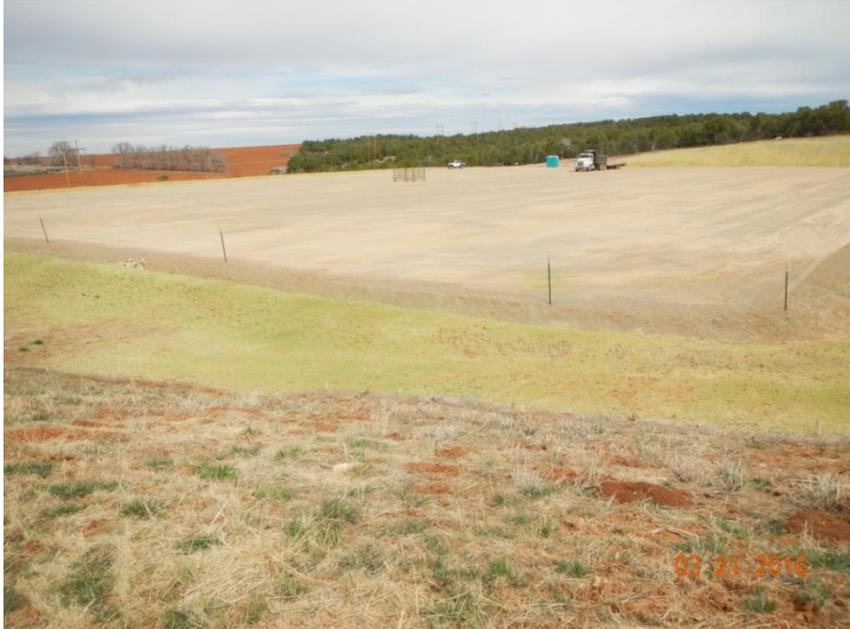
Photo 1: View of the project area from the southeastern corner facing center.

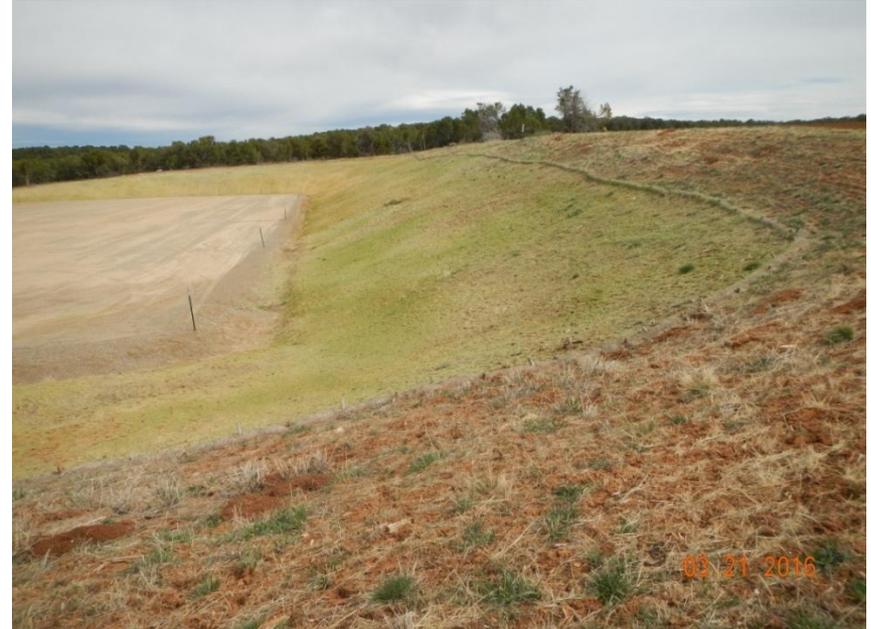
Photo 2: View of eastern portion of the project area from the southeastern corner facing northward. Cut and fill slopes have been seeded and/or tackifier with mulch applied. Revegetation is occurring in portions of the outer disturbance areas with wheatgrasses and sandberg bluegrass (*Poa secunda*).

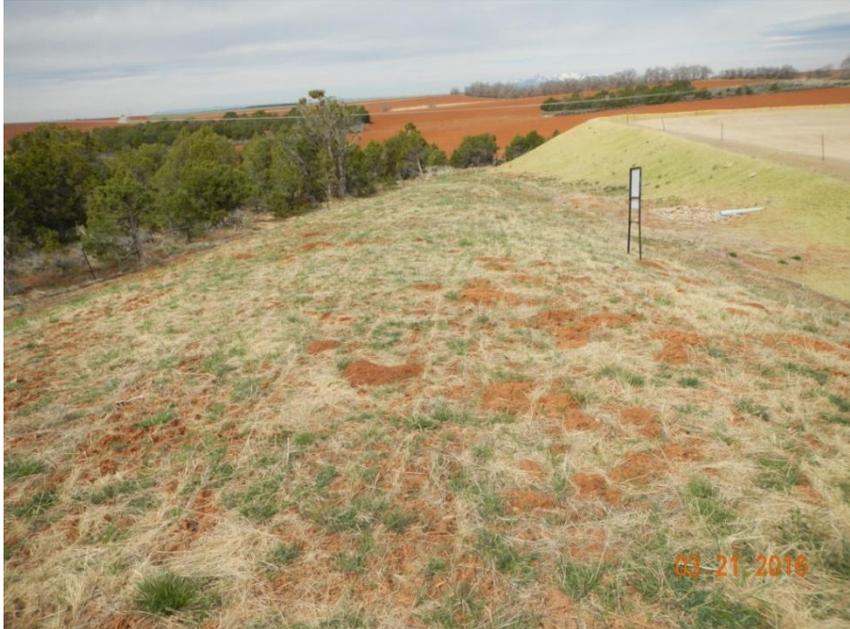
Photo 3: View of the southern portion of the project area from the southeastern corner facing westward.

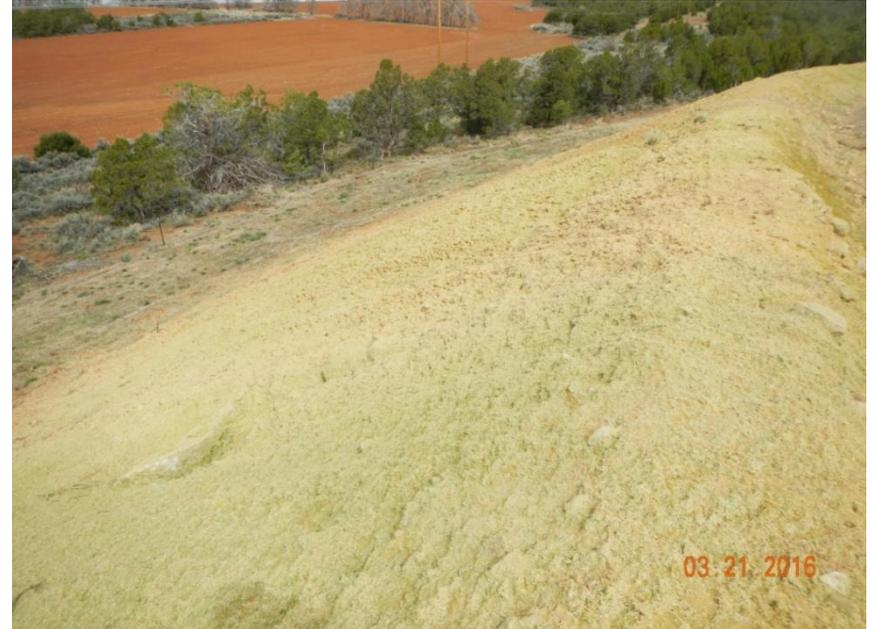
Photo 4: View of the western portion of the project area from the southwestern corner facing northward. Light green is tackifier and mulch on slope.

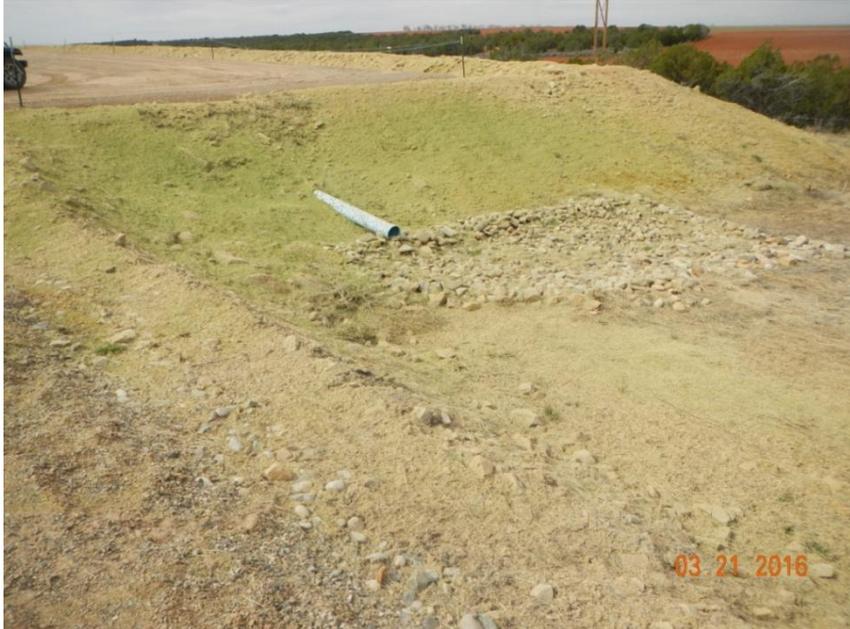
Photo 5: View of stormwater controls that appear to be functioning in the northern portion of the project area.

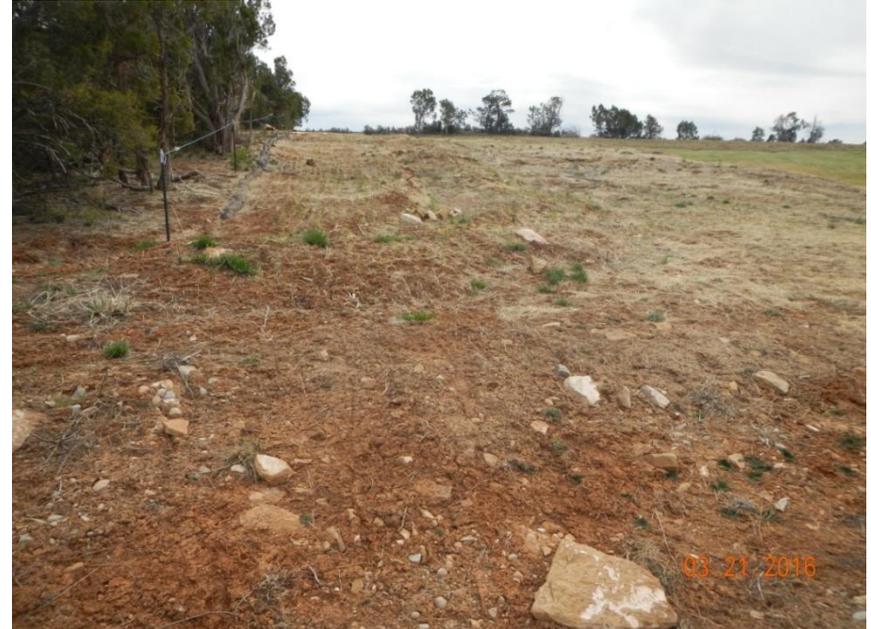
Photo 6: View of northeastern portion of the project area from the well pad entrance facing eastward.
