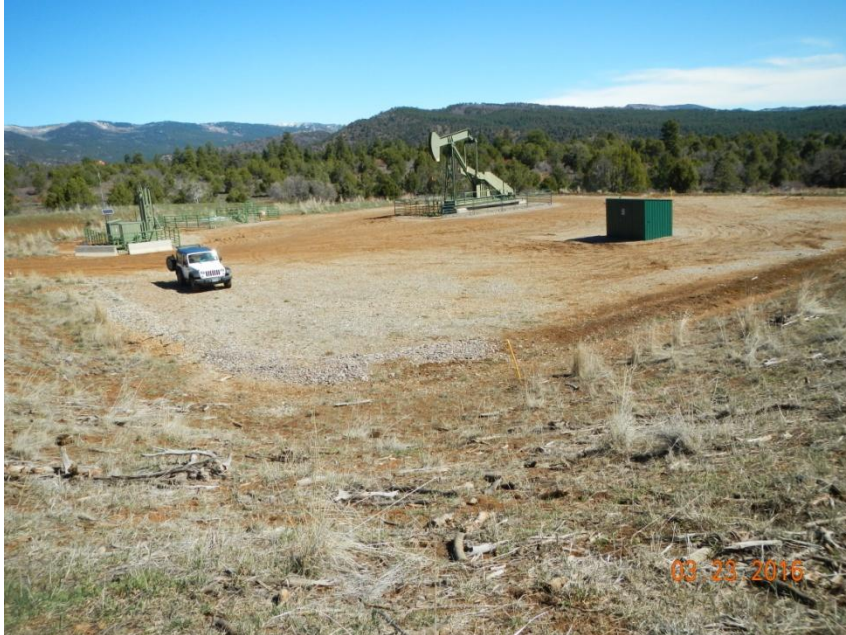
**Photo 1:** View of the project area from the southwestern corner facing center.

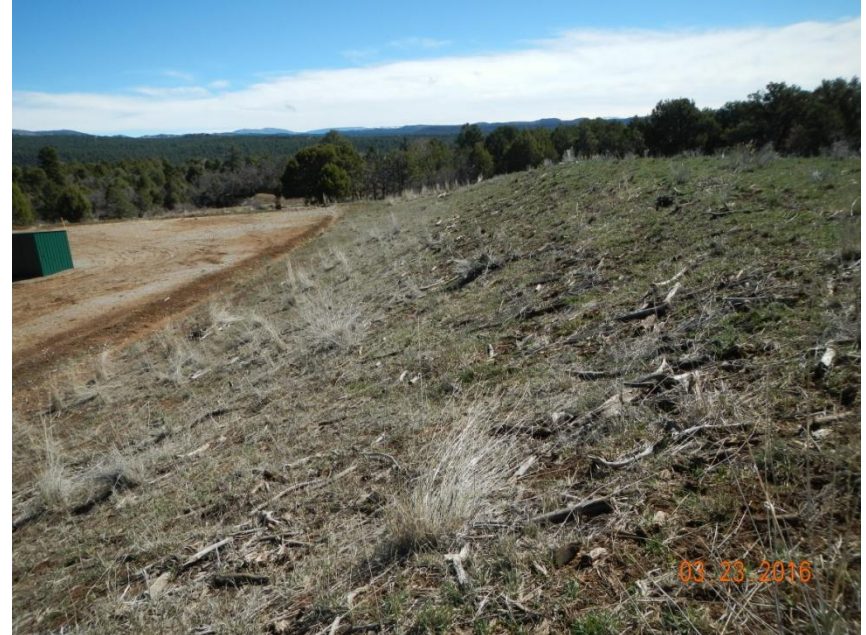
**Photo 2:** View of the southern portion of the project area from the southwestern corner facing eastward. Revegetation is largely comprised of grazed grasses such as intermediate wheatgrass (*Thinopyron intermedium*) and smooth brome (*Bromus inermis*).

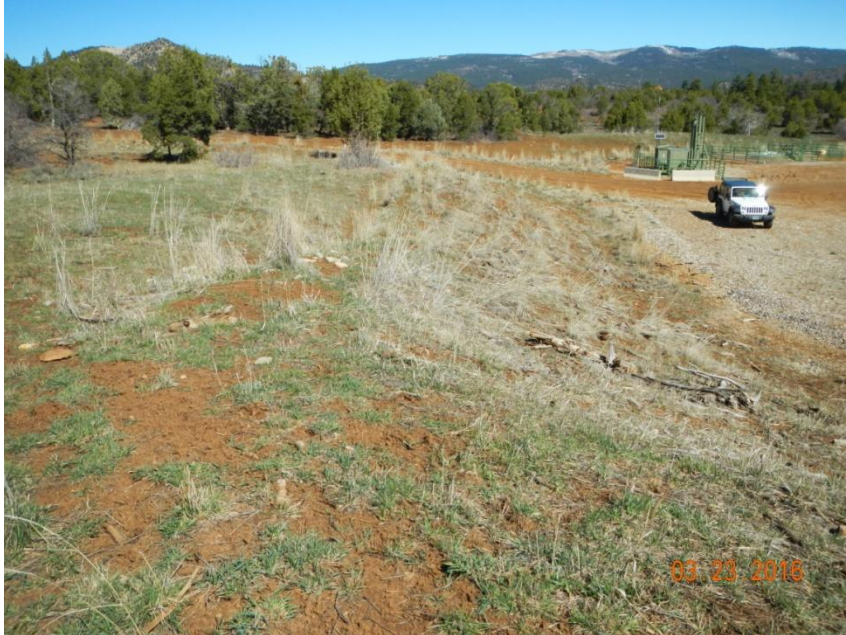
**Photo 3: View of the southwestern portion of the project area from the southwestern corner facing northward.**

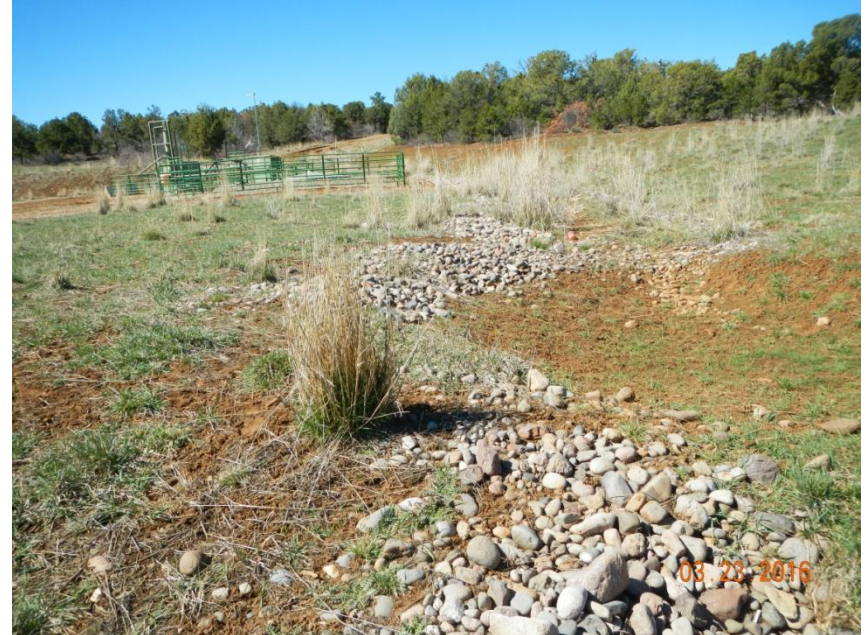
**Photo 4: View of the northern portion of the project area from the northeastern edge facing westward. Cobble run-down appears to be functioning at this time.**

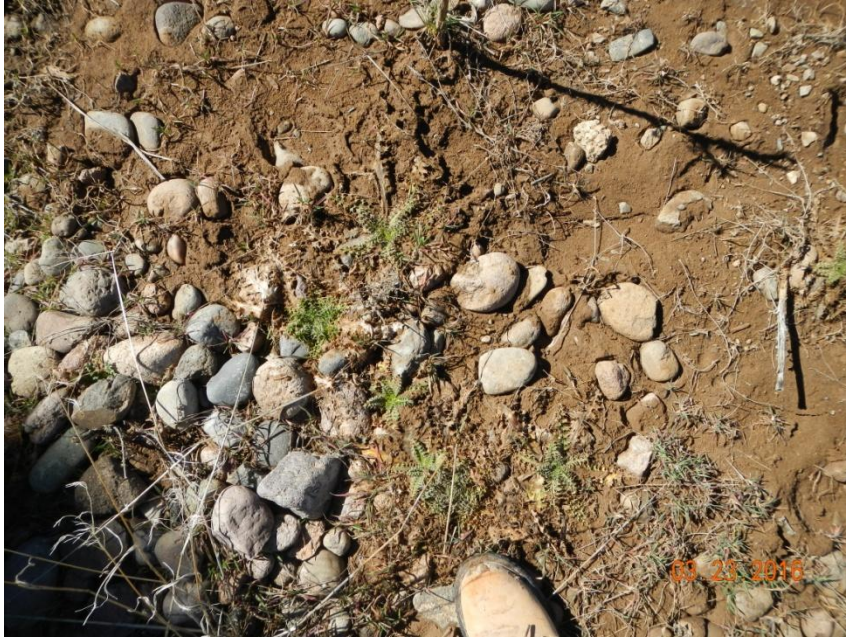
**Photo 5: View of musk thistle rosettes within the eastern portion of the project area. Musk thistles were observed throughout the interim reclamation area.**

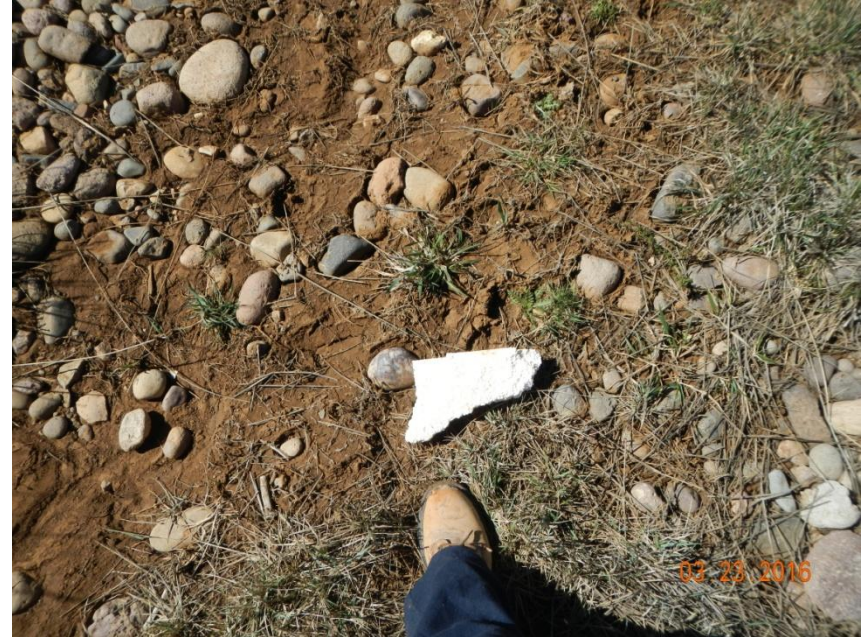
**Photo 6: View of small styrofoam debris within the eastern interim reclamation area. Several small pieces of debris such as styrofoam, black liner material, etc. are scattered around the interim reclamation area and need to be removed and properly disposed of.**

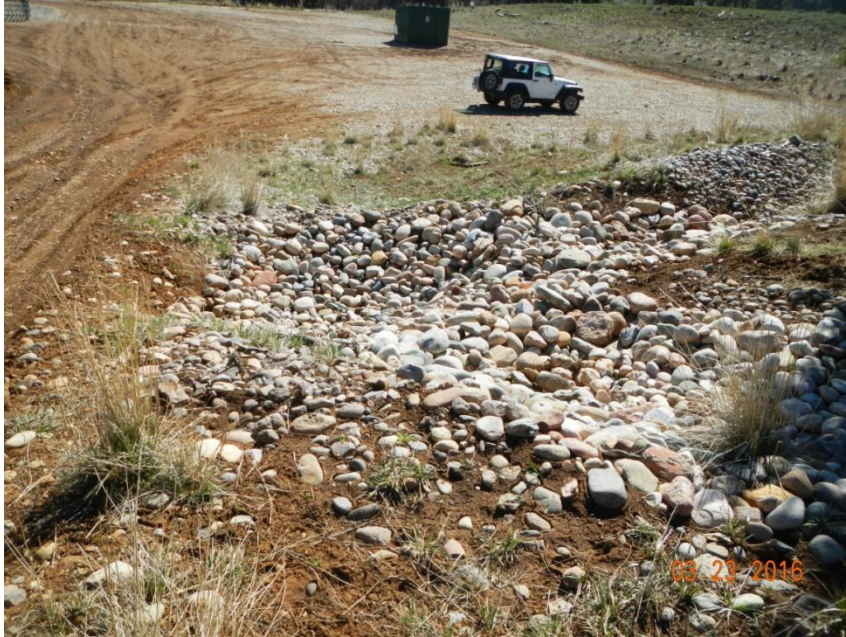
**Photo 7: View of stormwater controls that appear to be functioning in the western portion of the project area.**

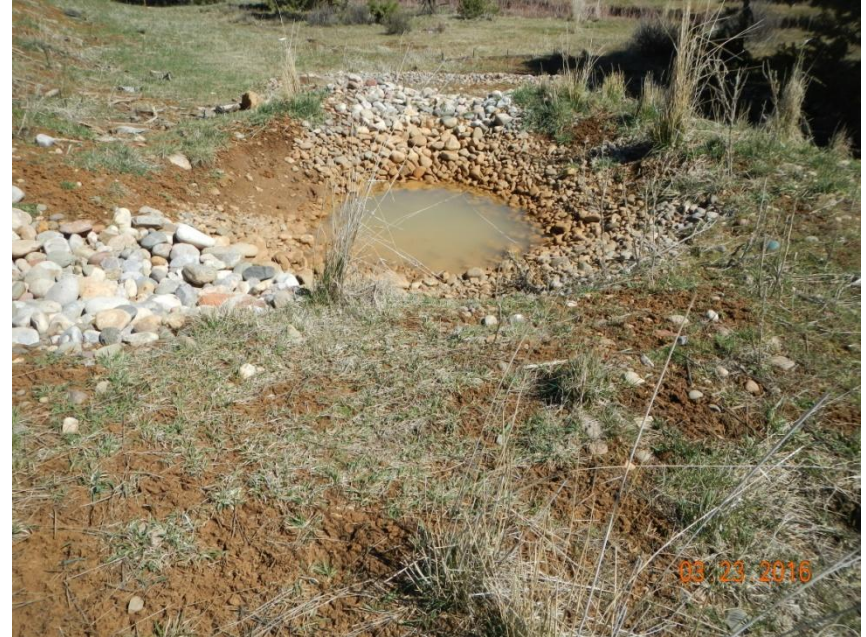
**Photo 8: View of silt trap in the southeastern portion of the project area that appears to be functioning.**

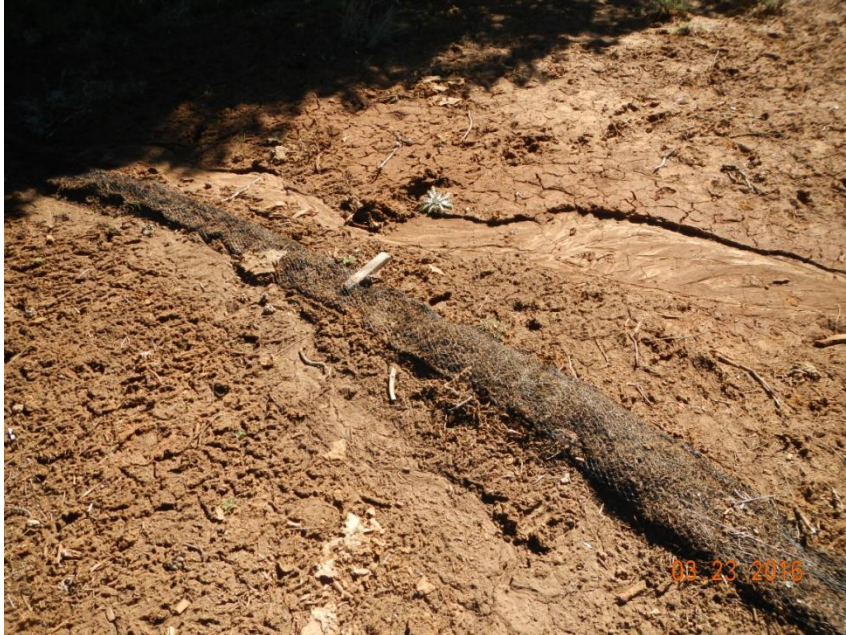
**Photo 9: View of wattles in the eastern portion of the project area that are no longer functioning.**
