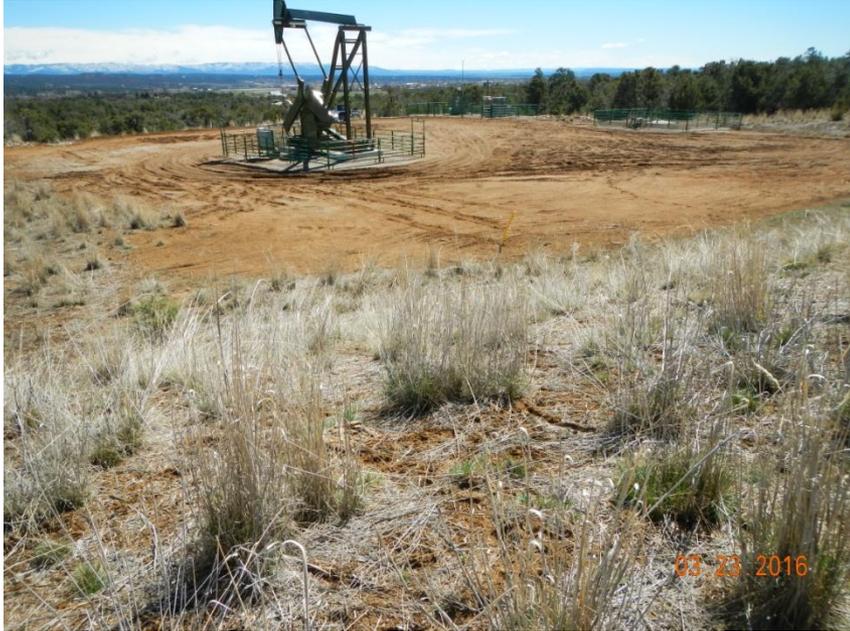
Photo 1: View of the project area from the northwestern corner facing center.

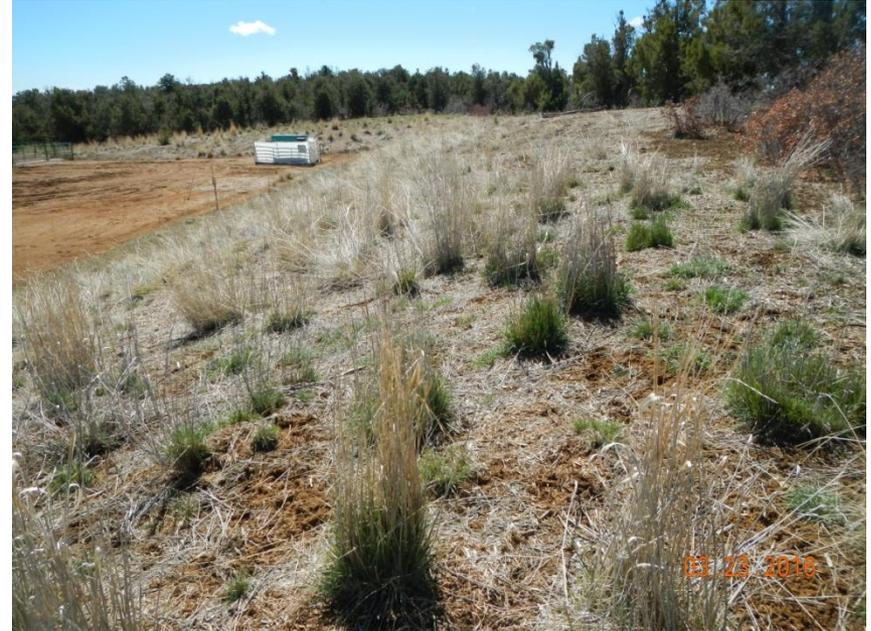
Photo 2: View of the western portion of the project area from the northwestern corner facing southward. Revegetation is largely comprised of grasses such as crested wheatgrass (*Agropyron cristatum*) and Intermediate wheatgrass (*Thinopyron intermedium*), and smooth brome (*Bromus inermis*).

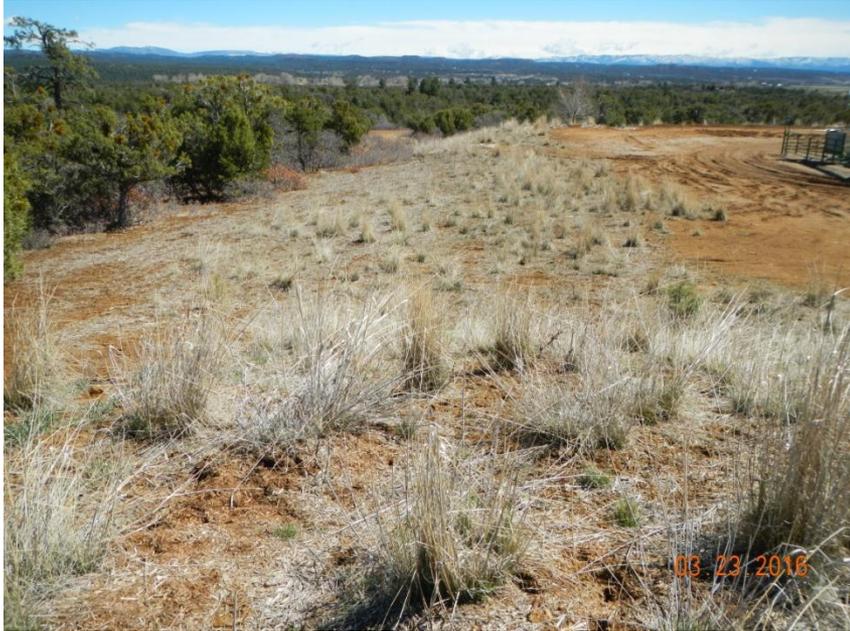
Photo 3: View of the northern portion of the project area from the northwestern corner facing eastward.

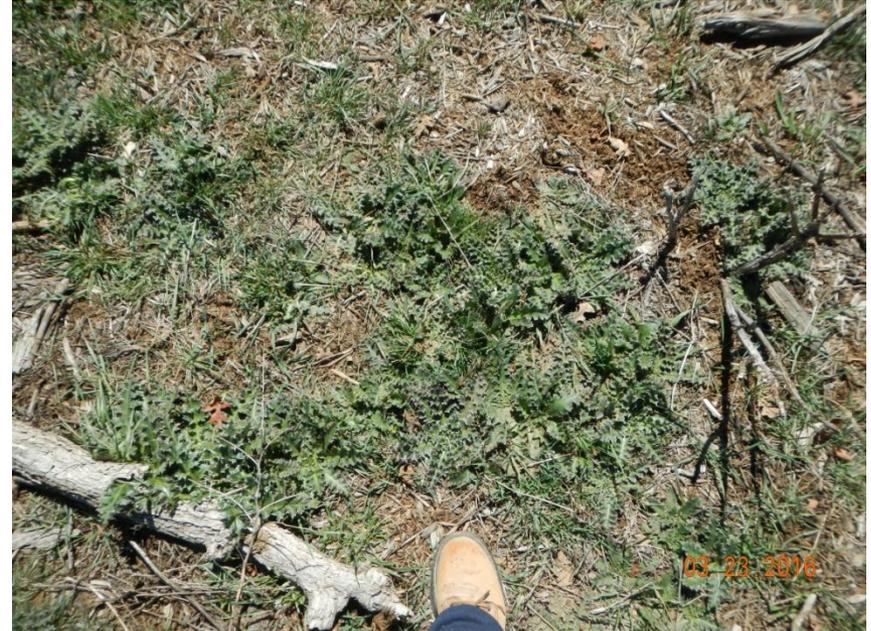
Photo 4: View of musk thistles (*Carduus nutans*) within the southern portion of the interim reclamation area. Musk thistles are growing throughout the interim reclamation area and need treatment.

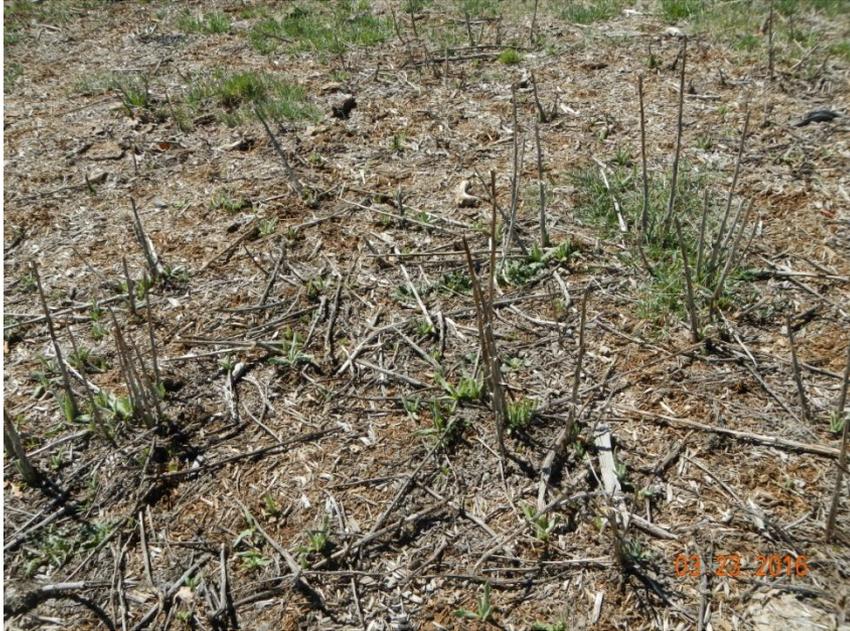
Photo 5: View of Canada thistles (*Carduus nutans*) within the southwestern portion of the project area.

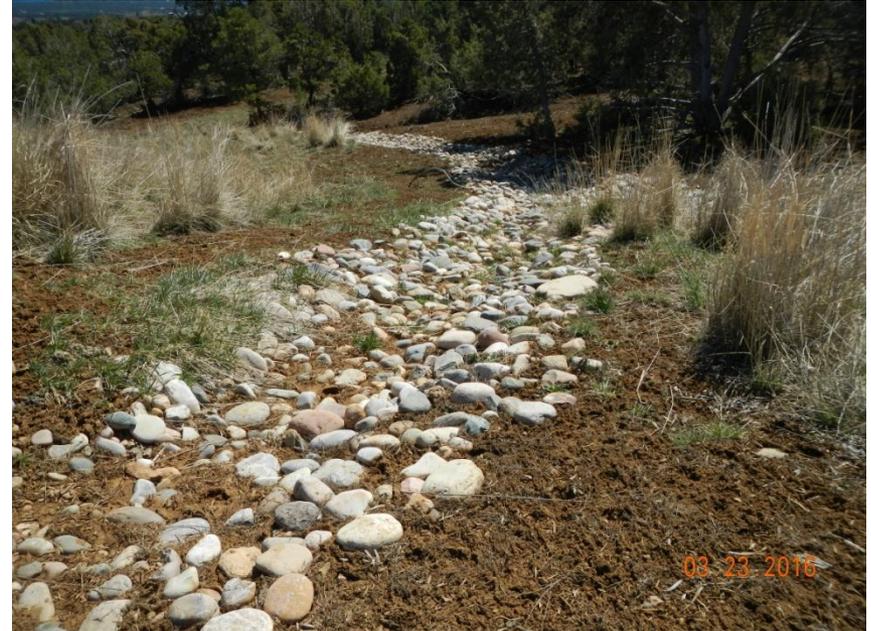
Photo 6: View of cobble run-down in the southern portion of the project area that appears to be functioning.

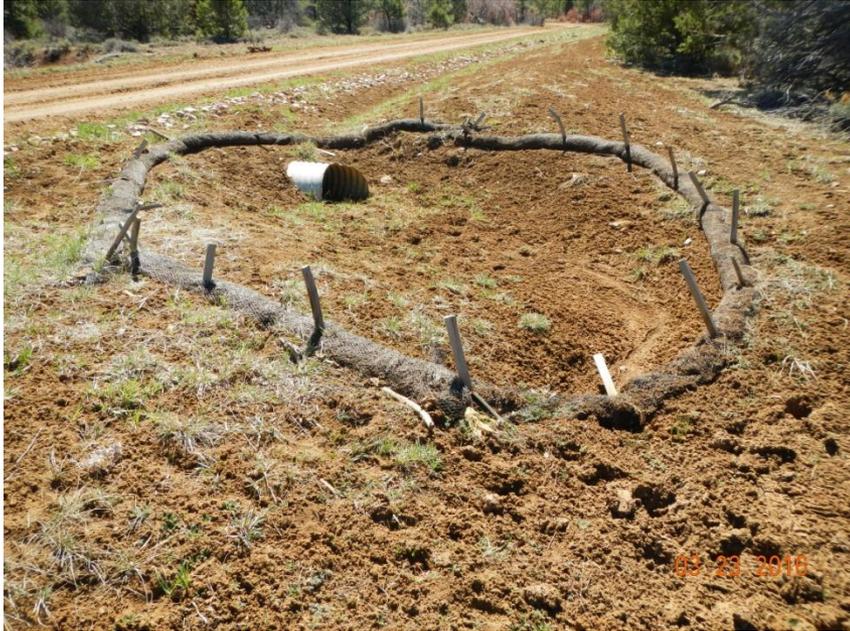
Photo 7: View of wattles along access road that are filling with sediment and need maintenance.

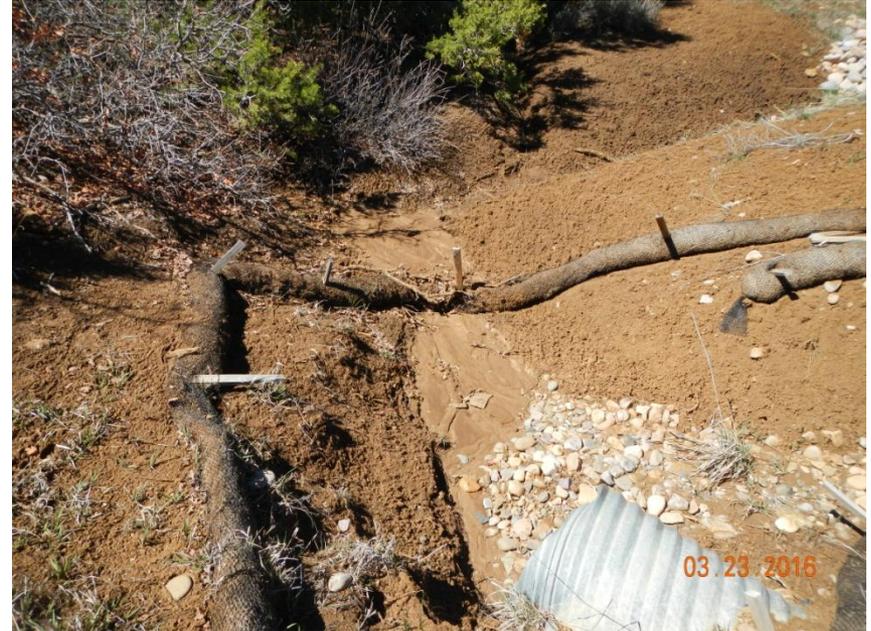
Photo 8: Another view of wattles along the access road that are filled with sediment and need maintenance or replacement.
