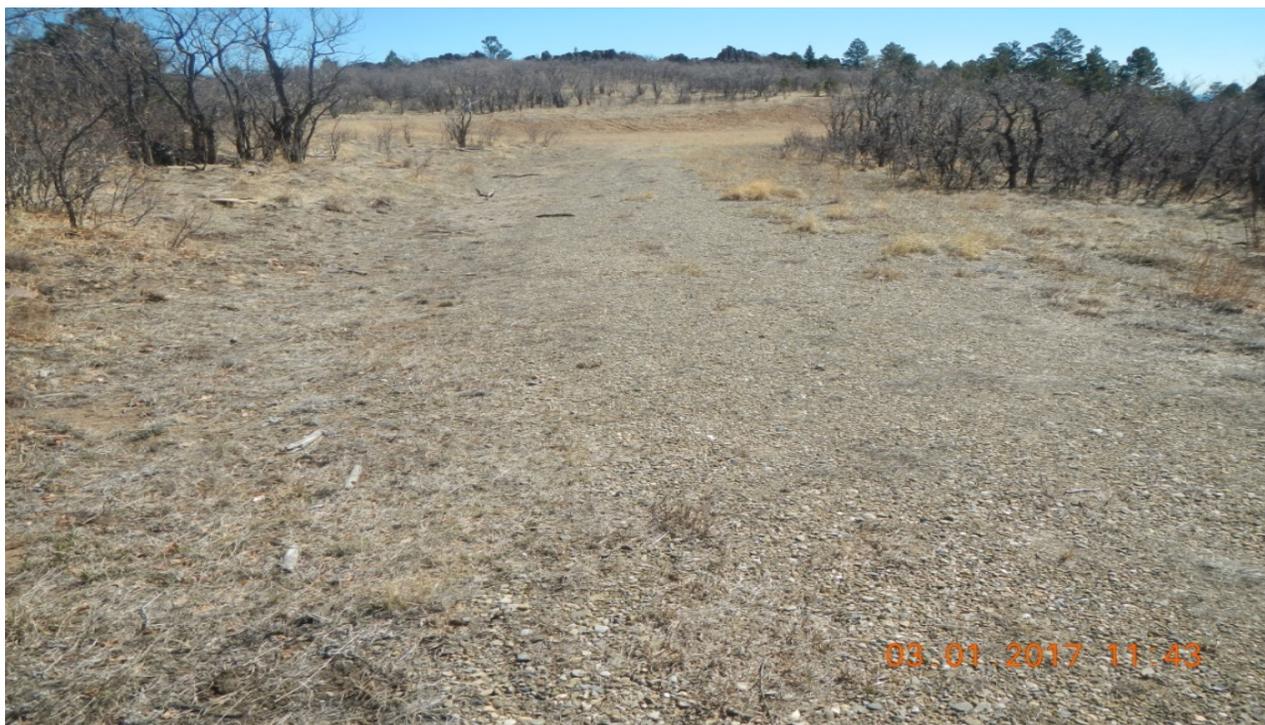
photo 1: Facing southeast along the access road.

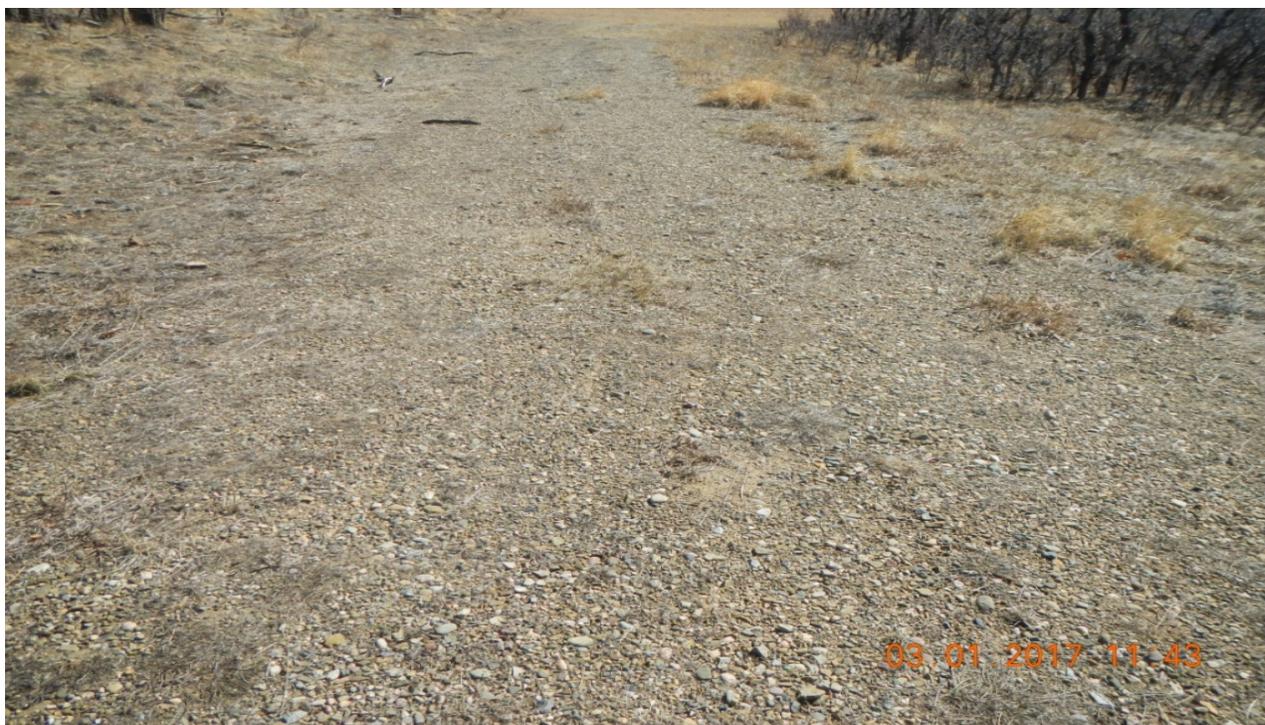
photo 2: Gravel remains along the access road.

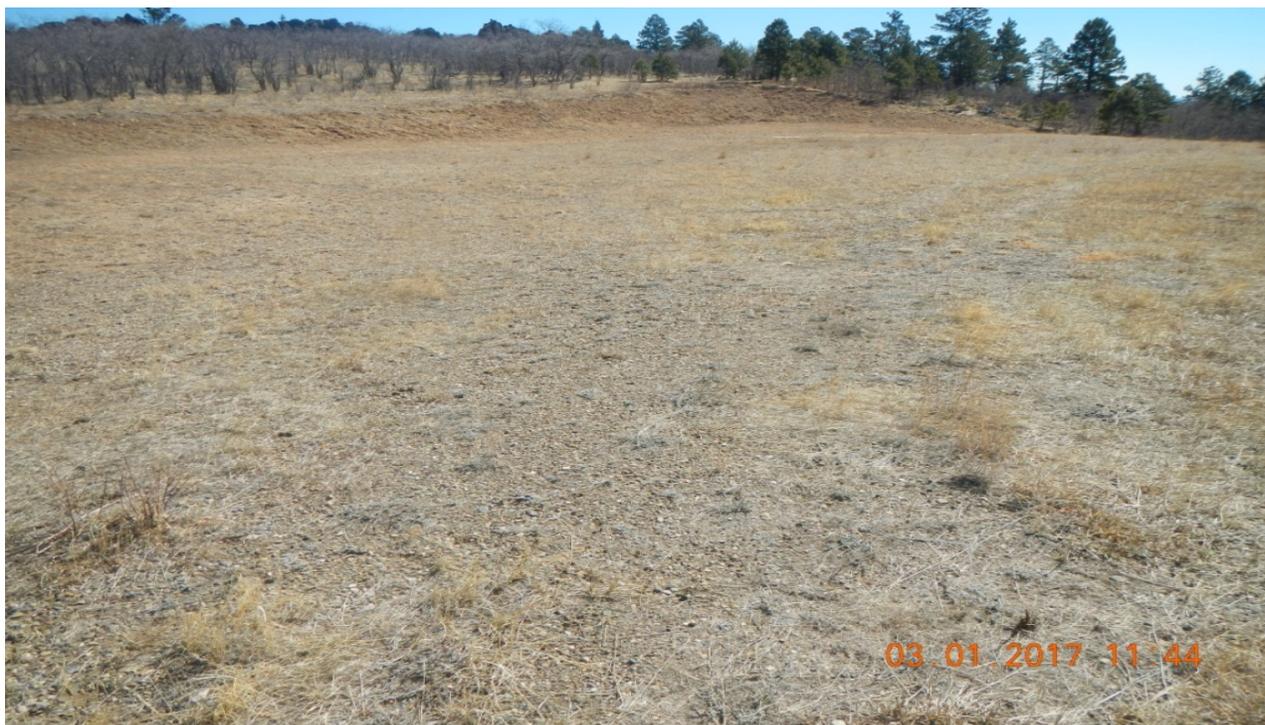
photo 3: Facing southeast toward the location.

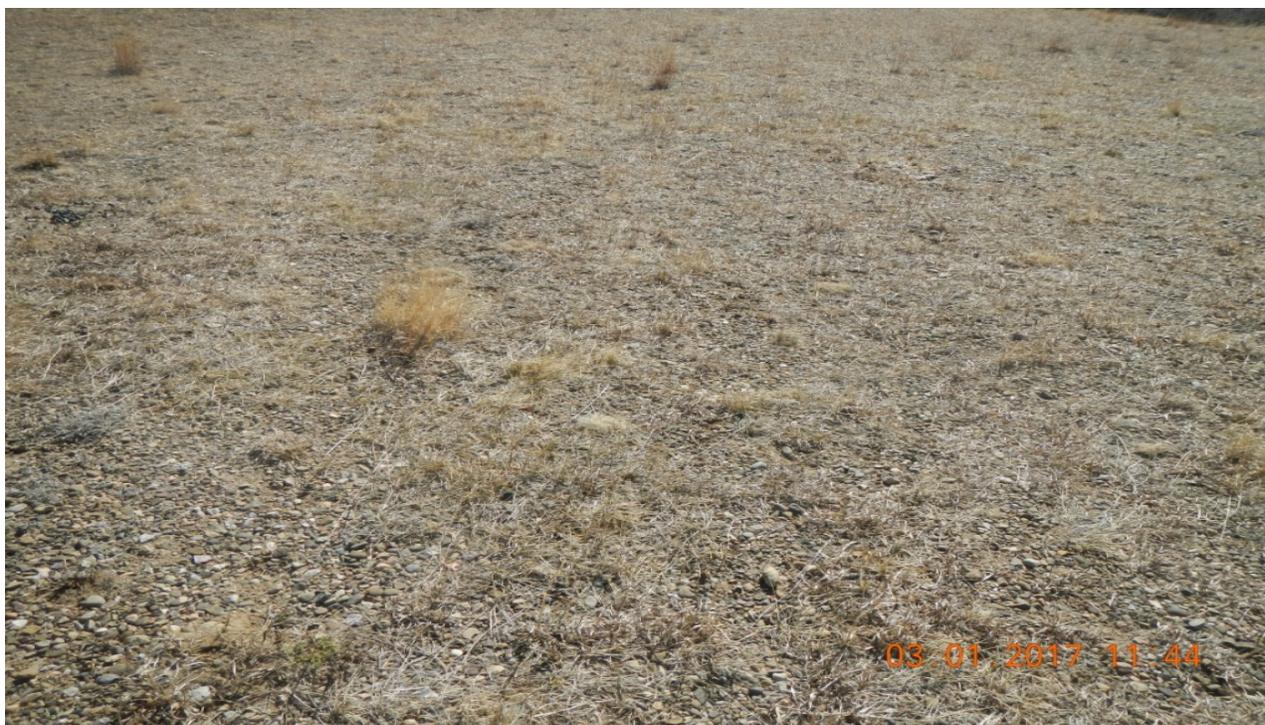
photo 4: Gravel remains in areas of the location.

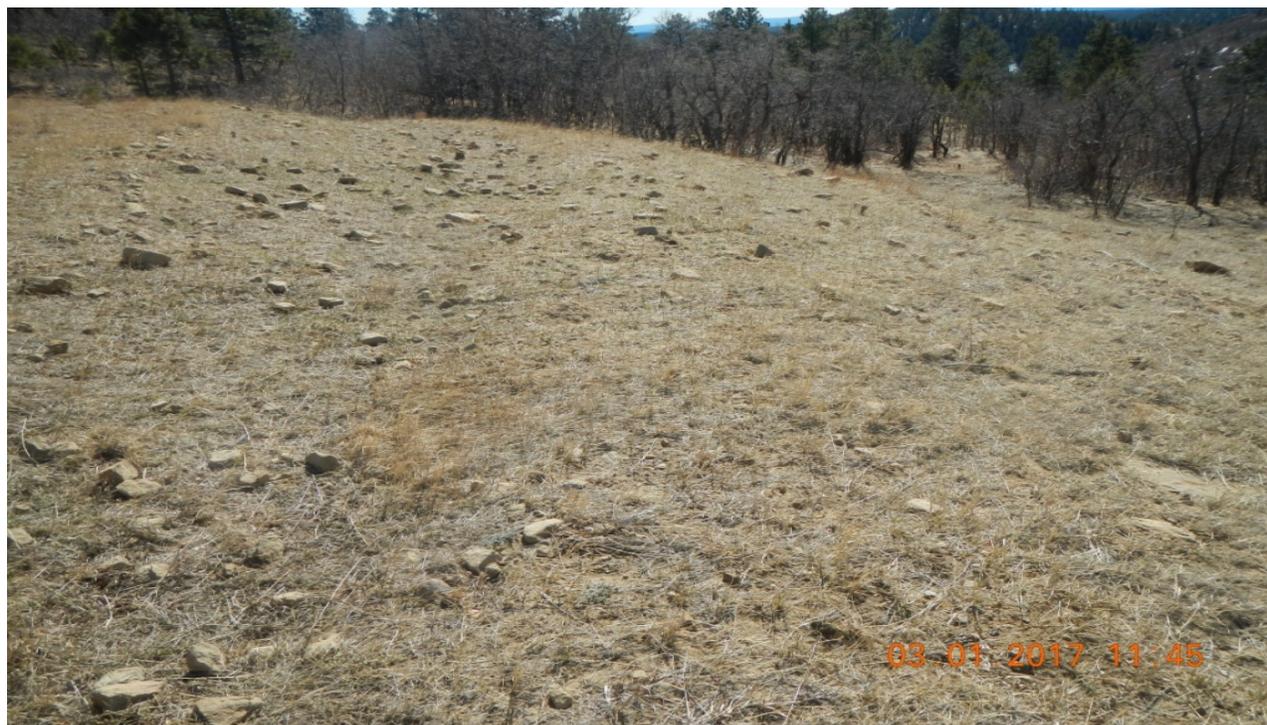
photo 5: Facing along the west fill slope.

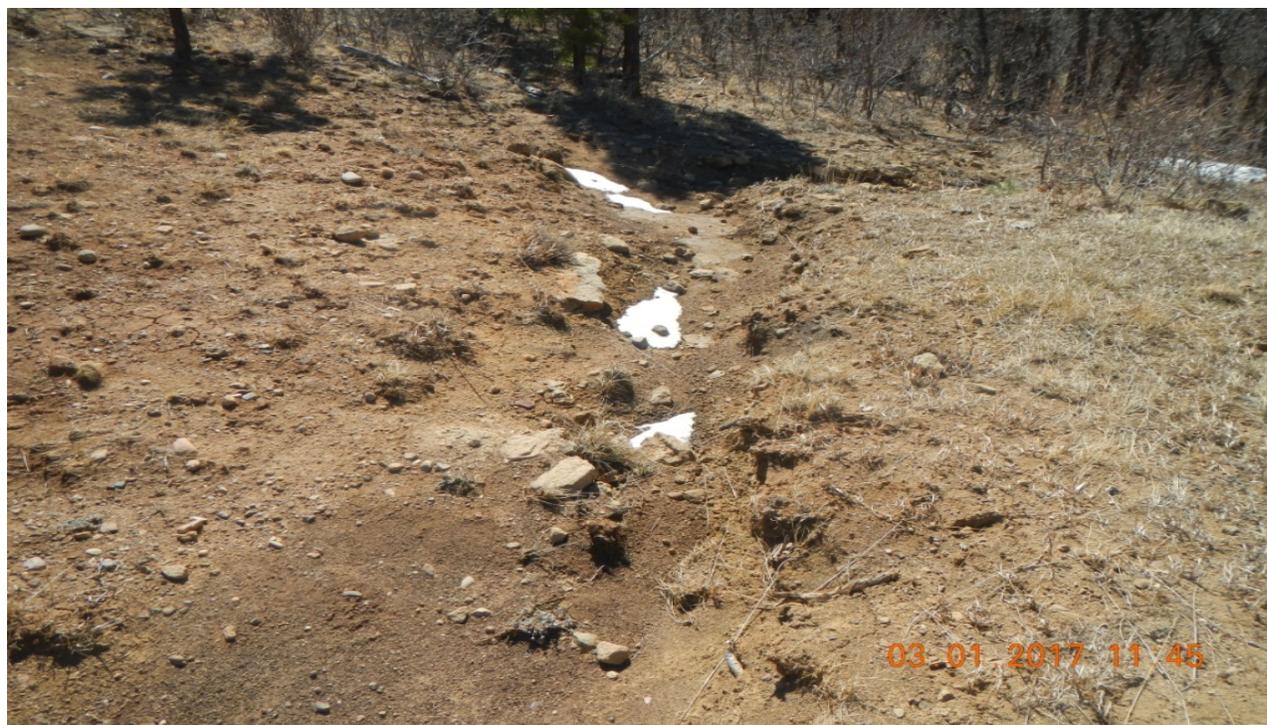
photo 6: There is an erosion channel off the south side of the location.

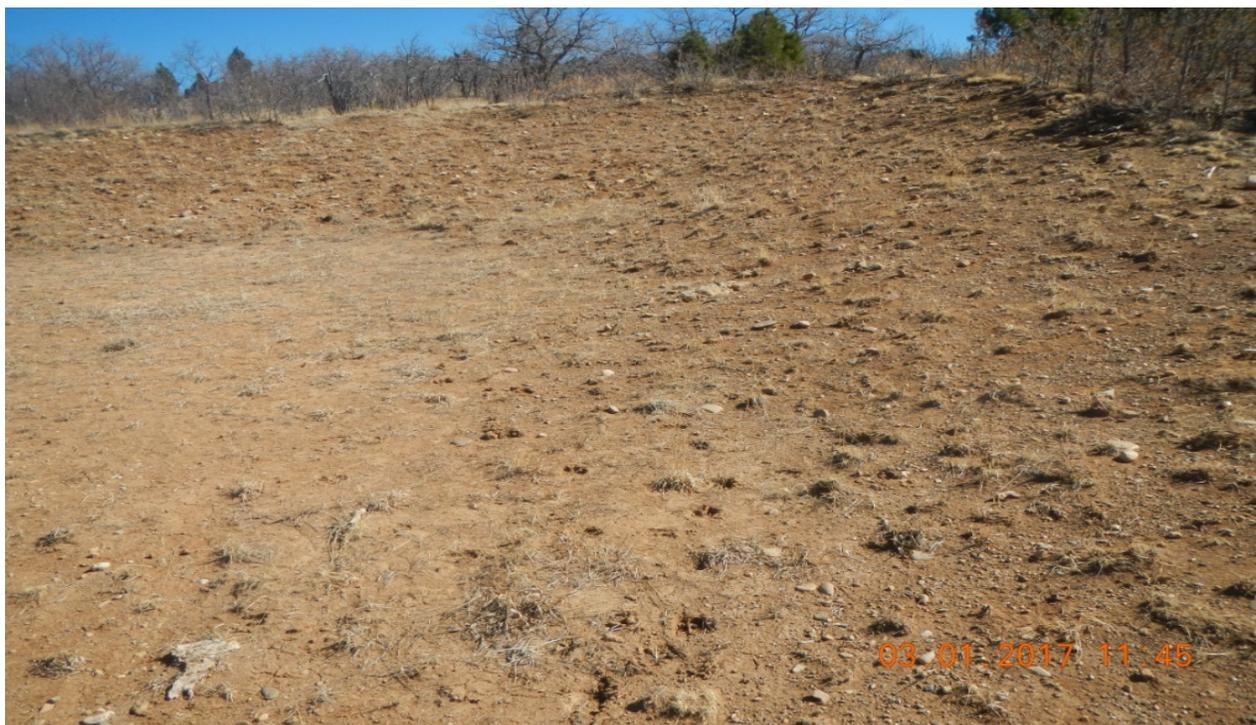
photo 7: Facing toward the southeast cut slope.

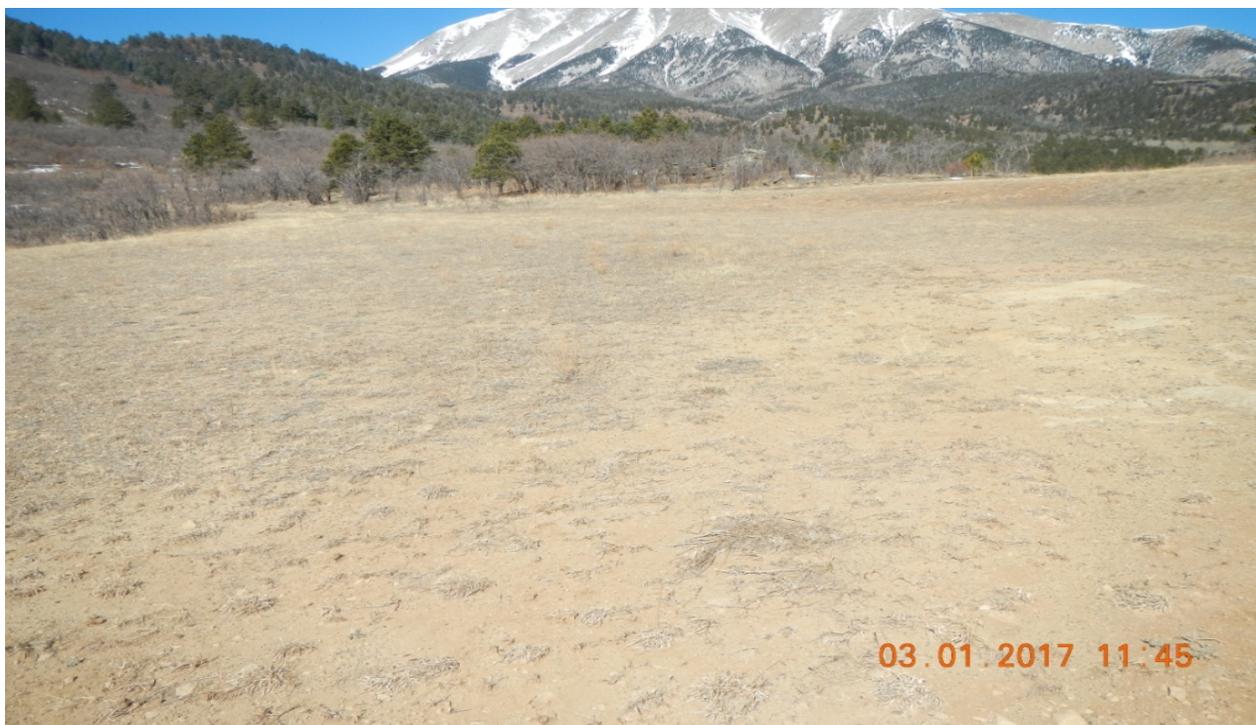
photo 8: South side of the location facing north.

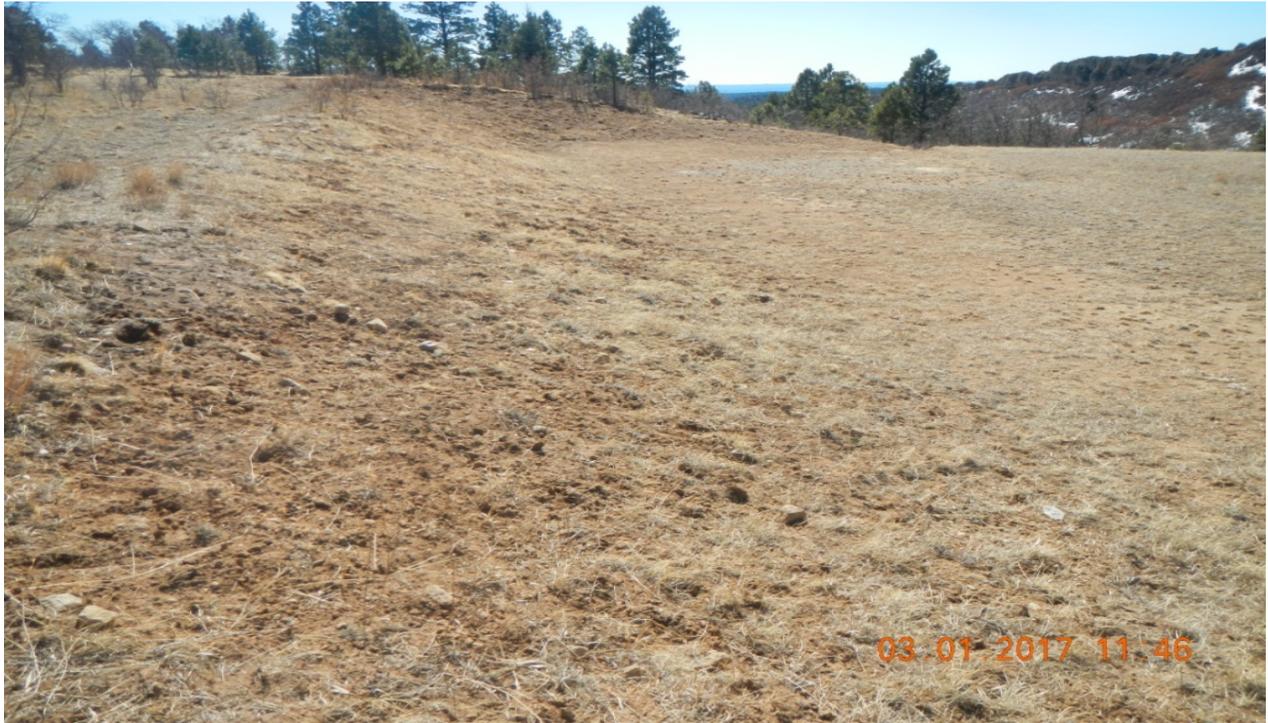
photo 9: Facing southeast along the cut slope of the location.

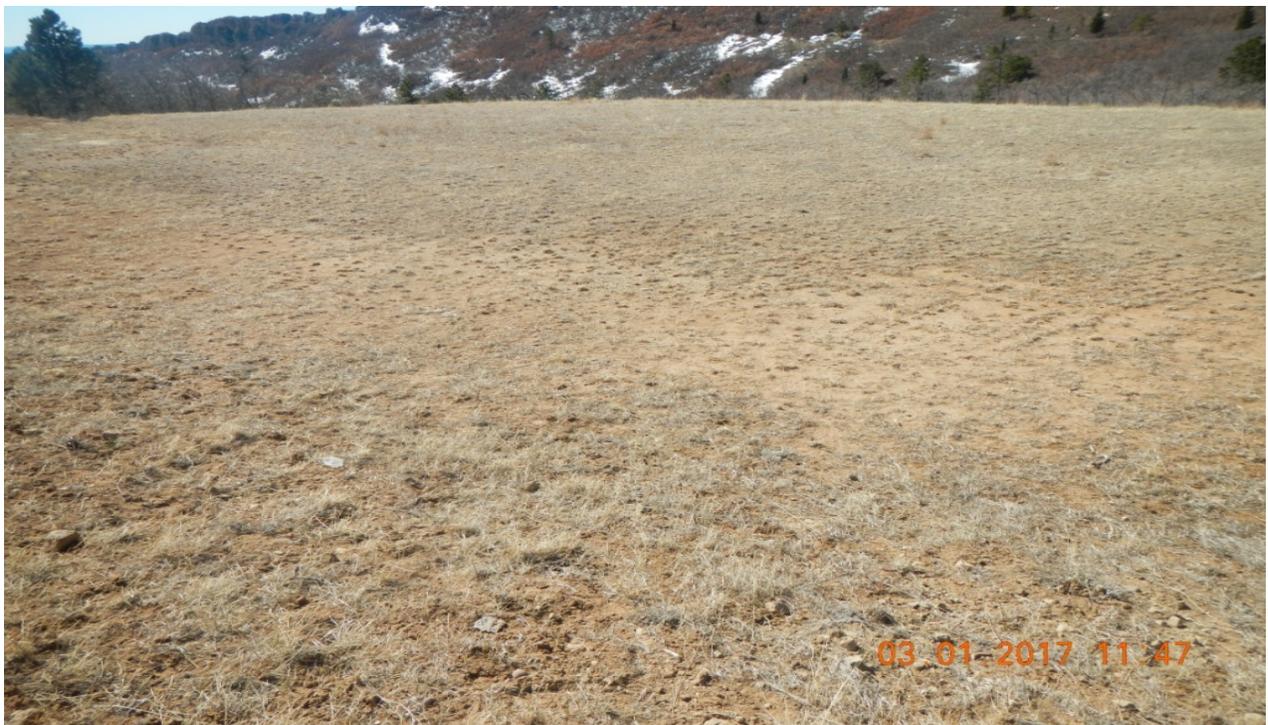
photo 10: Facing southwest toward the location.
