Inspection Photos
Location Name: Futhey 3
API: 05-013-06046

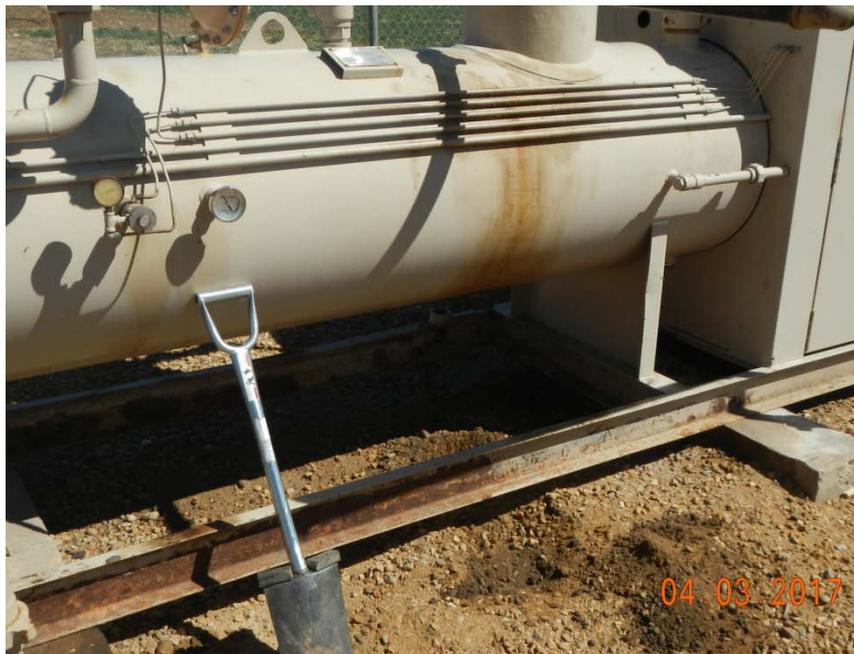
Stained soil under leaking pipe connection on separator.

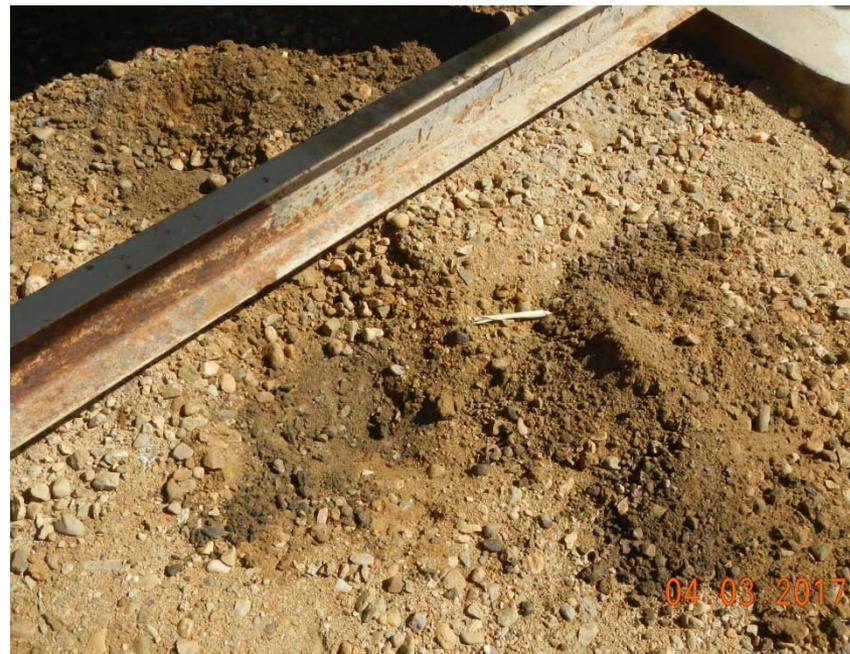
Close-up of stained soil under separator

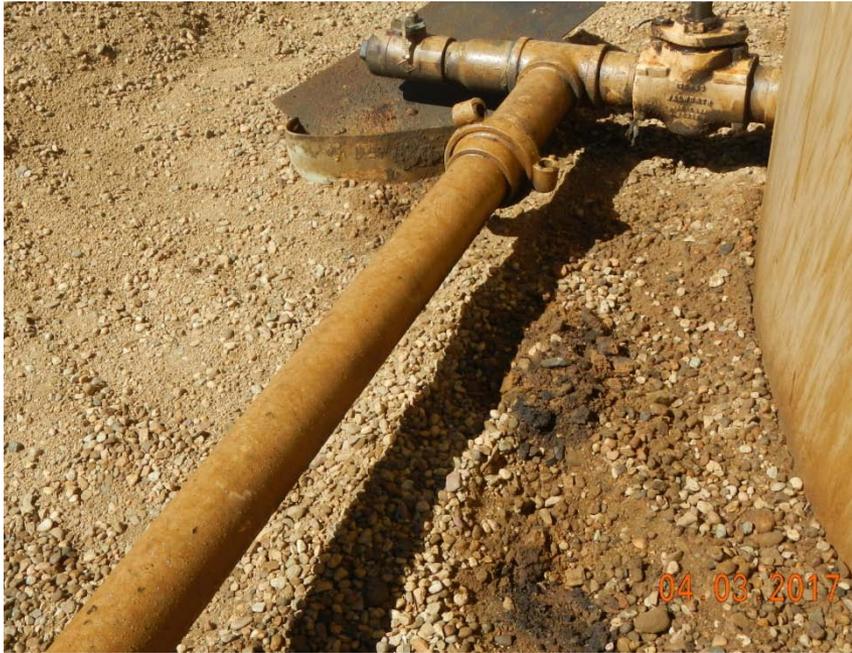
Stained soil at base of west oil tank
Taken from east looking west.

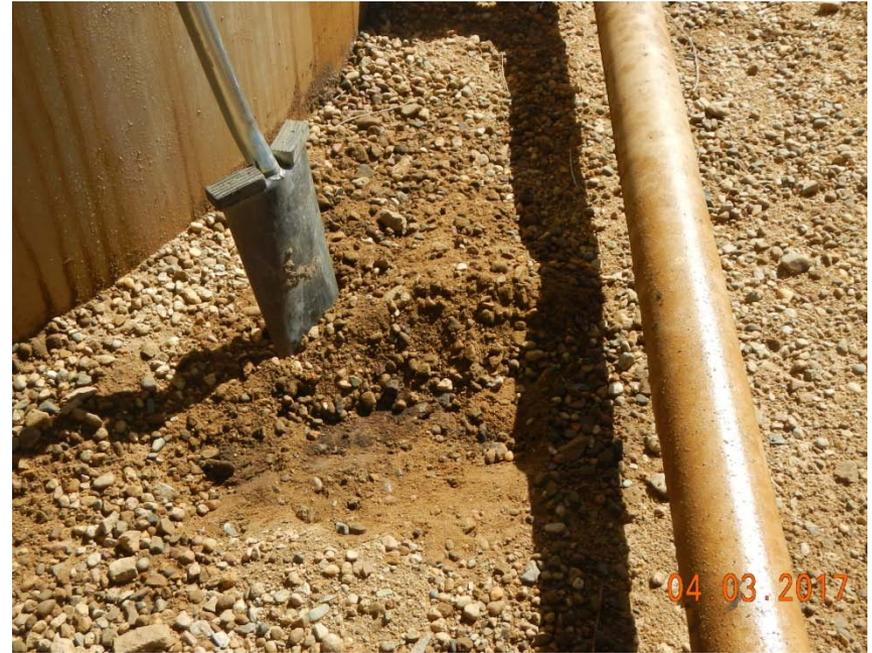
Stained soil at base of east oil tank.
Taken from between tanks looking east.

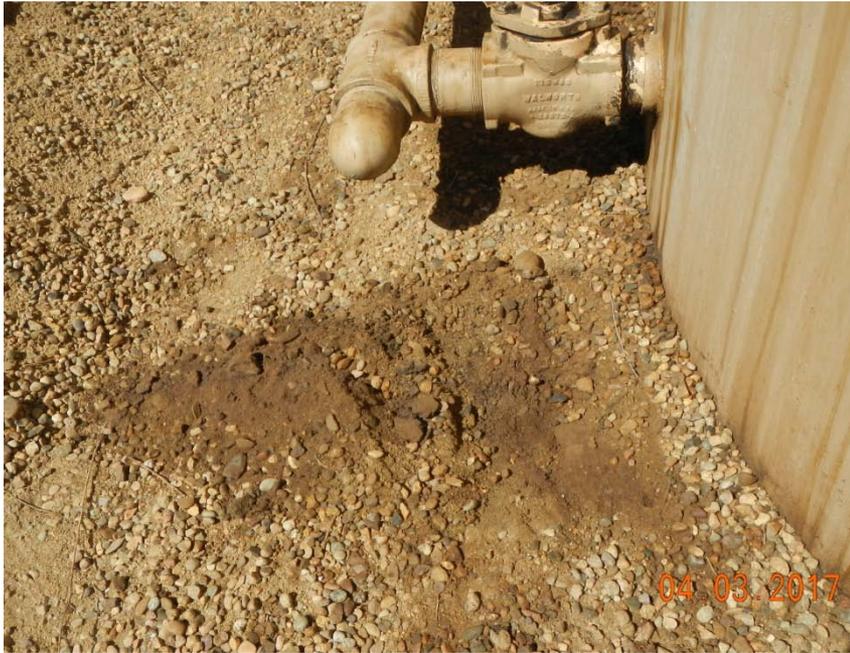
**Stained soil at base of east oil tank.
Taken from east looking west.**

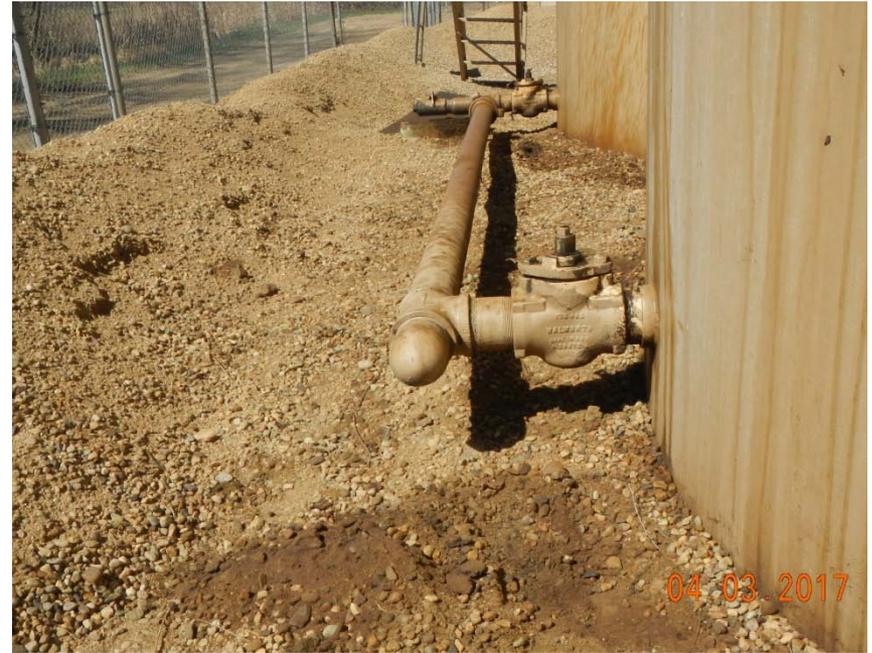
**Stained soil at base of both oil tanks.
Taken from east looking west.**
