Inspection Photos
Location Name: Iles Dome Unit 37
API: 05-081-05090

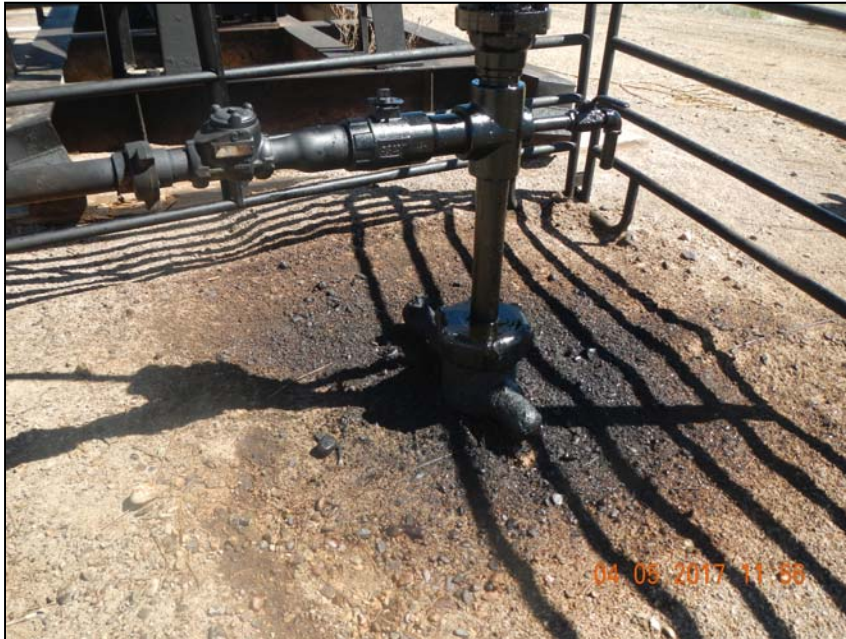
Photo 2. Ongoing leak at wellhead. Fresh oil and stained soil. 4/5/2017 Inspection

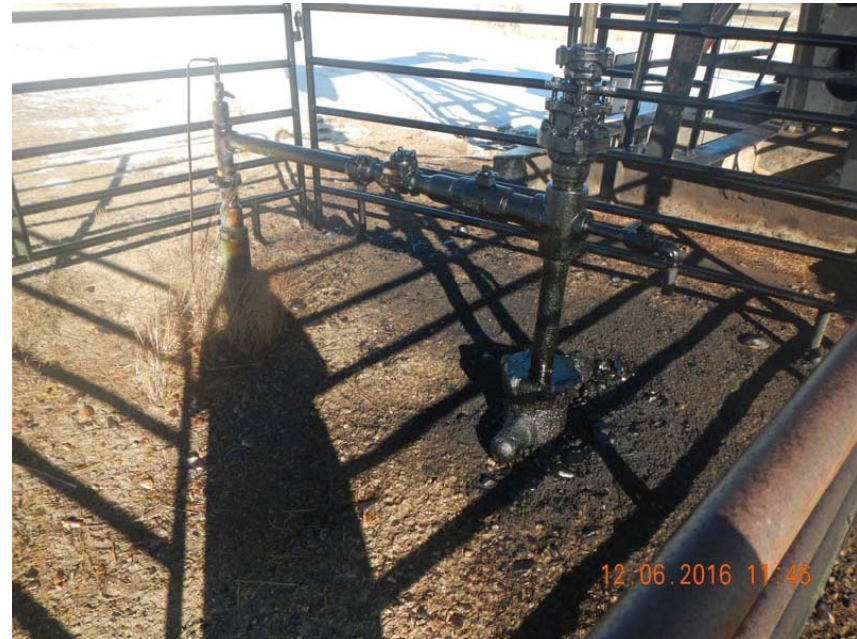
Photo 3. Ongoing leak at wellhead. Fresh oil and stained soil. 12/6/2016 Inspection
