Reference Area Photographs

Inspection Conducted on March 08,, 2017

SG Interests

McIntyre E&P Waste Management Facility

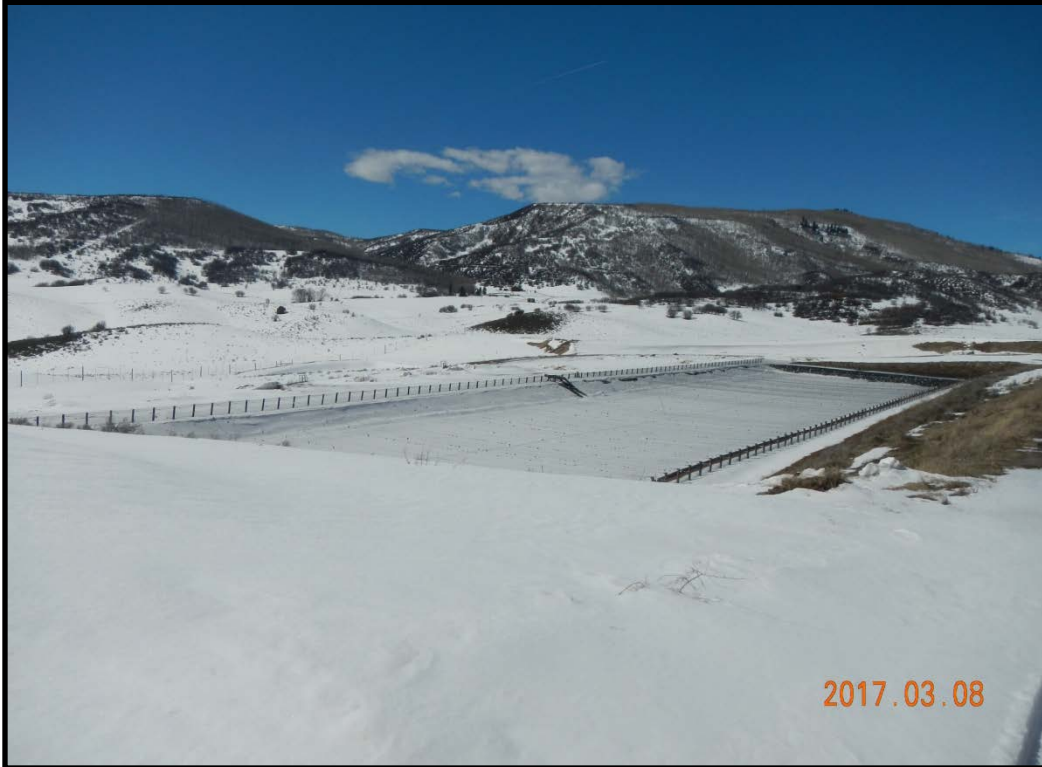
Lower Pit (Looking West)

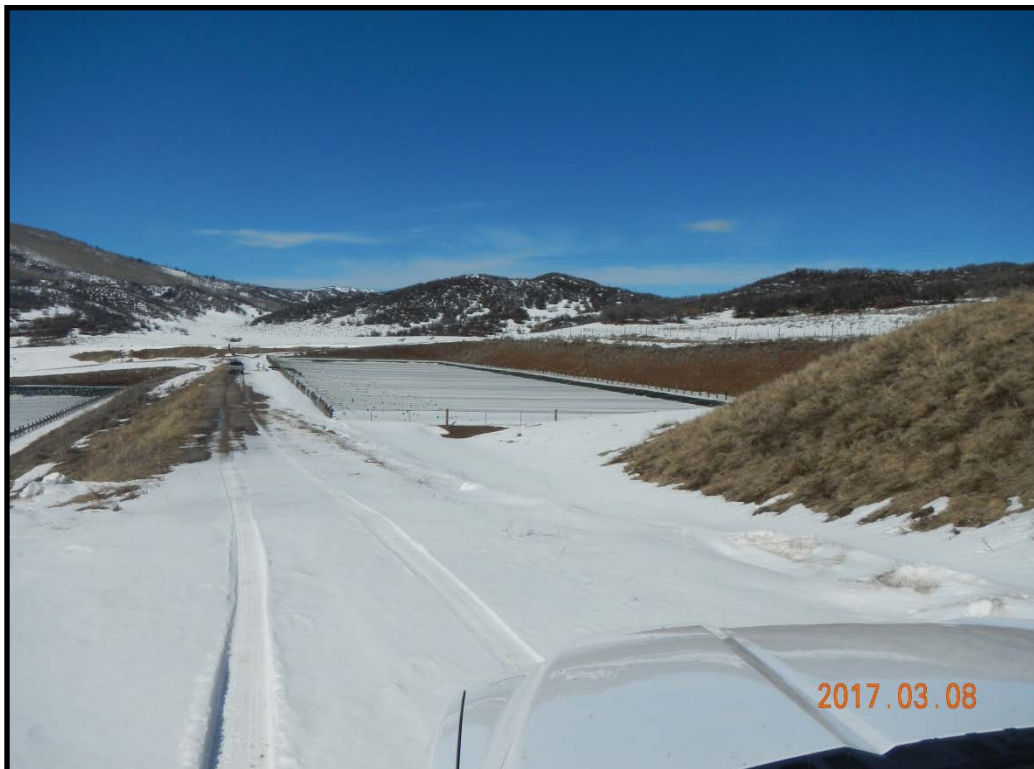
Upper Pit (Looking Norwest)

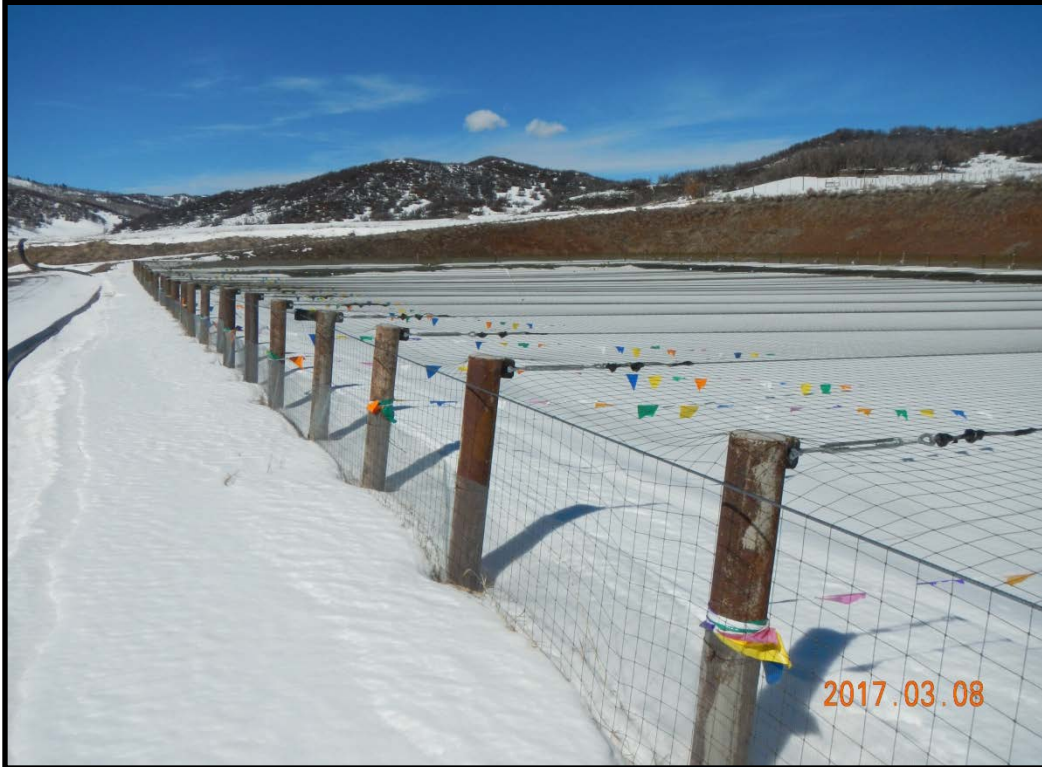
Upper Pit (looking Northwest). Netting in good general conditions. Color flags.

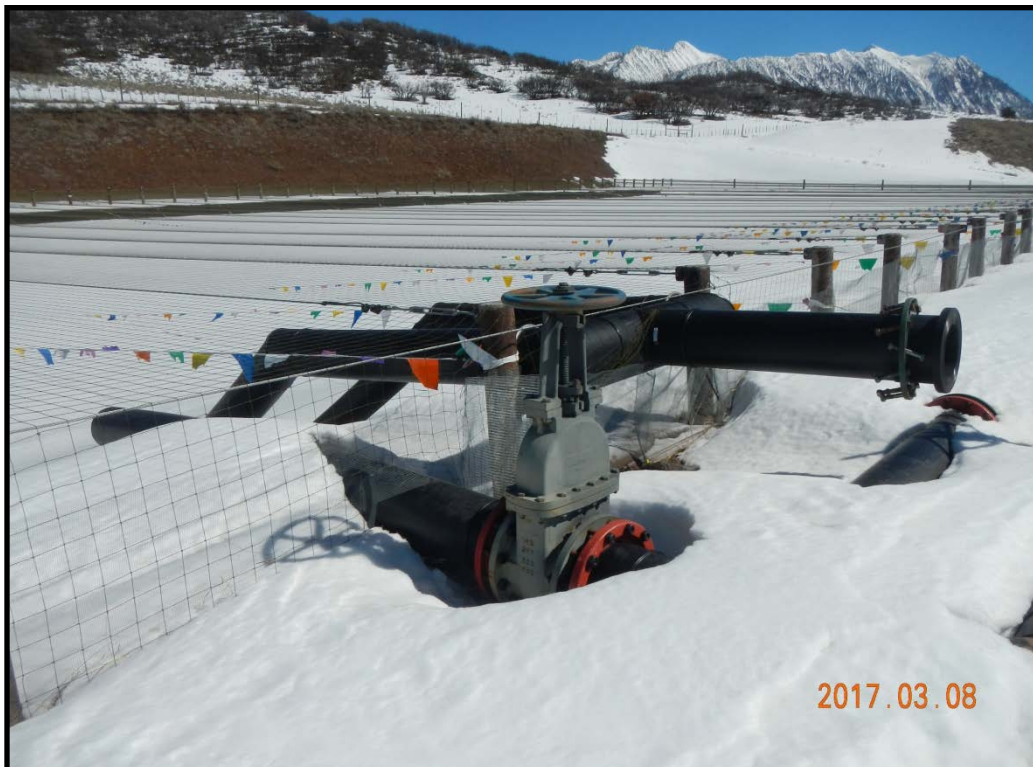
Upper Pit (looking East). Produced Water Discharge Manifold

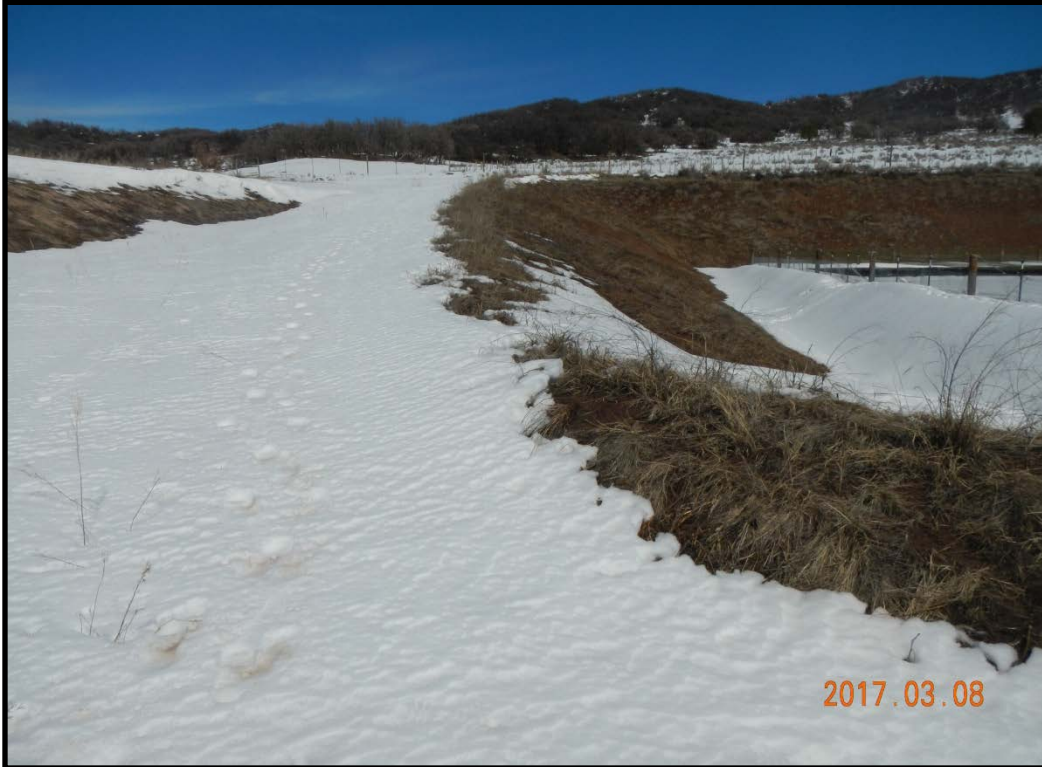
Access/Emergency road around the upper pit (looking Northeast)

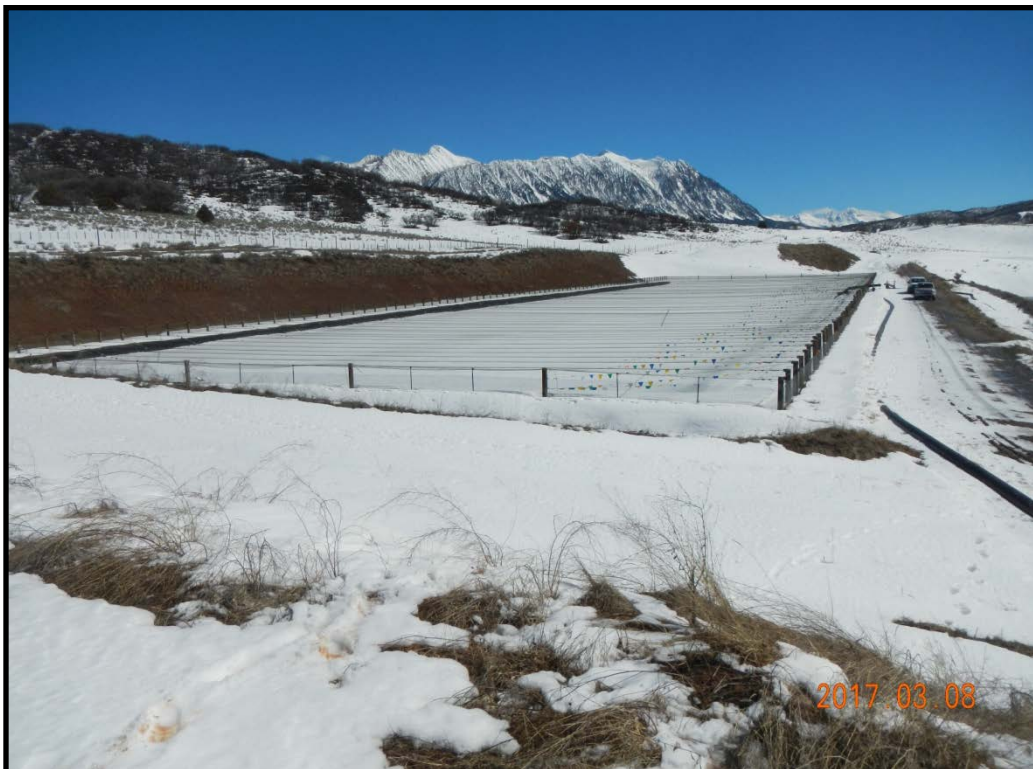
Upper Pit (looking Southeast)

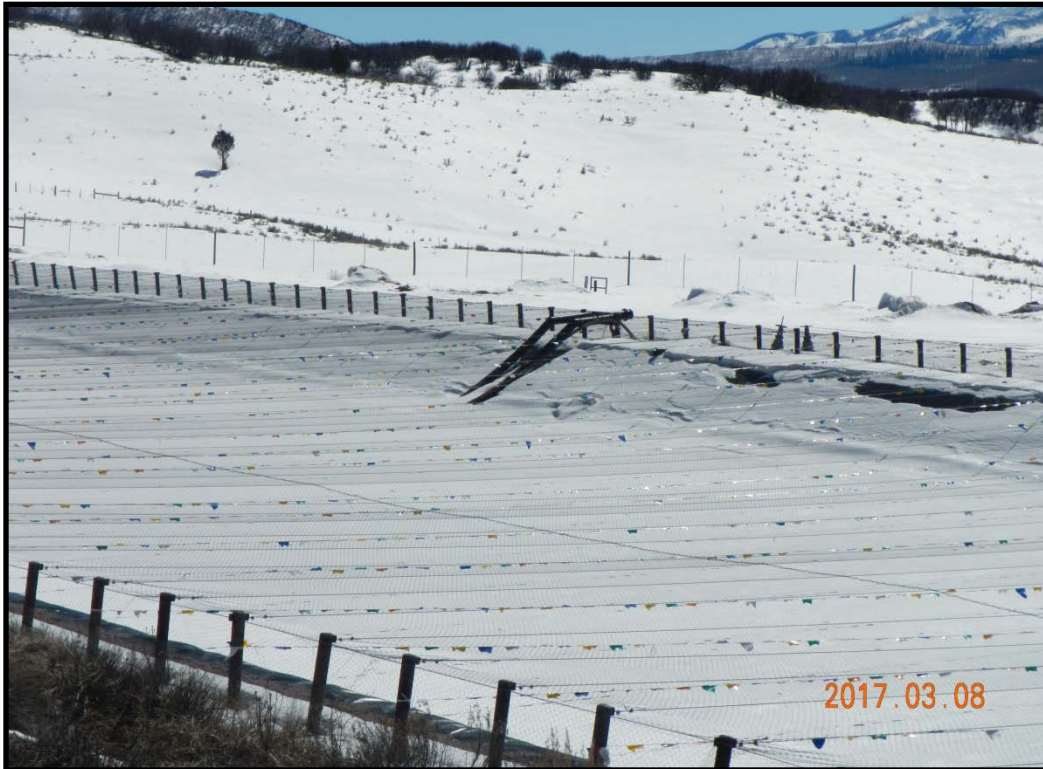
Lower Pit. Looking south. Manifold at the center of the photo.

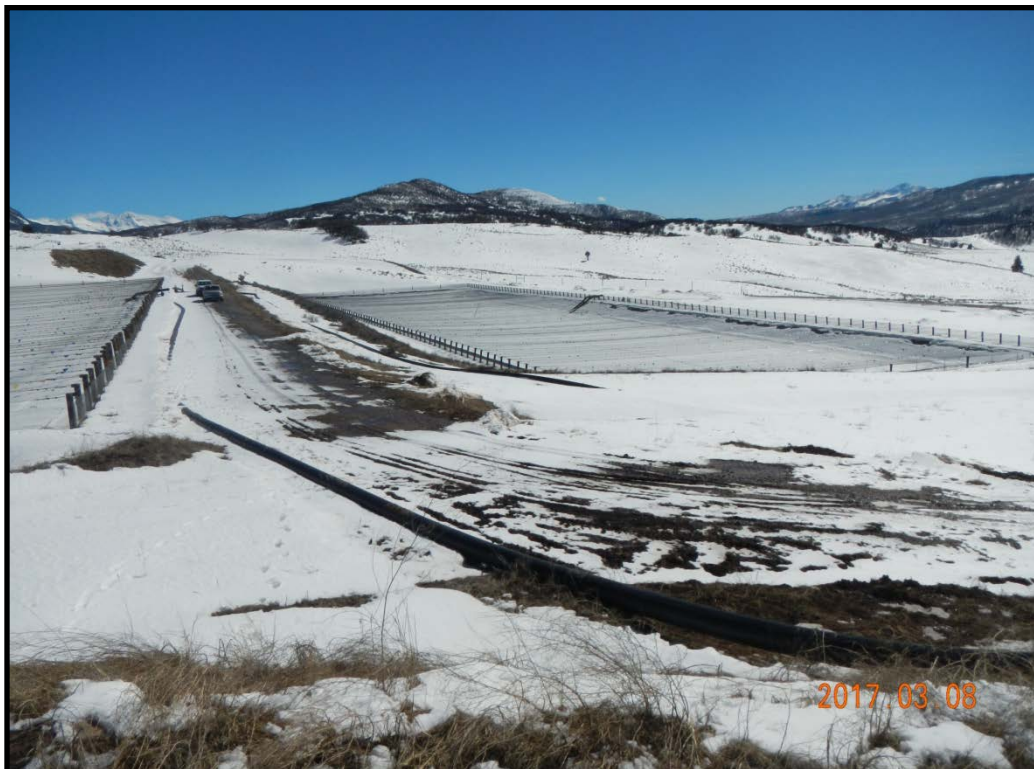
Lower Pit. Looking southeast. Access/service road continues around lower pit (and around upper pit as well).

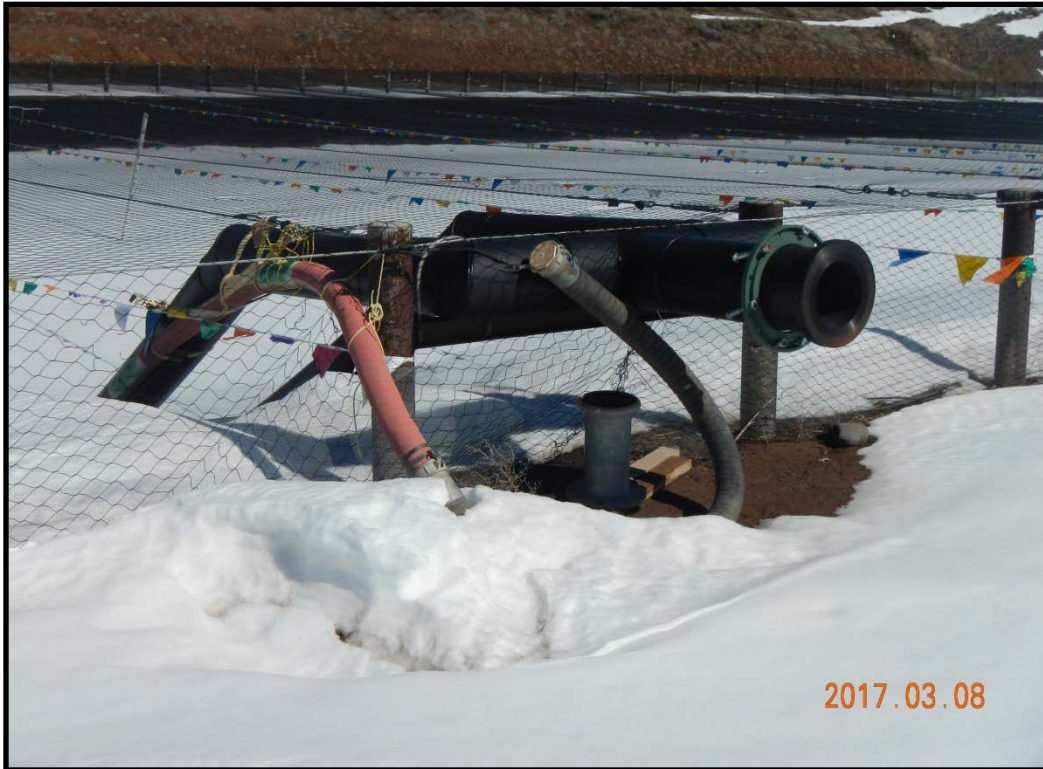
Lower Pit. Permanently Installed Produced Water discharge Manifold

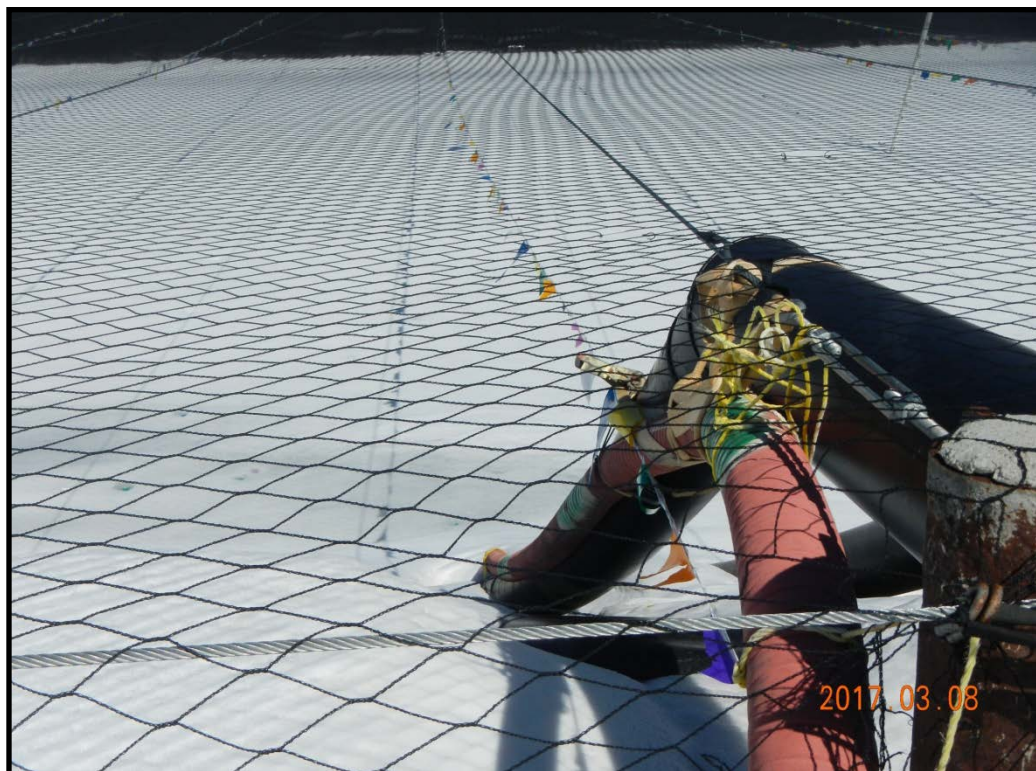
Lower Pit. Discharge piping
Some observed damage to the netting

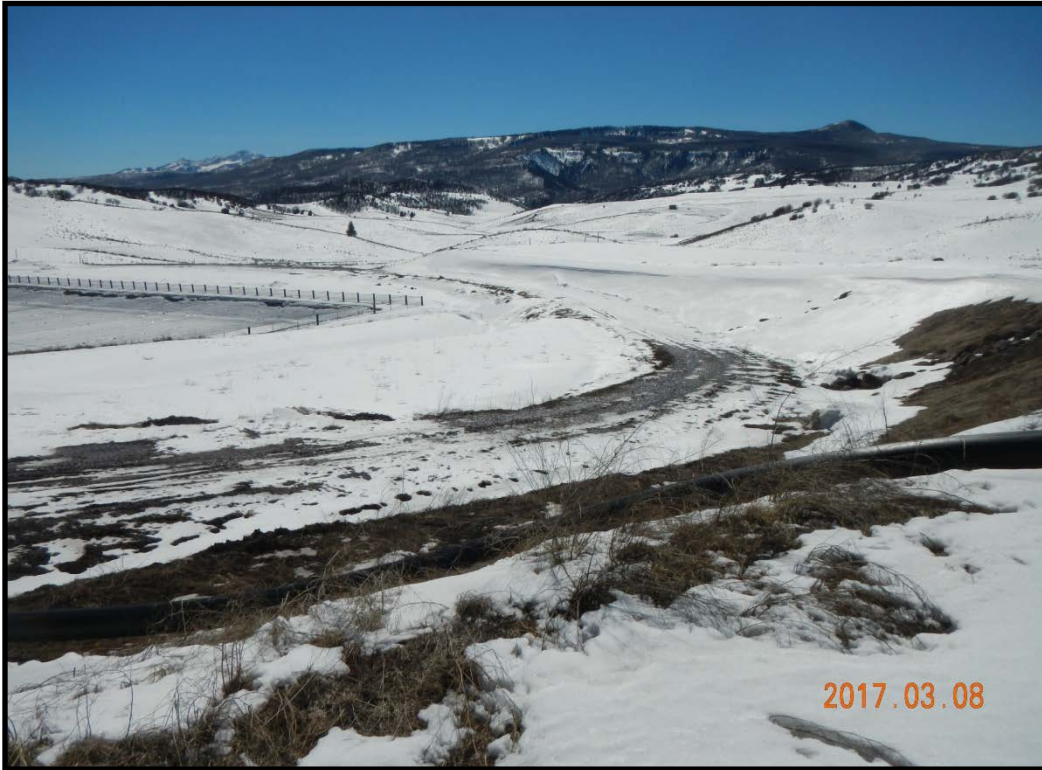
Lower Pit. Looking south. Access/service road and storm water management (drainage and retention pond on the down gradient side (far south on the photo).

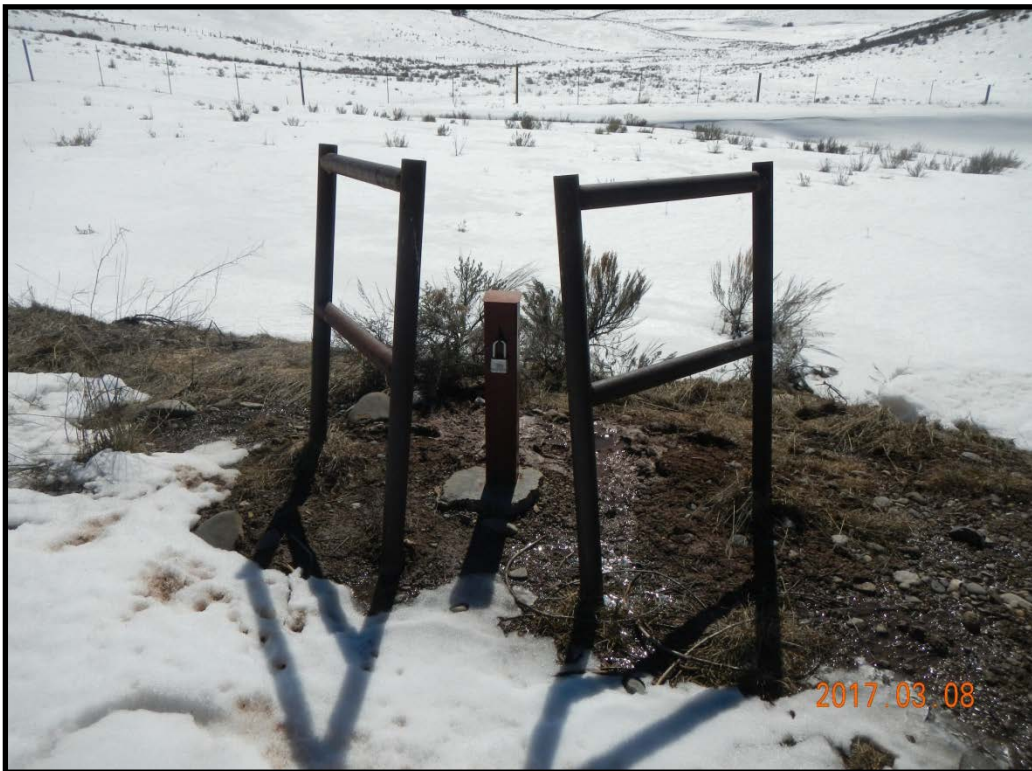
One of the three monitoring wells. All three on the south/down-gradient side of lower pit.
Note: There is a MW up-gradient (north) of the upper pit.

All four are regularly gauged and sampled
