April 17, 2017

COLORADO
Oil & Gas Conservation
Commission
Department of Natural Resources

Inspection Photos: Caerus Mesa N23-697
Loc#448427

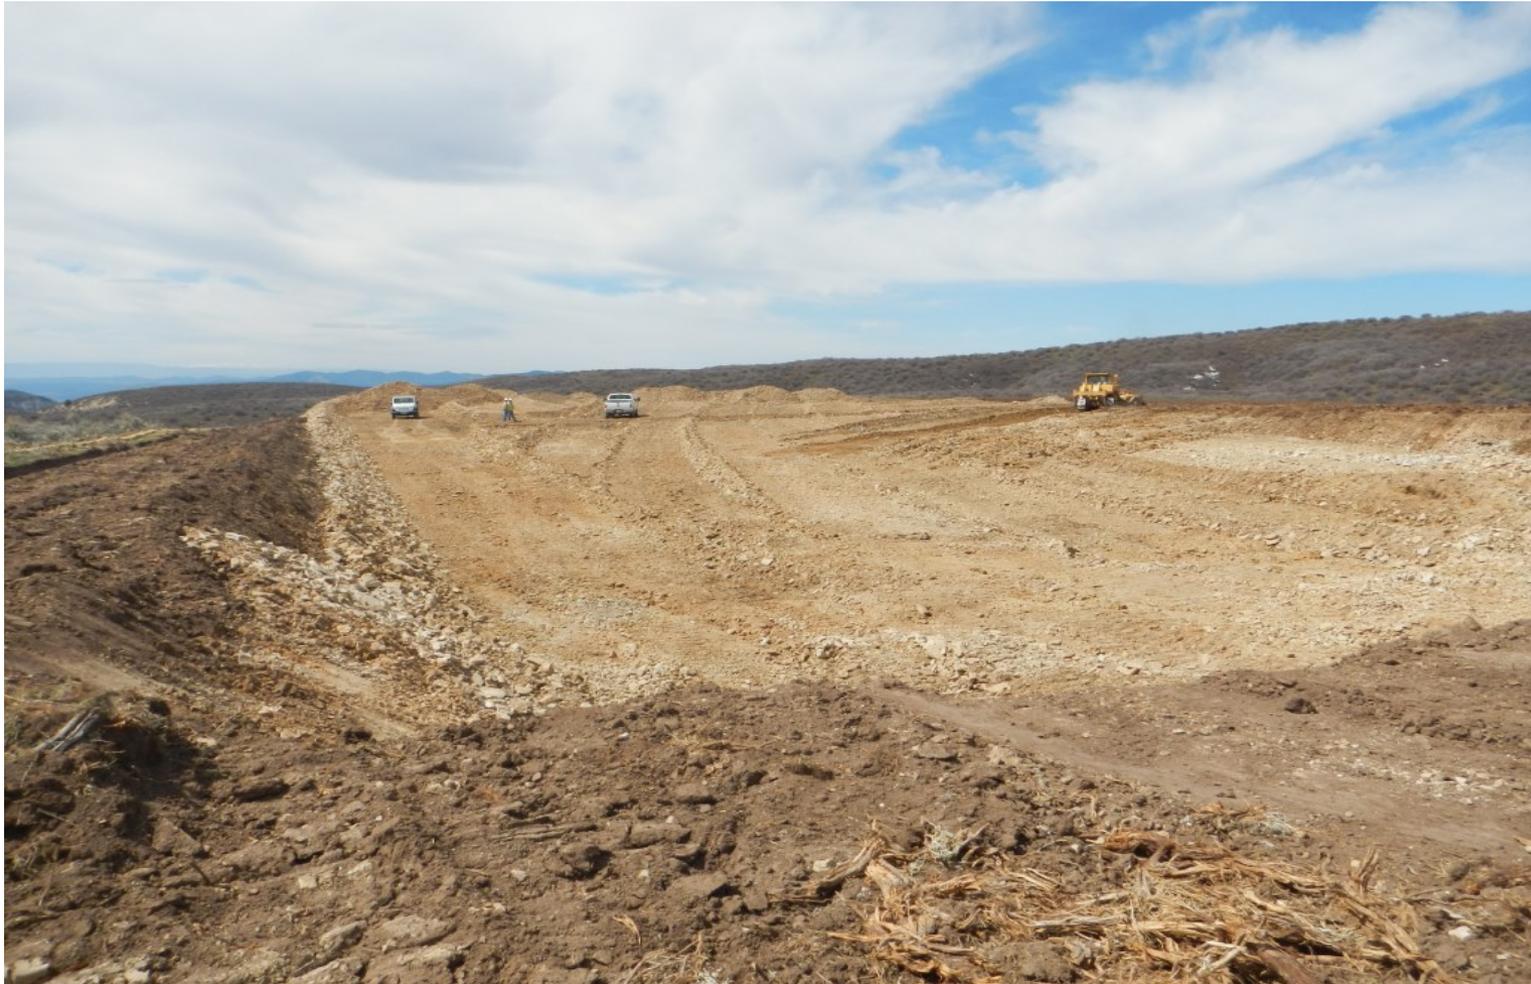
Photo#1:

Overview of Location to SW

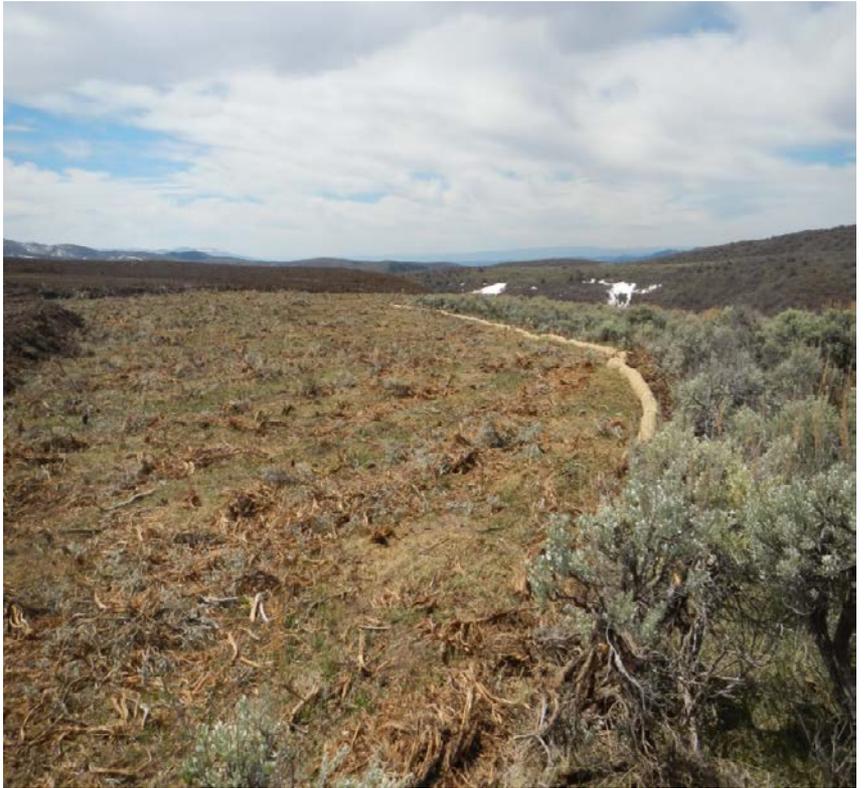
Photo#2:

Wattles have been installed around Perimeter of Location. One Wattle on South Perimeter needs to be reseeded.

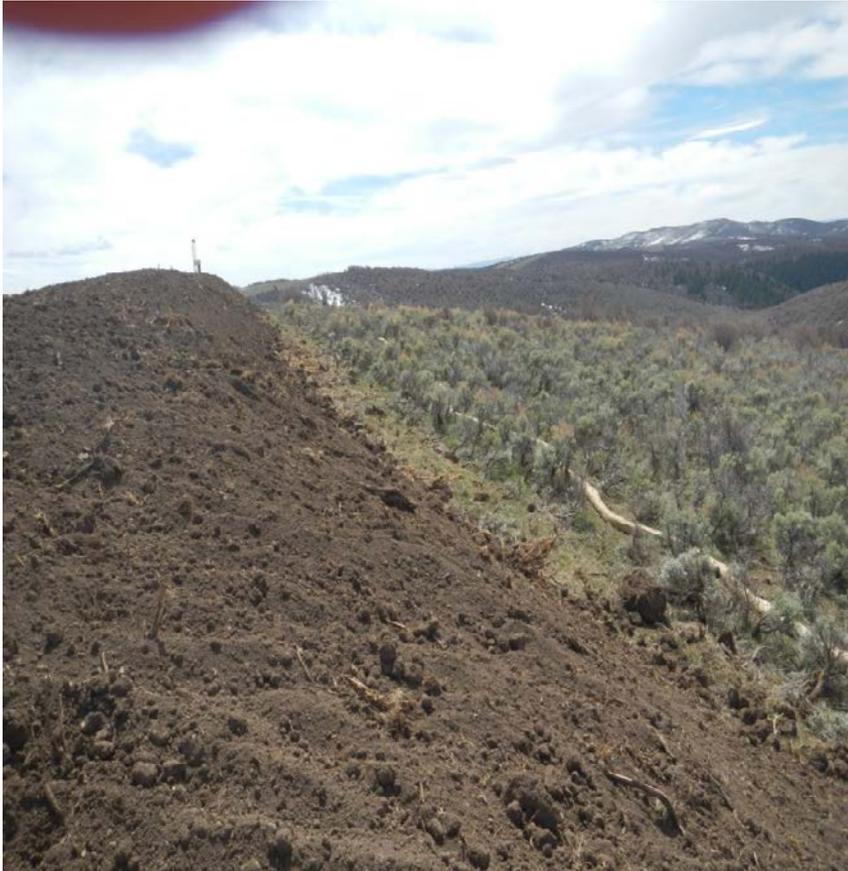
Photo#4:

Topsoil has been Salvaged and piled at outside toe of Fill slope around Location Perimeter.

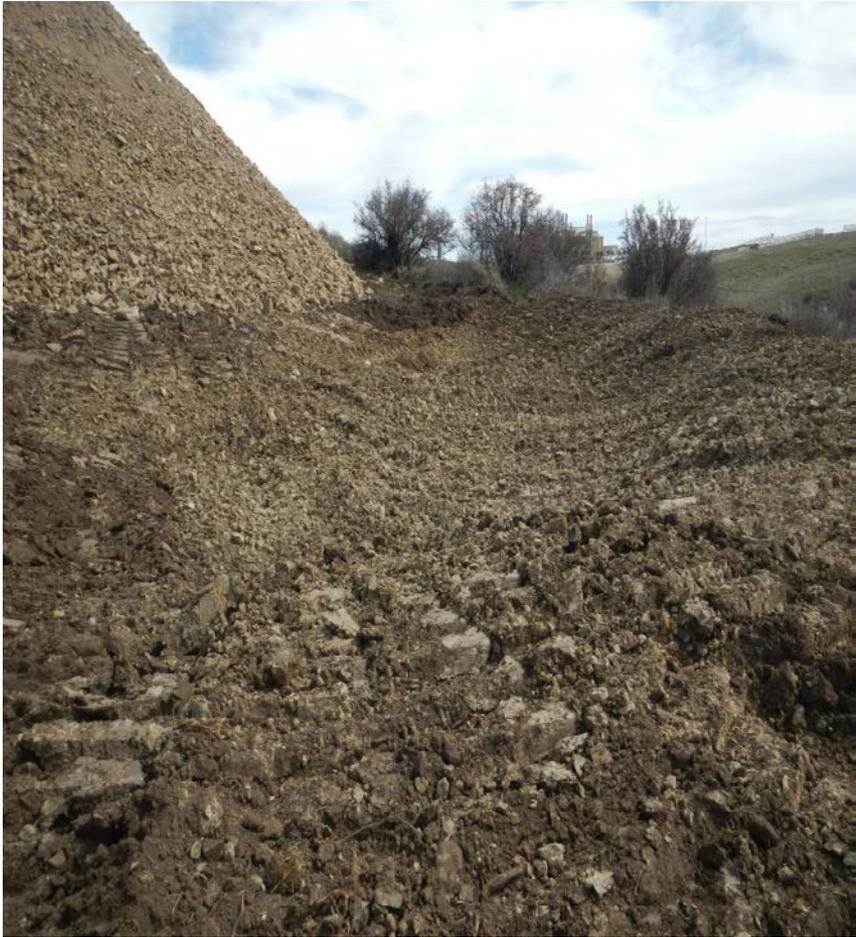
Photo#6:

Roughened in Retention & Detention Ponds are installed.

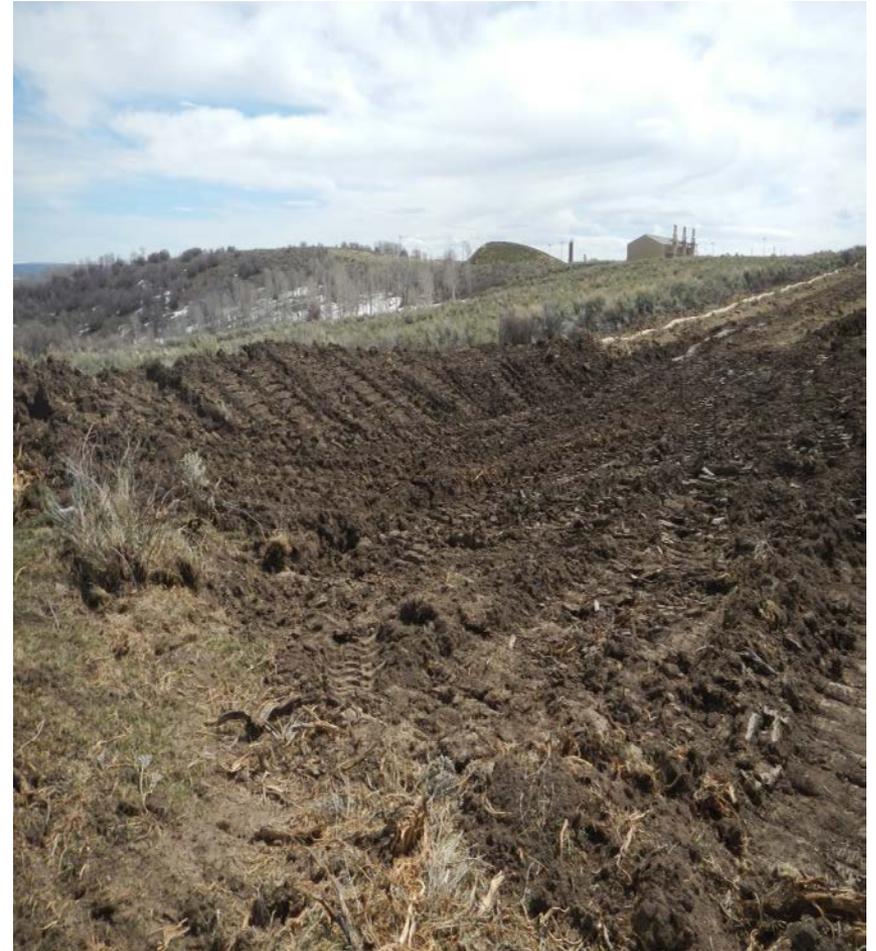
Photo#7:

Roughened in Retention & Detention Ponds are installed.

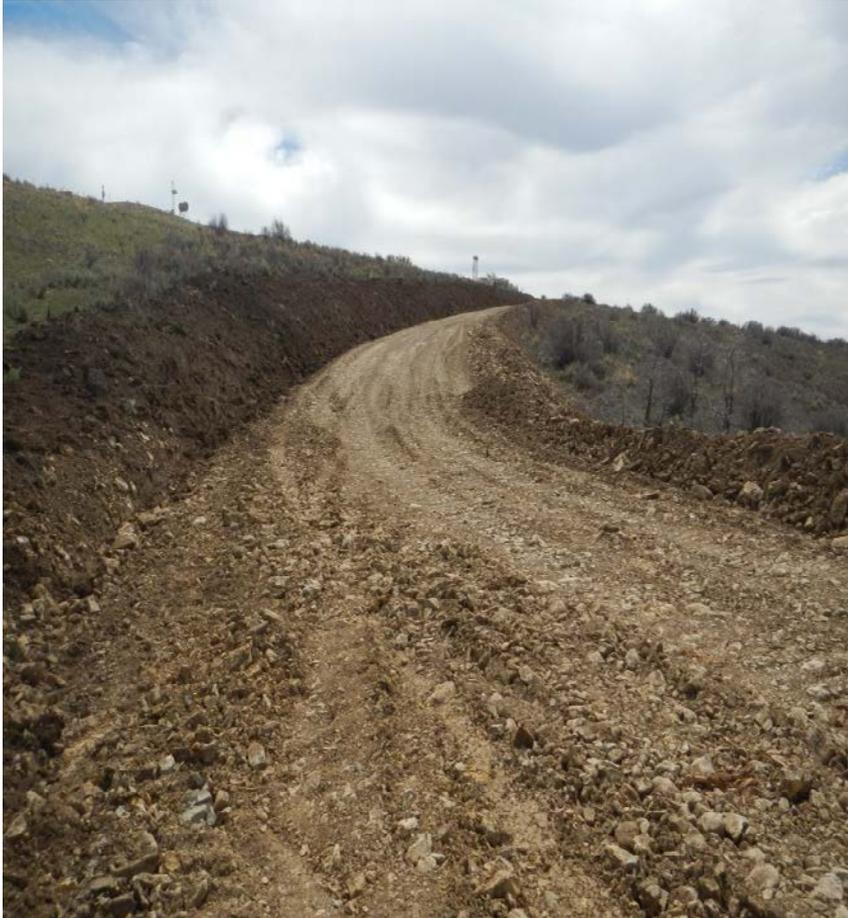
Photo#8:

Ditches / Culverts installed along Access Rd. Recommended to install BMPs in ditch along bottom edge of Access Rd Cut Slope to control SW flow / Sediment migration.
