November 16, 2016

Inspection Photos: TEP Crystal Creek API#045-06476

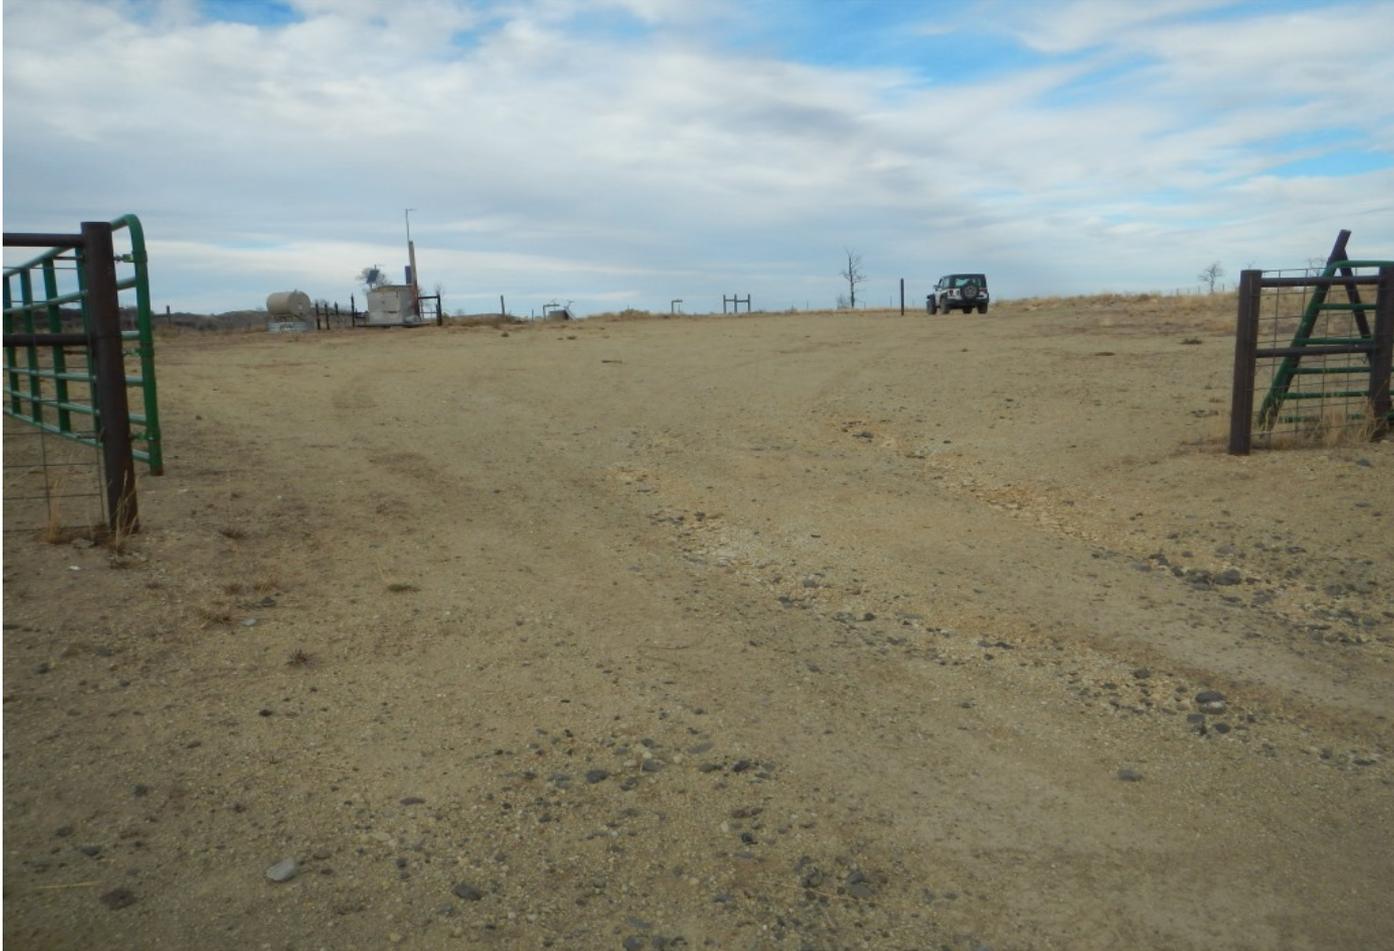
Photo#1: View of Location from Entry Road to NE

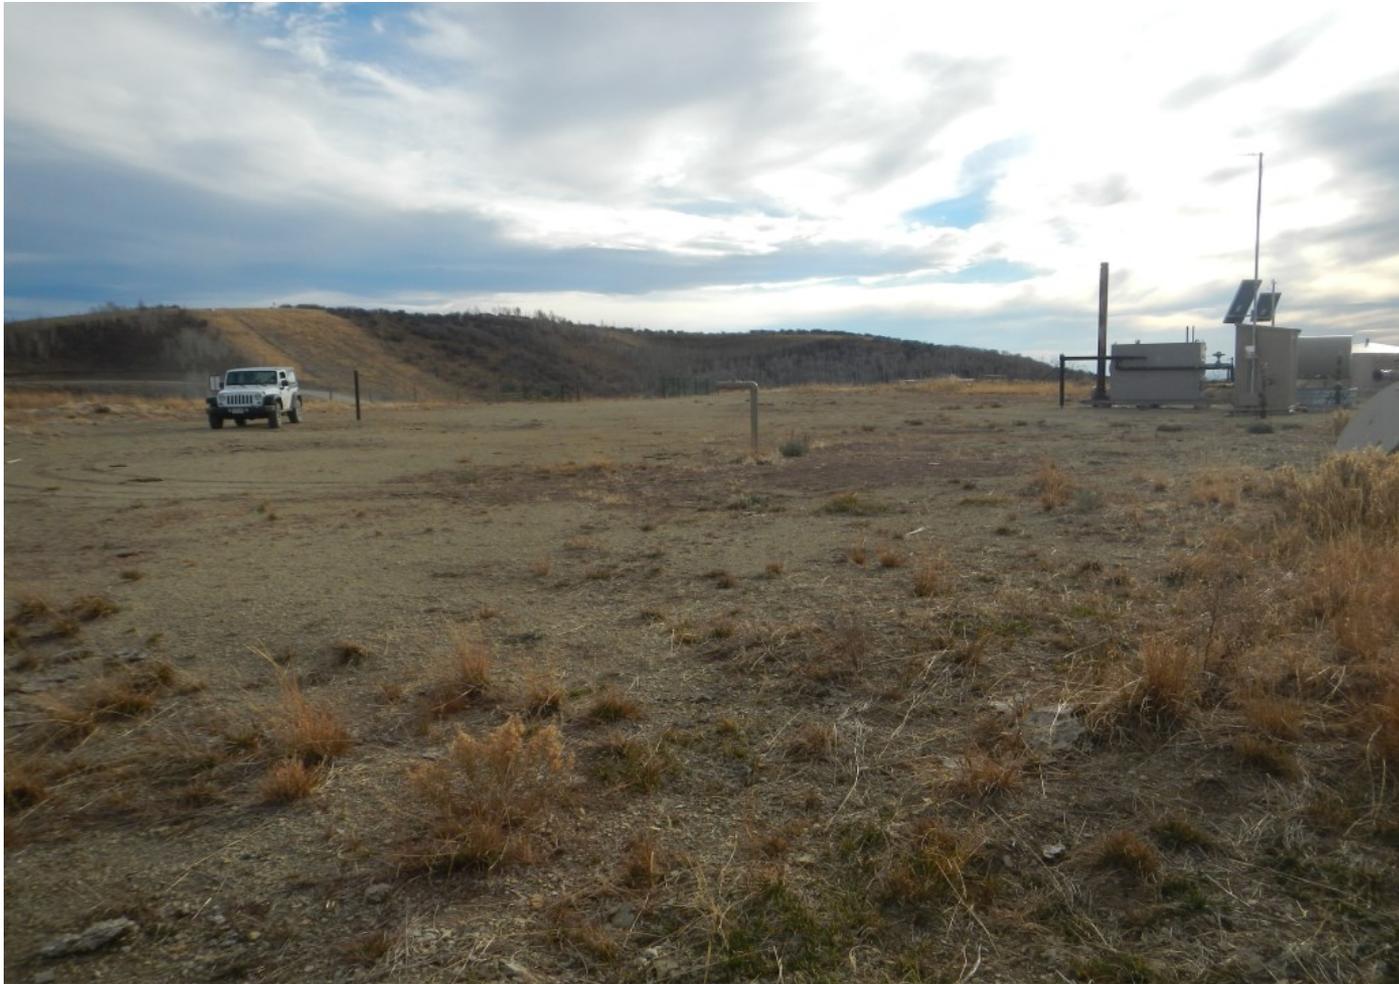
Photo#2: Overview of Location to SE

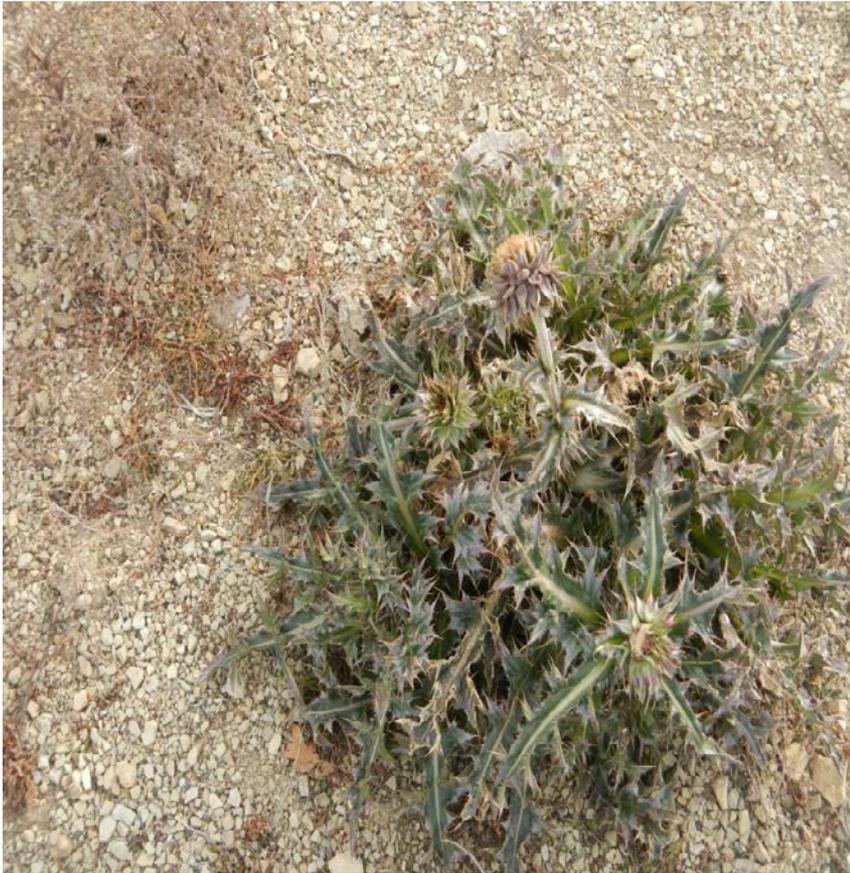
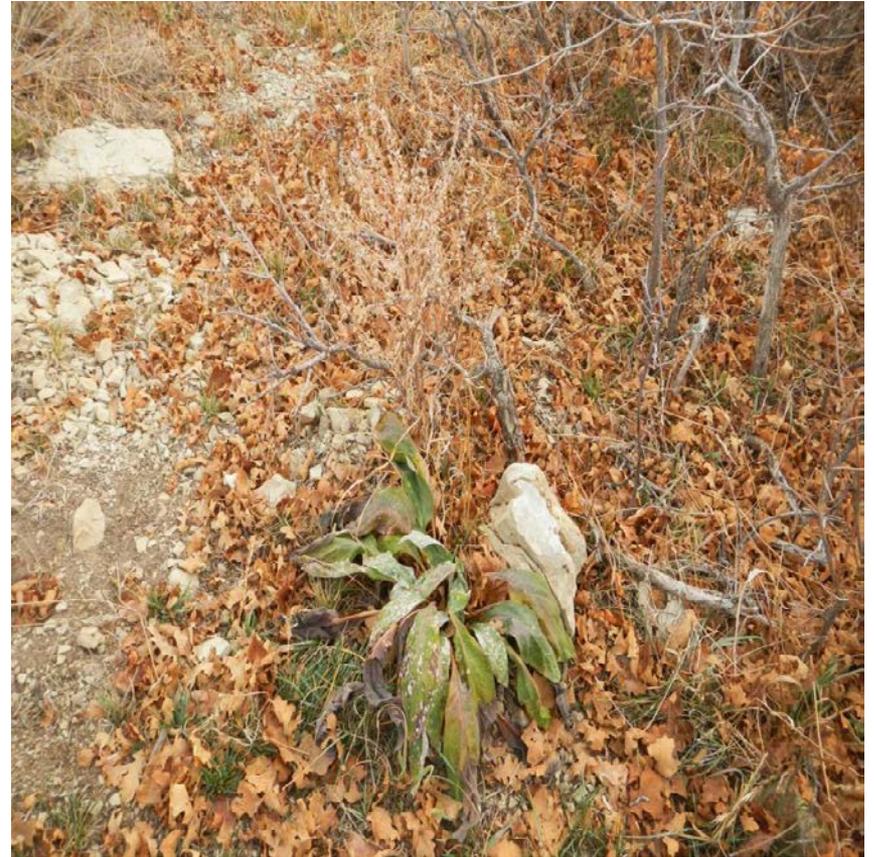
Photos# 3&4:

Noxious Weeds on Location; Houndstongue & Thistle.

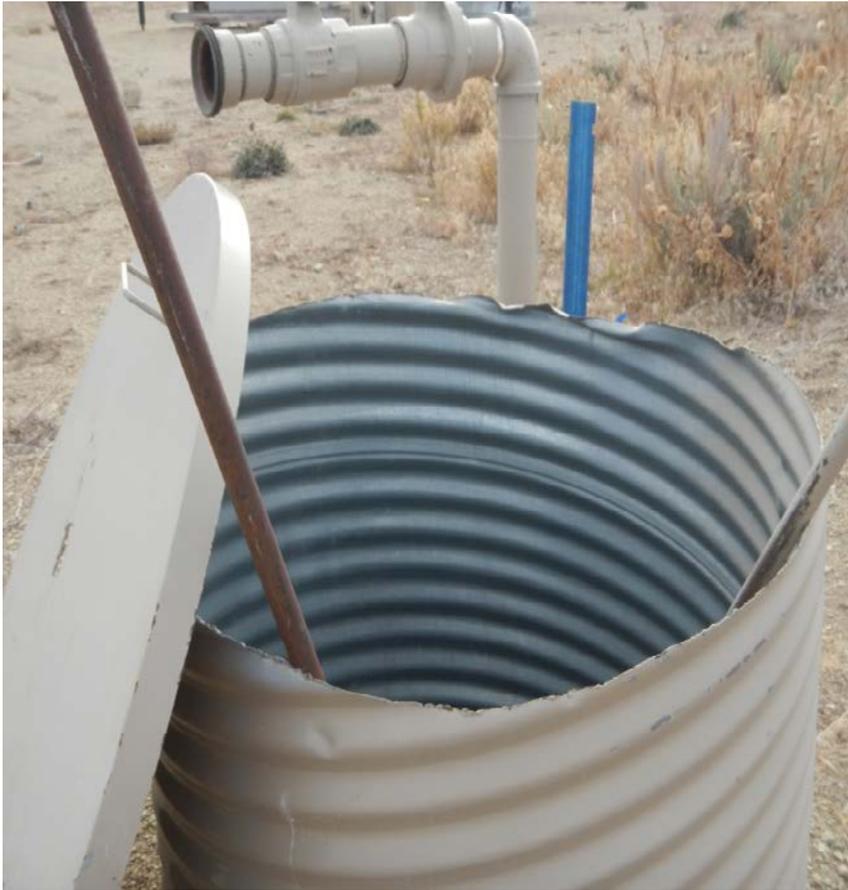
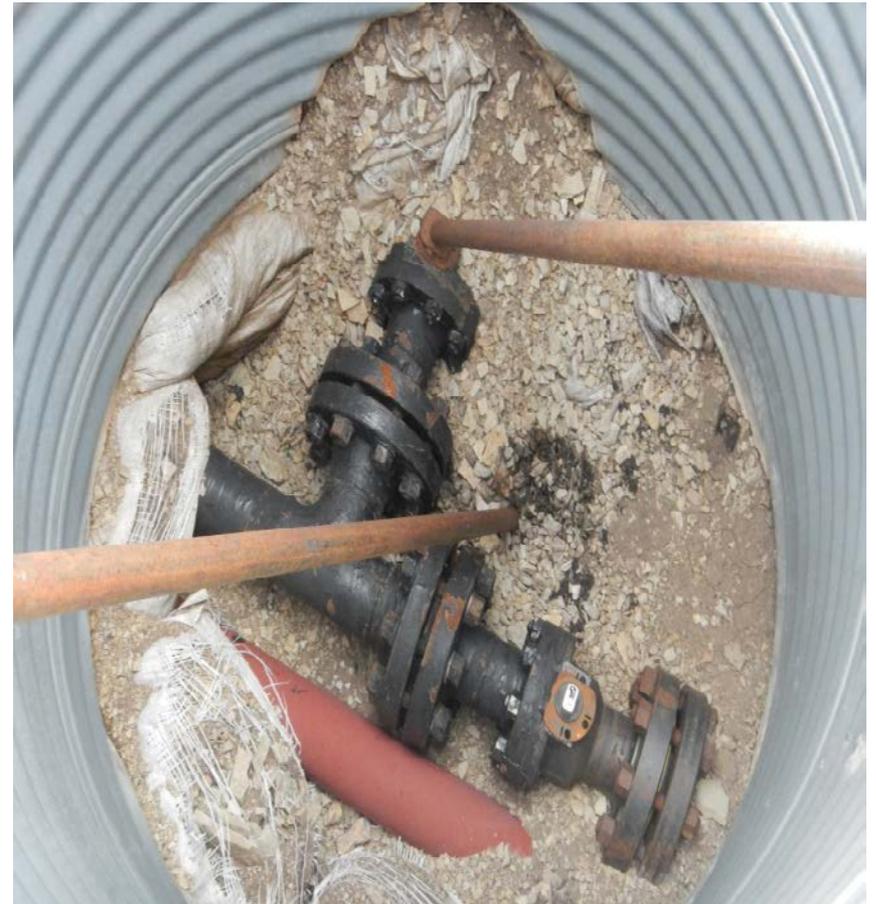
Photos#5&6:
Culverts Housing Lines/Valves are open

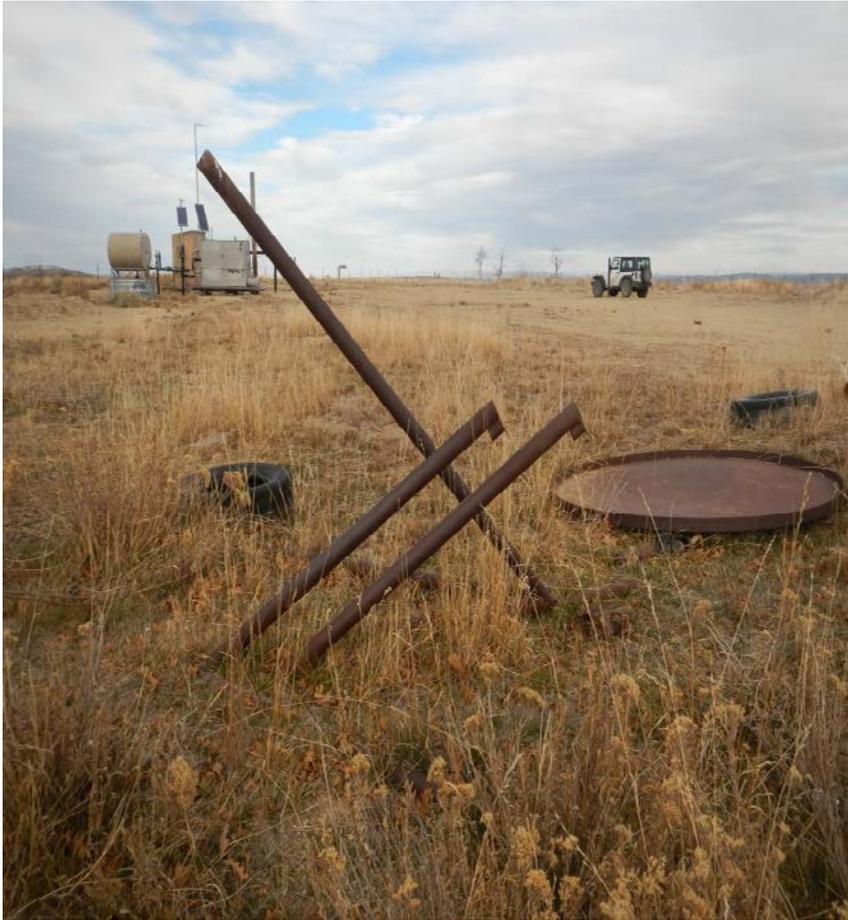
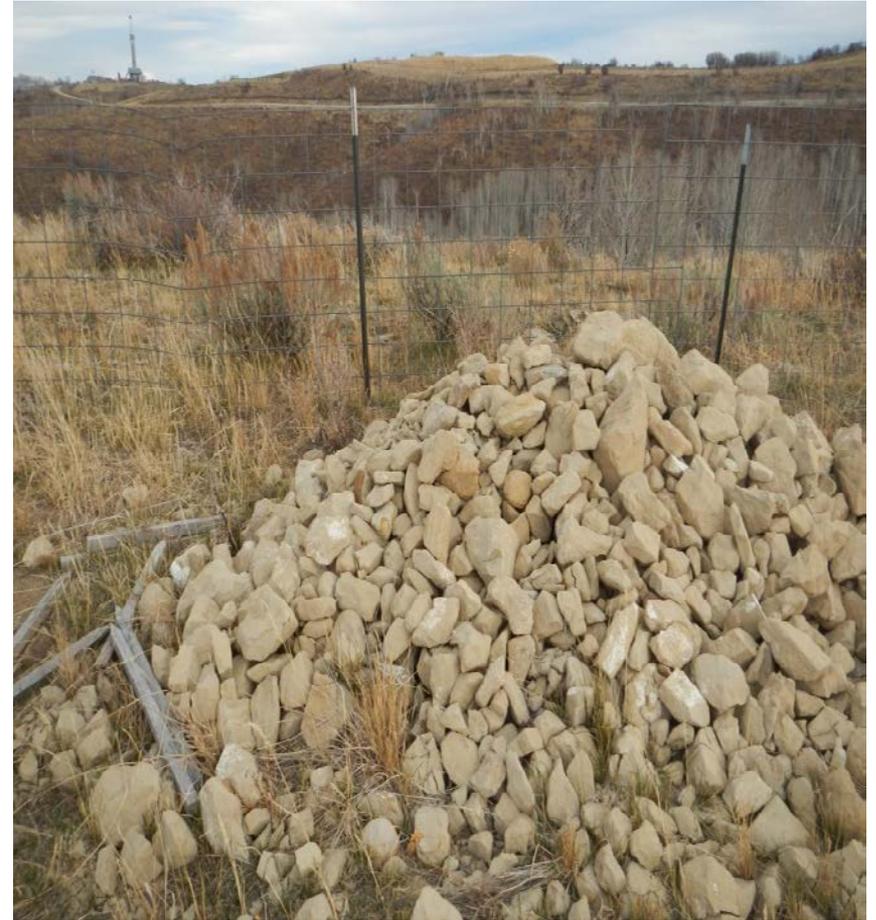
Photos#7&8:
Debris & Materials on Location

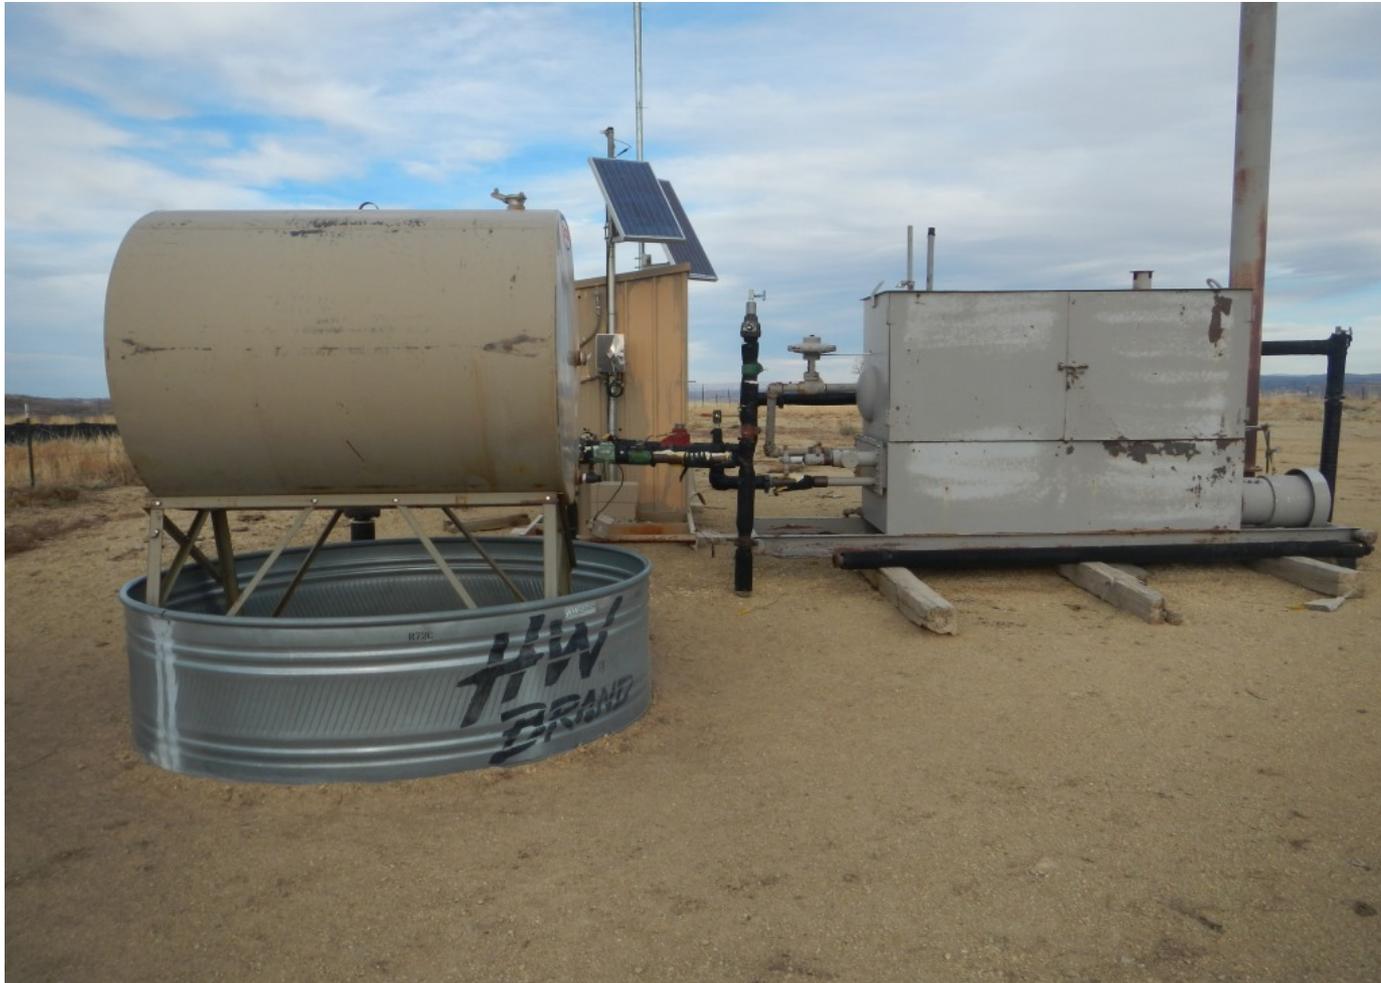
Photo#9: Facilities /Equipment on Location.

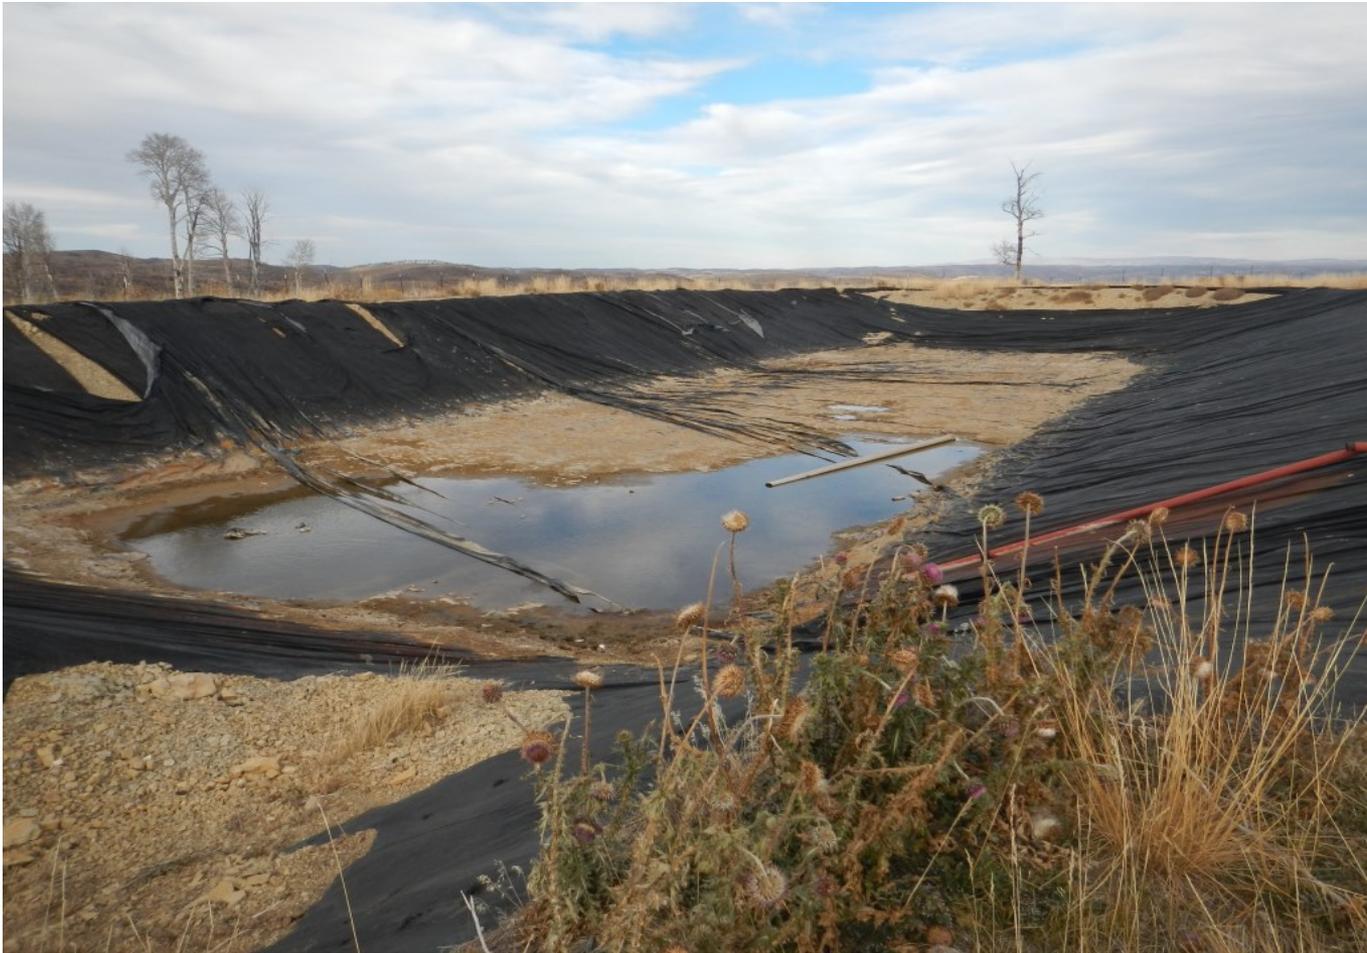
Photo#10: Large Pit Located to North of Well.
