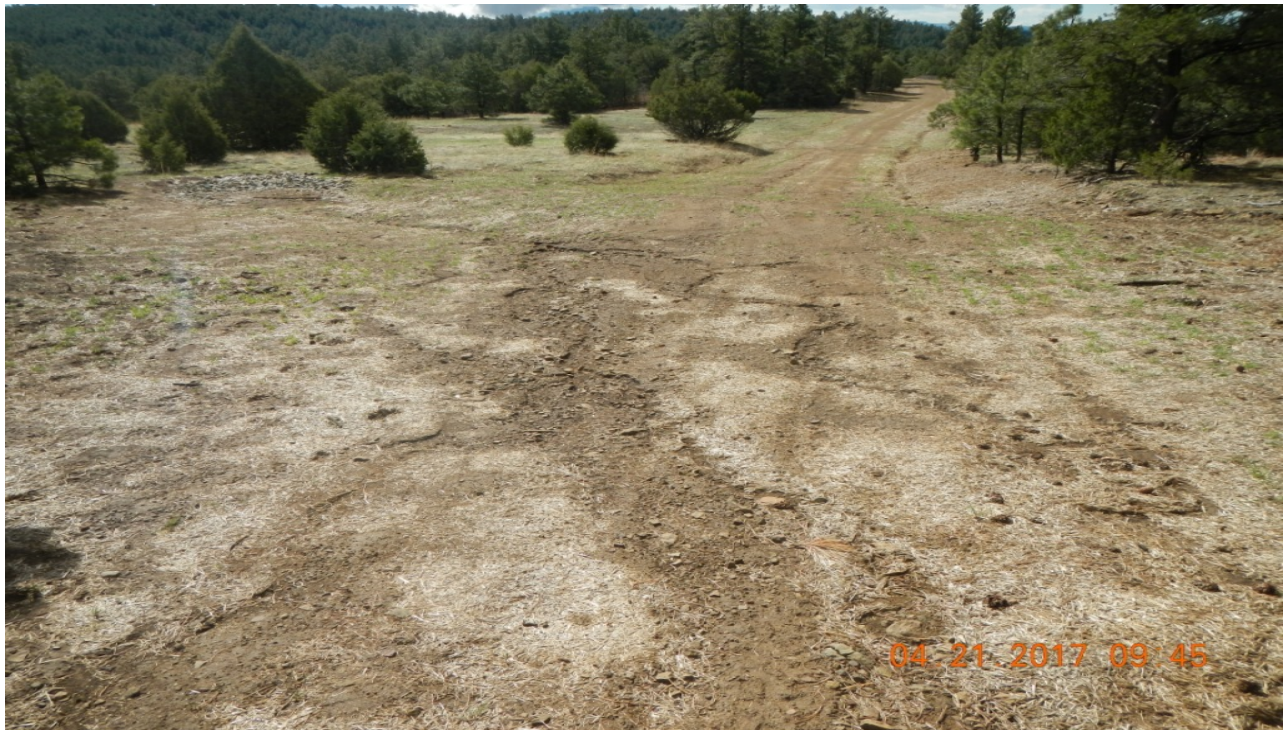
**photo 3:** There are minor signs of erosion at this area along the access road.

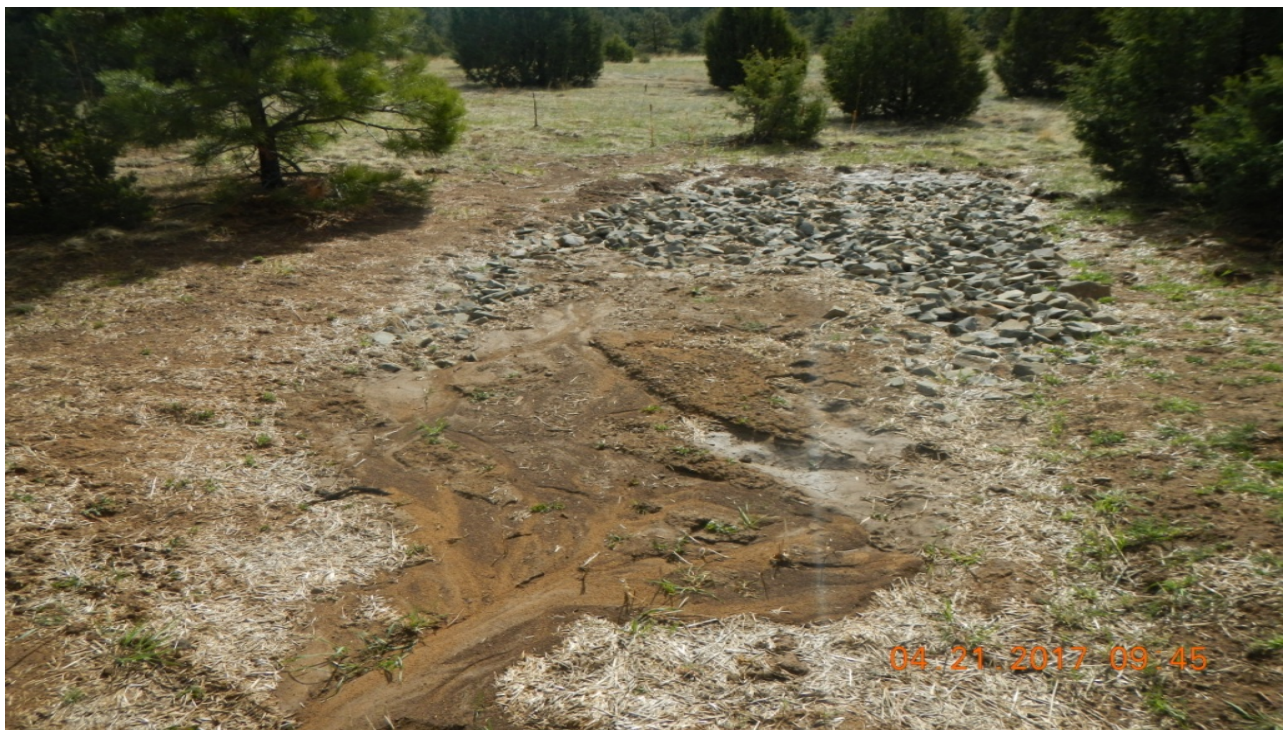
**photo 4:** Sediment is being deposited at the rock rip/rap.

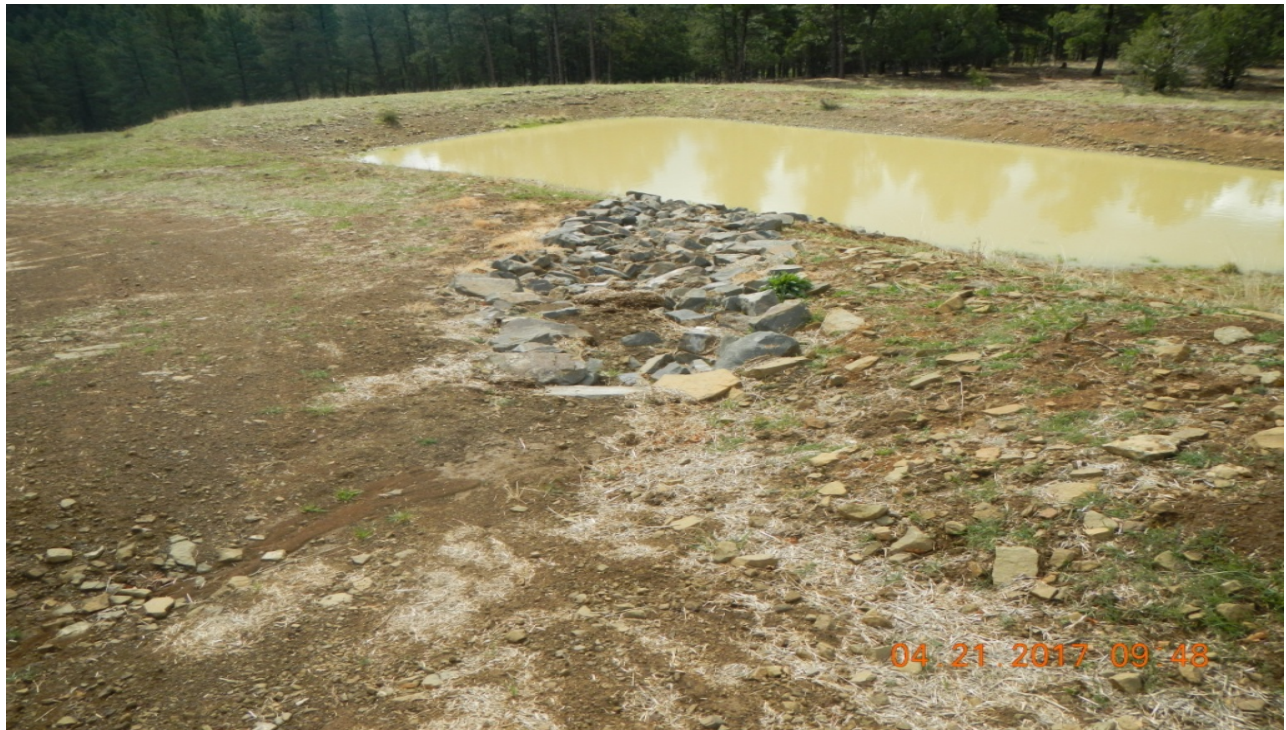
**photo 7:** Rock rip/rap is installed where stormwater is directed towards the pit.

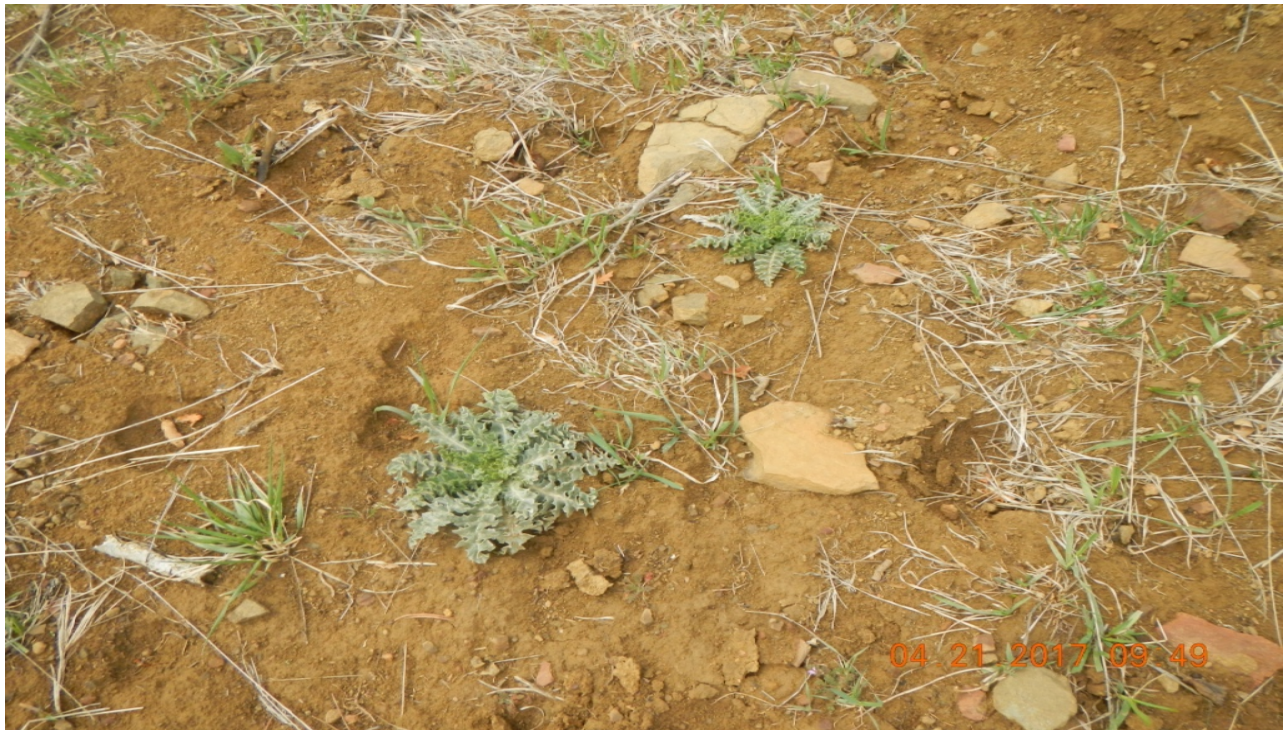
**photo 9:** There is noxious weeds (Musk thistle) beginning to germinate in areas around the pit.
