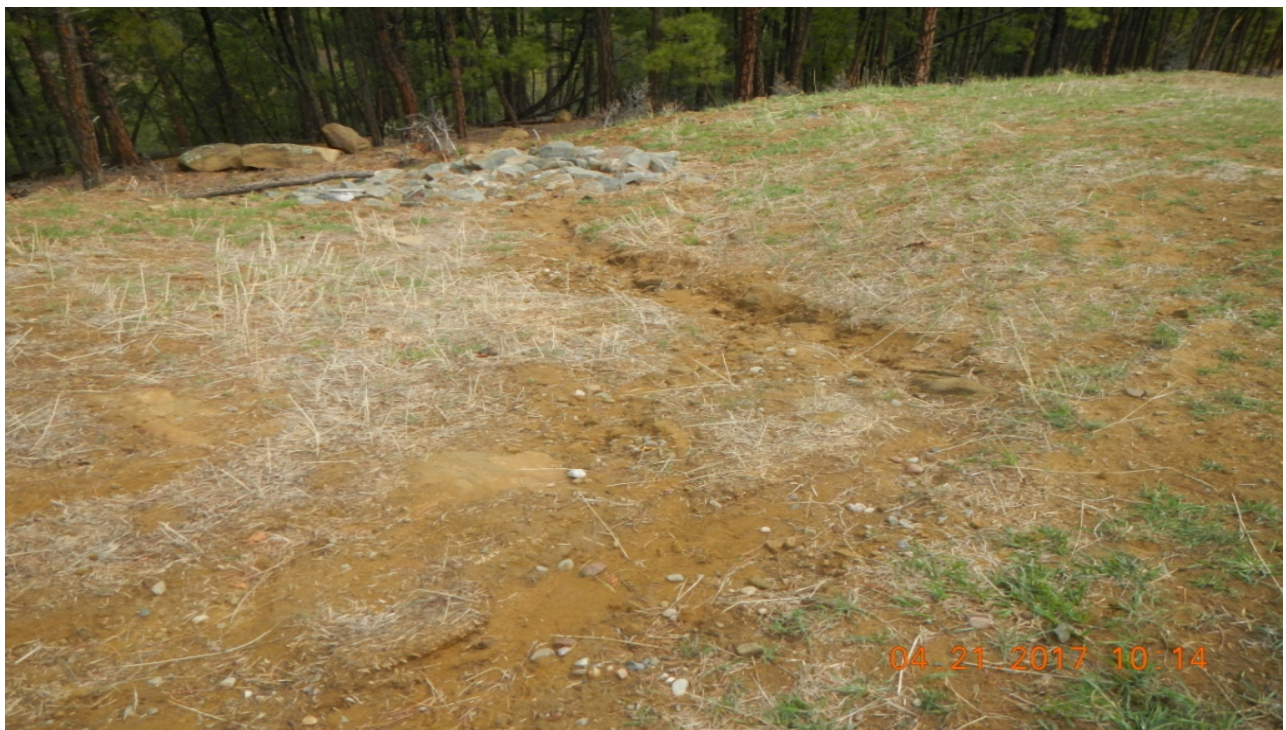
photo 4: The water bar diverts stormwater toward the rock rip/rap. There is scouring beginning to occur at this point.
