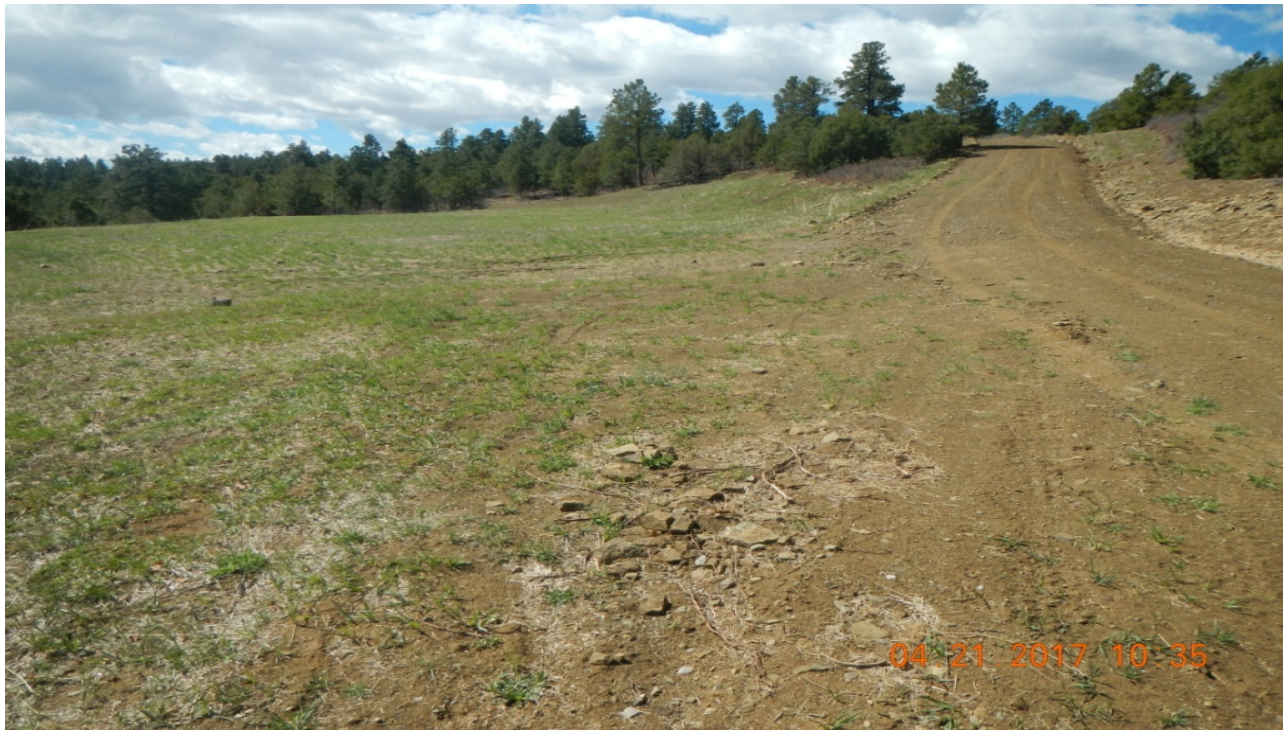
photo 1: Facing south toward the location off of the main access road.

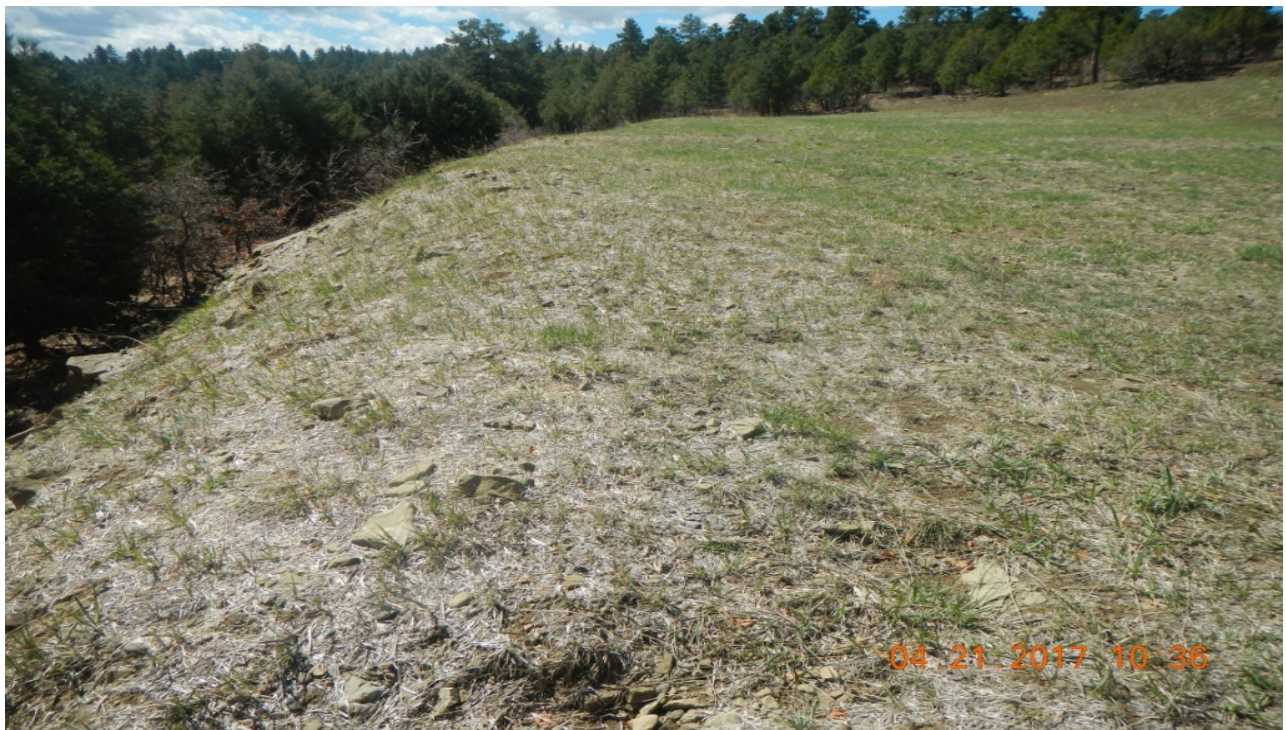
photo 2: Facing south along the east fill slope of the location.

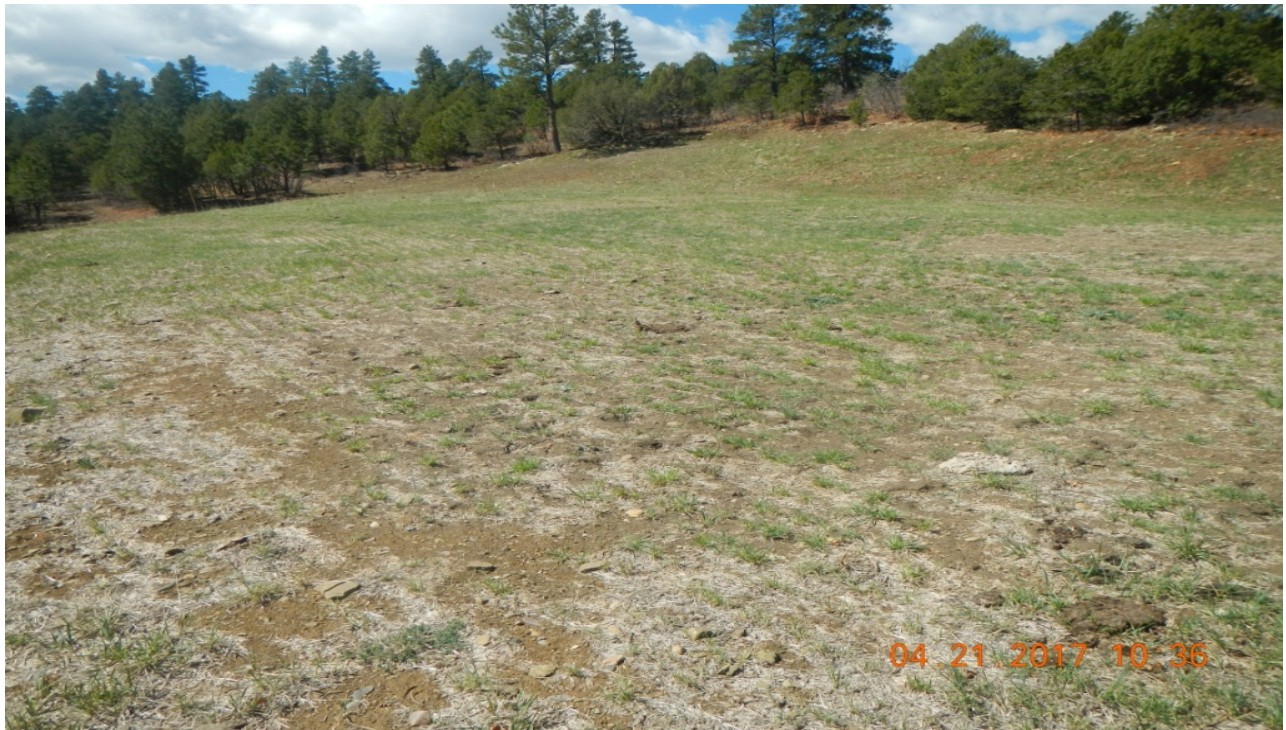
photo 3: Facing southwest at the location.

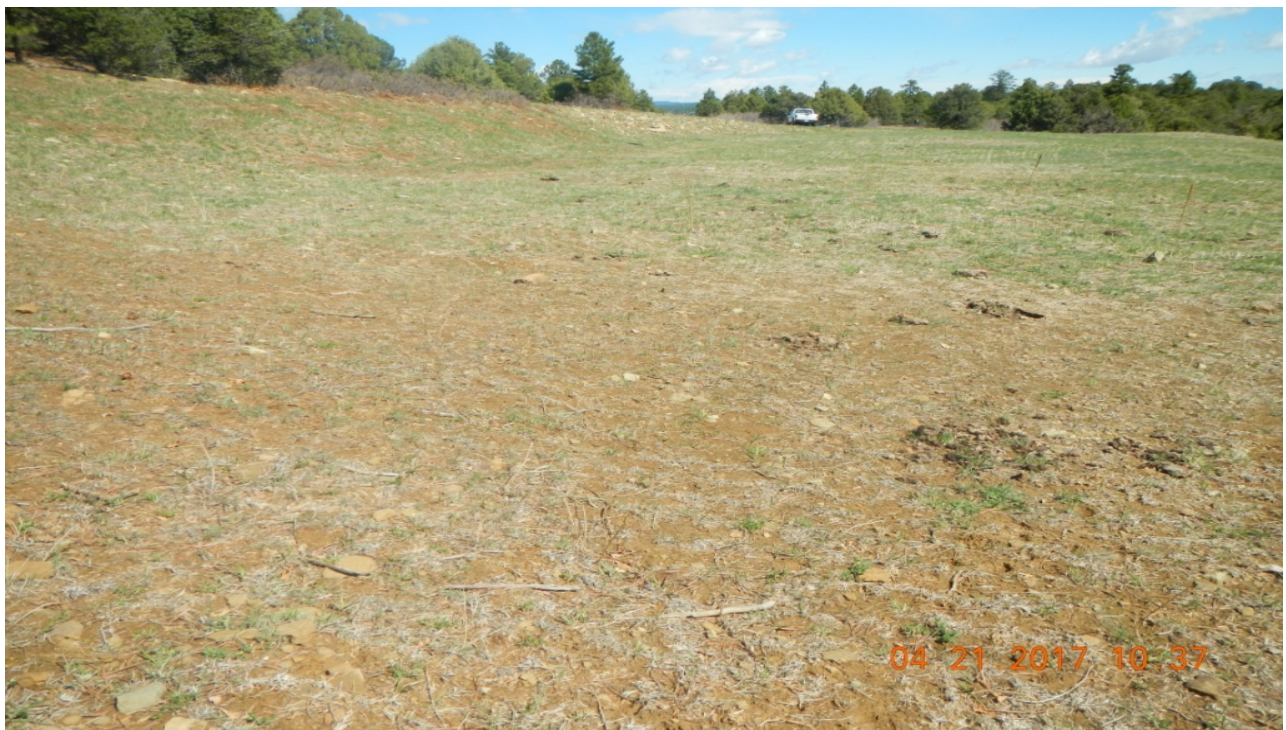
photo 4: Facing northwest at the location.

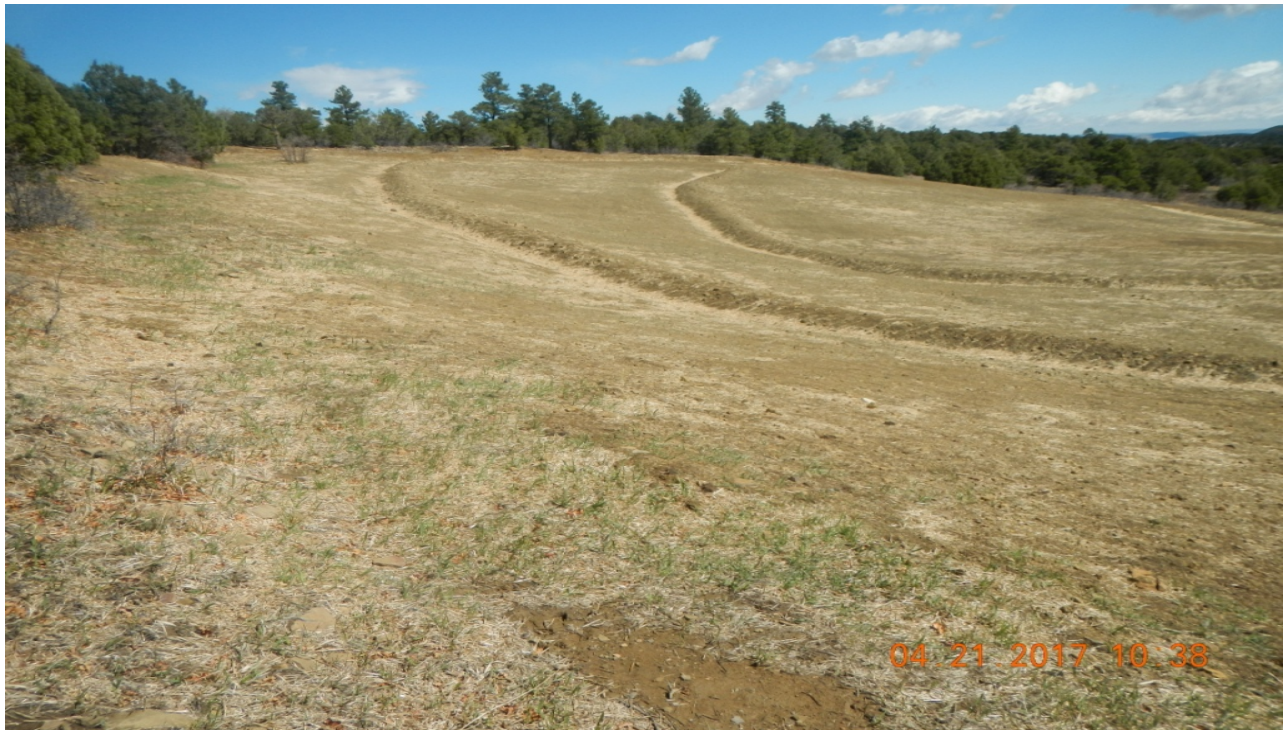
photo 5: South side of the reclaimed pit area facing north.

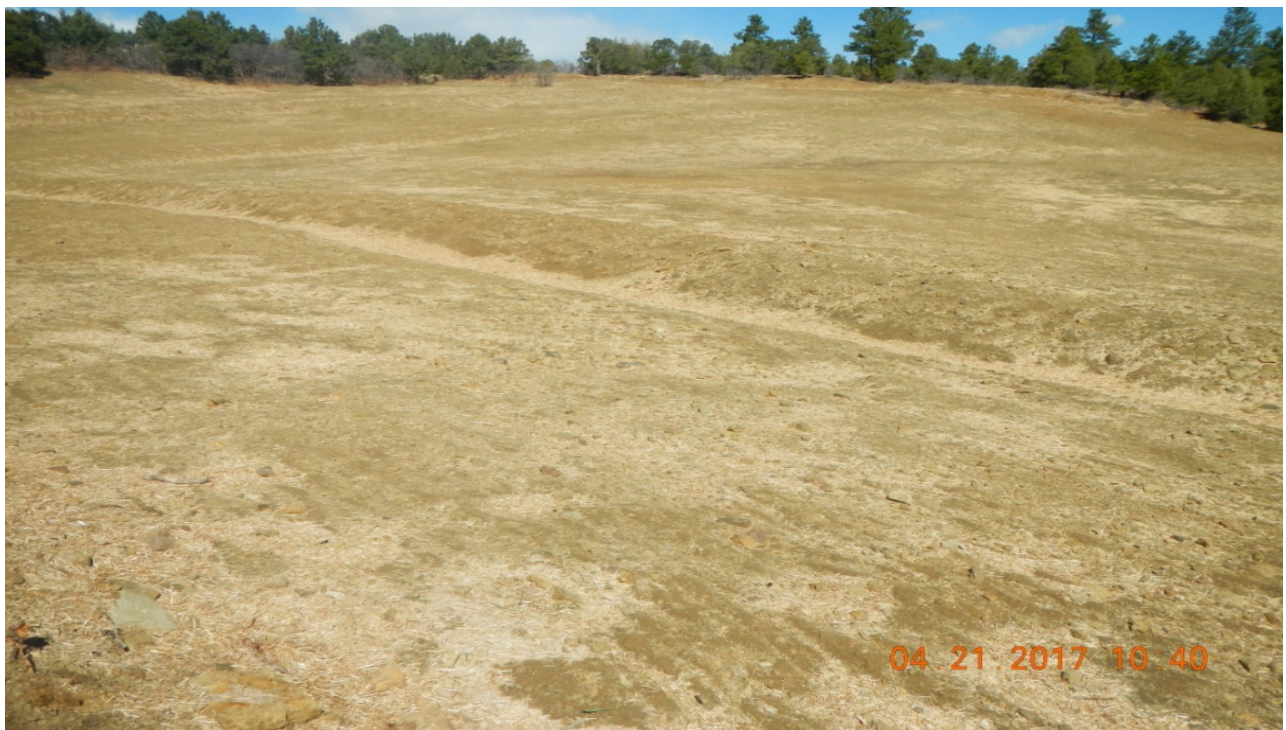
photo 6: Southeast side of the pit area facing northwest.

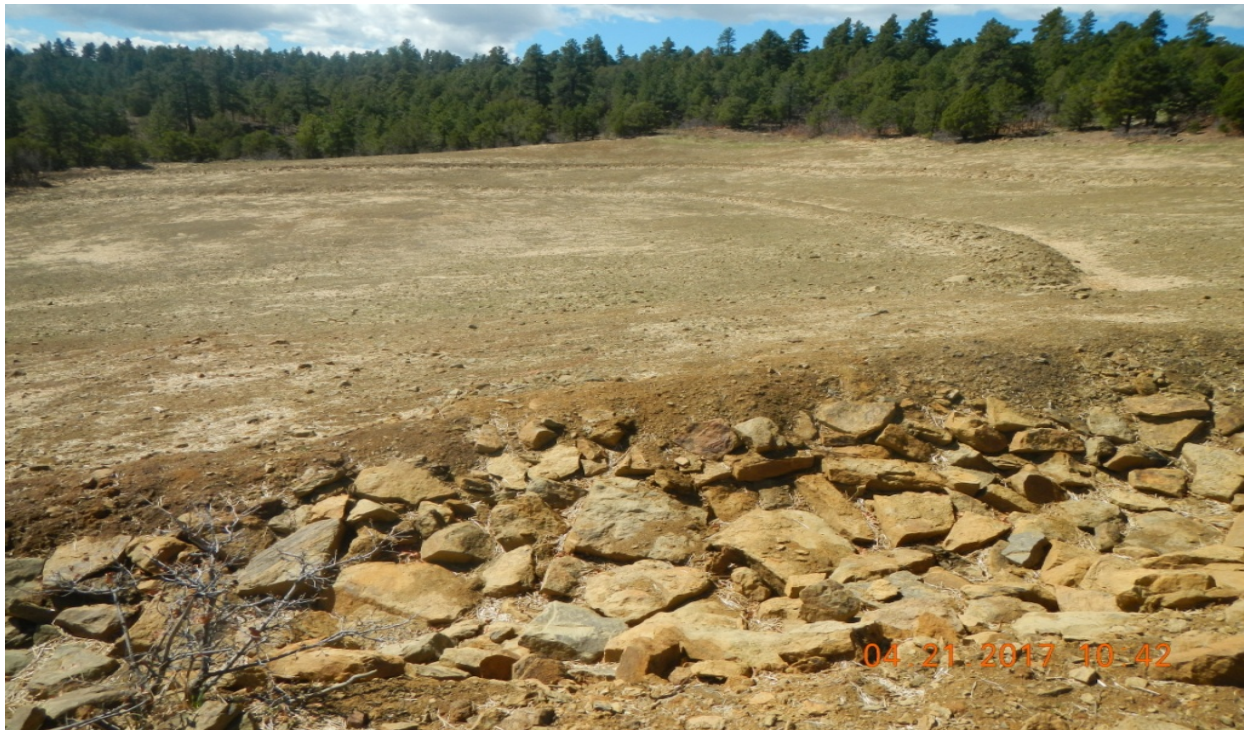
photo 7: North site of the offsite pit area facing south.

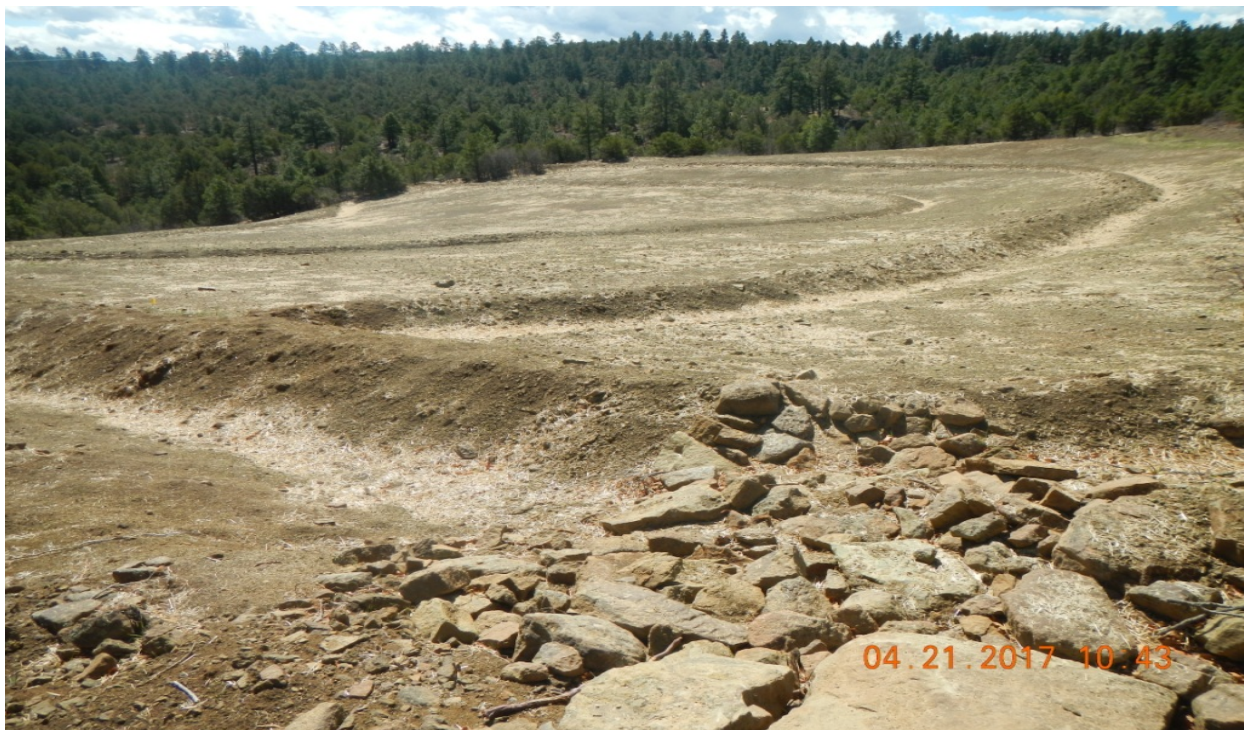
photo 8: Facing southeast toward the reclaimed pit area.

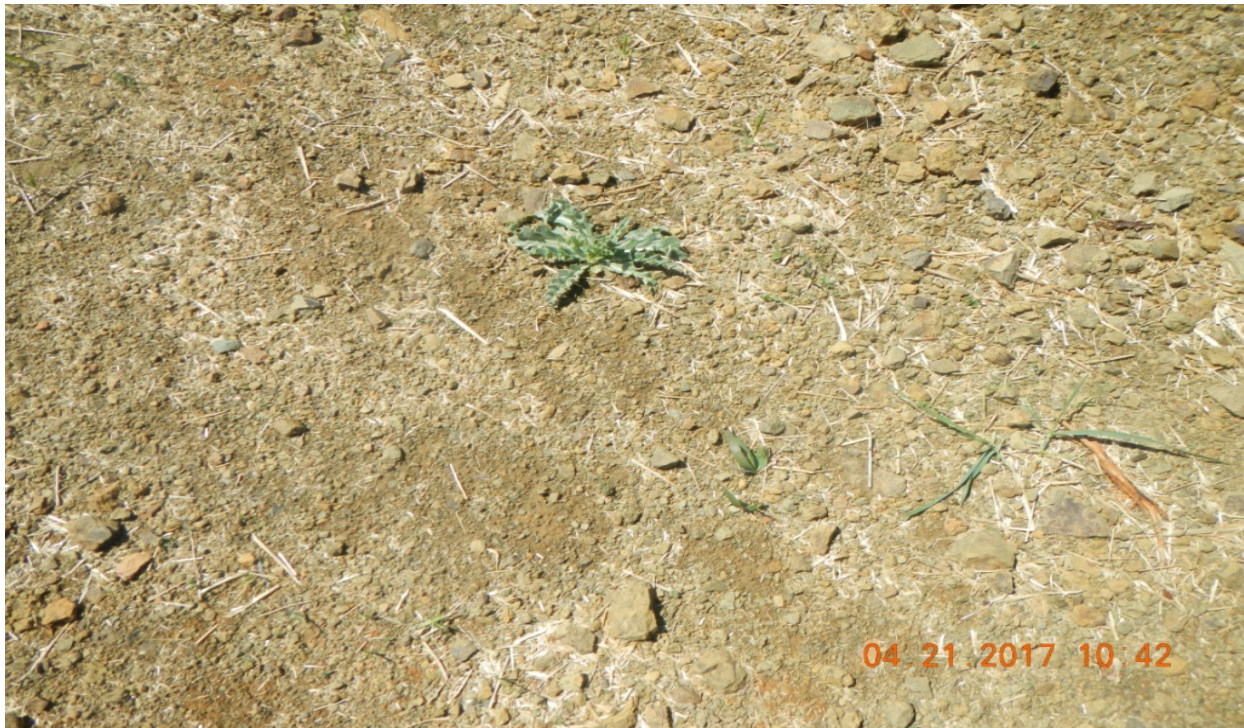
photo 9: Noticed a thistle beginning to germinate at the reclaimed area as well as at the location.

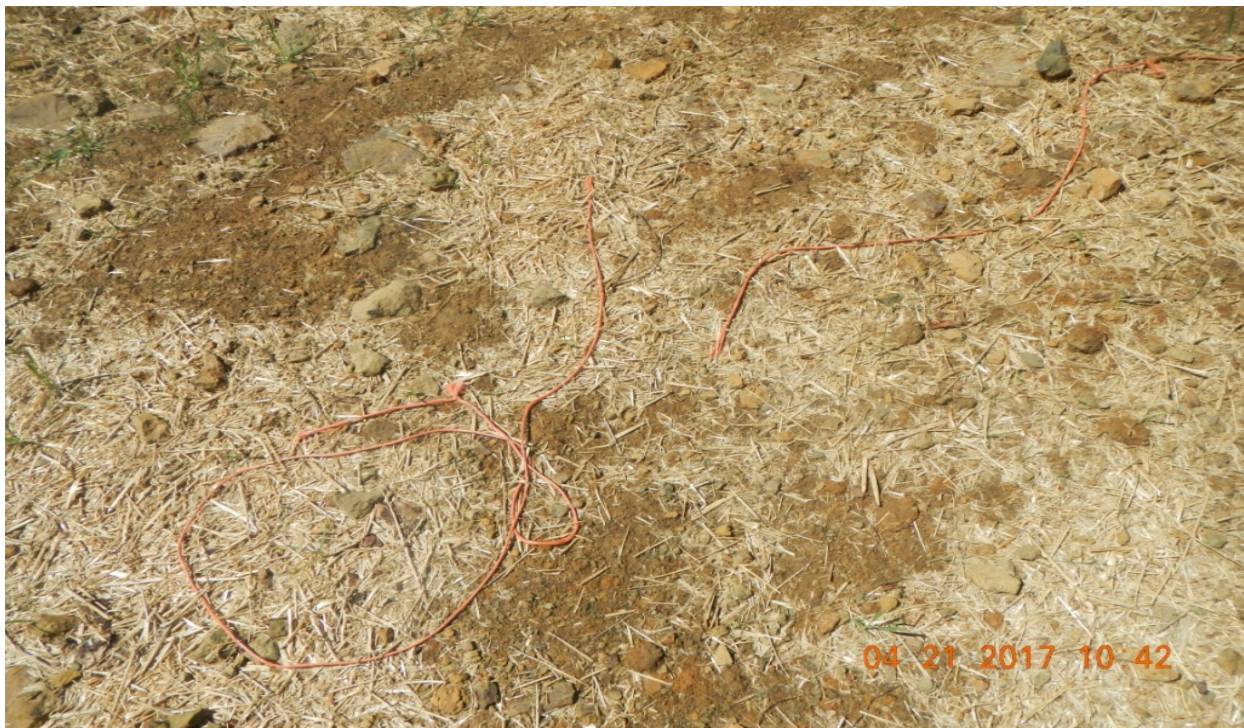
photo 10: There is solid color baling twine noticed at the location which may indicate that the straw mulch was not certified weed free.
