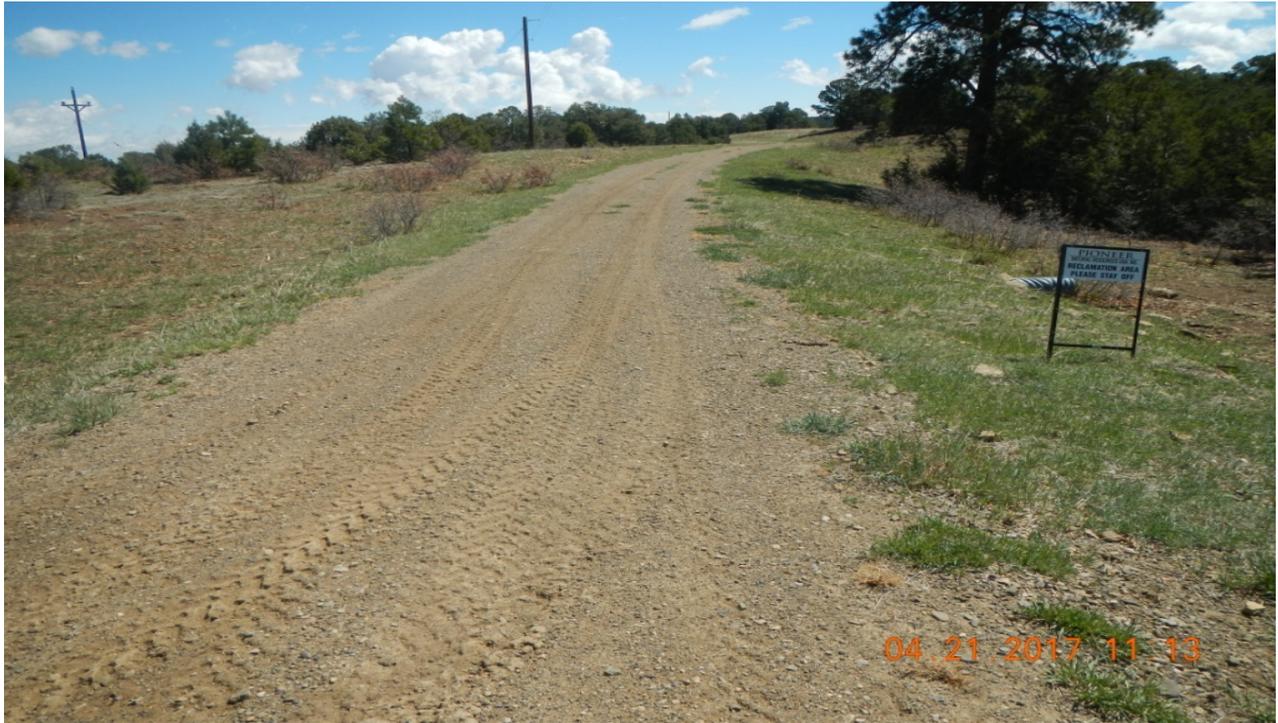
photo 1: Facing east toward at the beginning of the access road.

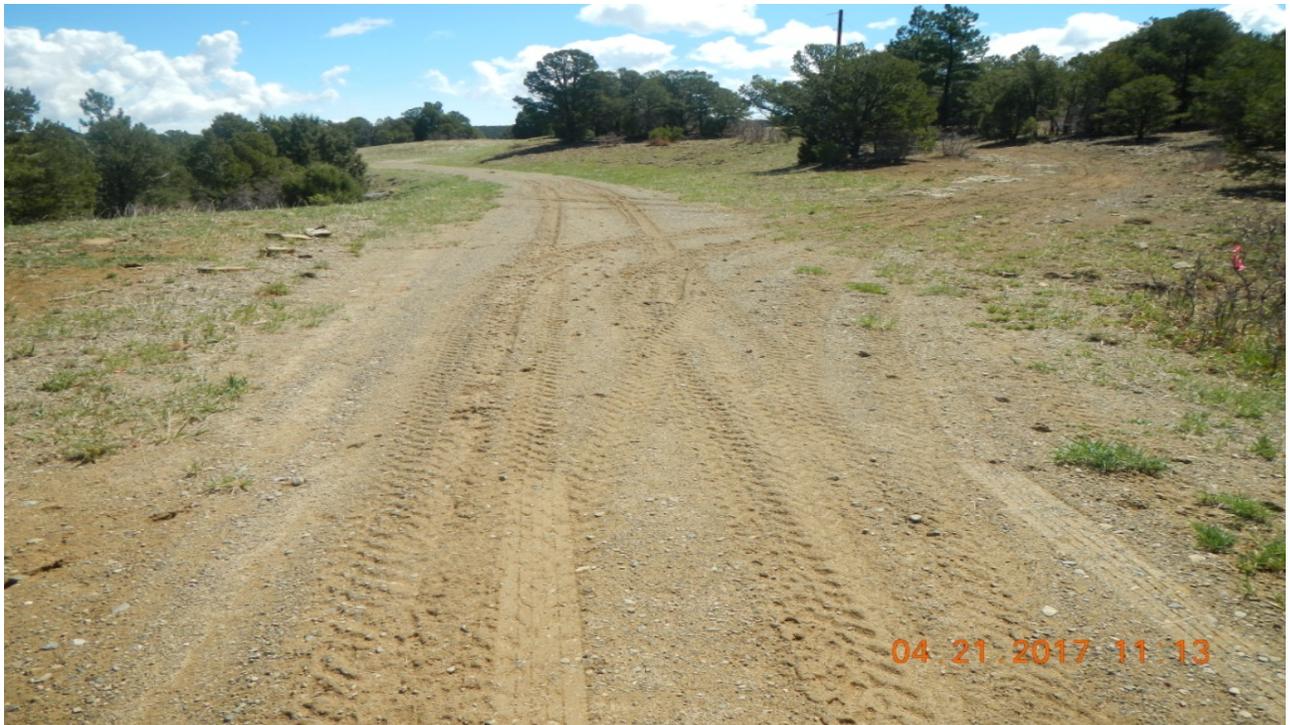
photo 2: Facing east along the access road. Some of the vehicle tracks turn to the right around the location.

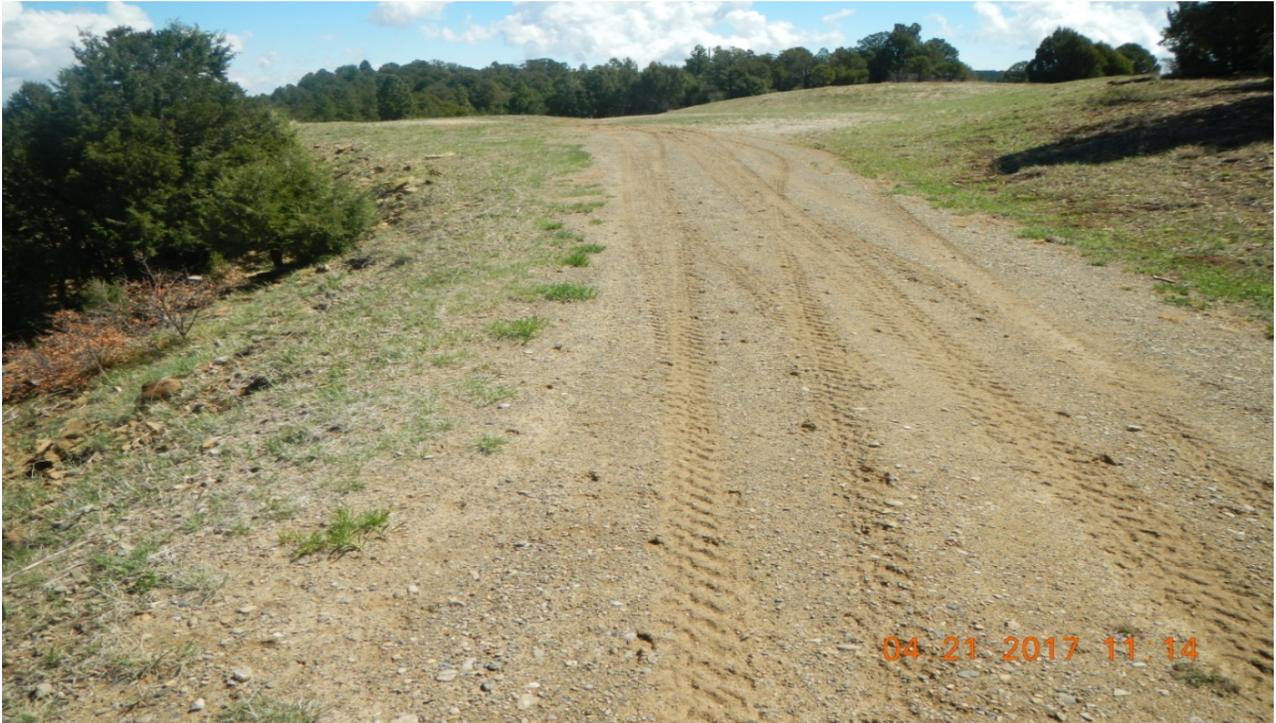
photo 3: Facing east toward the location.

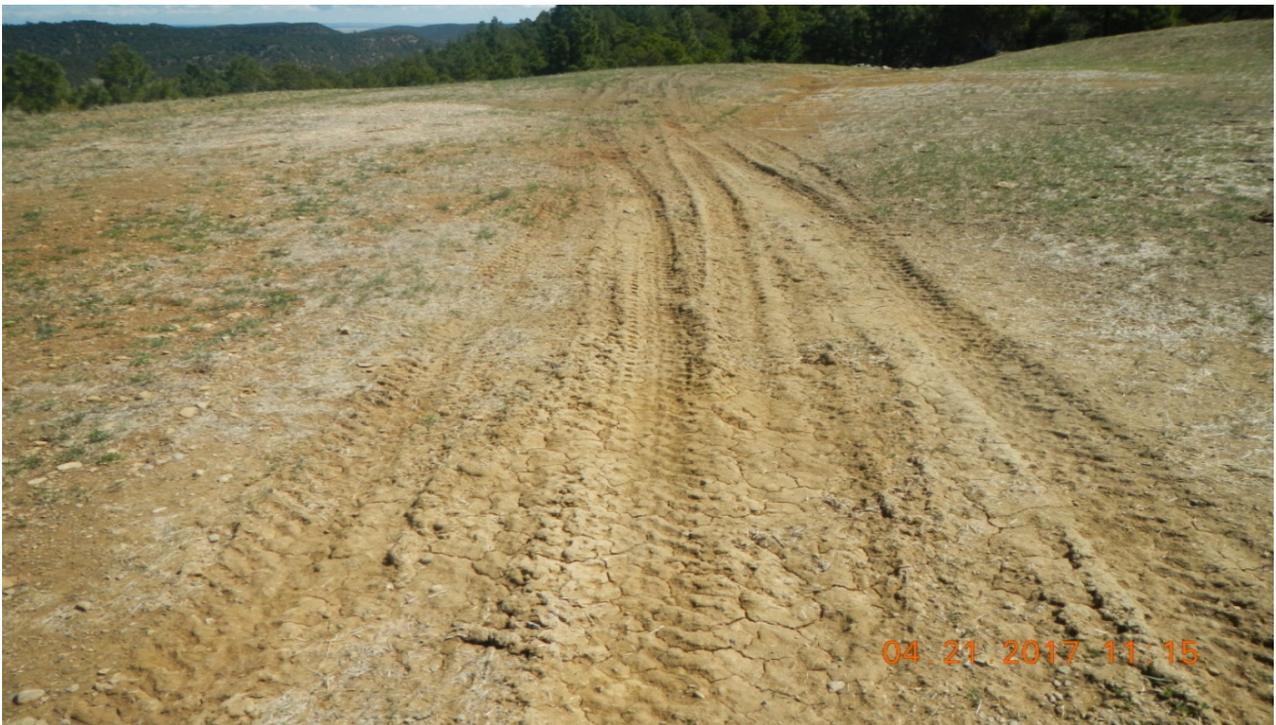
photo 4: Facing northeast at the location. Vehicle tracks appear to turn around on location.

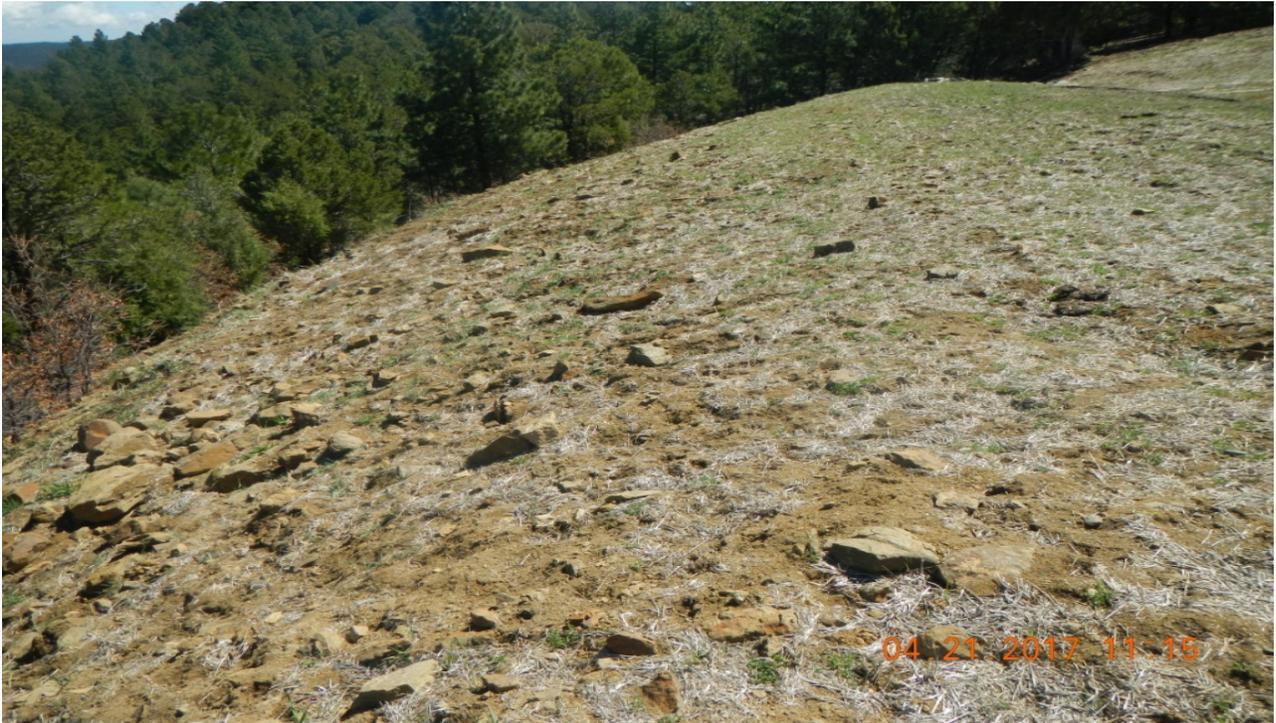
photo 5: Facing east along the north fill slope.

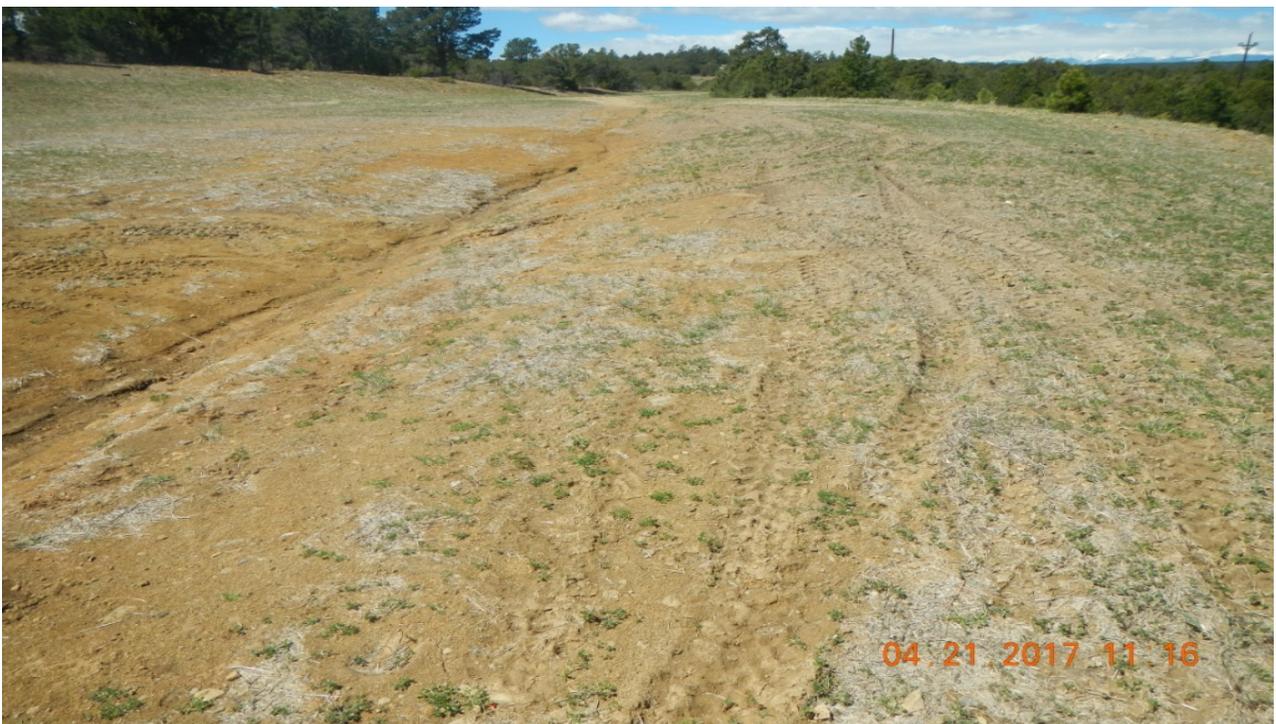
photo 6: Northeast side of the location facing southwest.

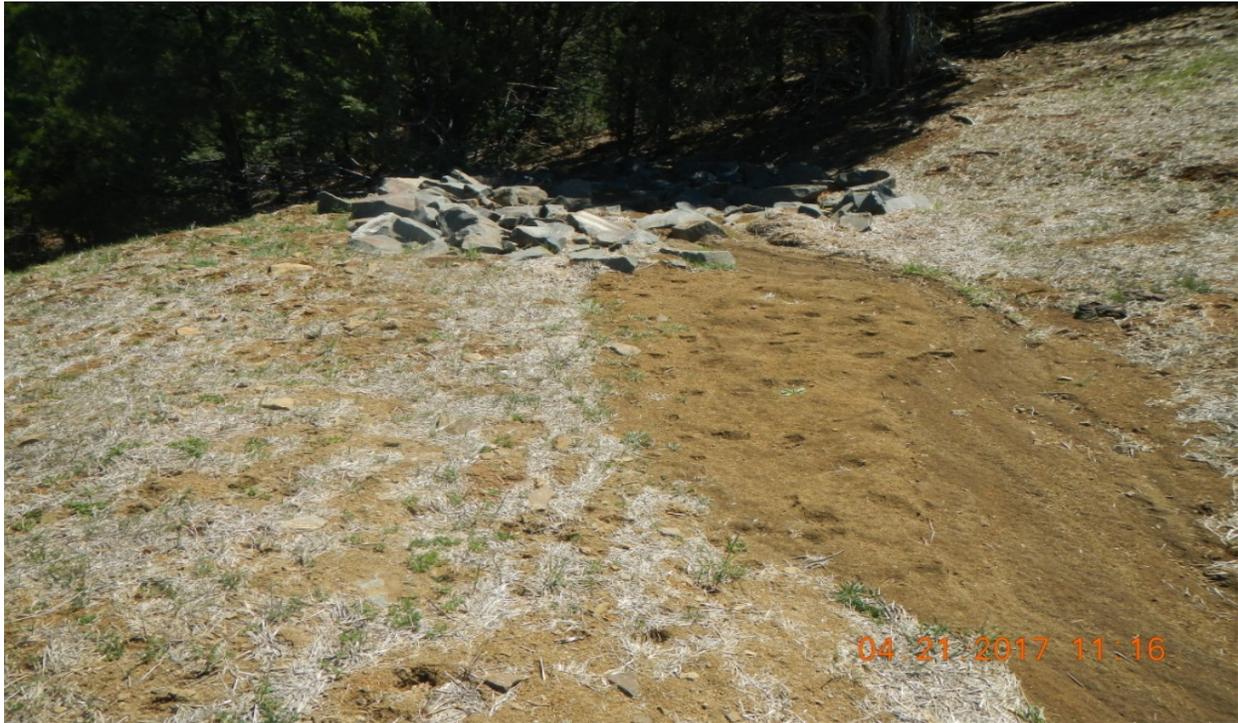
photo 7: The stormwater is directed to this point at the east side of the location. Sediment is accumulating in front of the rock rip-rap.

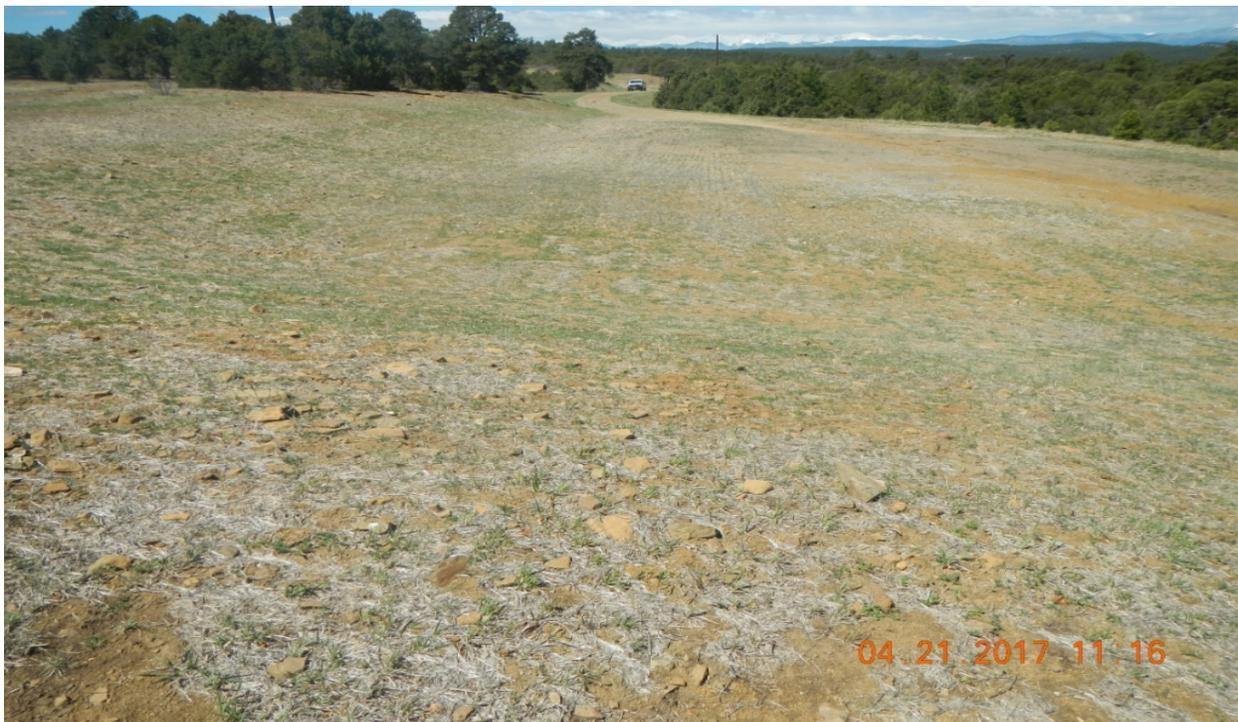
photo 8: East side of the location facing west.
