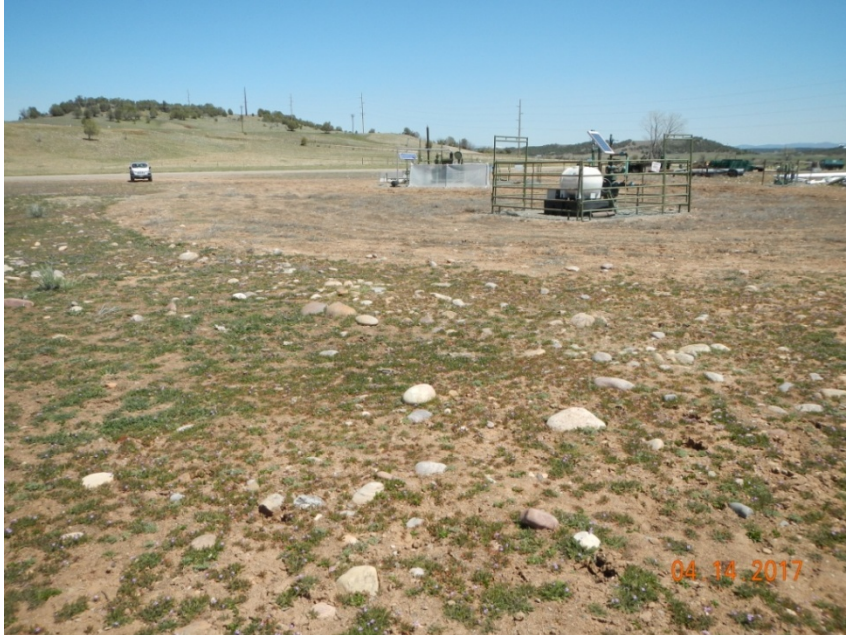
Photo 1: View of the project area from the southwestern corner facing center.

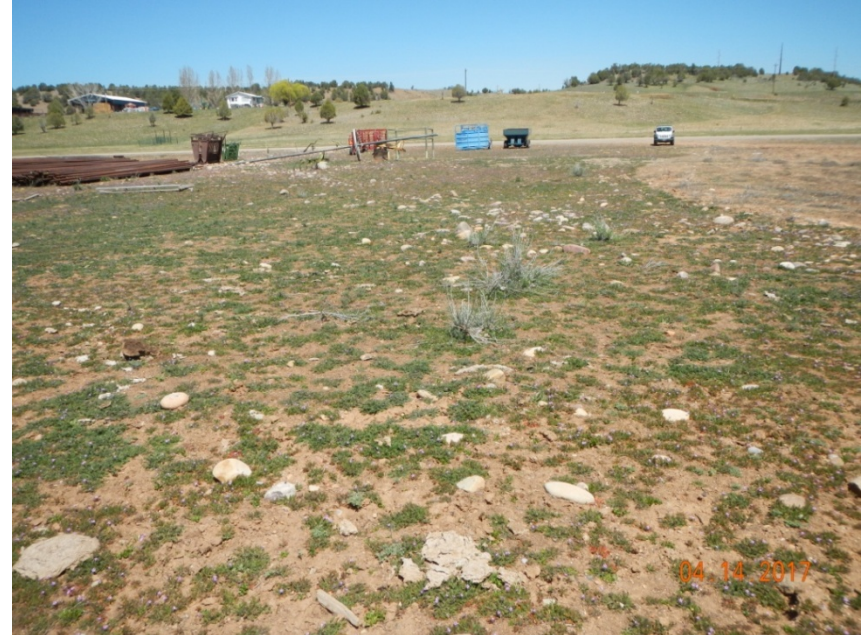
Photo 2: View of the western portion of the project area from the southwestern corner facing northward. Vegetation is largely weeds such as cranesbill (*Erodium cicutarium*). It does not appear that the interim reclamation area was ever seeded.

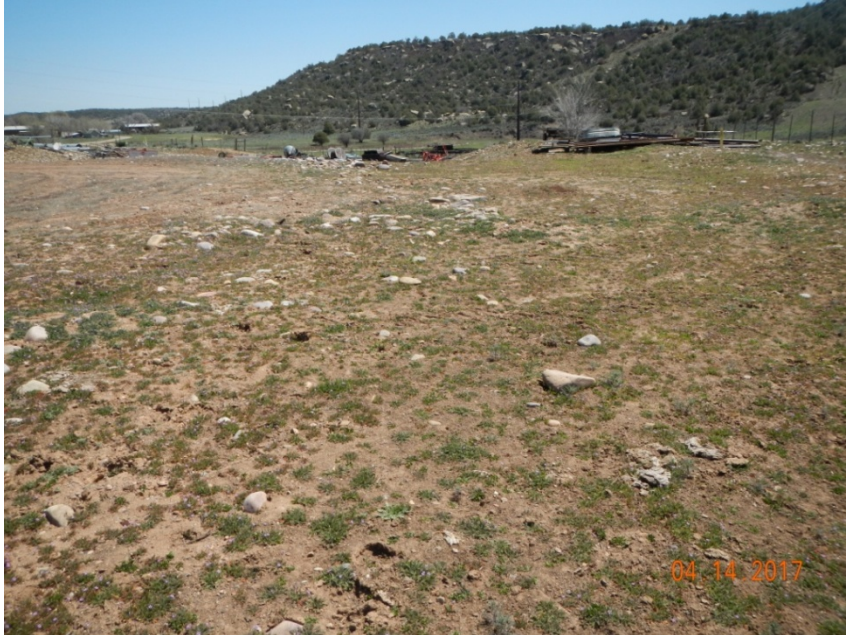
Photo 3: View of the southern portion of the project area from the southwestern corner facing eastward.

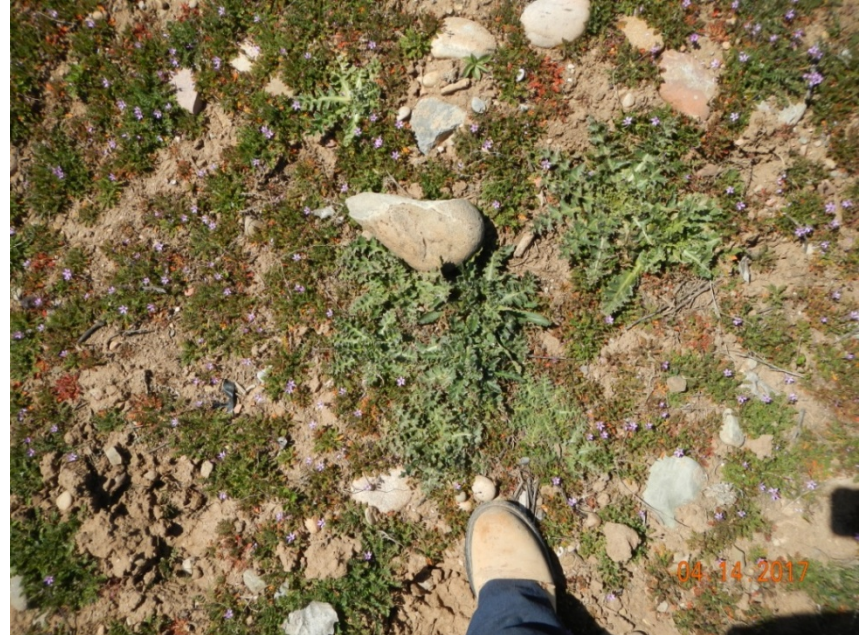
Photo 4: View of musk thistles (*Carduus nutans*) within the interim reclamation area.

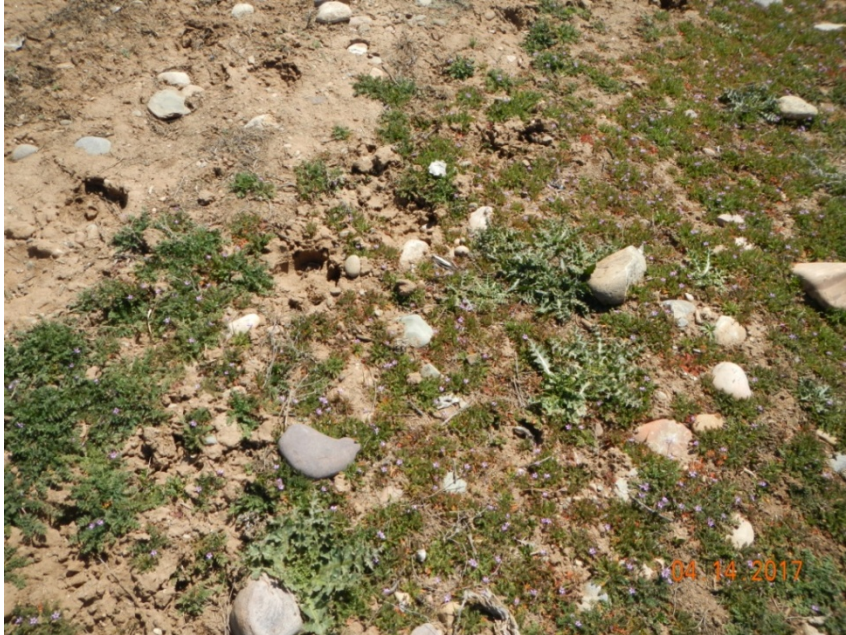
Photo 5: Another view of musk thistles within the interim reclamation area.
