Inspection Photos
Location Name: Mahoney #1
API: 05-123-08110

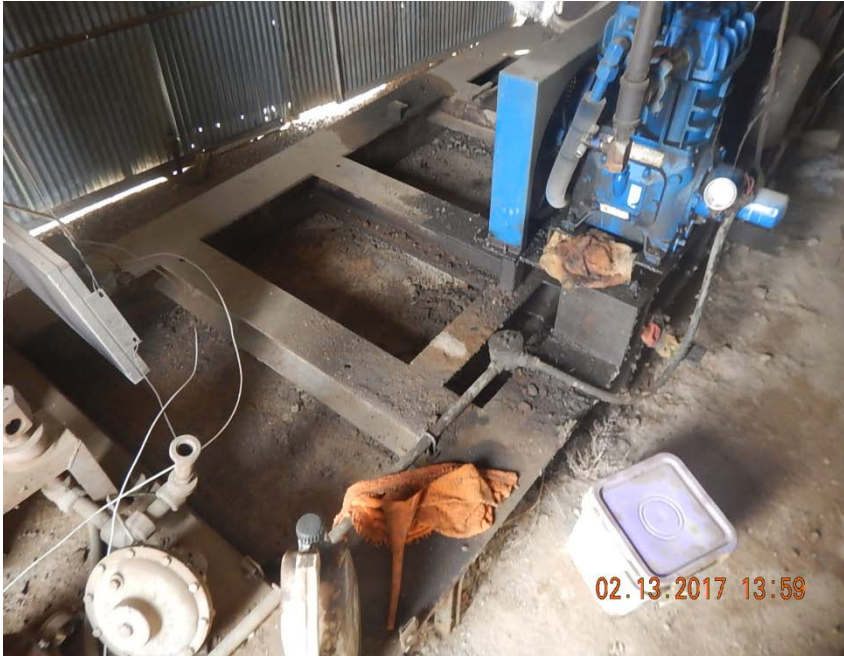
Photo from prior inspection for comparison purposes

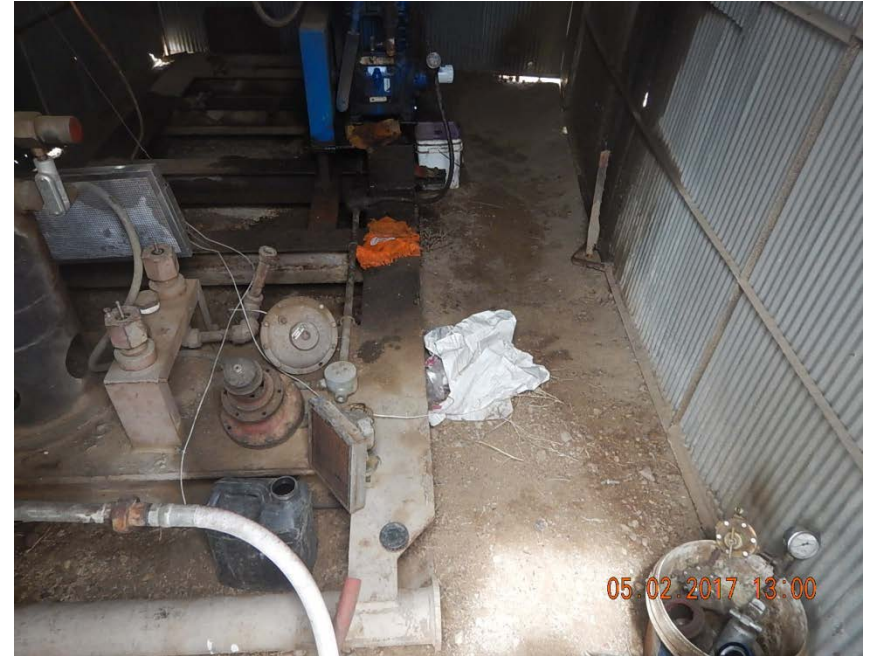
Photo 1: Stained soil at compressor removed

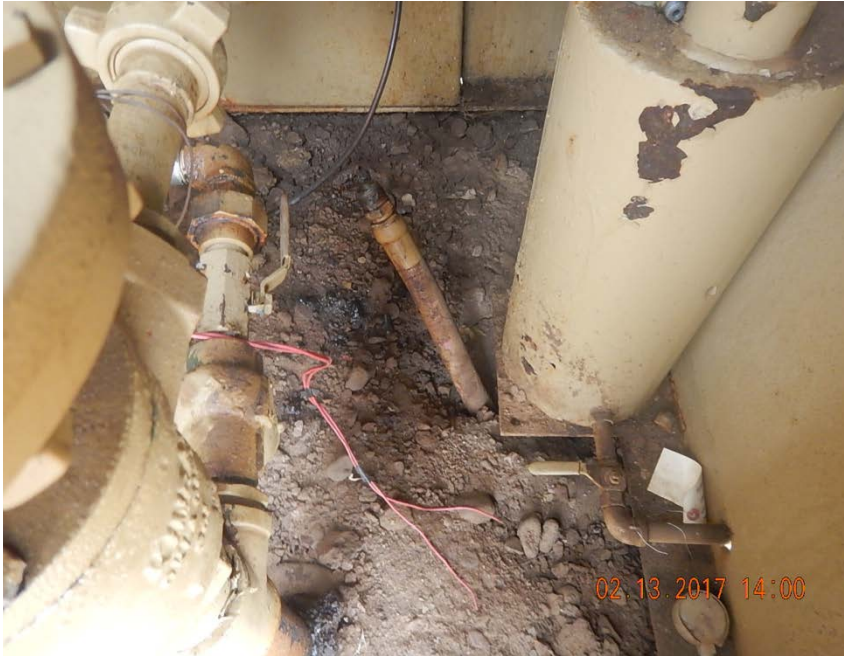
Photo from prior inspection for comparison purposes

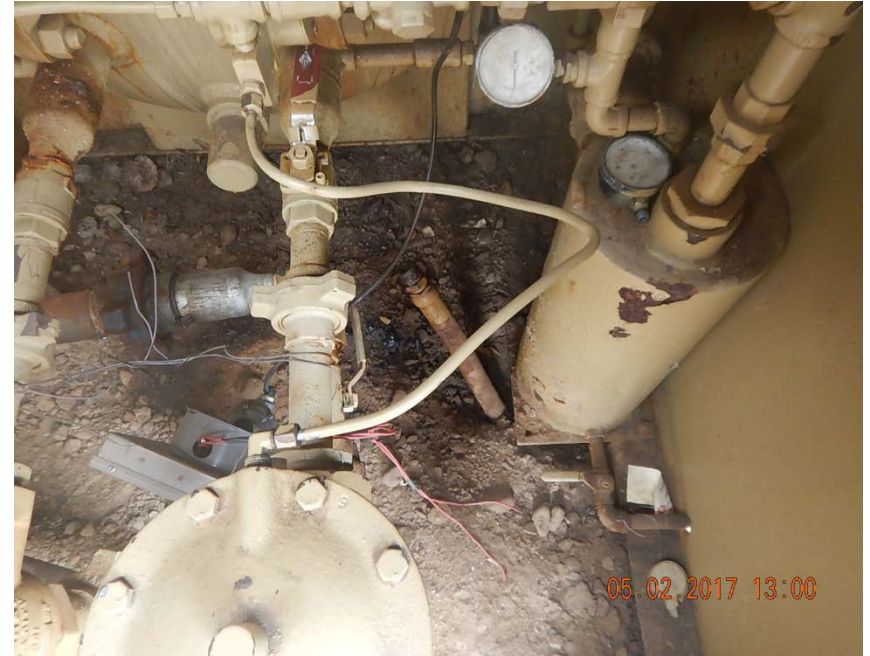
Photo 2: Stained soil in separator house

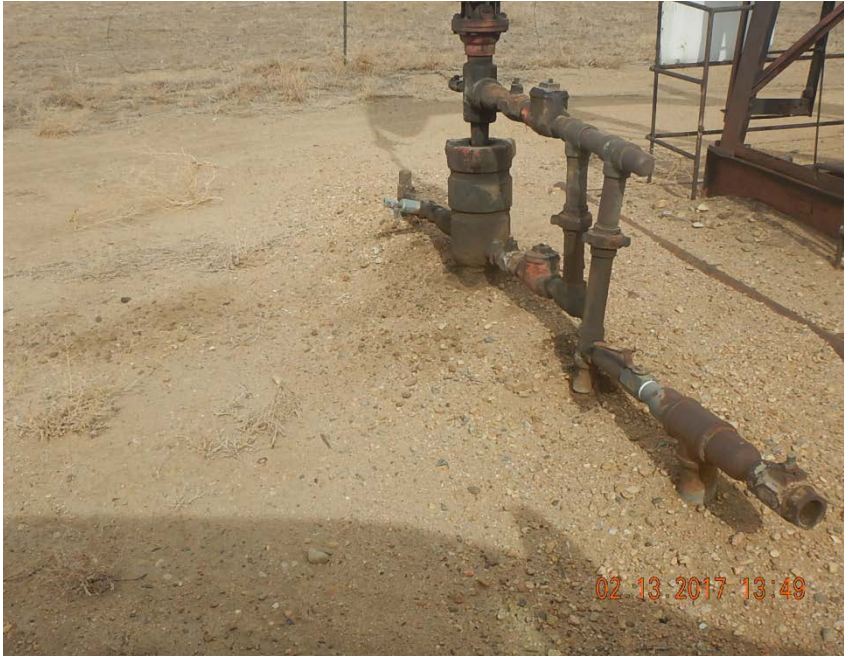
Photo from prior inspection for comparison purposes

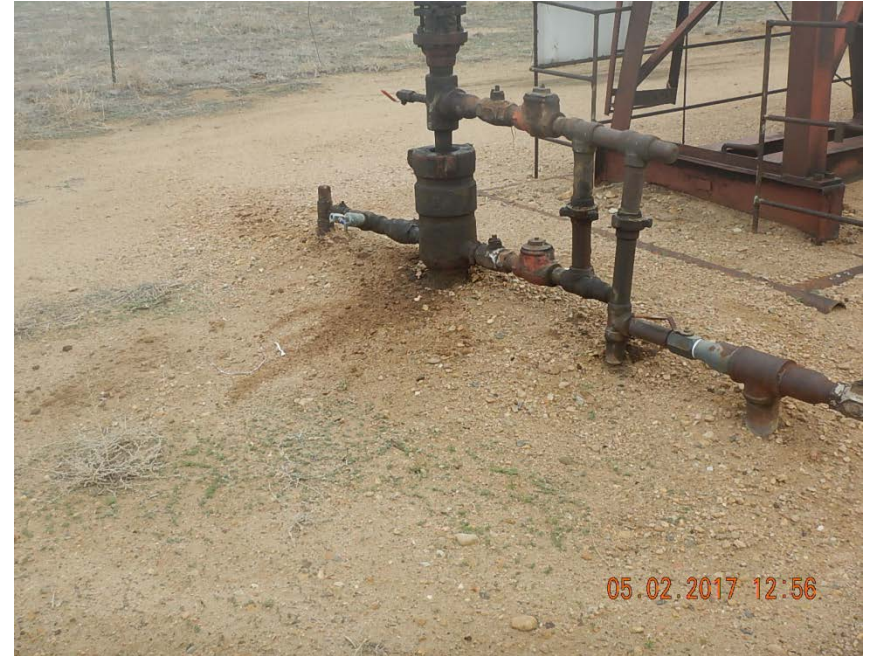
Photo 3: Stained soil at wellhead, bradenhead not plumbed to surface.

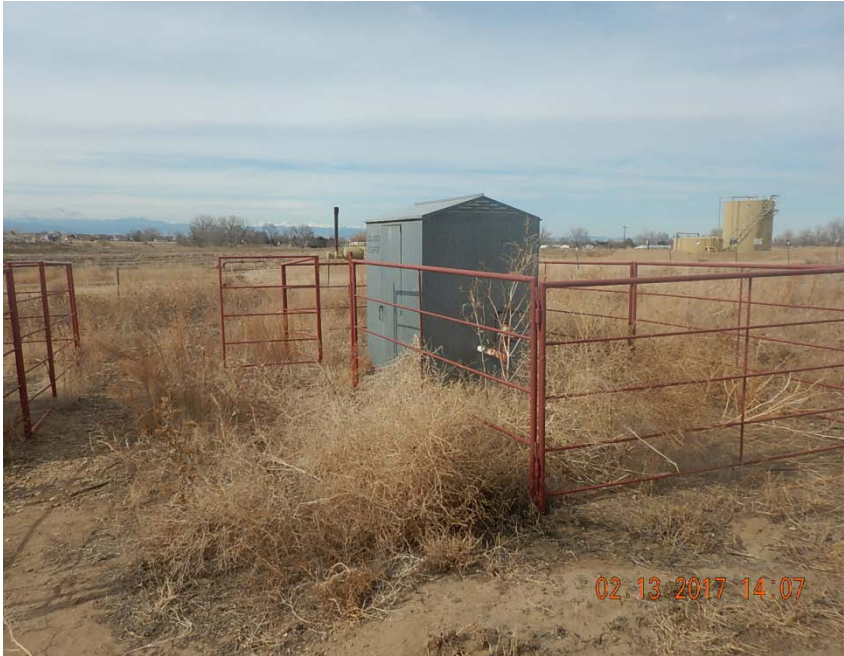
Photo from prior inspection for comparison purposes

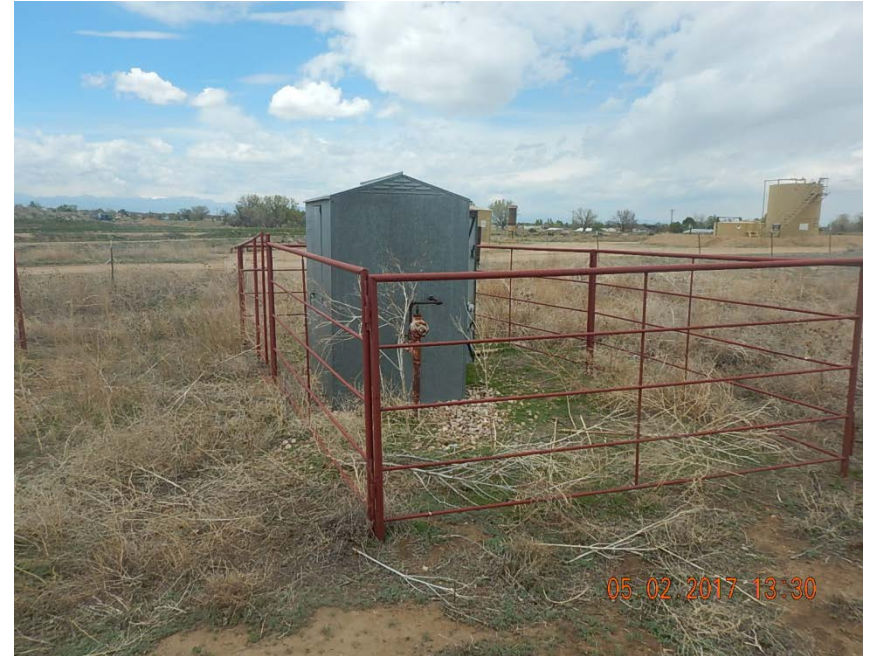
Photo 4: Weeds at meter controlled
