Reclamation and Stormwater Inspection

May 2, 2017

Operator: EXTRACTION OIL & GAS LLC- #10459

Location Name: BURROUGHS SOUTH SENE /PAD #1

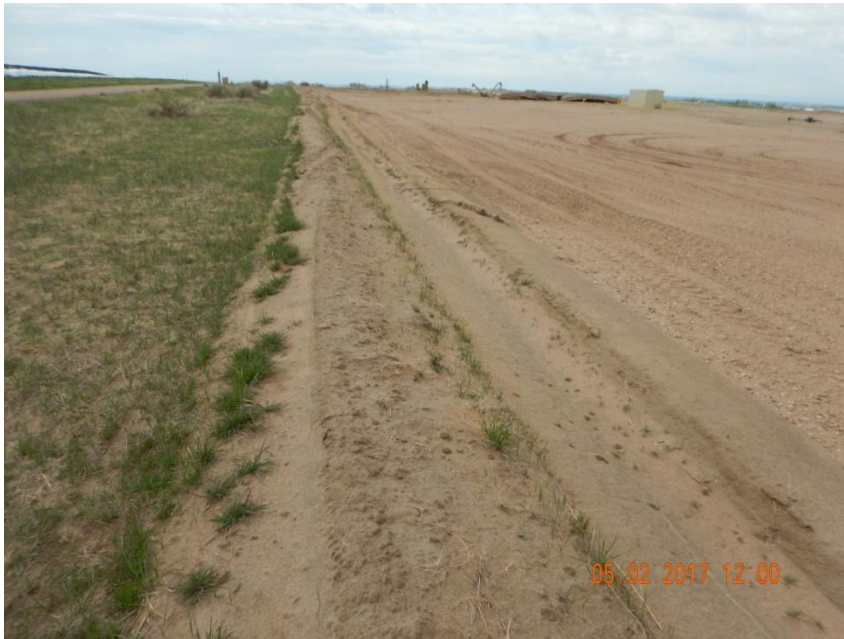
Photo 1. Photo taken from the eastern perimeter of the location, facing South. Ditch and berm BMP has been installed around most of the location in conjunction with other BMPs and appears to be properly functioning.

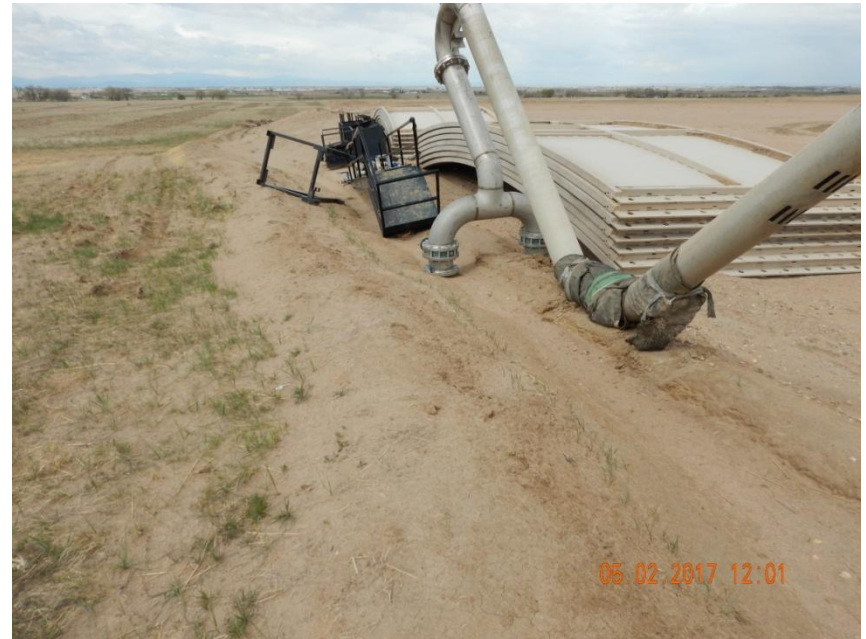
Photo 2. Photo taken from the southern perimeter of the location, facing West. Oil and gas locations are to be kept free of supplies. Appears supplies are being stored along the southern location, some of which have been placed along the BMP area.

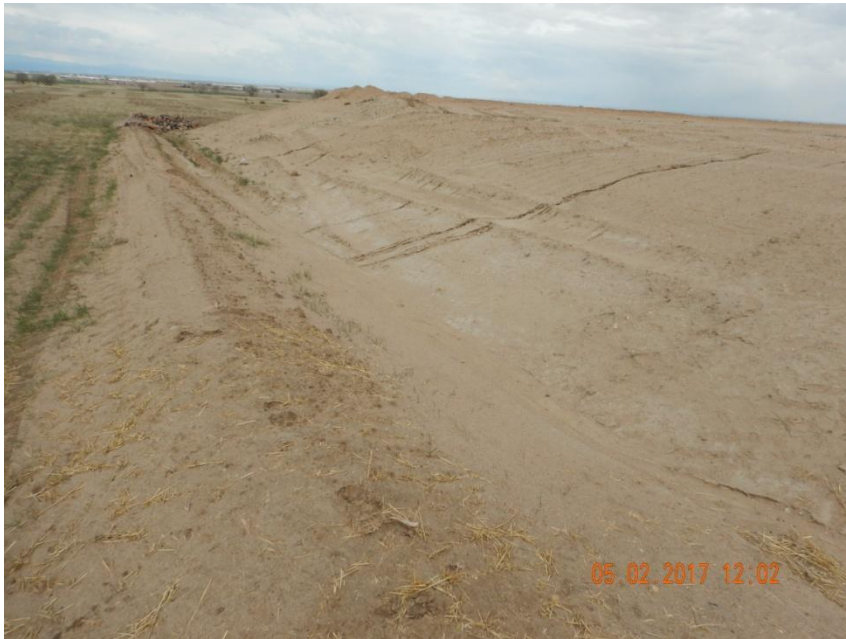
Photo 3. Photo taken from the southwestern perimeter of the location, facing West. Minor rill erosion along the fill slope. BMPs are in place to capture sediment laden storm runoff from leaving location.

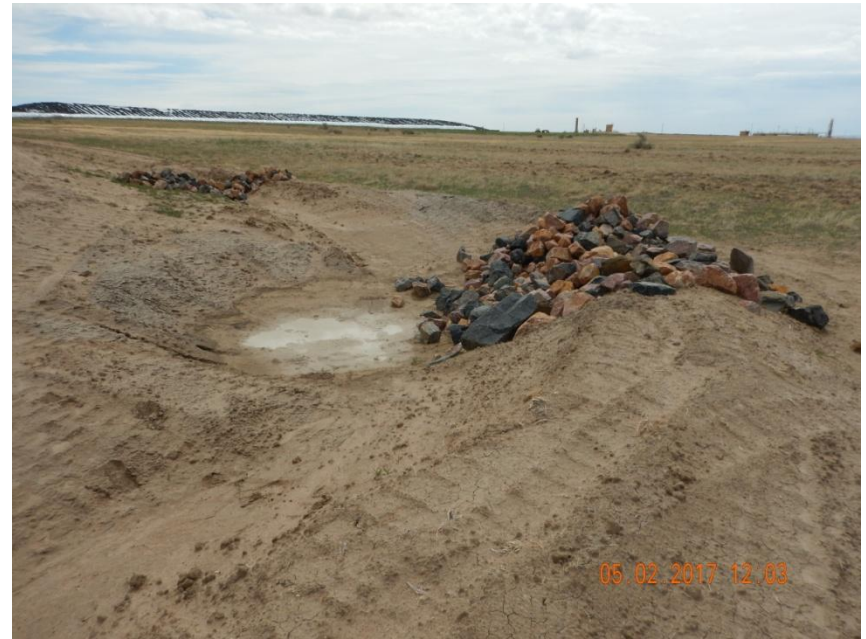
Photo 4. Photo taken from the southwest perimeter of the location, facing Southeast. Sediment trap has been installed with both inlet and outlet protection, as well as check dams.

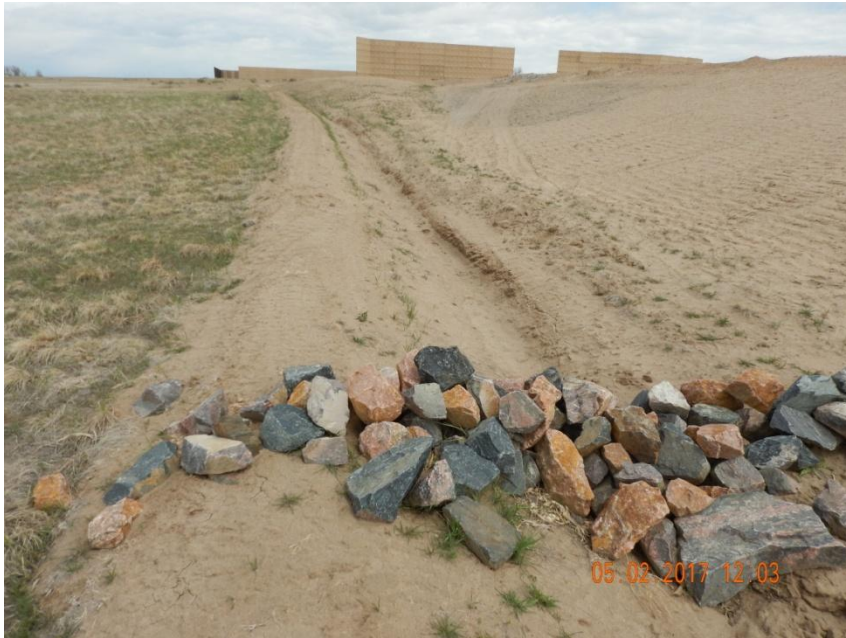
Photo 5. Photo taken from the southwestern perimeter of the location, facing North. Ditch and berm BMP has been installed in conjunction with check dams prior to the sediment trap.

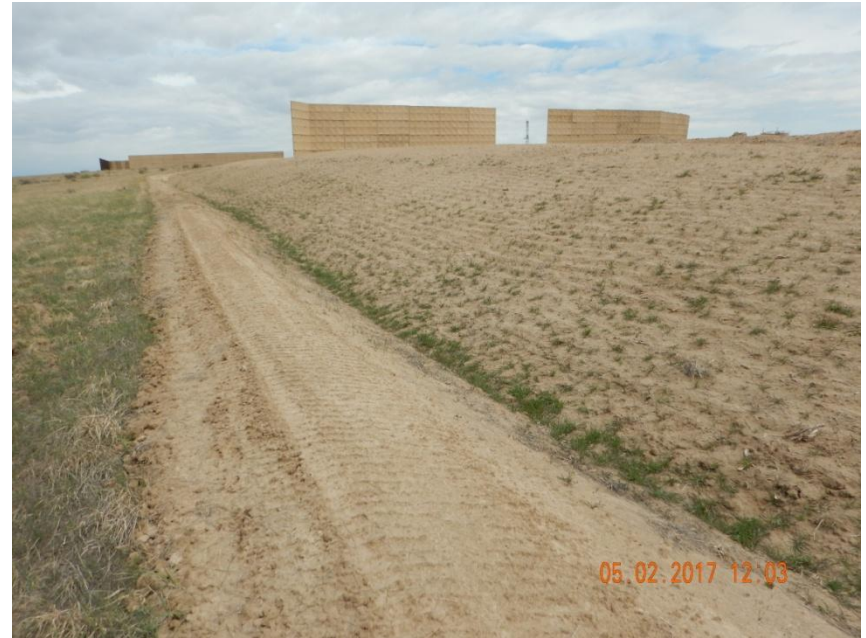
Photo 6. Photo taken from the western perimeter of the location, facing North. Ditch and berm BMP has been installed around the topsoil stockpile. Topsoil has been salvaged, stored and temporarily stabilized along the western perimeter of the location.

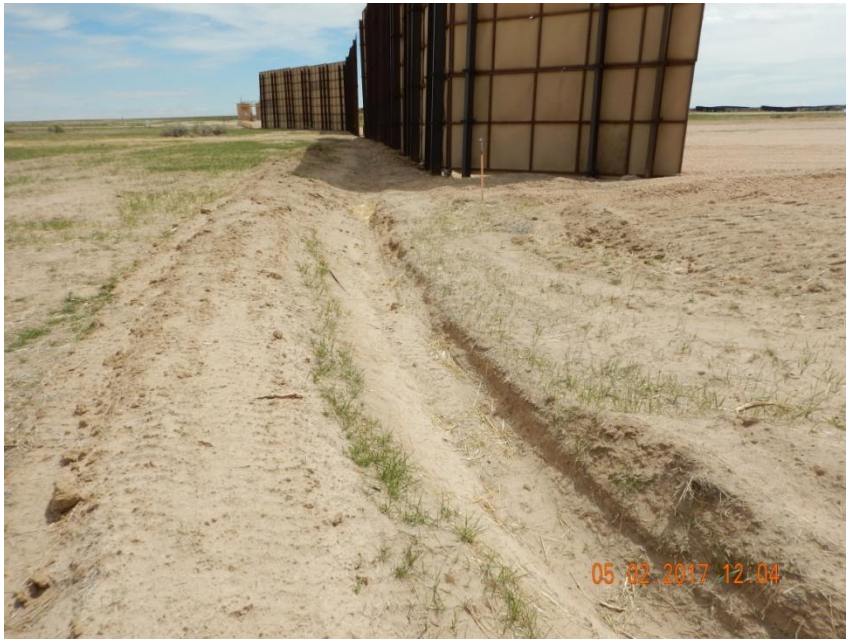
Photo 7. Photo taken from the northwest perimeter of the location, facing East. Ditch and berm BMP has been installed along portions of the northern perimeter of the location.

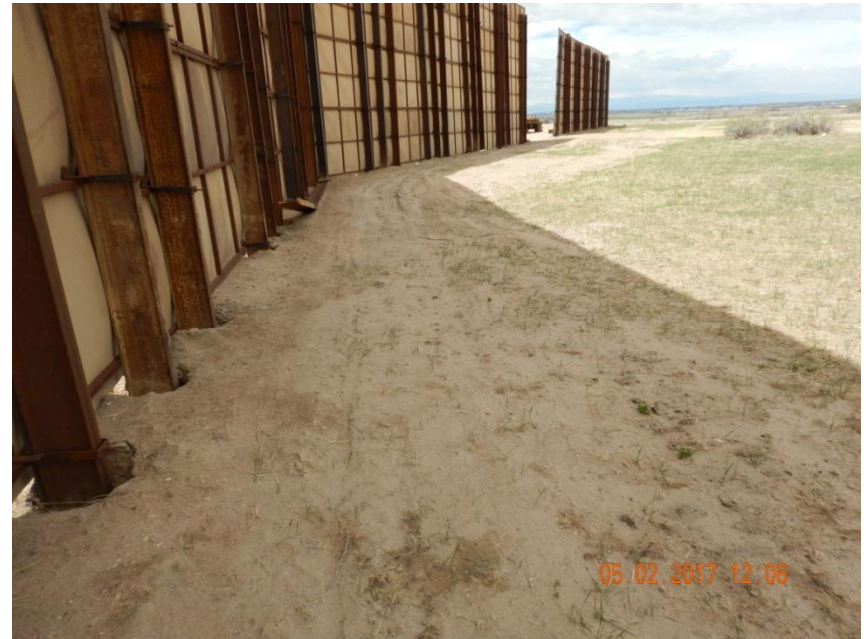
Photo 8. Photo taken from the northeastern perimeter of the location, facing West. No stormwater BMP observed. Operators do need to control run-on onto location to minimize erosion and site degradation which may require stormwater BMPs.
