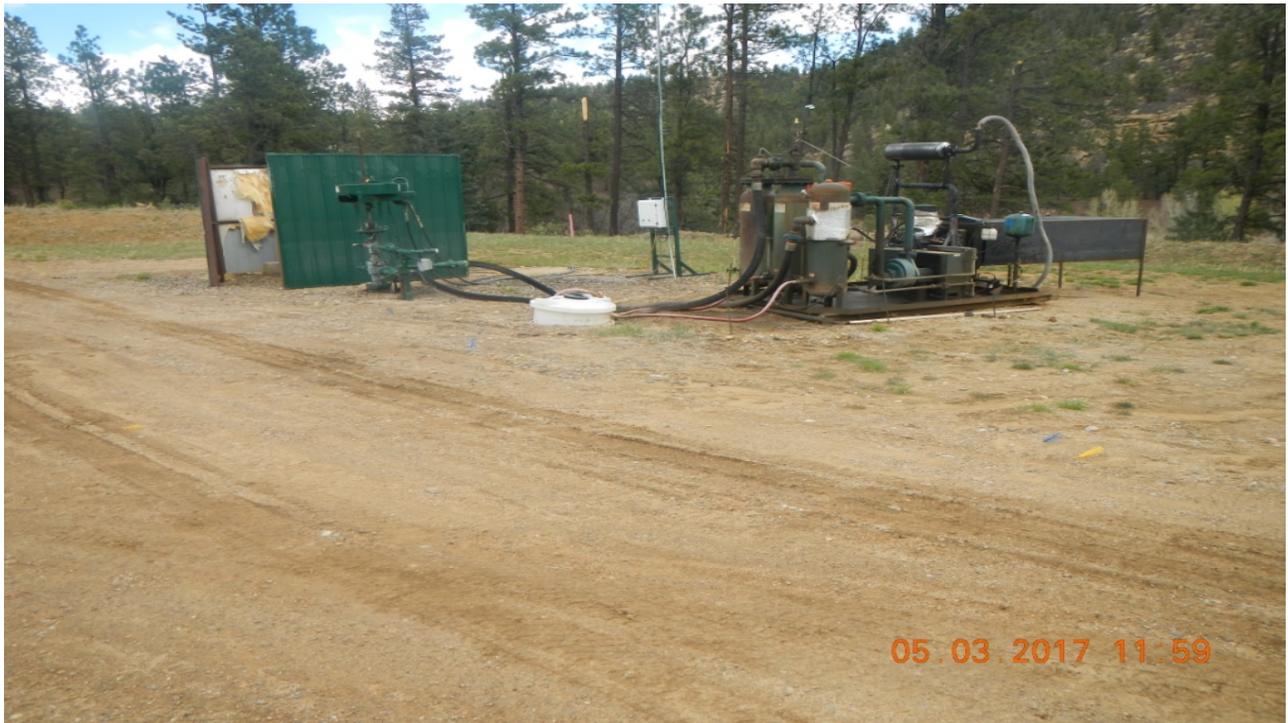
photo 1: Facing toward the production equipment.

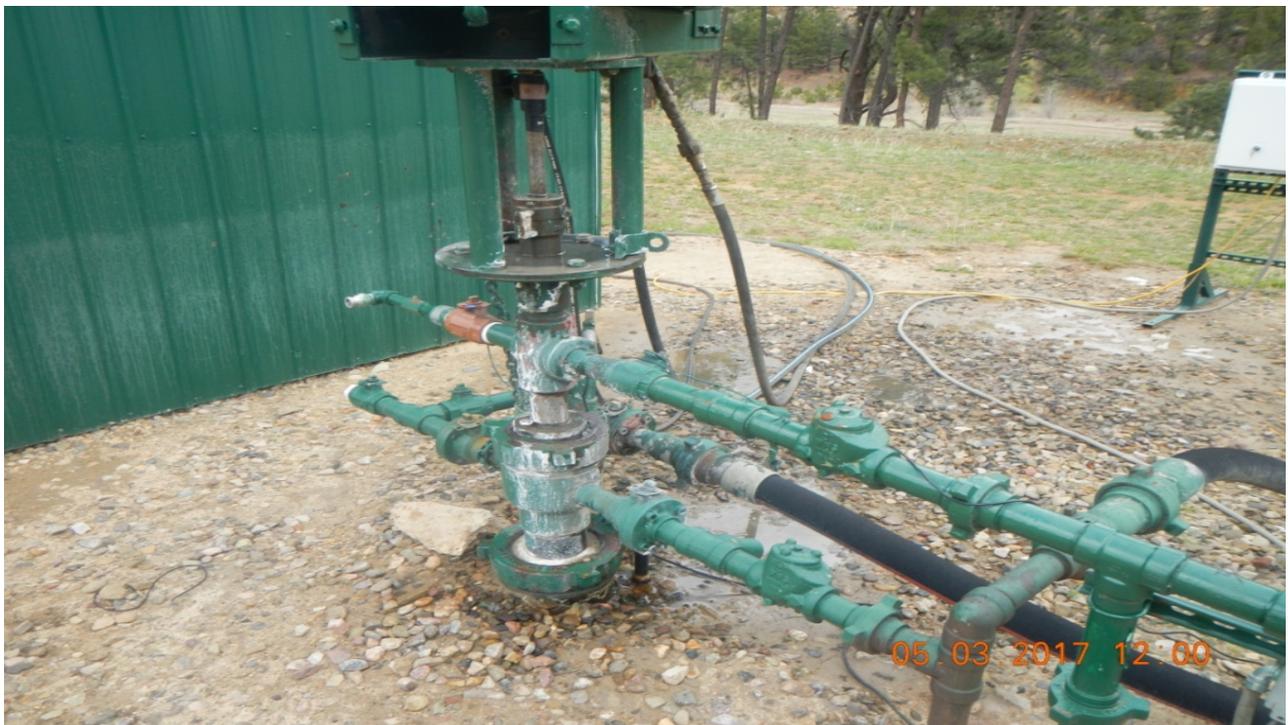
photo 2: There is a slow dripping water leak coming out of the wellhead.

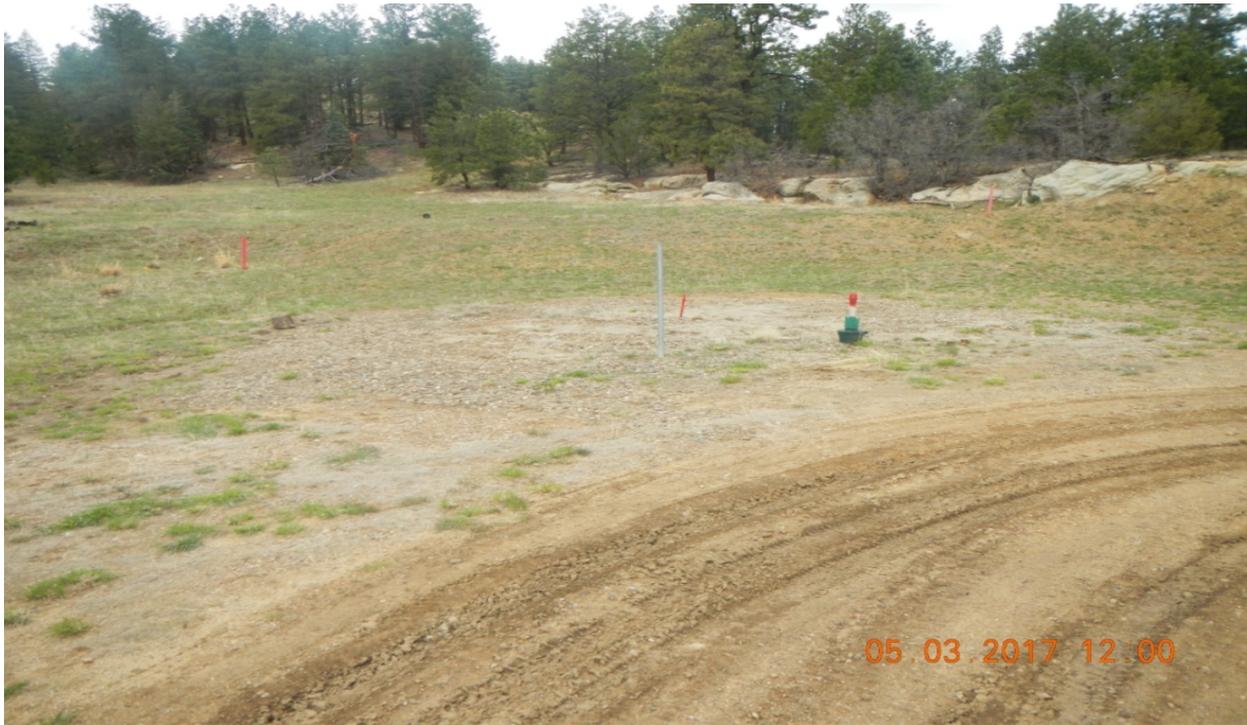
photo 3: Facing toward the west side of the location..

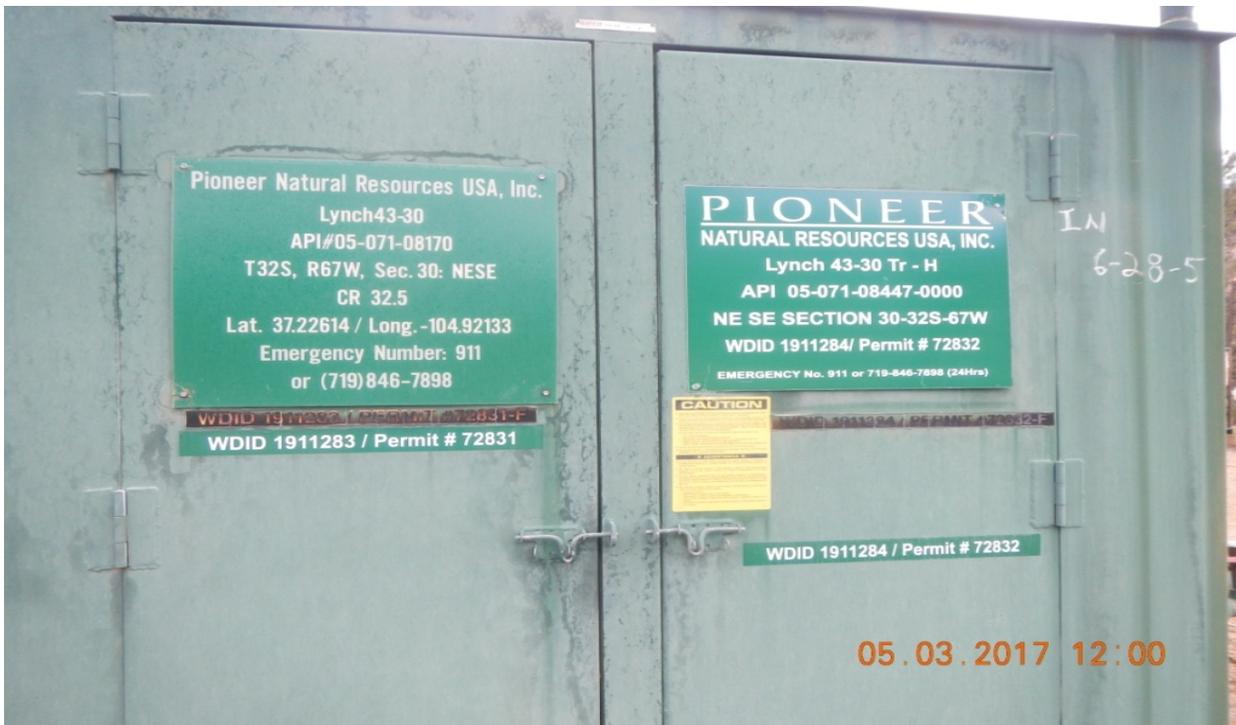
photo 4: Well signs.

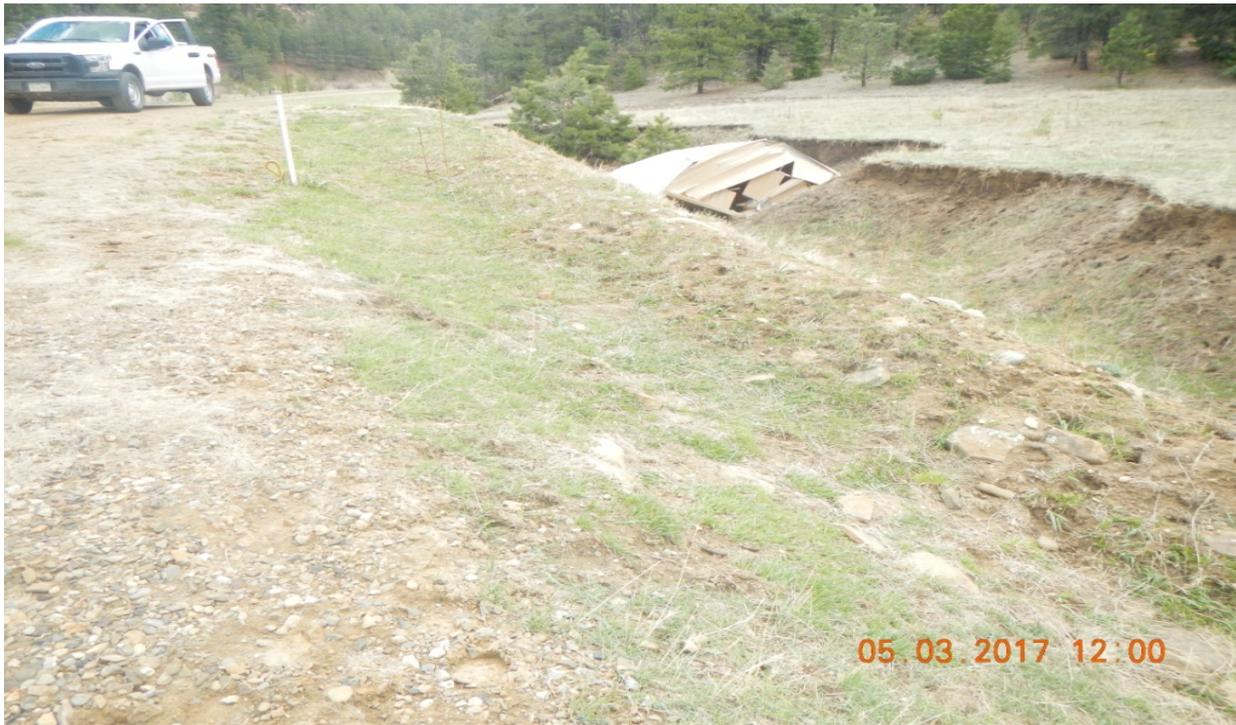
photo 5: There is a metal shed which is in the arroyo adjacent to the site.

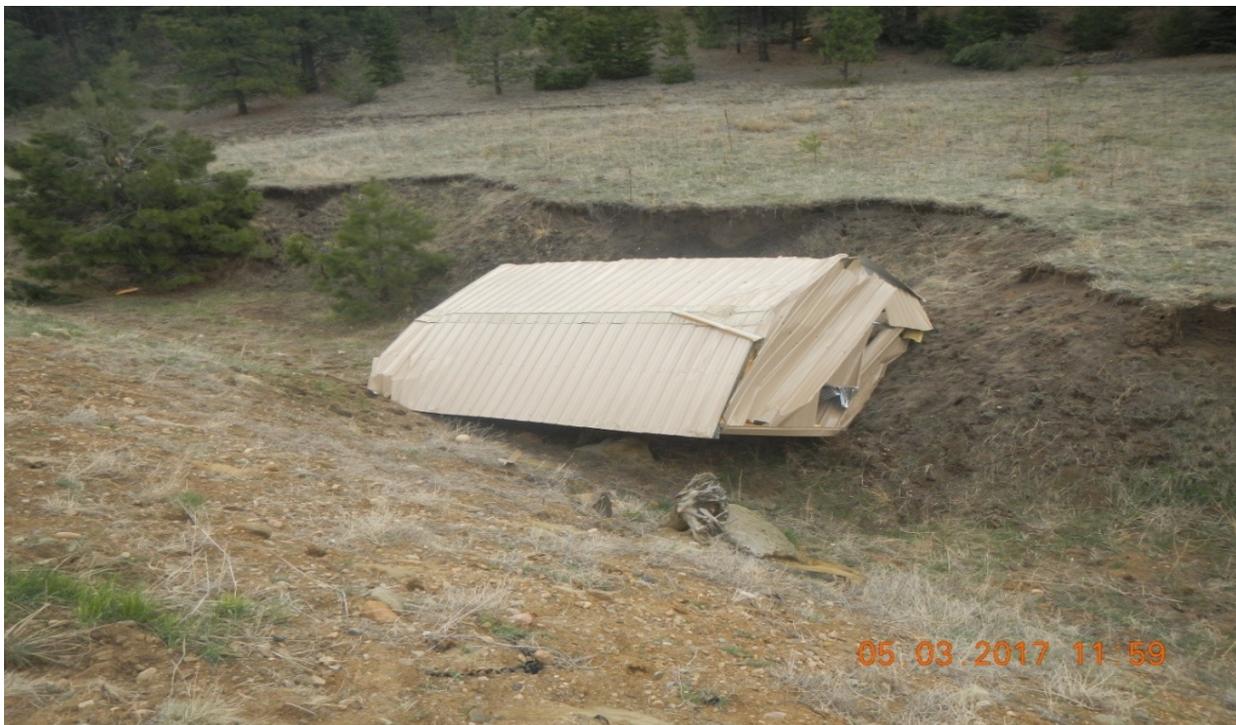
photo 6: Damaged metal shed in the arroyo adjacent to the location.
