Construction and Stormwater Inspection

May 2, 2017

Operator: FIFTH CREEK ENERGY OPERATING COMPANY LLC- #10629

Location ID: 444164

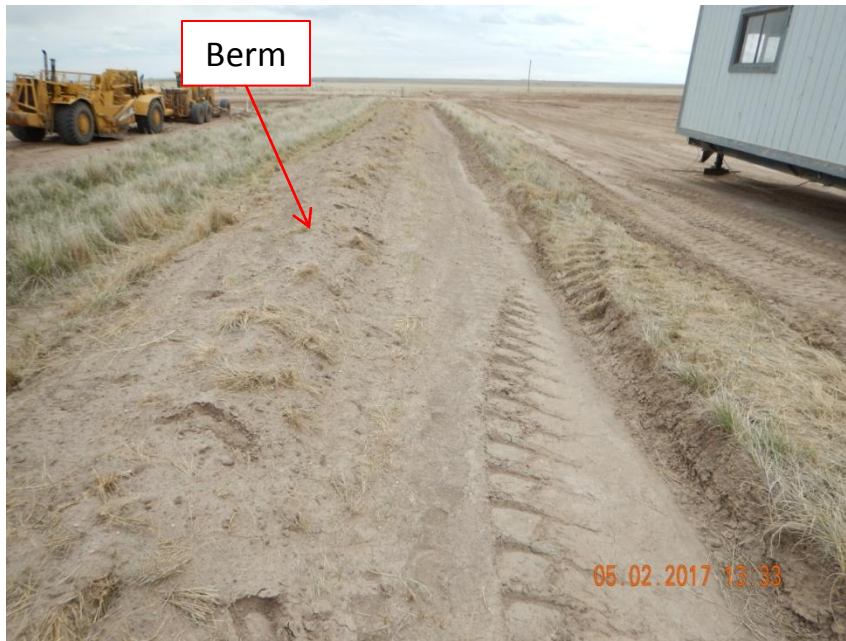
Photo 1. Photo taken from the northeastern location, facing South. Ditch and berm BMP has been installed around the entire perimeter of the location. Berm material does not appear to be sufficiently stabilized to prevent unconsolidated soil material from leaving location.

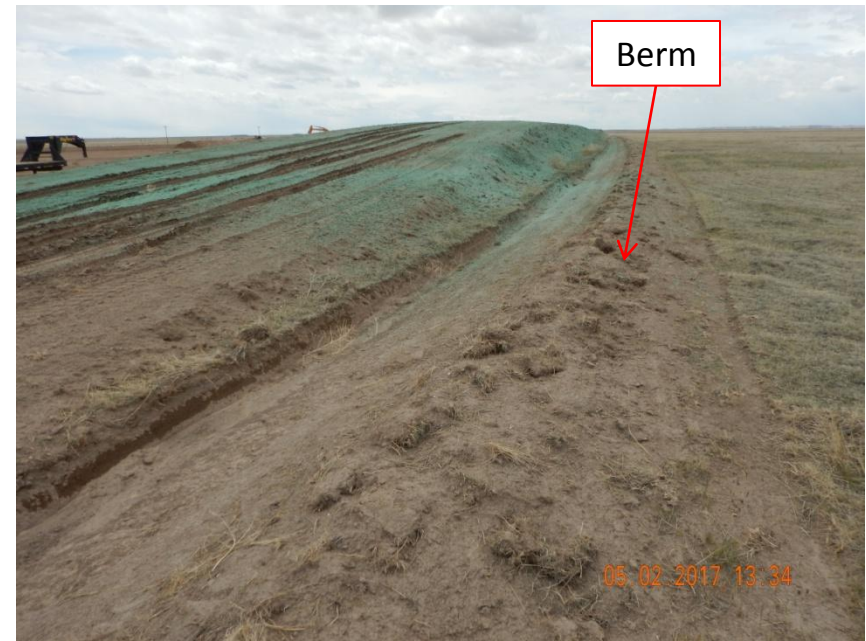
Photo 2. Photo taken from the northeastern location, facing West. Ditch and berm BMP has been installed around the entire perimeter of the location. Berm material does not appear to be sufficiently stabilized to prevent unconsolidated soil material from leaving location. Topsoil stockpile stored along the northern perimeter of the location.

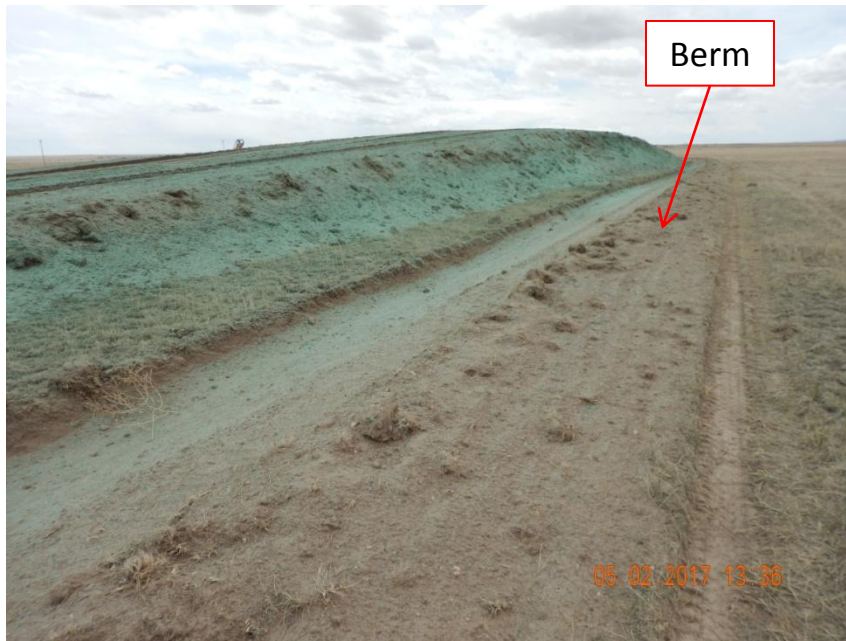
Photo 3. Photo taken from the northwestern location, facing West. Ditch and berm BMP has been installed around the entire perimeter of the location. Berm material does not appear to be sufficiently stabilized to prevent unconsolidated soil material from leaving location. Topsoil stockpile stored along the northern perimeter of the location.

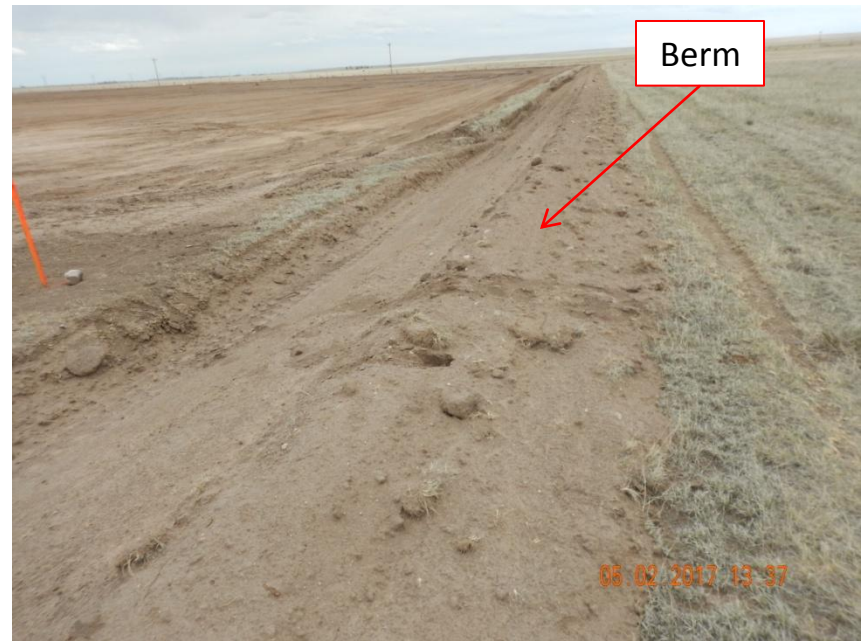
Photo 4. Photo taken from the western location, facing South. Ditch and berm BMP has been installed around the entire perimeter of the location. Berm material does not appear to be sufficiently stabilized to prevent unconsolidated soil material from leaving location.

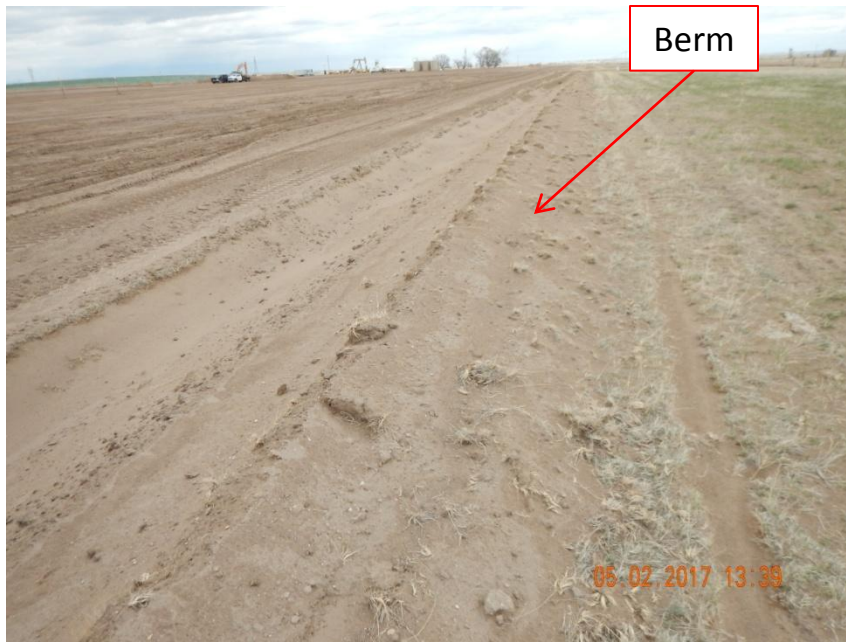
Photo 5. Photo taken from the southwestern location, facing East. Ditch and berm BMP has been installed around the entire perimeter of the location. Berm material does not appear to be sufficiently stabilized to prevent unconsolidated soil material from leaving location. BMP maintenance may be required along portions of the ditch BMP as sediment appears to be accumulating in the ditch BMP.

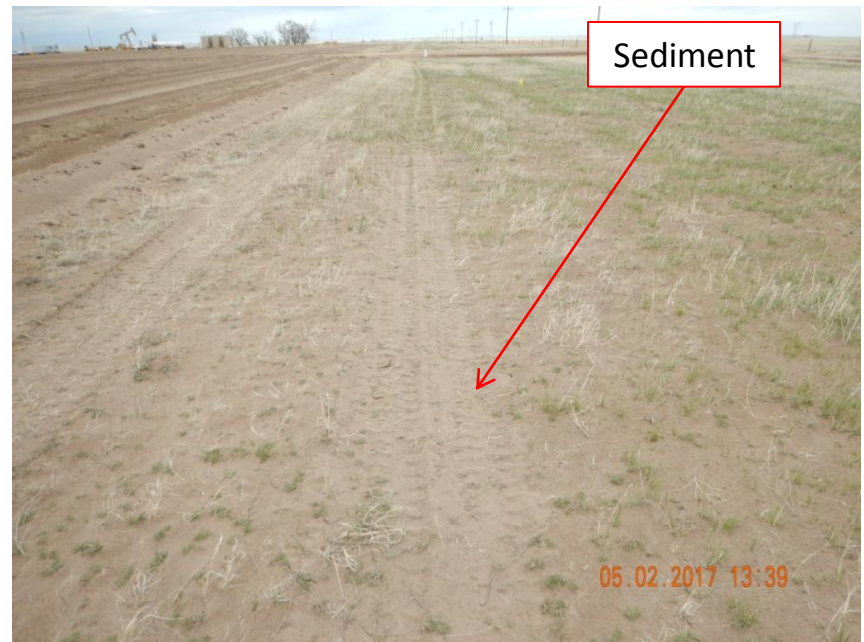
Photo 6. Photo taken approximately two meters from the southern perimeter of the location, facing East. Sediment material from the location appears to be accumulating along portions off location along the southern perimeter due to wind erosion.

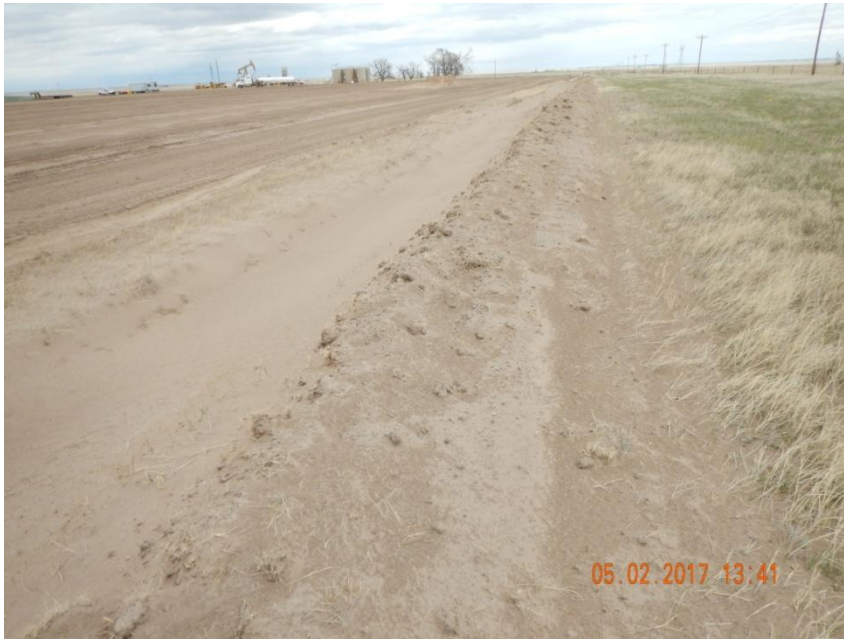
Photo 7. Photo taken from the southeastern location, facing East. Ditch and berm BMP has been installed around the entire perimeter of the location. Berm material does not appear to be sufficiently stabilized to prevent unconsolidated soil material from leaving location. BMP maintenance may be required along portions of the ditch BMP as sediment appears to be accumulating in the ditch BMP.

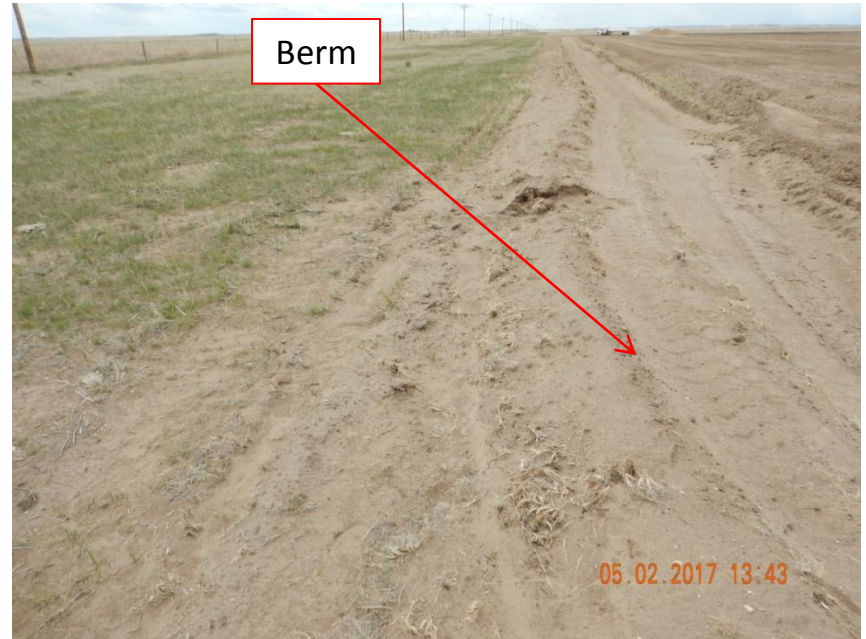
Photo 8. Photo taken from the southeast location, facing West. Ditch and berm BMP has been installed around the entire perimeter of the location. Berm material does not appear to be sufficiently stabilized to prevent unconsolidated soil material from leaving location. This photo illustrates how some of that material is starting to spread out.

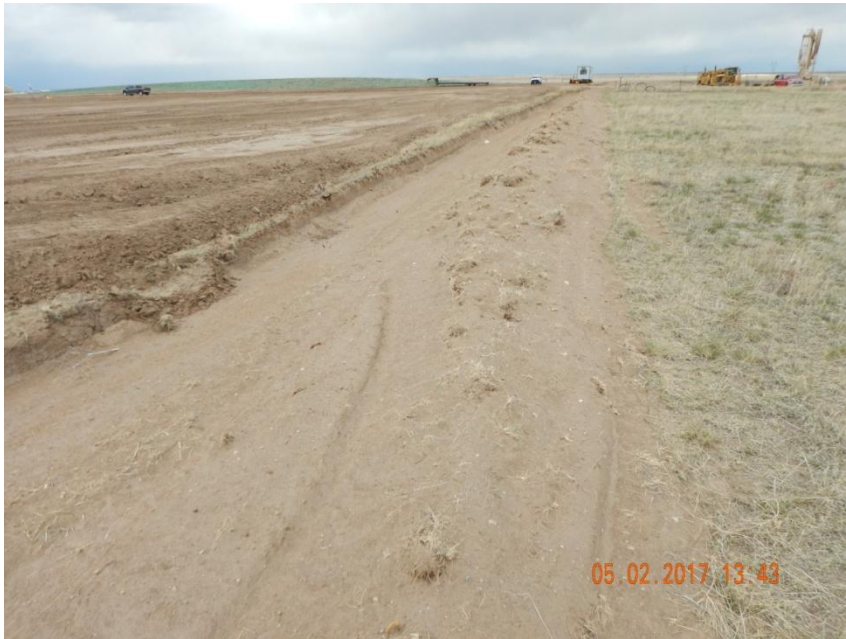
Photo 9. Photo taken from the southeast location, facing North. Ditch and berm BMP has been installed around the entire perimeter of the location. Berm material does not appear to be sufficiently stabilized to prevent unconsolidated soil material from leaving location.

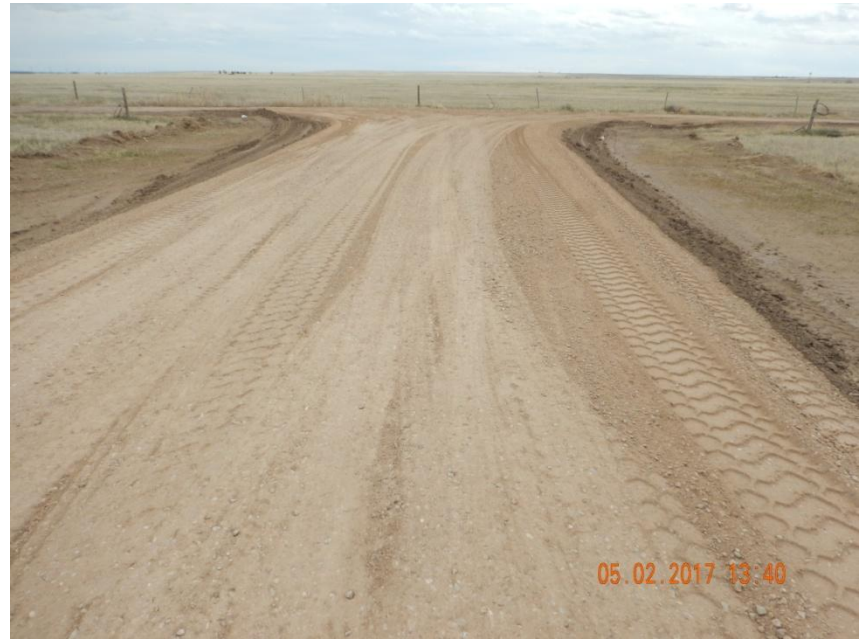
Photo 10. Photo taken from the entrance of the location, facing South. Gravel has been installed at the entrance of location.
